**UPDATE BAT AND BARN OWL SURVEY OF  
CLARENDON BARN, LISKEY HILL, PERRANPORTH, CORNWALL.**

**October 2021**

**Report No:** 20-164\_BBO\_Clarendon\_Barn

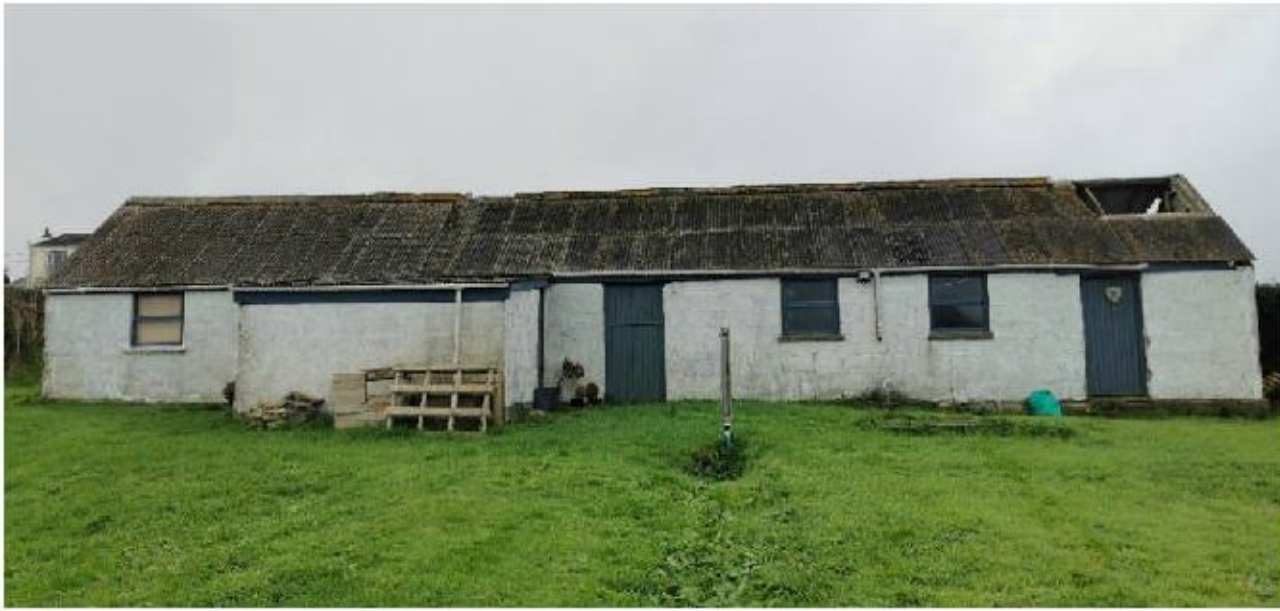
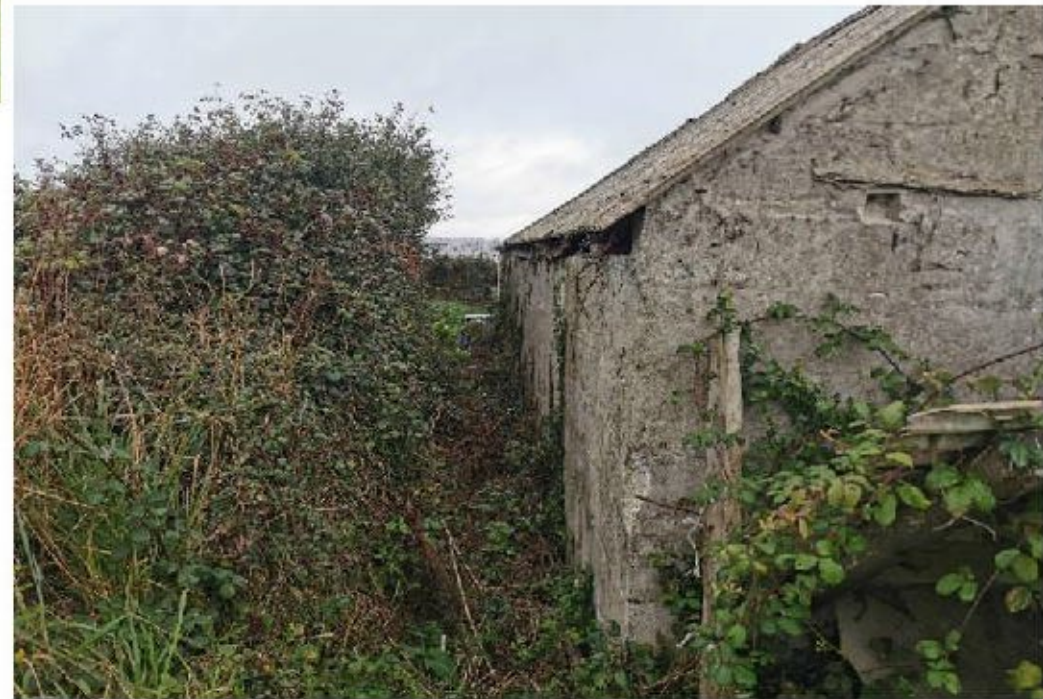
The barn is approximately 20 metres long and is comprised of breeze blocks with rendering on the northern aspect. An extension has been added to the western end of the building, along with another extension on the northern aspect. A small lean-to which is defunct and fallen through is located on the eastern end of the building. The building is located along a hedgebank with Bramble *Rubus fruticosus* agg. encroaching onto the eastern end. Ivy *Hedera helix* and Bramble have been managed along the entire southern aspect to prevent further growth.

The roof is pitched on the main building and flat roofed on the northern extension. They comprise asbestos sheeting with asbestos ridge tiles on the main roof, which is broken through and missing from part of the western end of the barn. There are also several large gaps across the roof face. The window frames are wooden, and all windows are relatively airtight. The fascias are wooden and are set back from the walls and from the wall tops of the barn. The guttering is PVC plastic piping.

**Photo 1, 2:** The barn from the northern aspect (top left), and the southern aspect along the hedgebank (bottom right).

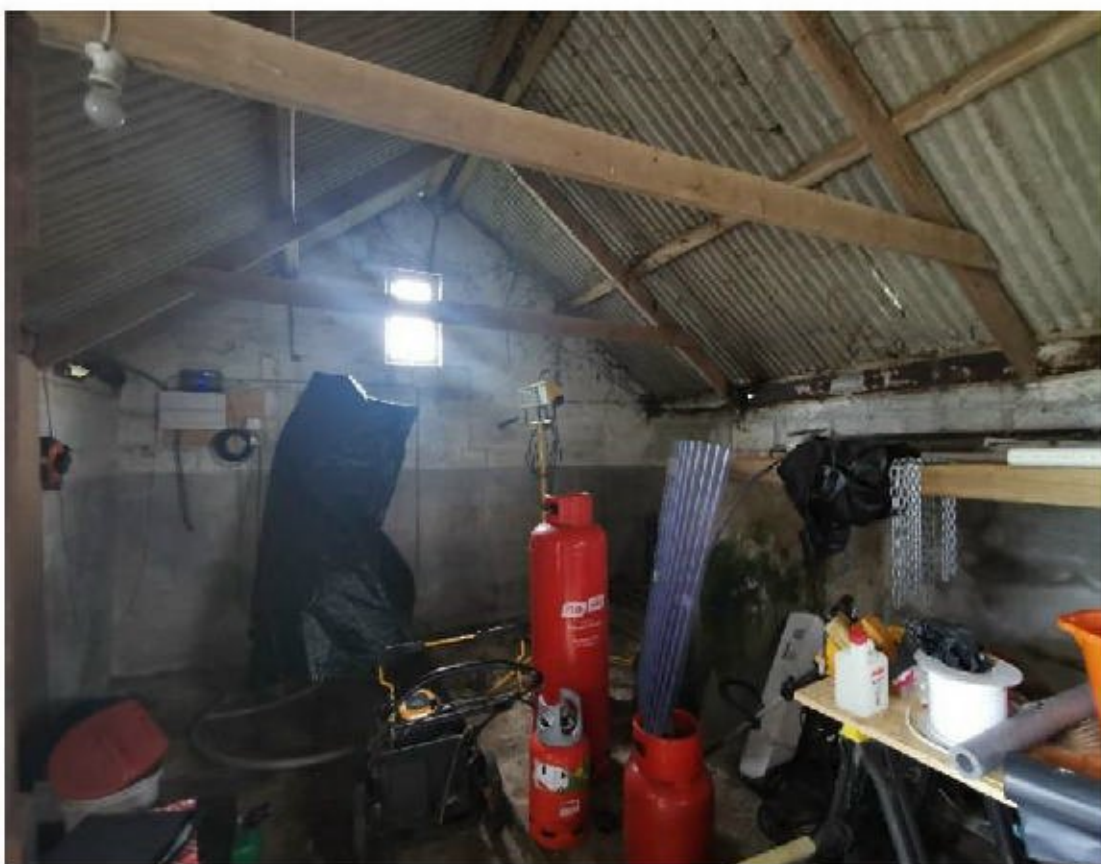
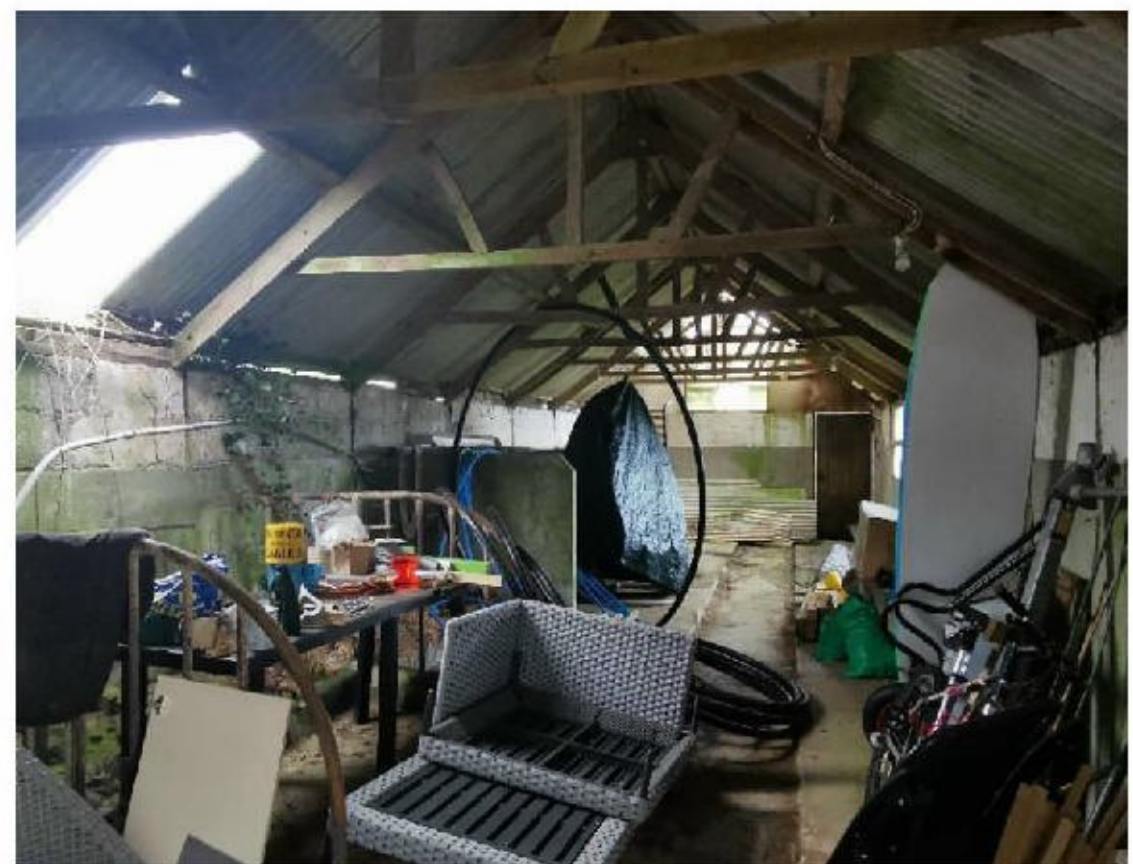
Internally, the barn is open and contains stored objects throughout. There are old domestic animal stalls along the southern wall. The western end is darker, and the roofing here contains less holes. The roofing is composed of wooden trusses with support beams. The roof does not meet the wall tops and as such the elements are able to enter the barn. The walls are cement rendered and the flooring is concrete based throughout.

**Photo 3, 4:** Internal aspects of the barn from the eastern (left) and western (right) ends.

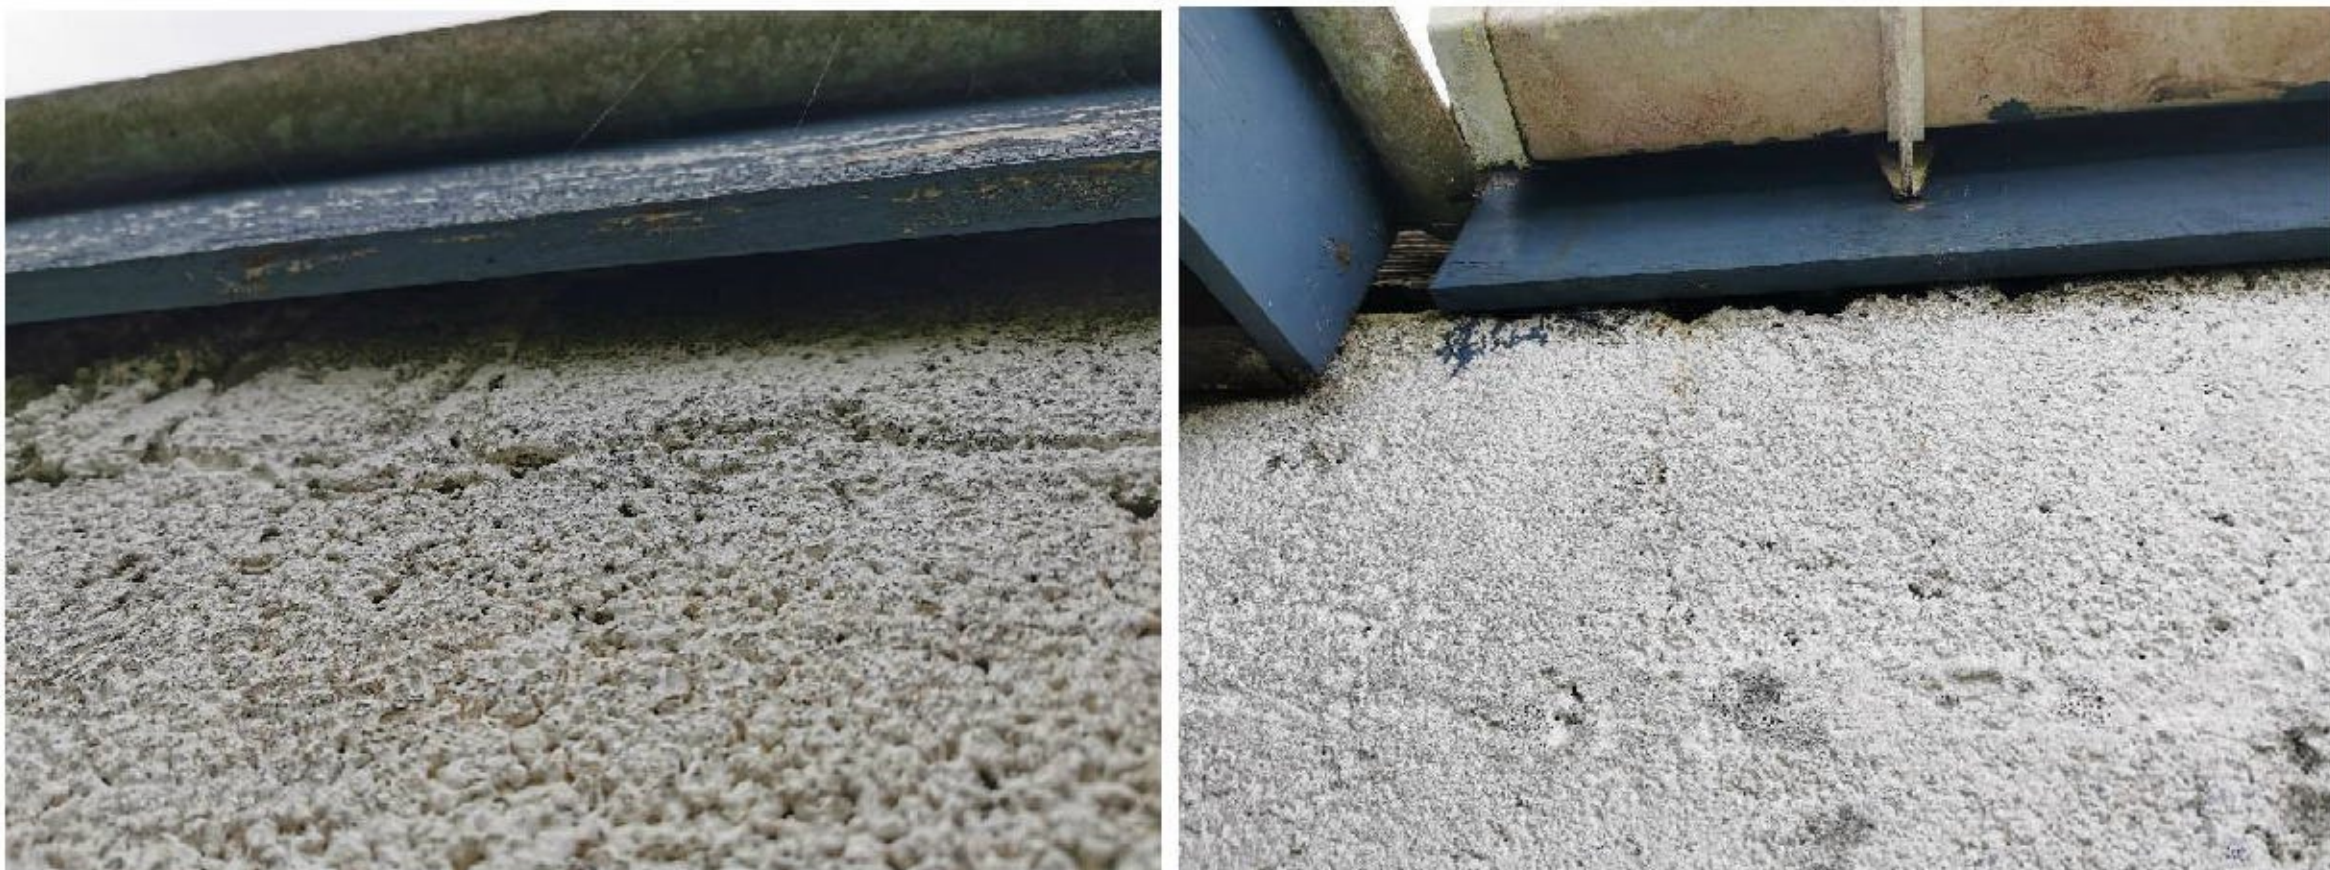
Externally, several spaces were noted behind the fascia boarding on the northern aspect along the northern extension. These are set back from the walls by approximately 2cm and allow access into the barn. They could allow bats roosting space on warmer evenings; however, these were searched thoroughly, and no bats were seen during the survey. The gaps were mainly filled with cobwebs and snails.

Photo 5, 6: Gaps behind the fascia boarding along the northern extension (left) and part of the northern aspect of the main barn (right).

No further surveys are recommended at this time. The survey did not find any evidence for the presence of bats at the barn and the building was assessed as having low potential for roosting bats.

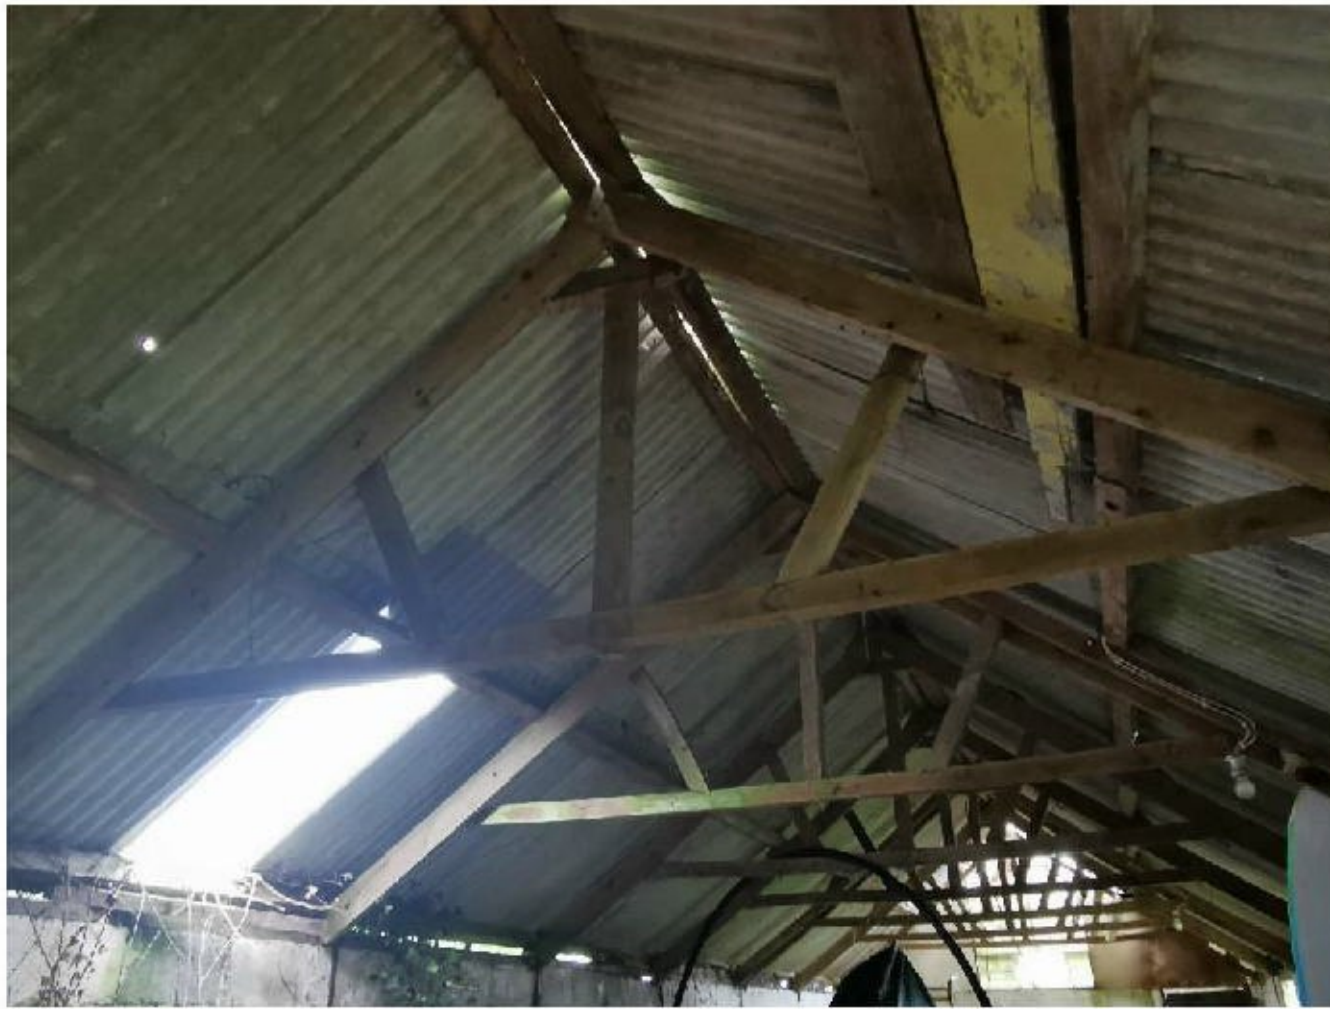
The wall tops do not reach the roof along the entire barn and as such large gaps are present in most places leading outside. The roof also contained many gaps throughout leading directly to outside. This

could allow access to bats for night roosting; however no evidence of this was discovered within the barn and the building is within an exposed location within the landscape.

Photo 7: The roof internally. There are large gaps between the wall tops and roof, missing asbestos sheeting and a partly missing roof at the western end.

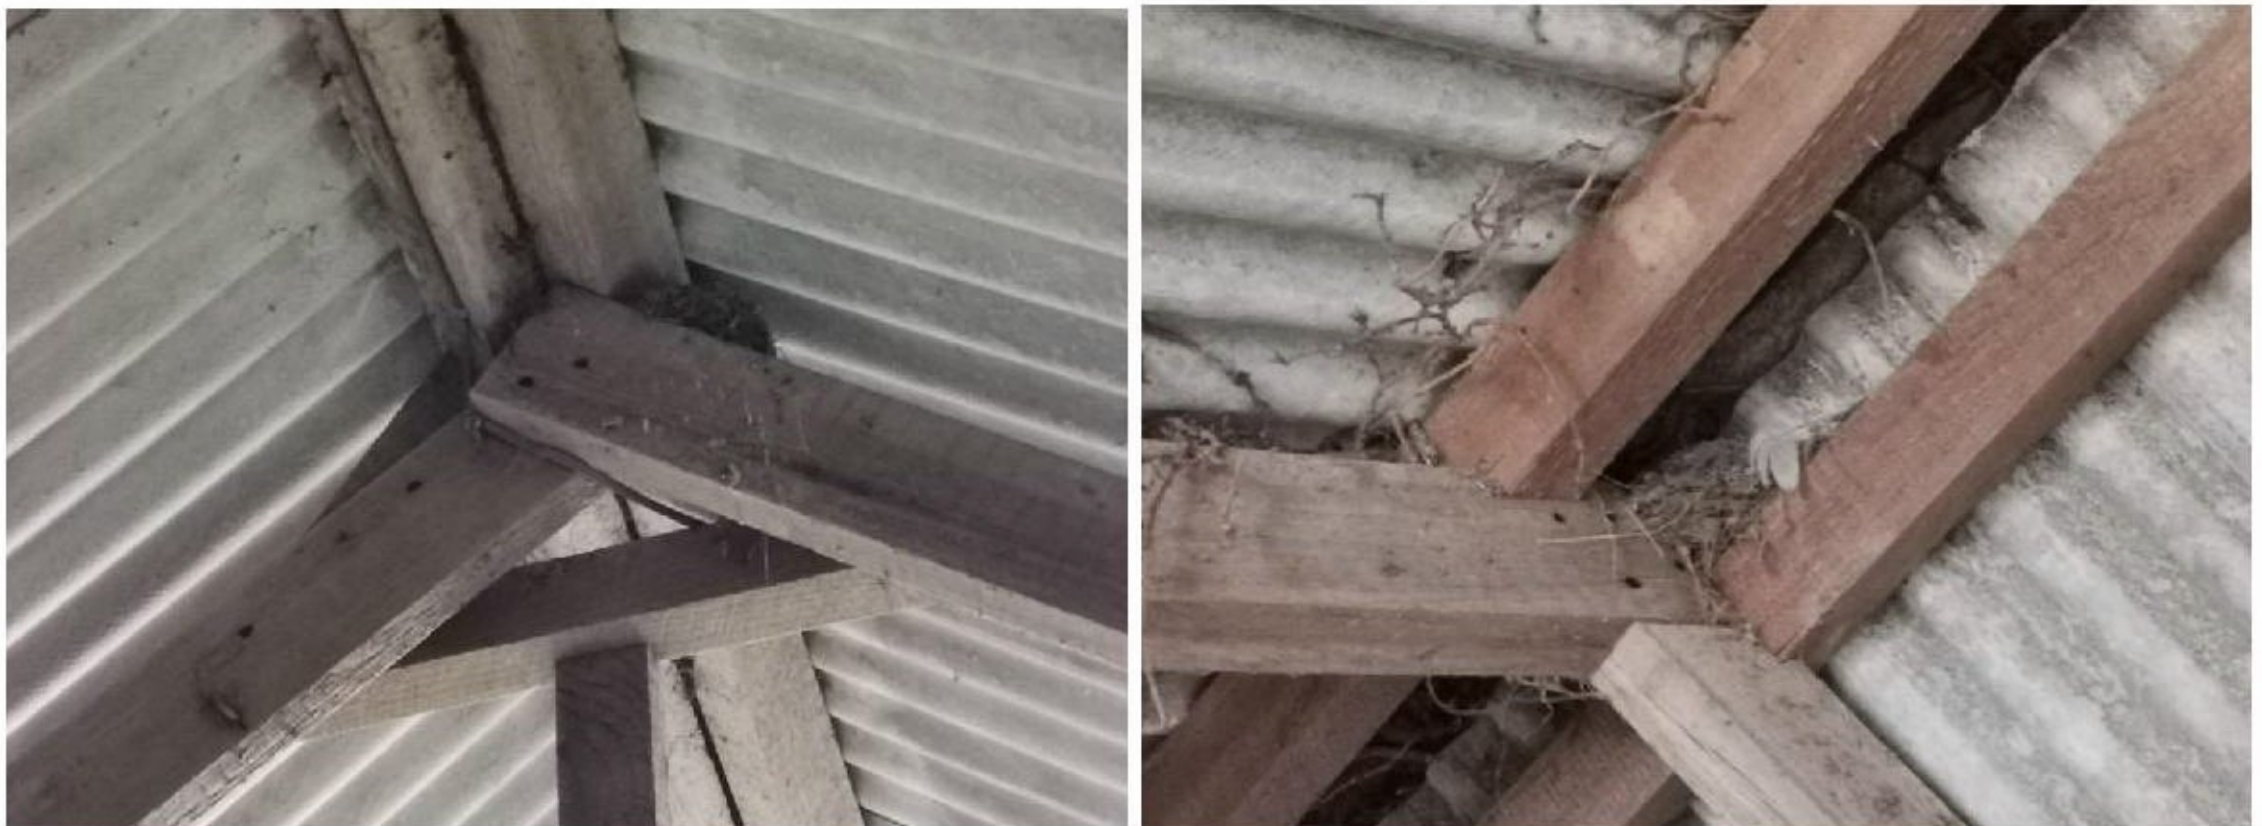
Evidence in the form of three Barn Swallow nests were discovered inside the barn within gaps where the trusses are attached.

Photo 8, 9: Two of the three Barn Swallow nests located within the rafters of the barn.

As a precaution a careful inspection of the barn for nesting birds should be carried out prior to works commencing. This would establish that no nesting birds are present before work proceeds. If nesting birds are found works should wait until the chicks have left the nest. This relates to legislation which affords protection to birds whilst nesting.

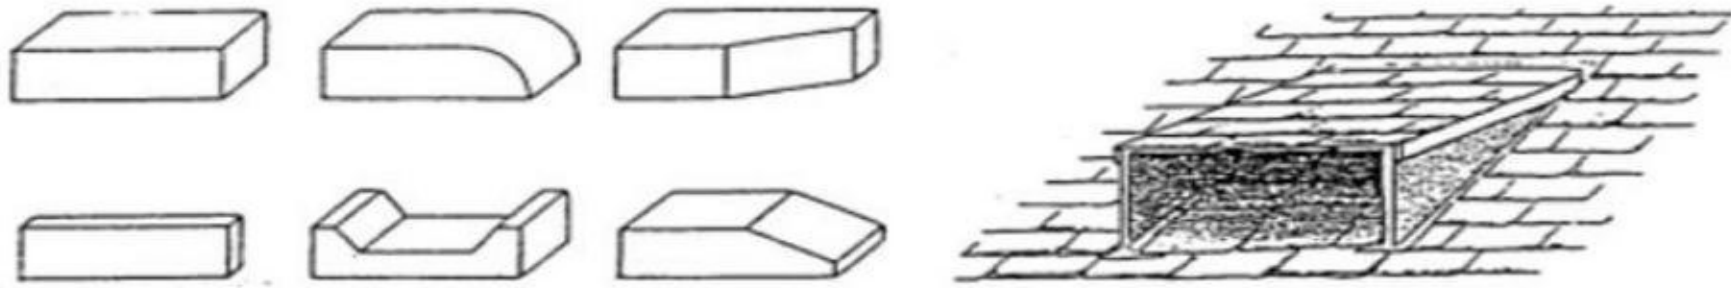
Walling bricks for creating bat access points. A standard brick is shown top left

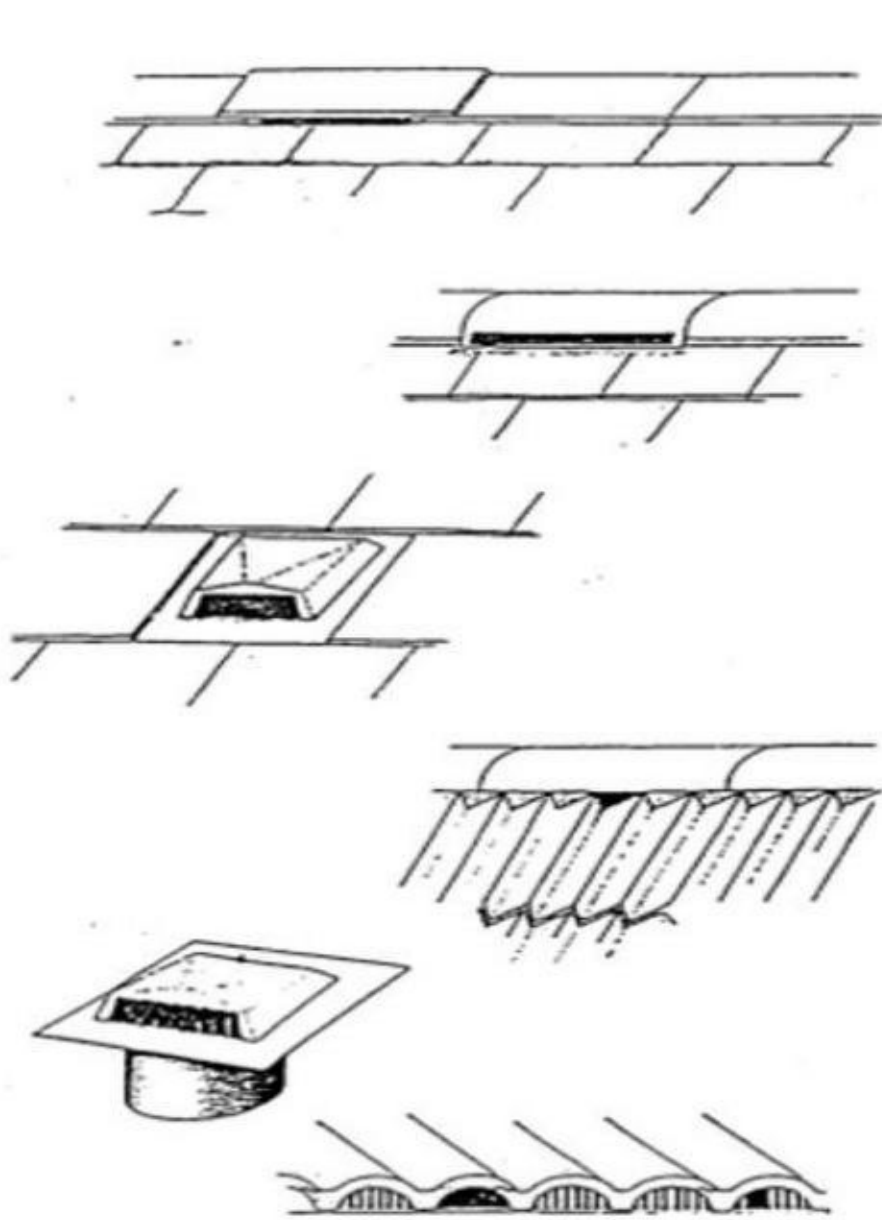
Ridge ventilators can be adapted as bats access points. It may be necessary to remove internal plastic moulding.

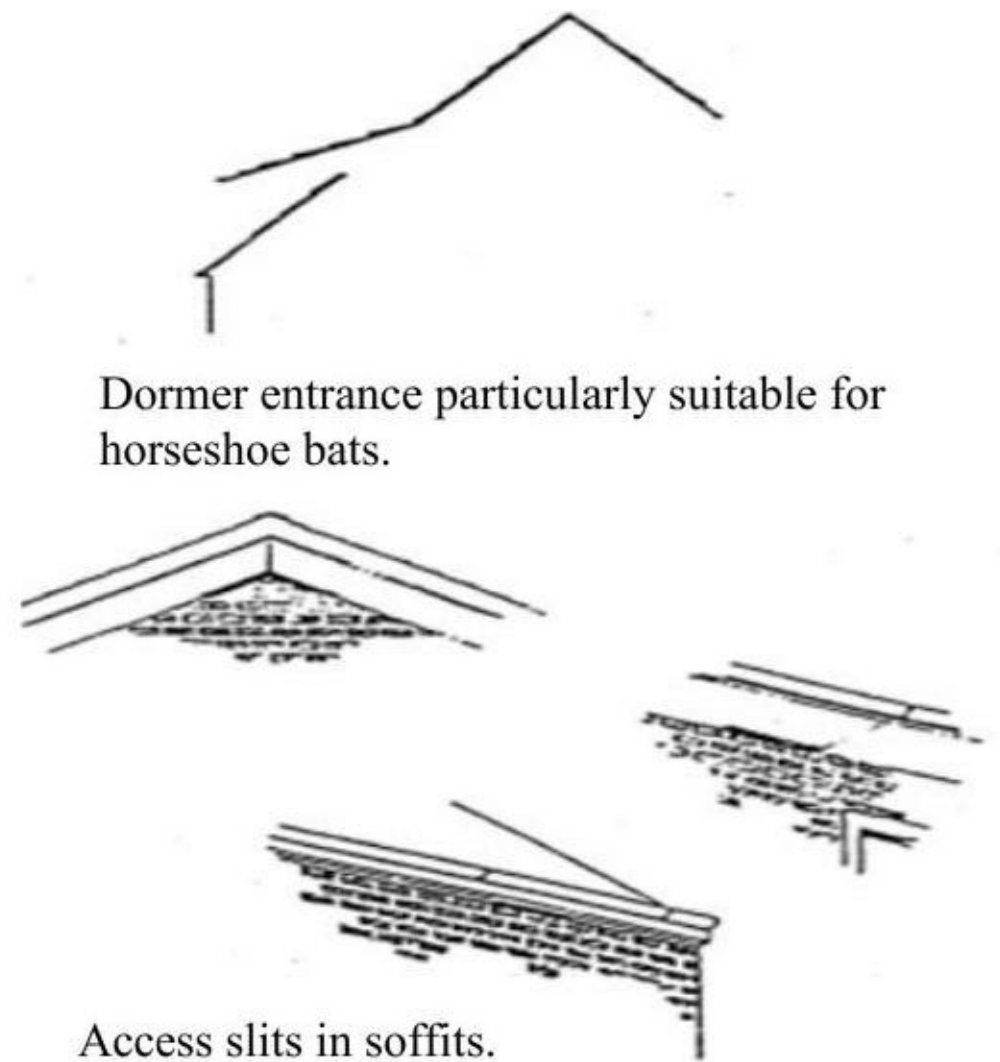
Dormer entrance particularly suitable for horseshoe bats.

Access slits in soffits.

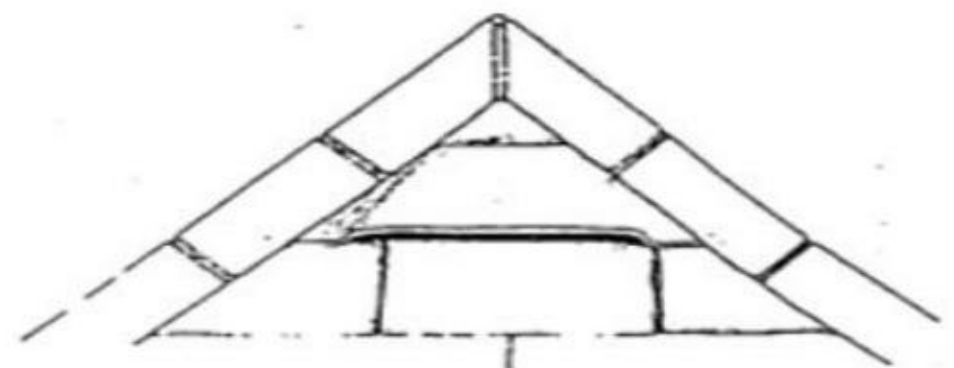
Lead saddle in place of a slate to allow bats access to ridge or roof void.
