**TINNERS ARMS, ZENNOR
TR26 3BY**

**PLANNING AND LISTED BUILDING APPLICATION
DESIGN AND IMPACT STATEMENT**

October 2021

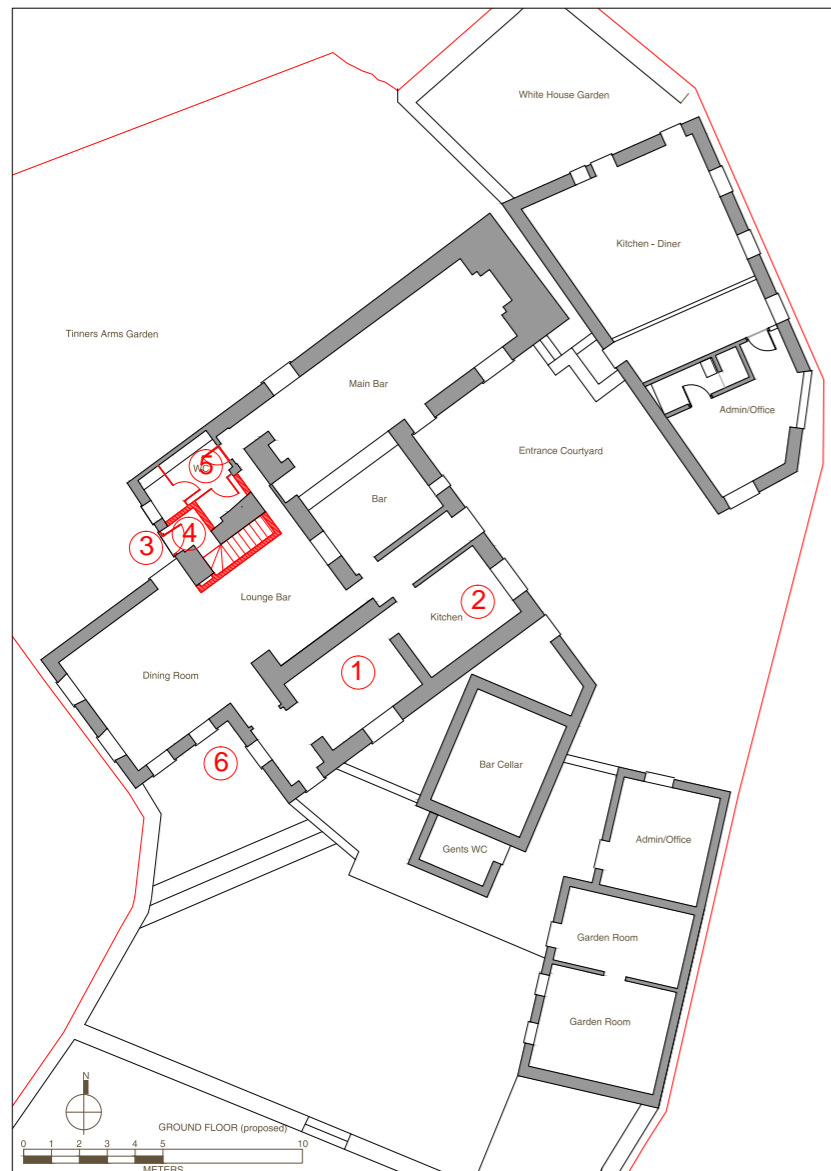
PLAN 2: PROPOSED GROUND FLOOR PLAN

PROPOSED WORKS: GROUND FLOOR

1. RELOCATE HAZARDOUS STAIR TO MANAGER'S APARTMENT (Currently sits within commercial kitchen).
2. RE-CONFIGURE COMMERCIAL KITCHEN AREA.
3. NEW EXTERNAL DOOR TO ACCESS STAIR
4. NEW STAIR TO MANAGER'S 1ST FLOOR APARTMENT (See 1 above)
5. RE-CONFIGURE LADIES WC
6. IMPROVE SIGNAGE TO TERRACE ENTRANCE AT REAR OF PUB.

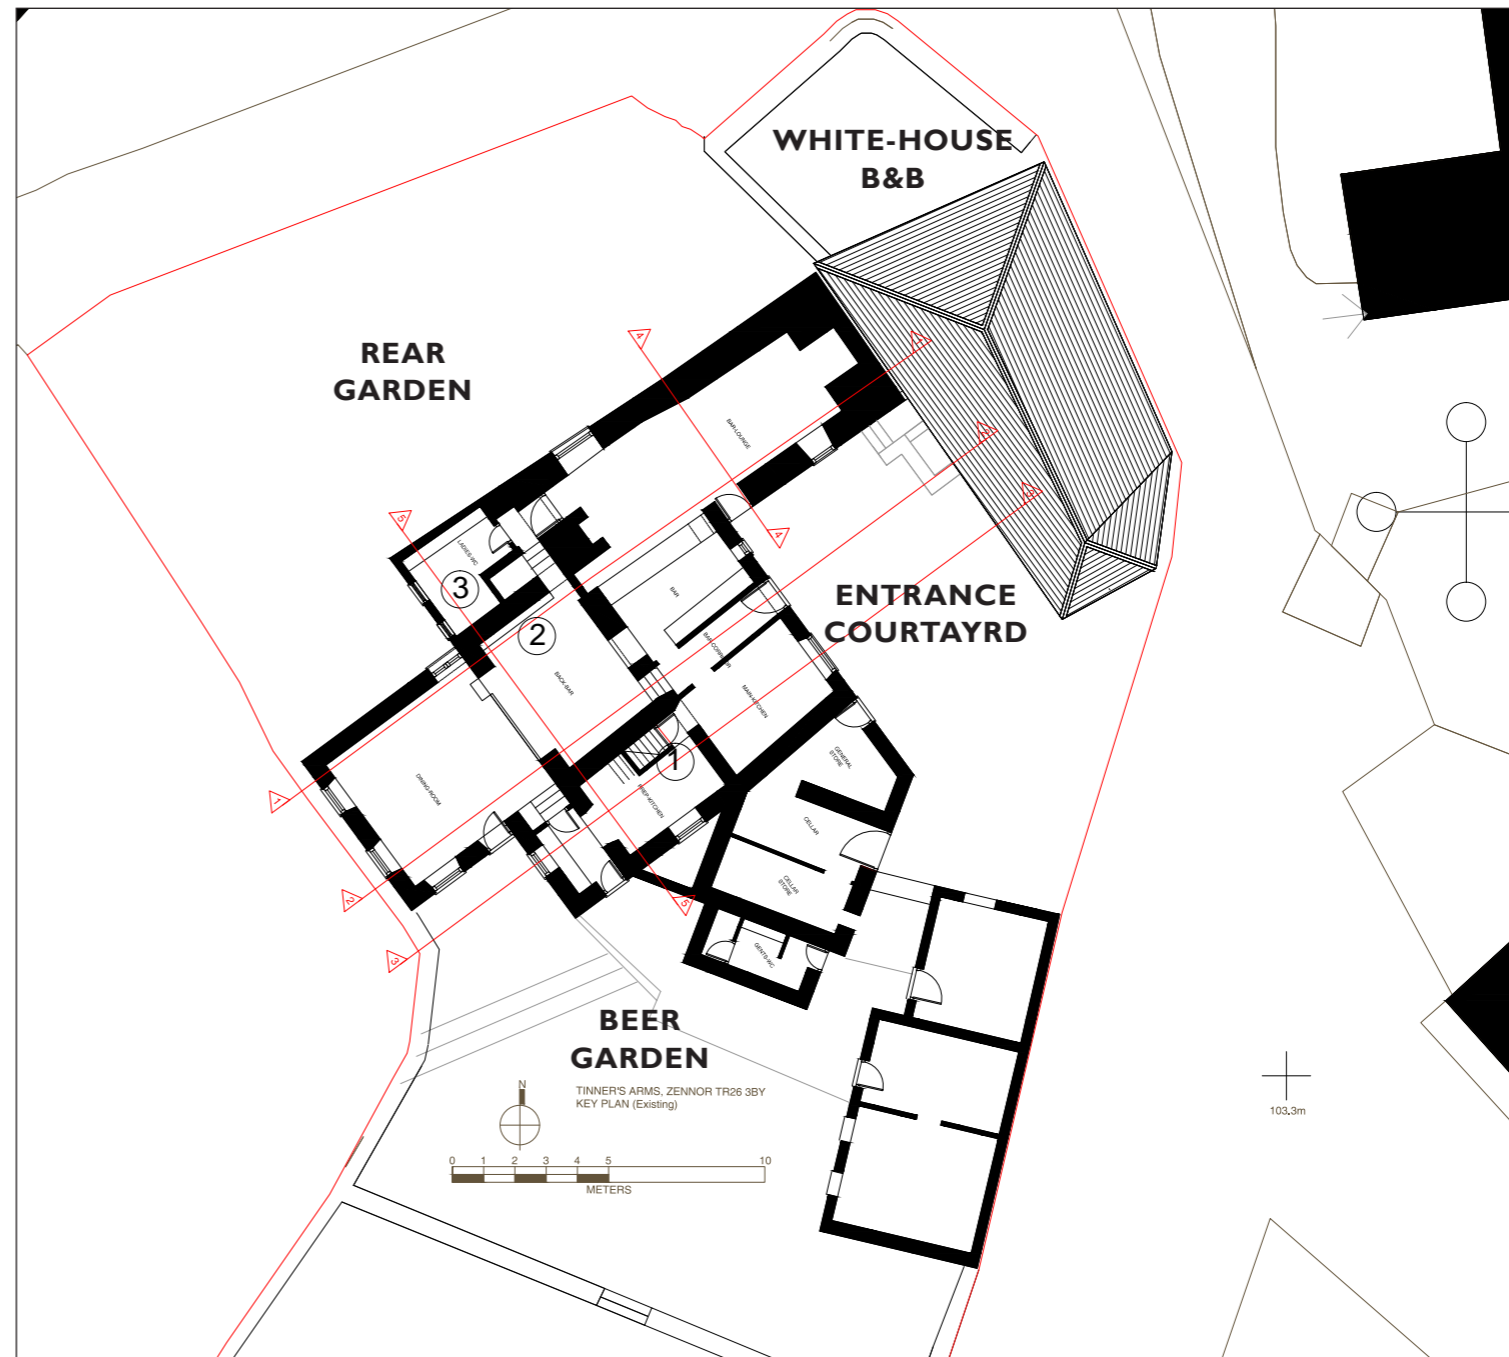
Fig. 6. Existing Key Plan

The existing access stair is extremely unsafe. It is the only stair within the building and does not allow for safe access and egress from first floor.

Further, the stair is located within the middle of a commercial kitchen and is therefore extremely unsafe and disrupts the workflow.

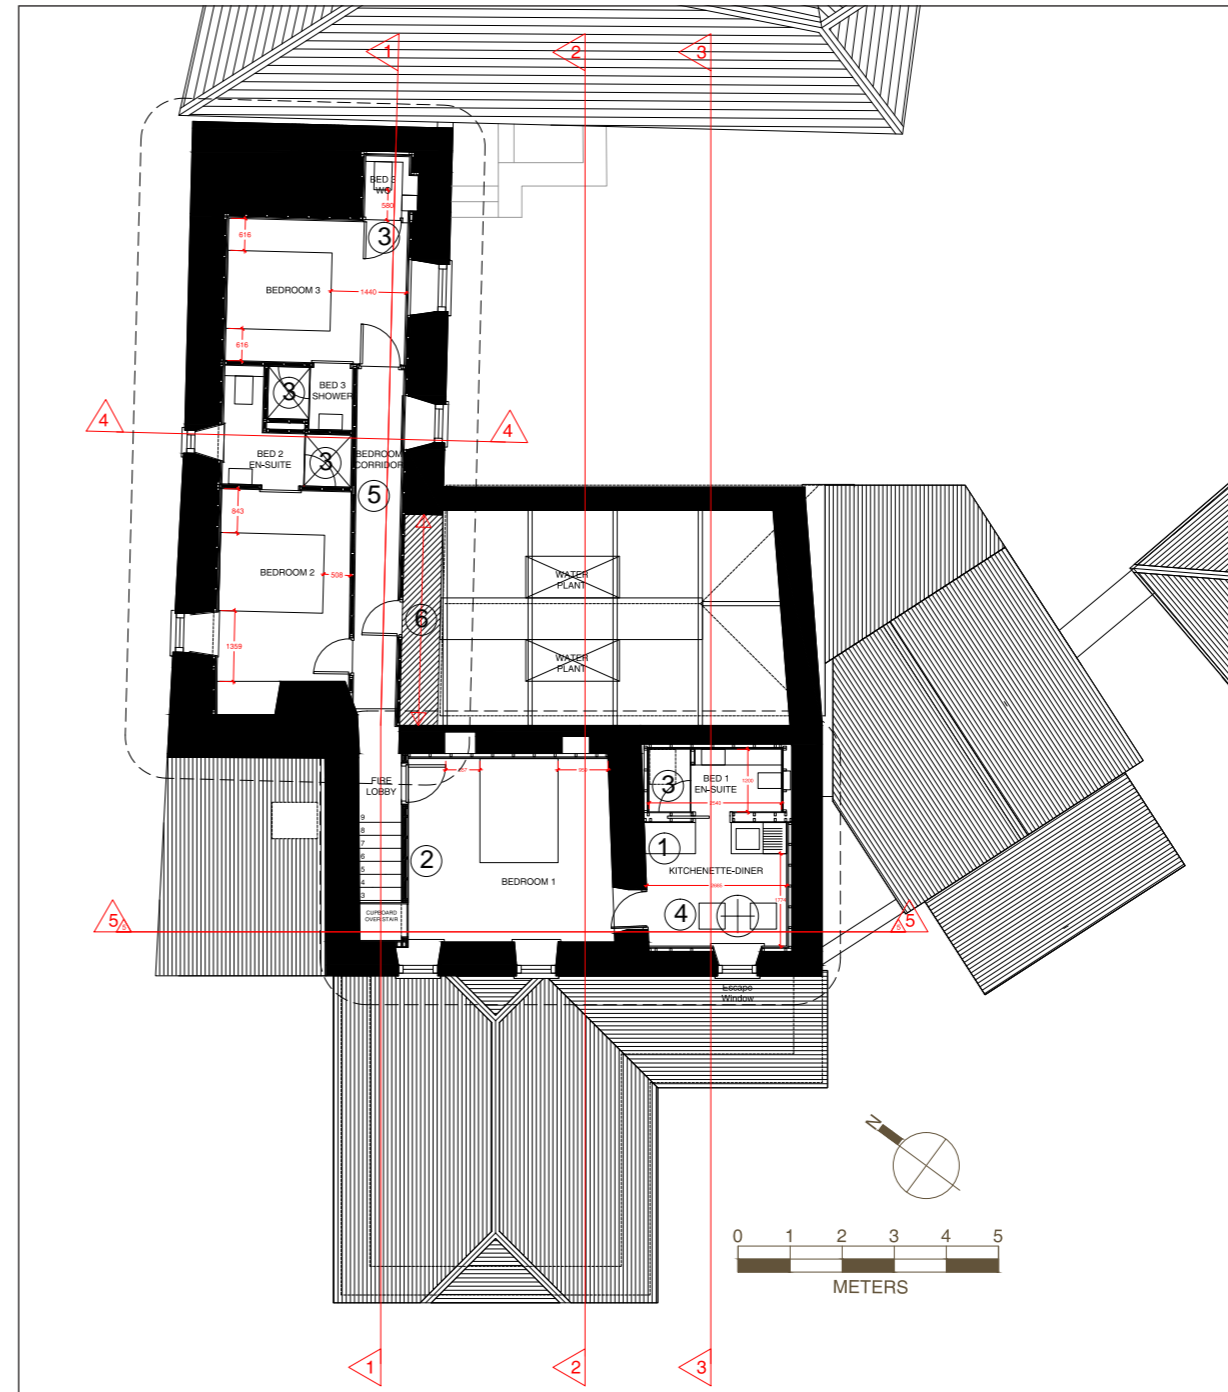
Fig.13. Proposed First Floor Plan

- ① Existing dangerous and non-compliant stair removed and floor made good with fire-resisting construction, to ensure fire safety standards are met.
- ② New access stair to 1st Floor accommodation. To be constructed from fire resisting construction to ensure fire-safety standards are met. Opening to be created between existing ladies WC and Back Bar to allow insertion of new stair.
- ③ New en-suites created with waste to discharge into existing drainage system at low level.
- ④ Small dining area created within existing bathroom area.
- ⑤ Partitions to be up-graded to ensure effective fire separation and to create a protected route in the event of a fire.
- ⑥ New fire-rated access door into plant space within attic over main kitchen.

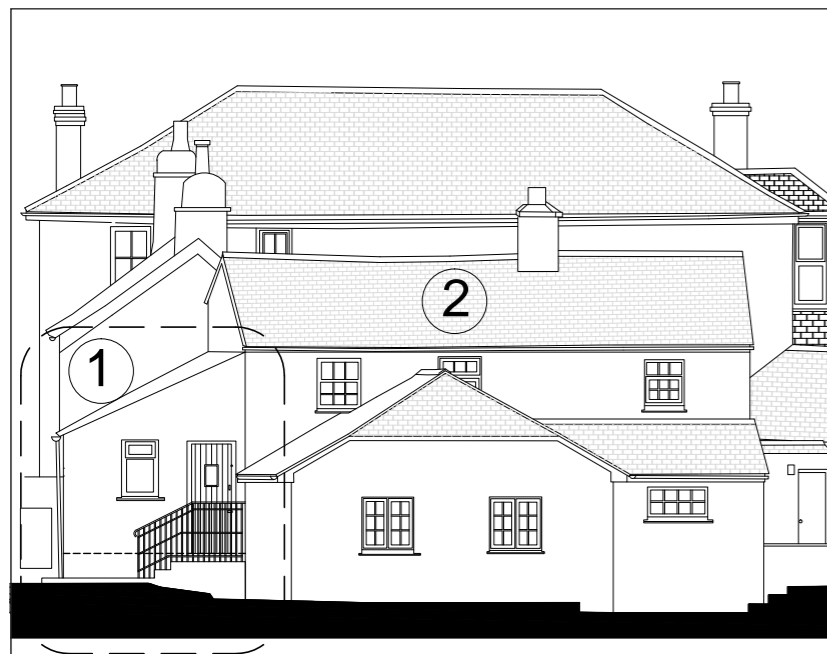
The elevations remain unchanged apart from a new entrance door and granite steps to the southwest elevation of the Ladies WC.

- ① New Timber "Plank" door (as per secondary doors within main pub entrance courtyard) with vision panel. To provide safe and secure access to first floor accommodation. Stepped access via granite built steps and traditional gunmetal railings.
- ② Failed roofs to be replaced with new slate roofs and replacement insulated ceiling as part of previously agreed emergency works planning regularisation.

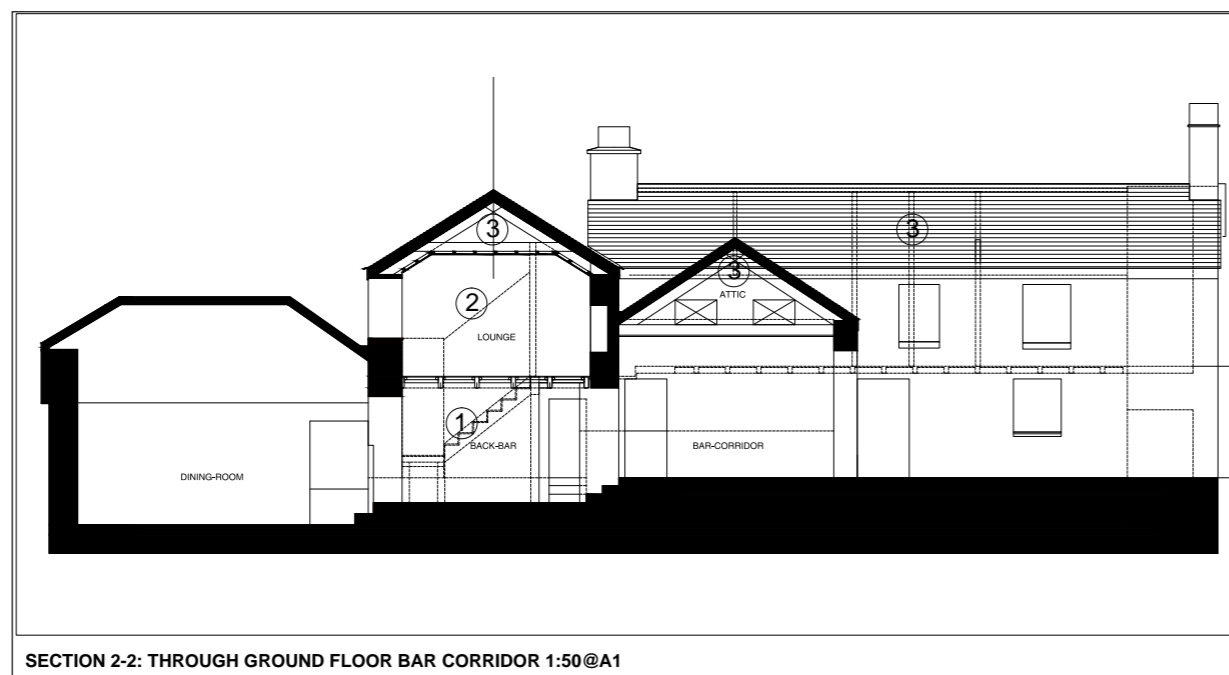
There are specific areas of essential works required to the Ground Floor. As previously noted, safe access to the first floor accommodation needs to be created to rectify the existing dangerous condition.

In addition, there are works relating to the emergency works programme, including the replacement of internal wall and ceiling finishes and the inclusion of insulated wall panelling

- ① New access stair to 1st Floor accommodation. To be constructed from fire resisting construction to ensure fire-safety standards are met. Opening to be created between existing ladies WC and Back Bar to allow insertion of new stair.
- ② Existing First Floor Accommodation to be refurbished, including replacement of internal wall and ceiling finishes, previously agreed as part of the emergency works programme.
- ③ Failed roofs to be replaced with new slate roofs and replacement insulated ceiling as as part of previously agreed emergency works planning regularisation.

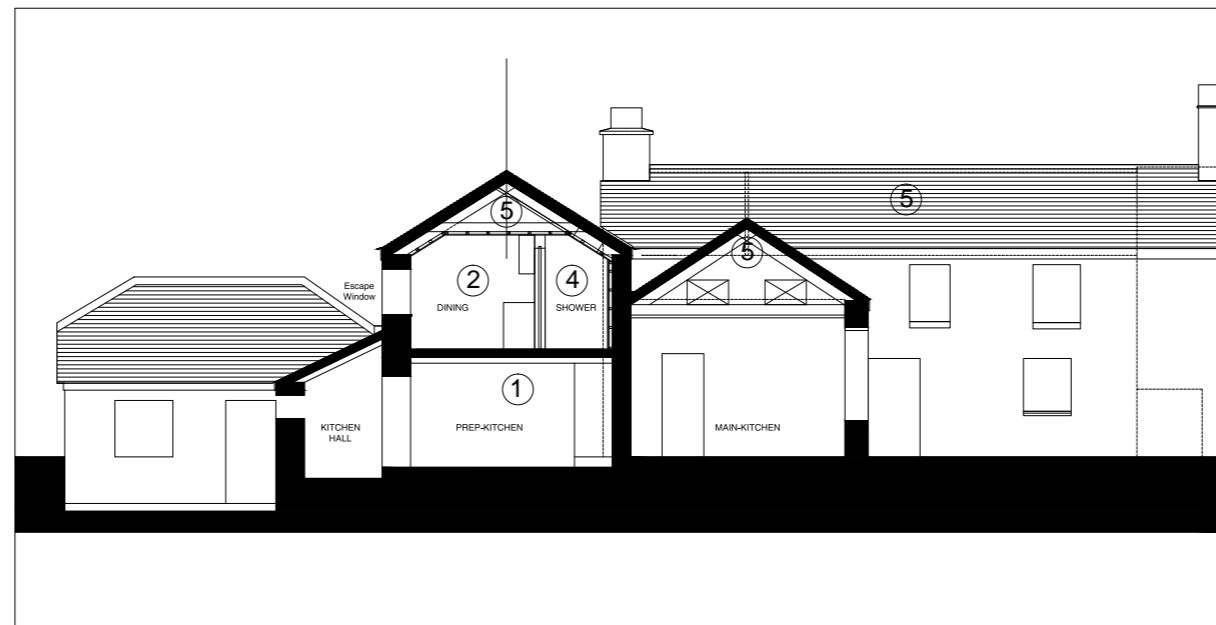
SECTION 3-3: THROUGH PREP KITCHEN 1:50@A1

There are specific areas of essential works required to the Ground Floor. As previously noted, safe access to the first floor accommodation needs to be created to rectify the existing dangerous condition.

In addition, there are works relating to the previously agreed emergency works programme, including the replacement of wall and ceiling finishes and the inclusion of insulated wall panelling

- ① Existing dangerous and non-compliant stair removed from commercial kitchen and area made good with fire resisting construction.
- ② Replacement stair located within back bar area to be built from fire resisting construction to permit safe access to refurbished first floor accommodation.
- ③ Existing First Floor Accommodation to be refurbished, including replacement internal wall and ceiling finishes, previously agreed as part of the emergency works programme.
- ④ New en-suite facilities incorporated at first floor level. En-suites to drain into existing drainage system.
- ⑤ Failed roofs to be replaced with new slate roofs and replacement insulated ceiling as as part of previously agreed emergency works planning regularisation.

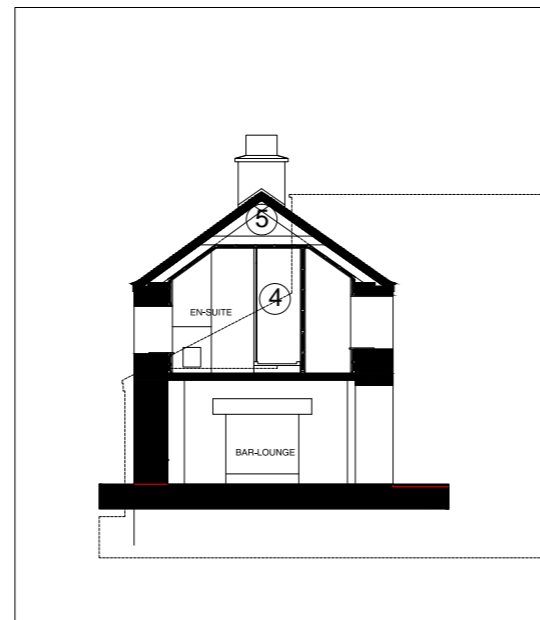
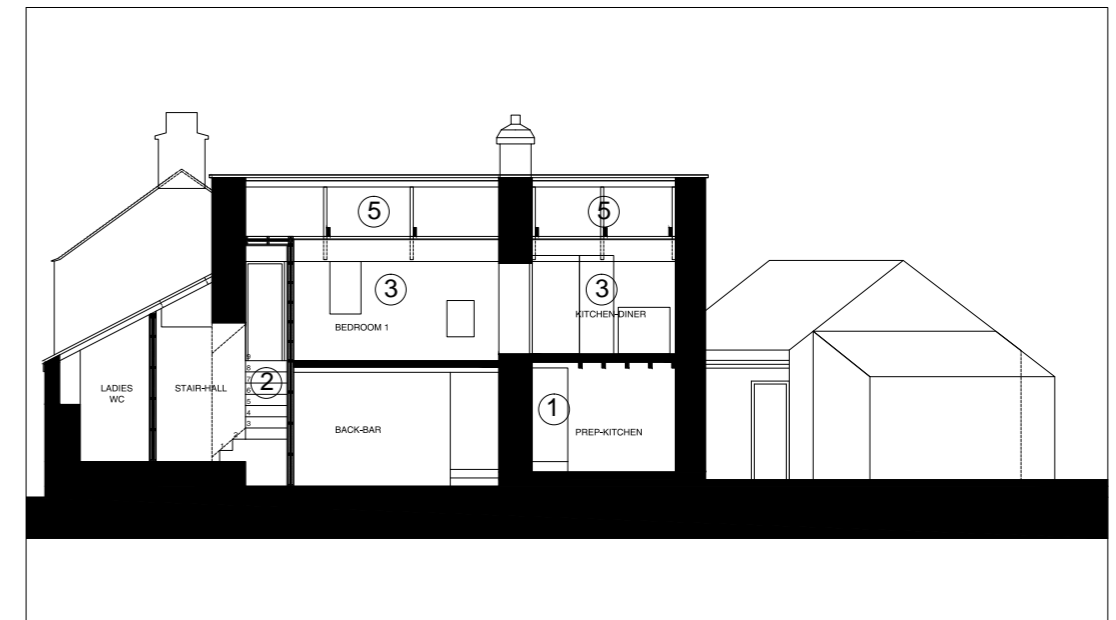
Fig.17. Proposed Sections 3-3, 4-4 & 5-5

There are specific areas of essential works required to the Ground Floor. As previously noted, safe access to the first floor accommodation needs to be created to rectify the existing dangerous condition.

In addition, there are works relating to the previously agreed emergency works programme, including the replacement of wall and ceiling finishes and the inclusion of insulated wall panelling

- ① Existing dangerous and non-compliant stair removed from commercial kitchen and area made good with fire resisting construction.
- ② Replacement stair located within back bar area to be built from fire resisting construction to permit safe access to refurbished first floor accommodation.
- ③ Existing First Floor Accommodation to be refurbished, including replacement internal wall and ceiling finishes, previously agreed as part of the emergency works programme.
- ④ New en-suite facilities incorporated at first floor level. En-suites to drain into existing drainage system.
- ⑤ Failed roofs to be replaced with new slate roofs and replacement insulated ceiling as as part of previously agreed emergency works planning regularisation.

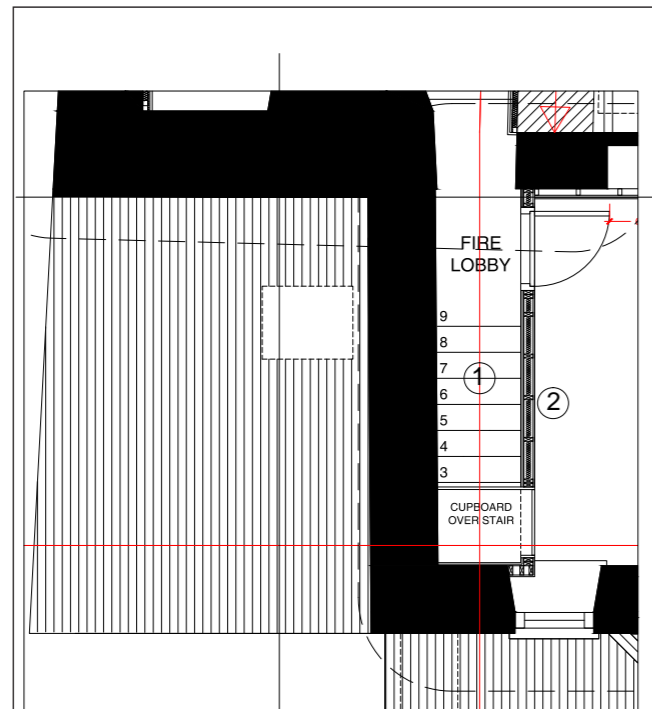
PLAN 2: PROPOSED STAIRCASE FIRST FLOOR PLAN: 1:25@A1

SECTION 2: PROPOSED STAIRCASE LONGITUDINAL SECTION: 1:25@A1

PLAN 1: PROPOSED STAIRCASE GROUND FLOOR PLAN: 1:25@A1

SECTION 1: PROPOSED STAIRCASE TRANSVERSE SECTION: 1:25@A1

- ① New timber staircase created within stairwell of fire-resisting construction to create safe access and egress from first floor accommodation.
- ② Stairwell created in fire resisting construction comprising timber framing with fire-resisting plasterboard to create a fire rated enclosure
- ③ Opening created in separating wall to create access from new entrance hall into stairwell.
- ④ New entrance hall.
- ⑤ New entrance door within existing late 20th century external wall.
- ⑥ New stepped access from rear garden.

The replacement stair is to be located within the back bar area aligning with the separating wall between the back bar and the Ladies WC at ground floor level.

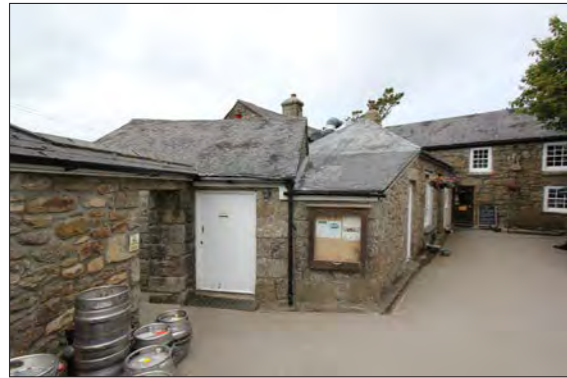
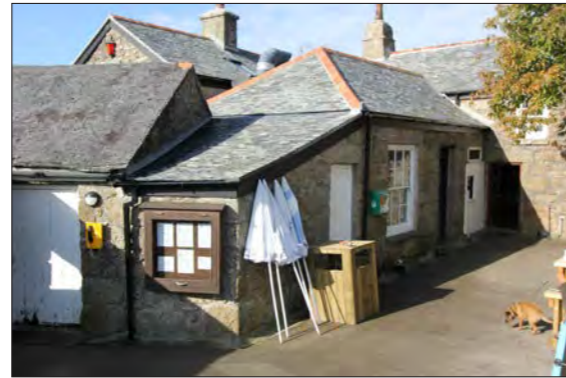
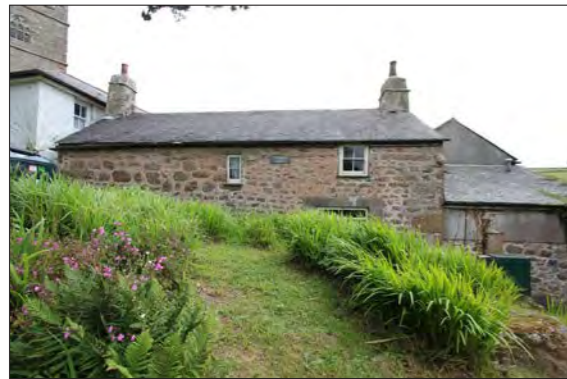
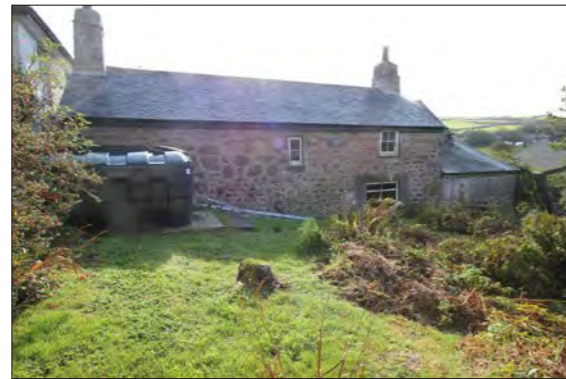
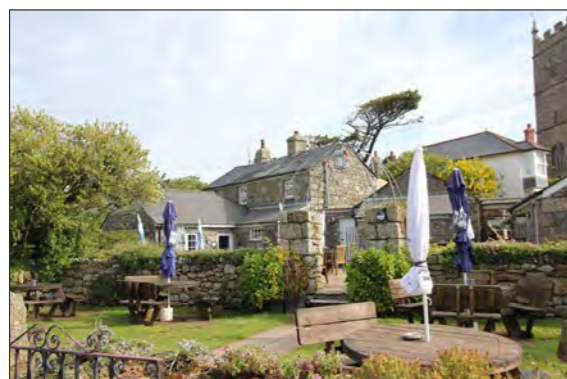
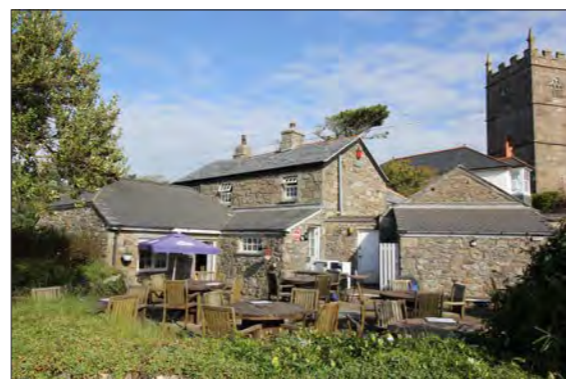
Fig. 21. Before & After Roofs (Emergency Works)

ROOFS PRIOR TO FAILURE

REPLACEMENT ROOFS

The Client approached a local roofing company experienced in working with Listed Buildings (JS Roofing) and a proposed approach was agreed that included the removal of the existing roofs, reclamation of slates, repair of roof timbers and the relaying of reclaimed slates in a dry laid scantel format.

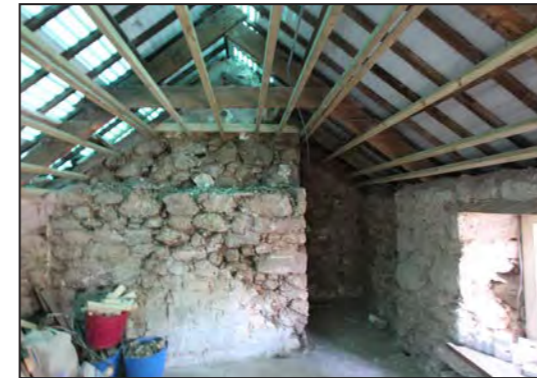
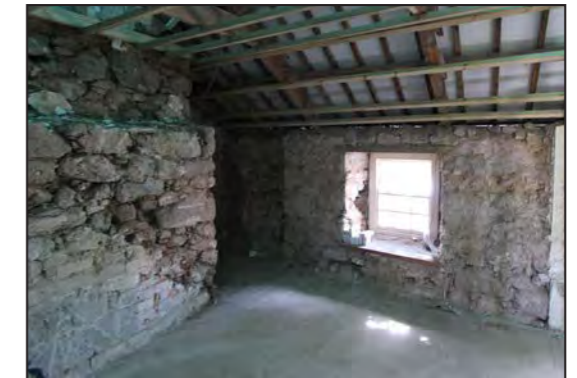
POOR QUALITY MASONRY

This action uncovered extremely poor quality masonry with crumbling or missing pointing to the granite and poor quality stonework. It quickly became evident that the masonry walls needed to be consolidated and we proposed the use of Lime Pointing and Bag-Rubbed Lime Render to the inside face of the exposed granite walls. This allows the walls to breathe.

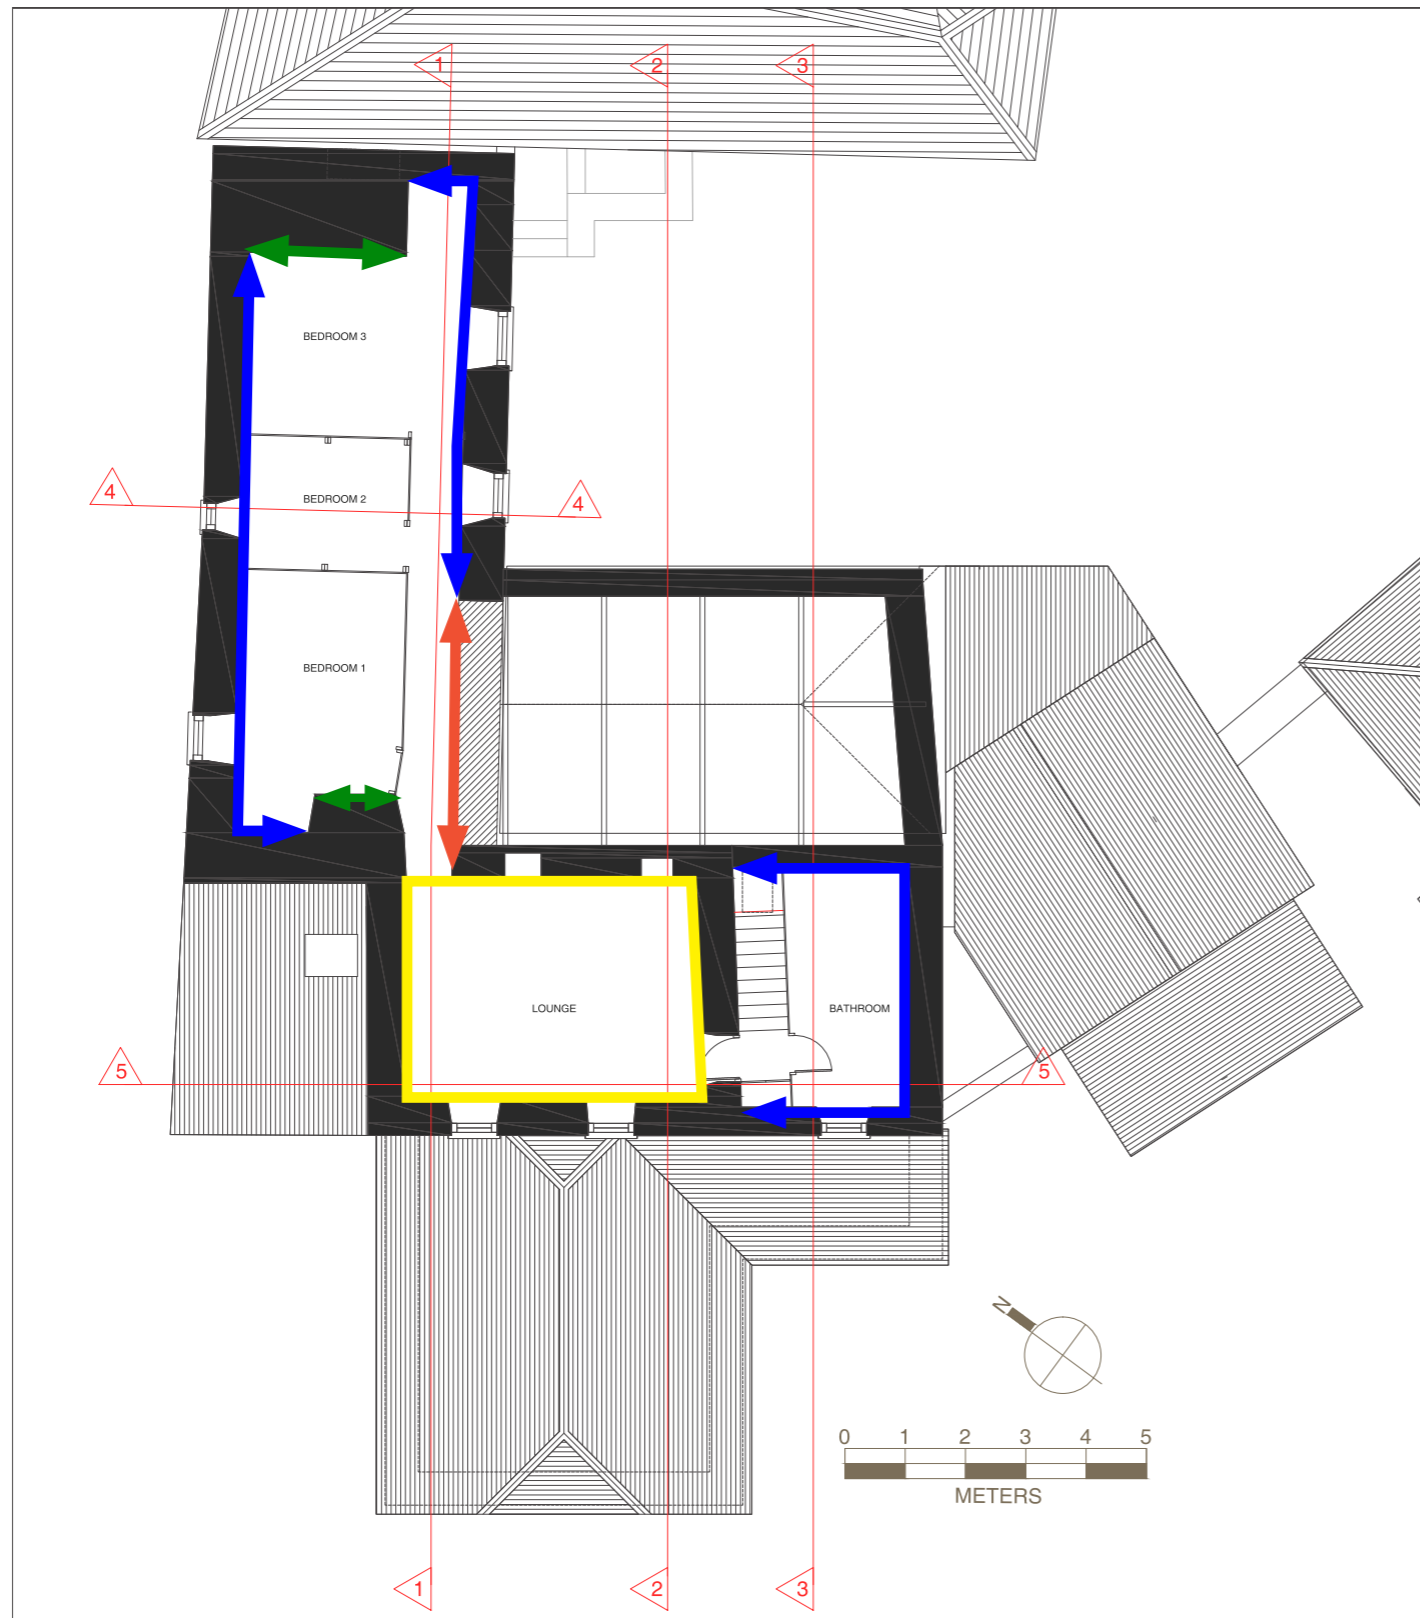
Fig. 25 Existing 1st Floor Plan (Agreed Emergency Works to walls)

Cement pointing: not removed as would severely damage underlying granite. Walls to be lined with timber panelling and breathable insulation.

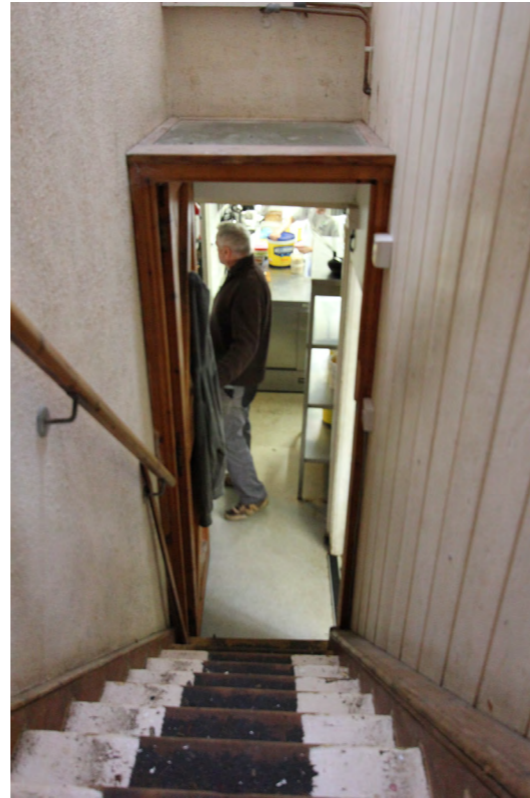
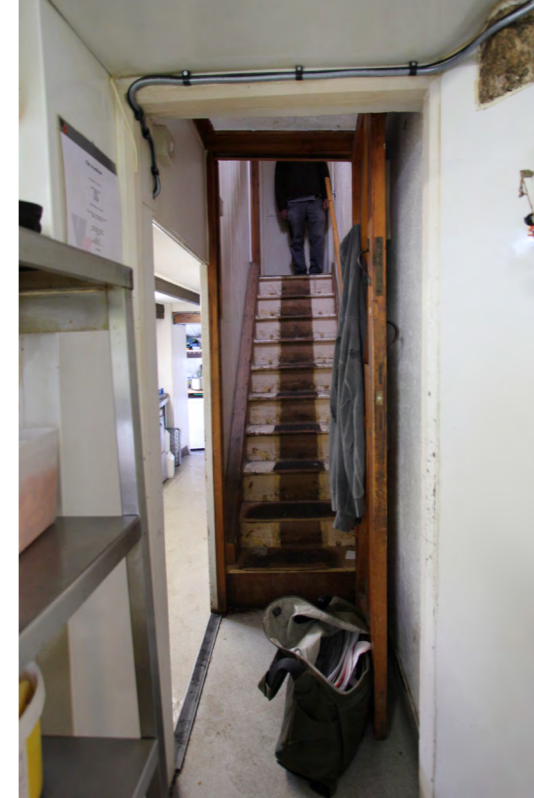
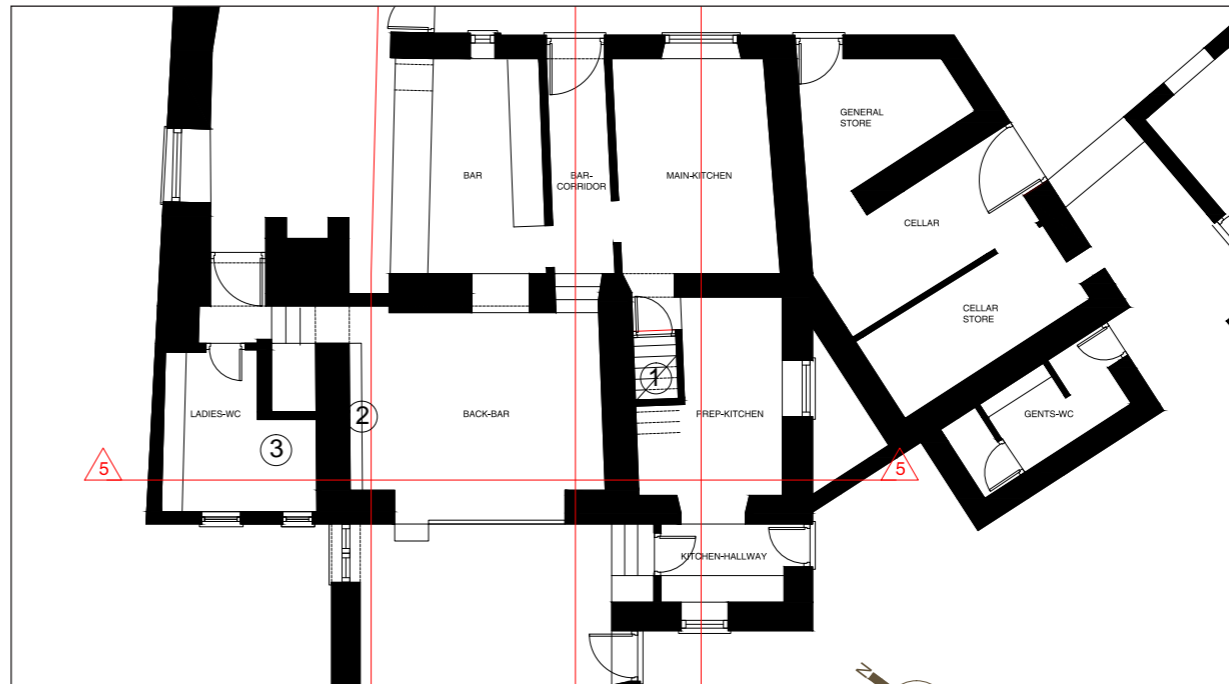
It is proposed that the existing stair is removed from this location and walls and ceiling made good with fire resisting construction. This will also require a new area of flooring to be inserted at first floor level. (See adjacent photographs and part Ground Floor Plan of the existing condition).

Fig. 26. Part Ground Floor Plan Indicating Position of Dangerous Stair, along with Associated Photographs

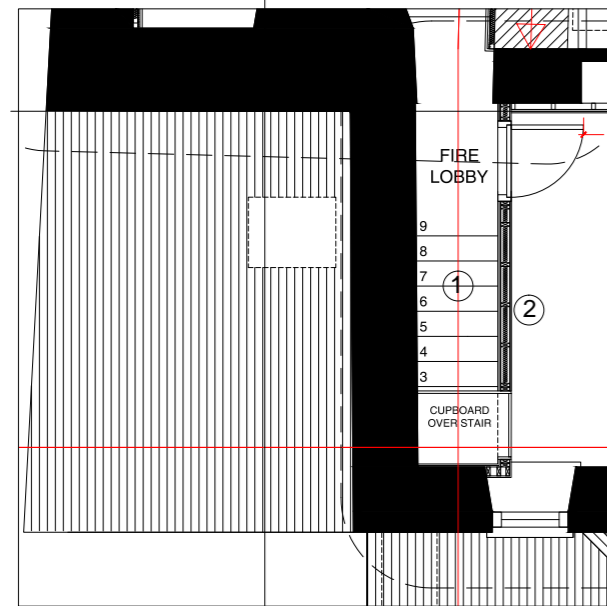
PLAN 2: PROPOSED STAIRCASE FIRST FLOOR PLAN: 1:25@A1

PLAN 1: PROPOSED STAIRCASE GROUND FLOOR PLAN: 1:25@A1

The existing finishes to this separating wall were opened up to establish if a fireplace was present in this location. No fireplace was found and it can be seen that the impact on the historic fabric is minimal and discreet, whilst providing for this vital new and safe access route.

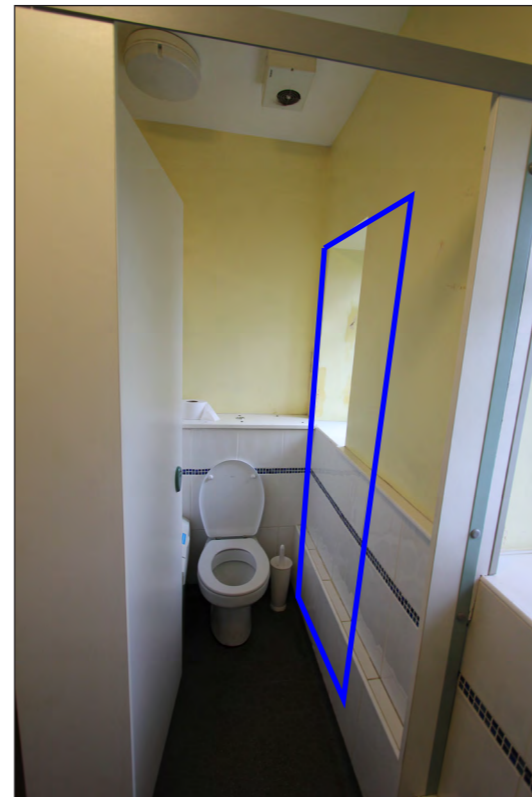
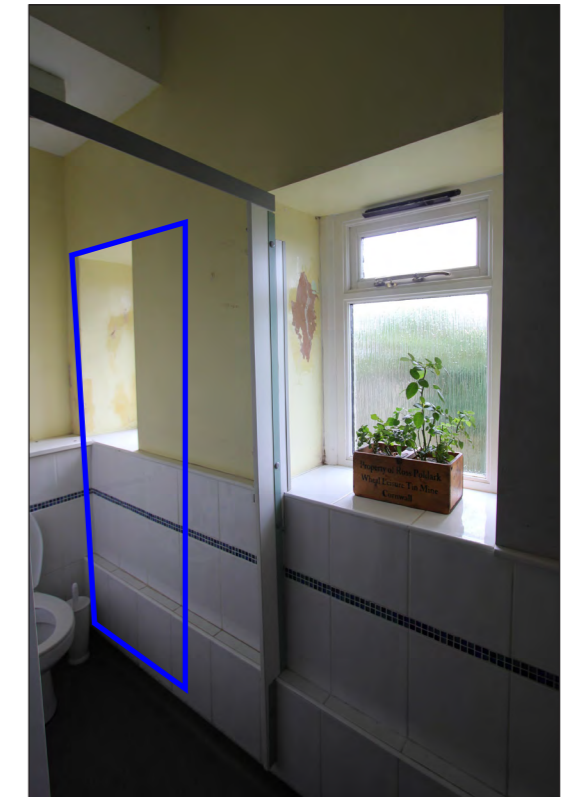
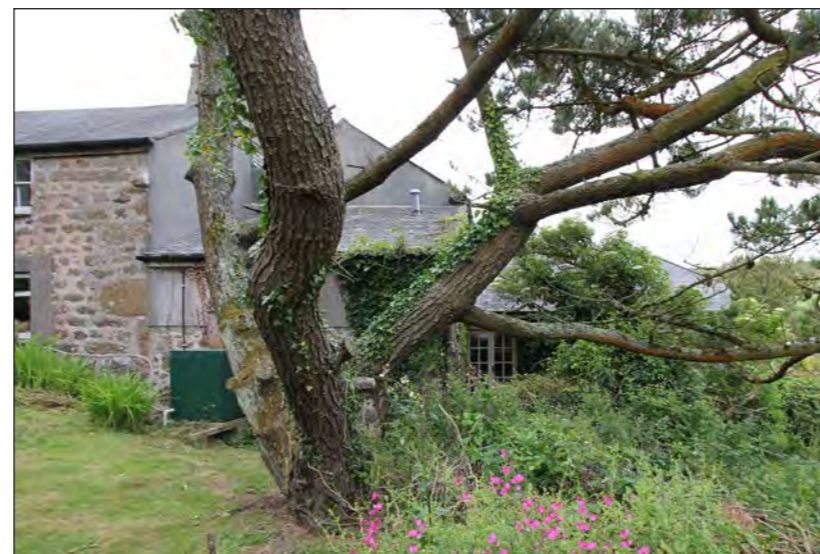
Fig. 28. Photos Describing Location for New Entrance to Rear of Pub.

1. View of Ladies WC where Door is to be Created for New Entrance.
2. View of Ladies WC where Door is to be Created for New Entrance.
3. View back to Ladies WC from Rear Garden. NB: Proposed entrance cannot be seen from outside the site as it sits discretely behind boundary planting.
4. External Photo of South Elevation to Ladies WC
5. External Photo of South Elevation to Ladies WC
6. Proposed South Elevation Indicating New Entrance.

NB: Approximate area of opening up for new door is edged in blue.

It can be seen that the entrance has a minimal impact on the external appearance of the building (being set-back from the boundary and in a discreet corner, behind boundary planting). Further, the entrance door will be constructed within the existing late 20th C construction, therefore having a minimal impact on the historic fabric.

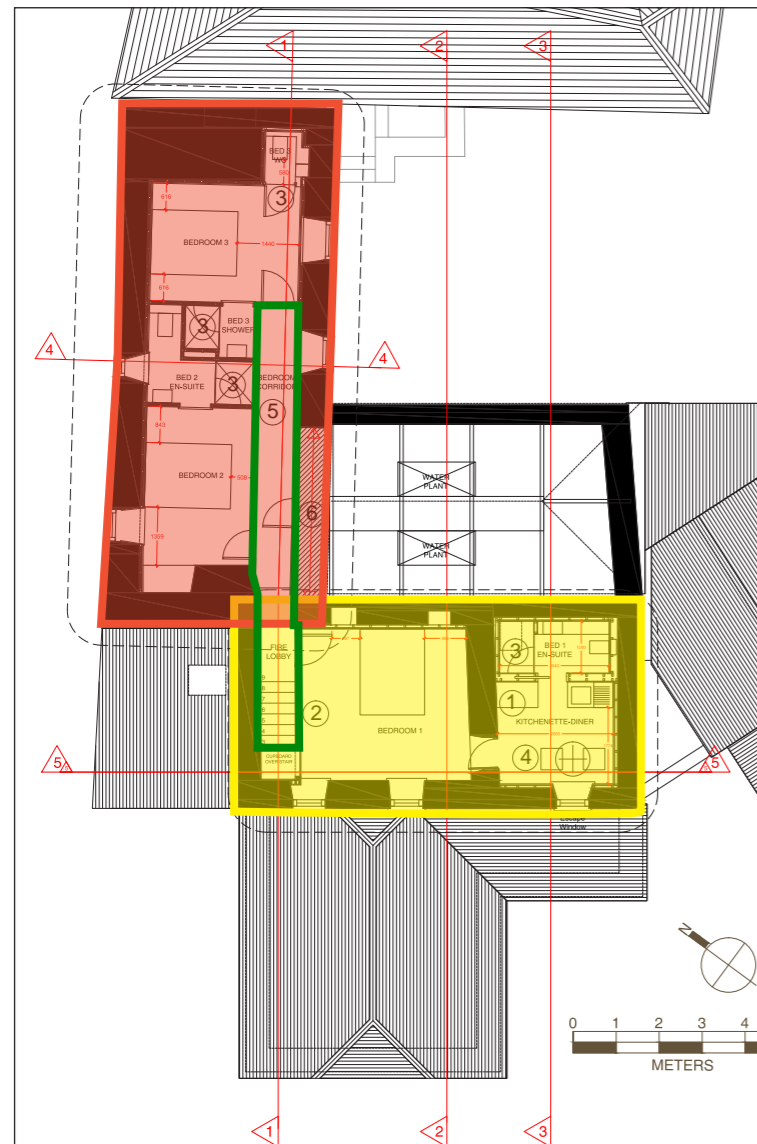
Fig. 29. First Floor Plan Describing N-S & E-W Blocks

- ① Existing dangerous and non-compliant stair removed and floor made good with fire-resisting construction, to ensure fire safety standards are met.
- ② New access stair to 1st Floor accommodation. To be constructed from fire resisting construction to ensure fire-safety standards are met. Opening to be created between existing ladies WC and Back Bar to allow insertion of new stair.
- ③ New en-suites created with waste to discharge into existing drainage system at low level.
- ④ Small dining area created within existing bathroom area.
- ⑤ Partitions to be up-graded to ensure effective fire separation and to create a protected route in the event of a fire.
- ⑥ New fire-rated access door into plant space within attic over main kitchen.

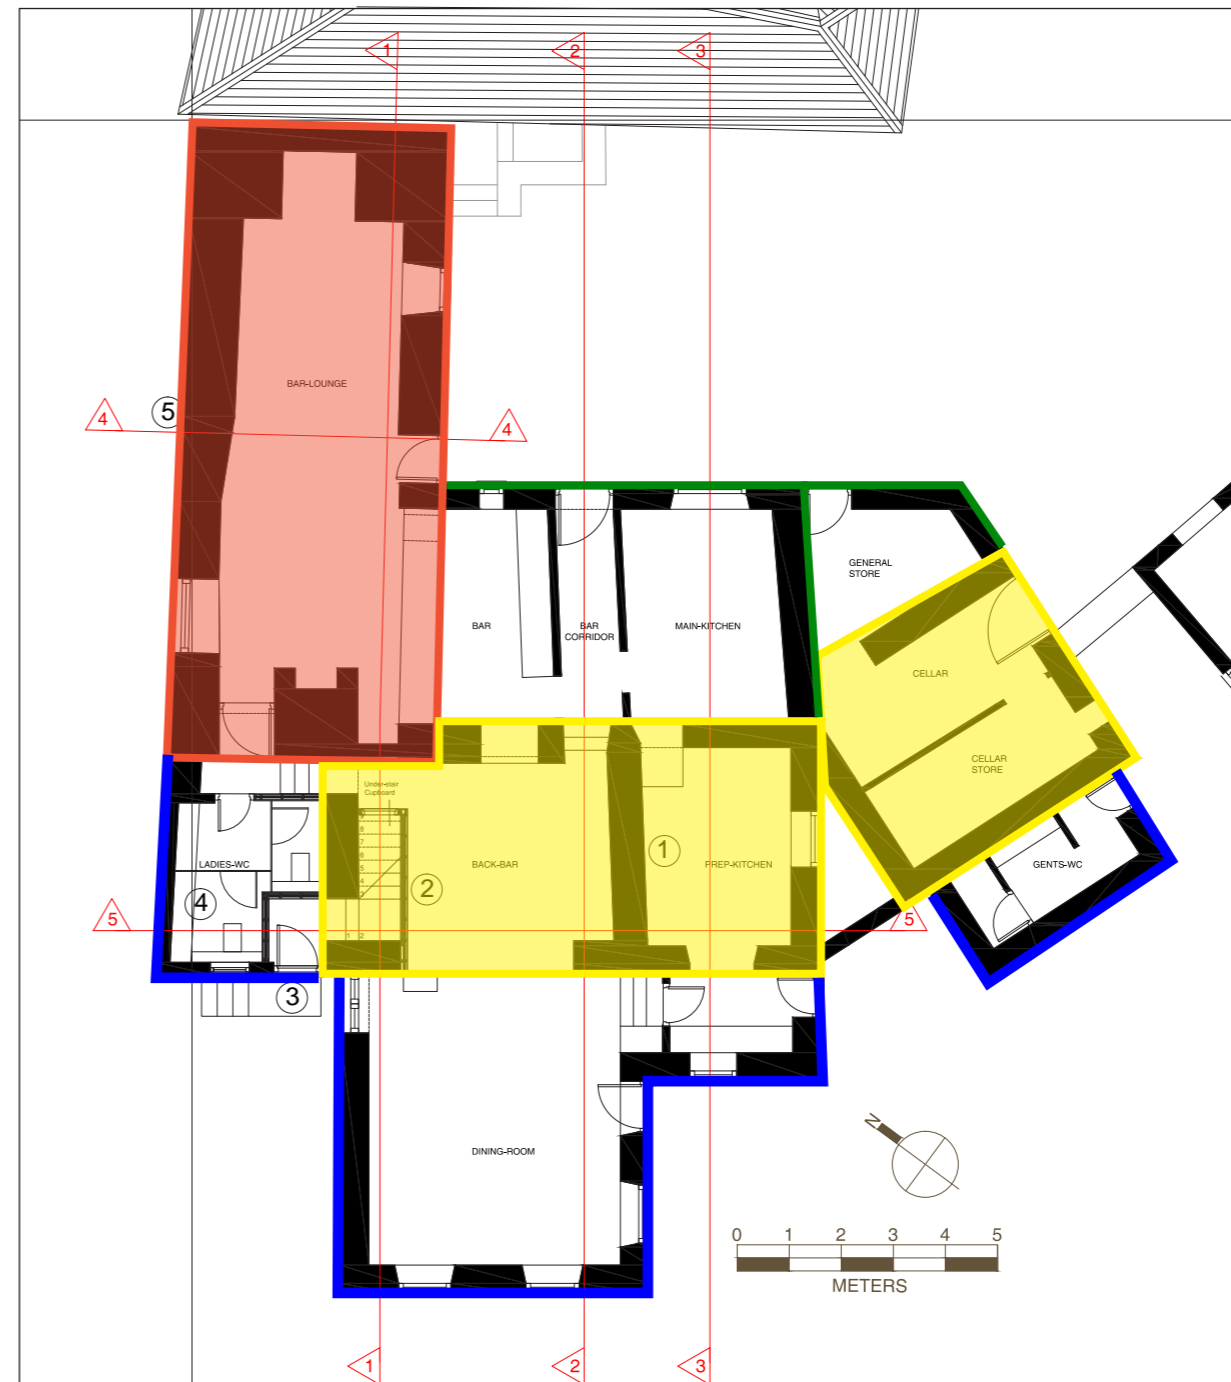
Fig.30. Proposed Ground Floor Plan Illustrating Development Chronology

- C17th -C 18th (Excluding later alterations)
- Early C19th (With C20th alterations)
- Circa 1900 (With C20th alterations)
- C20th

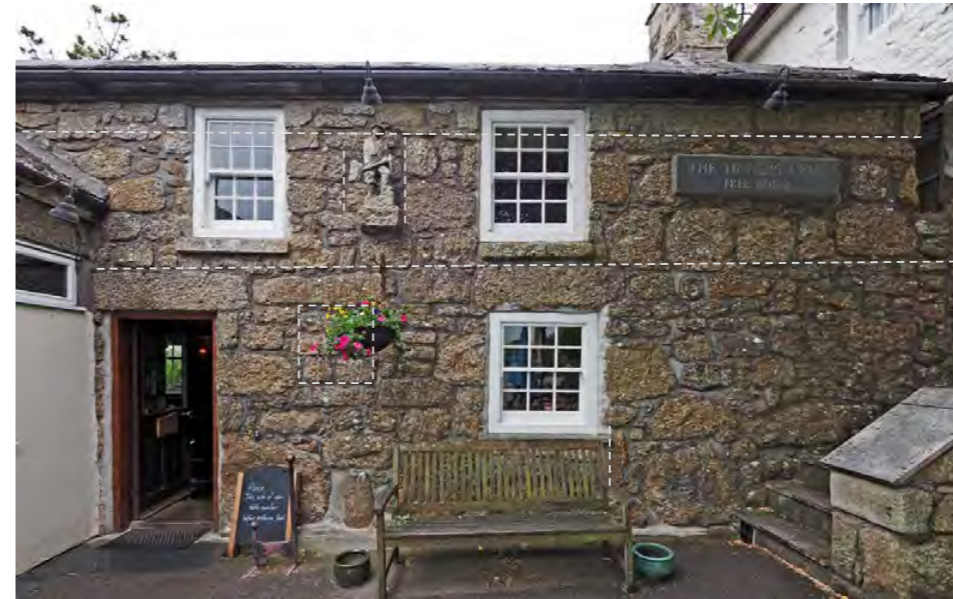
Fig 8: Front wall of original building annotated to show anomalies including: former probable window opening left of centre; re-facing, rebuilding or remodelling of much of first-floor stonework, and original probable eaves level at top

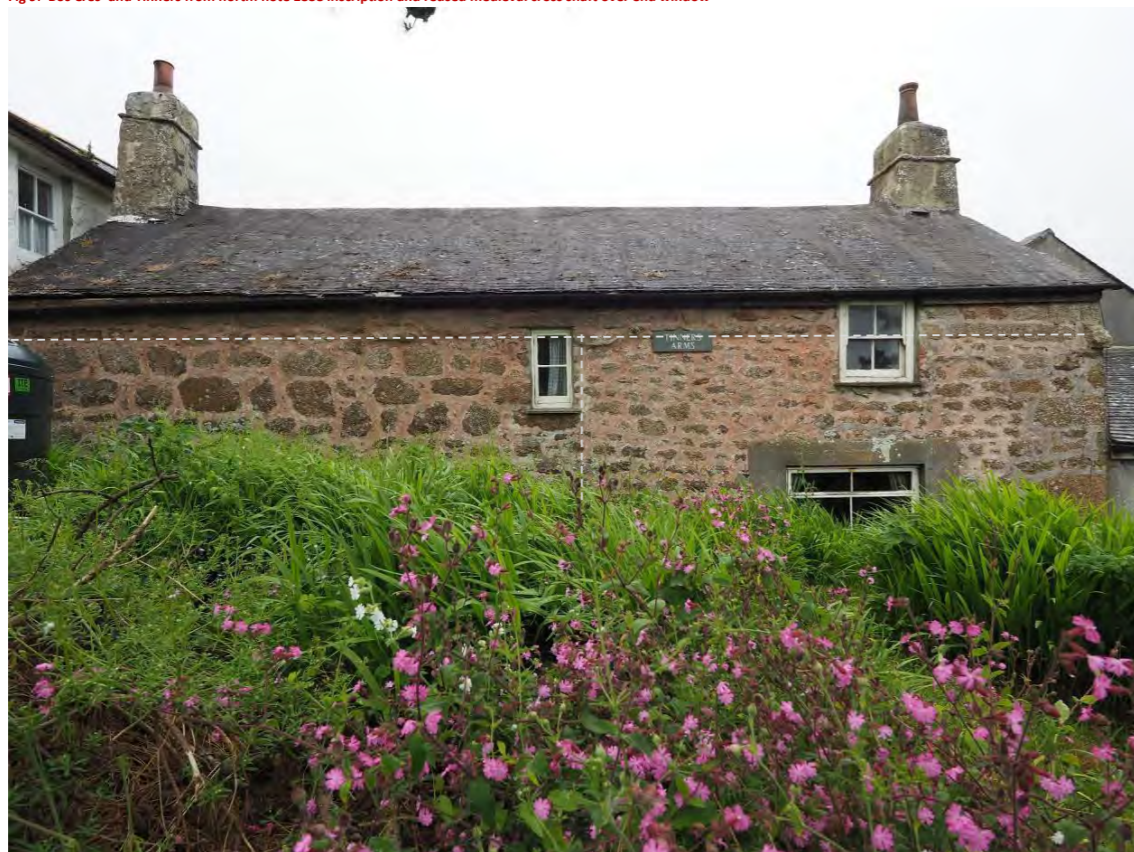
Fig 10: Tinners rear wall annotated to show original probable eaves level with kneeler stone at far right; walling left of central former stair window has larger stones probably due to re-facing or rebuilding; C20 inserted window at far right
