**TINNERS ARMS, ZENNOR
TR26 3BY**

**PLANNING AND LISTED BUILDING APPLICATION
DESIGN AND IMPACT STATEMENT**

October 2021

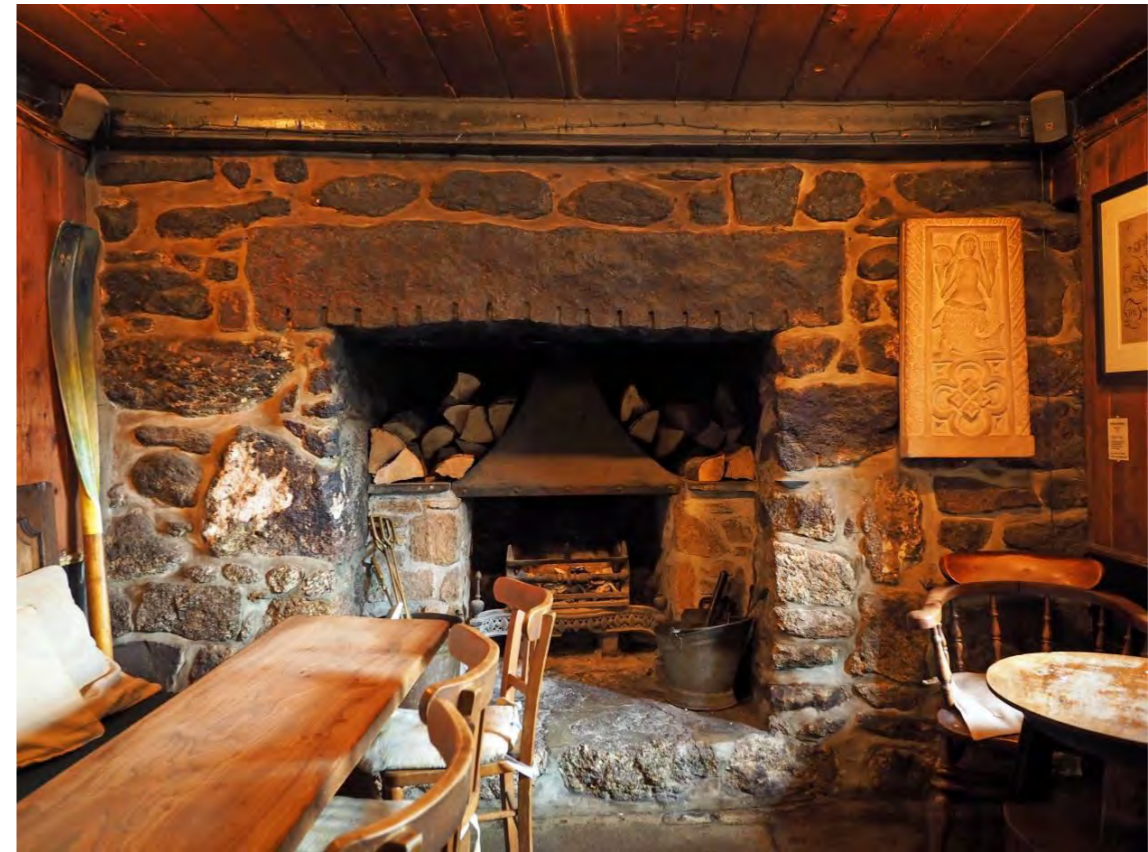
Fig 19: NE fireplace clearly rebuilt in the C19 including granite lintel with drill holes of post 1800 type; traces of limewash indicate former decorative inner wall finish
