# The Mount, Terwick Lane, Dumpford, W.Sussex. GU31 5JN.

## Phase 1 Daytime Bat Assessment

**August 2021**

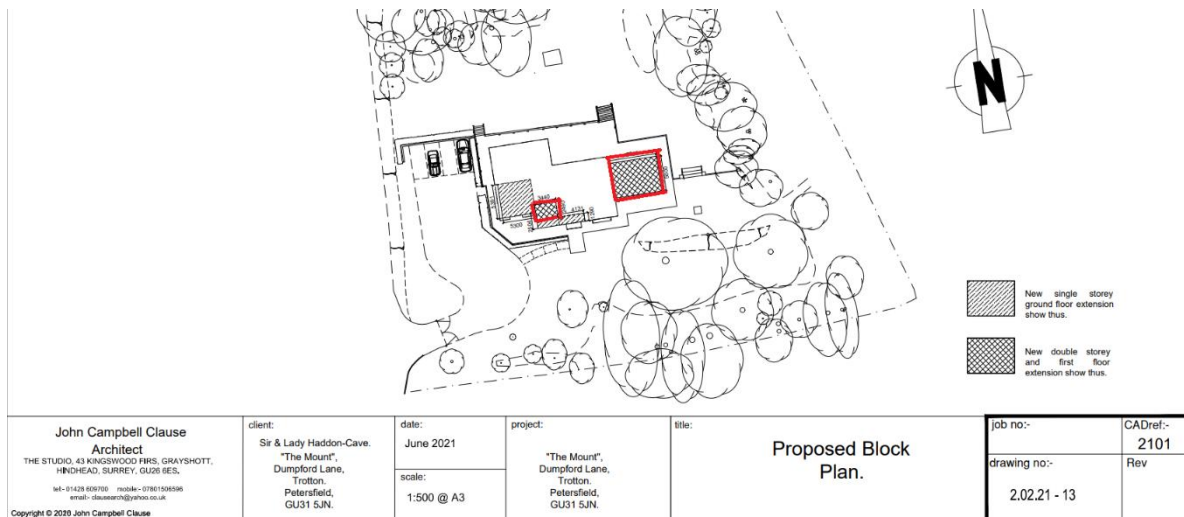
**Figure 3:** Architect’s drawings showing proposed changes to main house. The proposal will result in the temporary disturbance of a roof void currently used by bats and disturbance to an area of roof covering with the potential to support roosting bats.

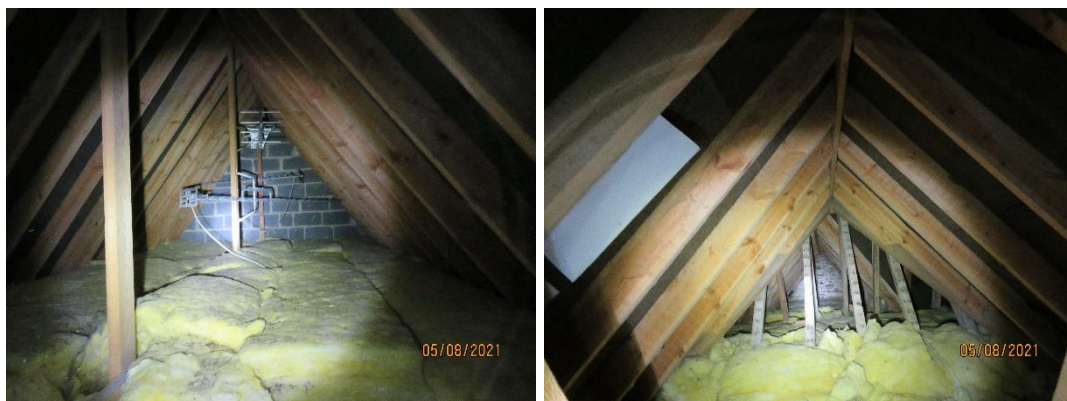
There are two roof voids, with one being a low void over the main house that links to the larger void of the east wing extension and the other being a separate void over the northwest wing. The second void will not be affected by the proposed works. However, it is noted that both roof voids are used by Brown Long-eared bats *Plecotus auritus*, with the main roof void and east wing currently hosting a small maternity colony. Approximately ten bats were observed in a cluster at the ridge, but further individuals or clusters may be located elsewhere in the less accessible parts of the void. The void is insulated but largely unboarded and insulation covers ceiling joists making a thorough inspection unsafe. The roof is lined with 1F bitumen felt in good condition and no obvious access points were noted. Temperatures in the void at the time of survey (approx. 1430hrs) were 20.9°C with a relative humidity of 69.6%. There is also a small, inaccessible void beneath a catslide roof on the southern elevation.

**Figures 4 & 5.** Main roof void. Numerous bat droppings were scattered on the roof insulation and a small maternity cluster of Brown Long-eared bats was observed at the ridge. Figure 5 is looking west along an inaccessible part of the void above the main body of the house towards a stone-built gable end.

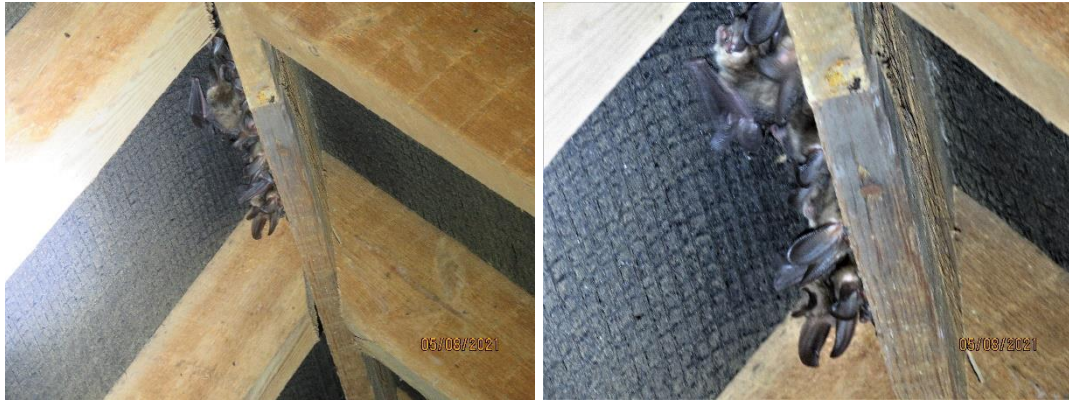
**Figures 6 & 7.** Small maternity cluster of Brown Long-eared bats at ridge. Approximately ten bats were noted.

The Mount has a **confirmed roost** of Brown Long-eared bats *Plecotus auritus* in the roof void of the main house. A social cluster of approximately ten bats was noted. Further colony members may be present in inaccessible areas of the roof void. At a time of year when bats gather to produce their young, this is likely to be a small **maternity roost**. Most, if not all, of this year's bat pups would by now be developed juveniles and indistinguishable from adults without close examination, which would be disturbing to the bats at a highly sensitive time of year. Brown Long-eared bats are also using the roof void of the north-west wing, as evidenced by numerous droppings, but no bats being observed. However, this void will not be affected by the proposed works.

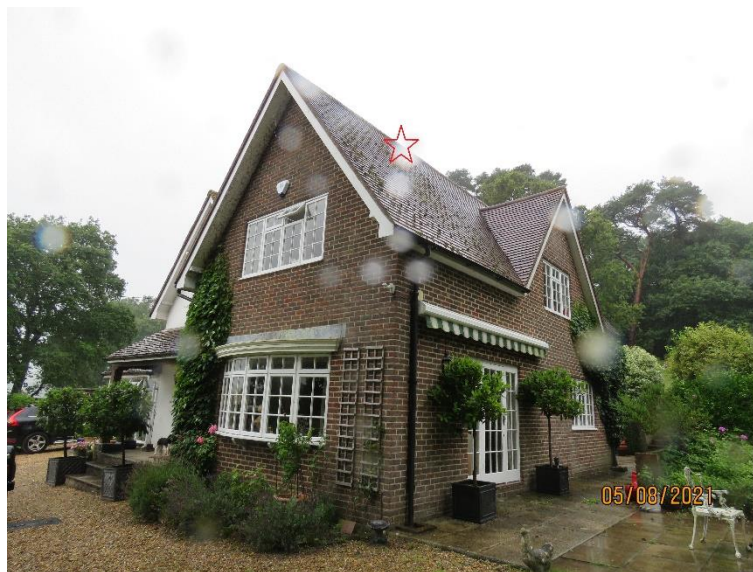
**Figure 8.** Showing east wing built in 1978/79. The red star indicates approximate position of maternity cluster in roof void.

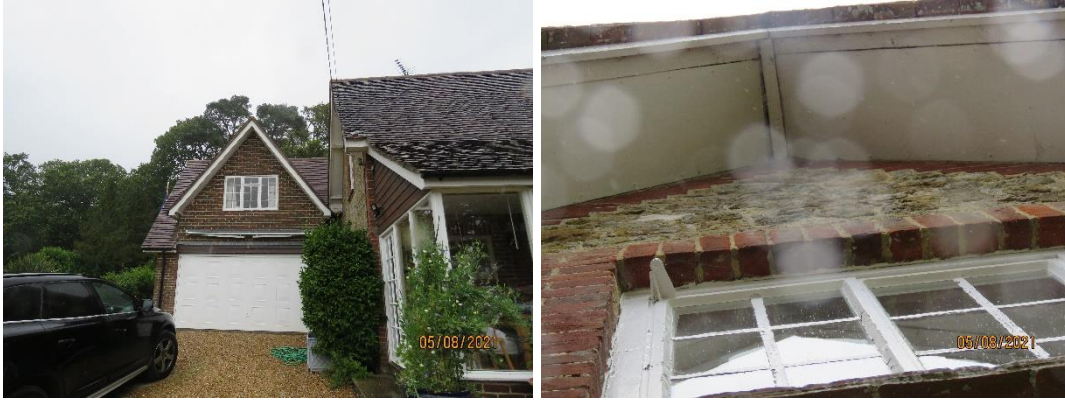
**Figures 9 & 10.** Showing northwest wing (roof void not affected by proposals) and stone built western elevation gable end of original house where a proposed single storey extension will be located. Also, apex of stone-built gable end with a gap to soffit that may be an access point for the resident bats.

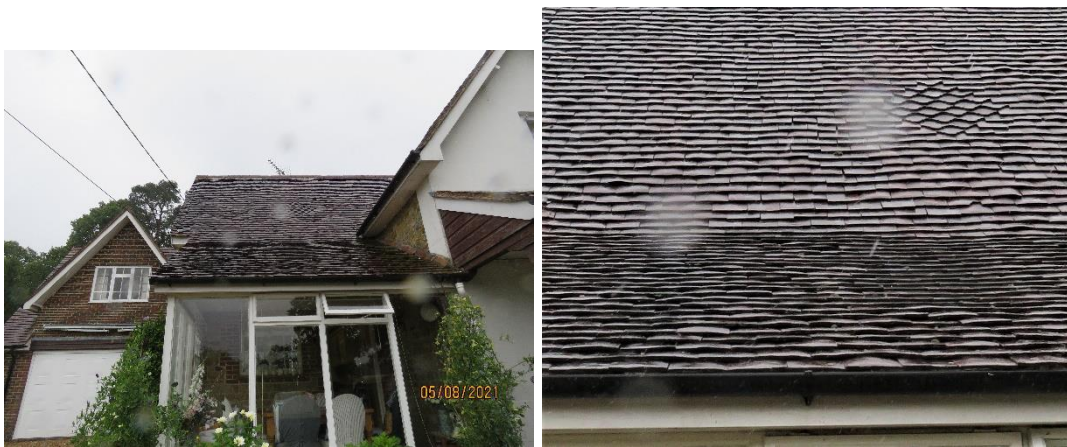
**Figures 11 & 12.** The catslide roof on southern elevation where a new two storey extension is proposed. Example of general tile gaps in this area.

In general the building has a high suitability for roosting bats with external features such as tile gaps present, particularly in association with the older parts of the building where a two storey extension is proposed for the southern elevation that will result in the loss of the existing catslide roof and concealed void beneath and will key into the ridge of the south-facing pitch, which is connected to the area of roof void where the bats were observed to be roosting. A further two storey extension will key into the gable end at the eastern elevation,

extremely close to where the maternity colony is situated. These external potential roost features have high suitability for external crevice dwelling species, such as *Pipistrellus* species. Therefore, a sequence of **Phase 2 dusk emergence / dawn return surveys is required to further characterise the roost and inform a licence application to undertake the proposed works.**

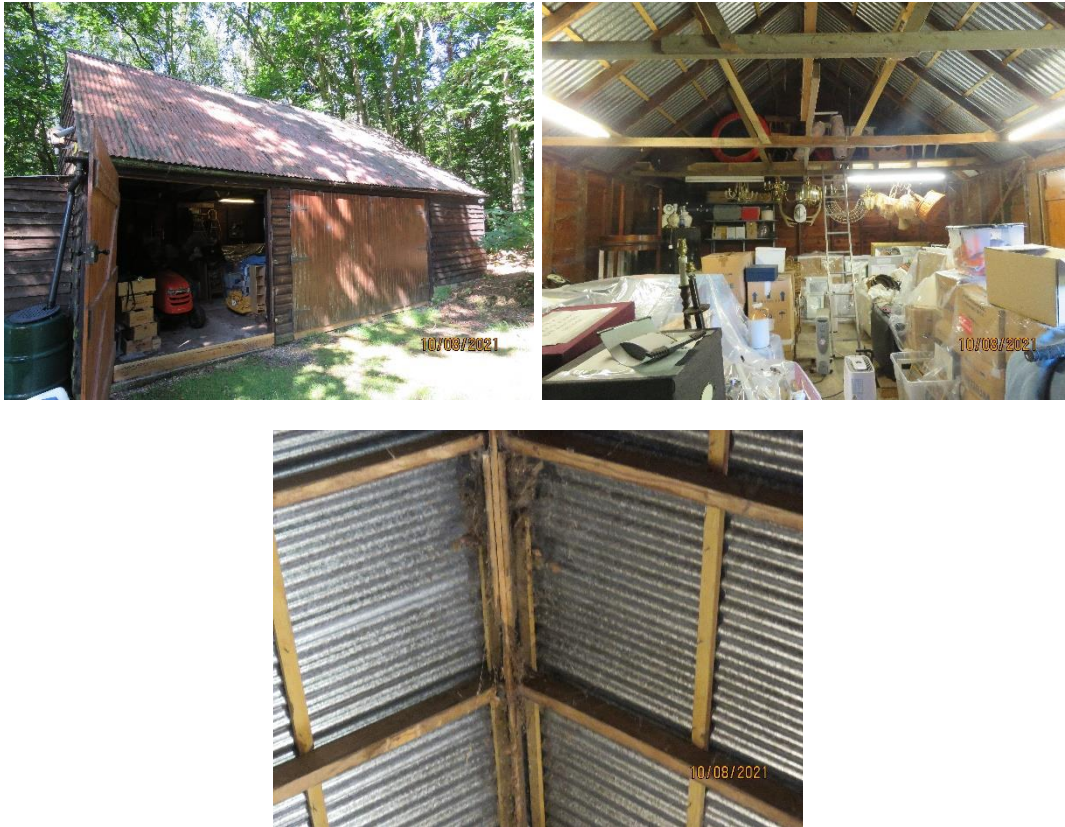
### **Outbuilding**

A large single-skin wooden outbuilding with a dual pitch corrugated steel roof will be converted internally to provide habitable accommodation for the duration of the works to the main house, after which it will be retained as habitable accommodation. Externally the existing roofing and cladding materials will remain unchanged, with the exception that the existing double doors will be replaced with glass doors or similar. Internally an insulated living space will be created beneath the level of the joists, creating a large roof void. There was no evidence that bats have accessed the building, such as droppings, poor thermal insulation due to corrugated tin sheet roofing material and single skin cladding.

Figures 13 & 15. The outbuilding external, internal and cobwebbed ridge.
