The Mount, Terwick Lane, Dumpford, W.Sussex. GU31 5JN.

Phase 2 Bat Emergence Survey

S.G. Dodd MSc MCIEEM MRES

September 2021

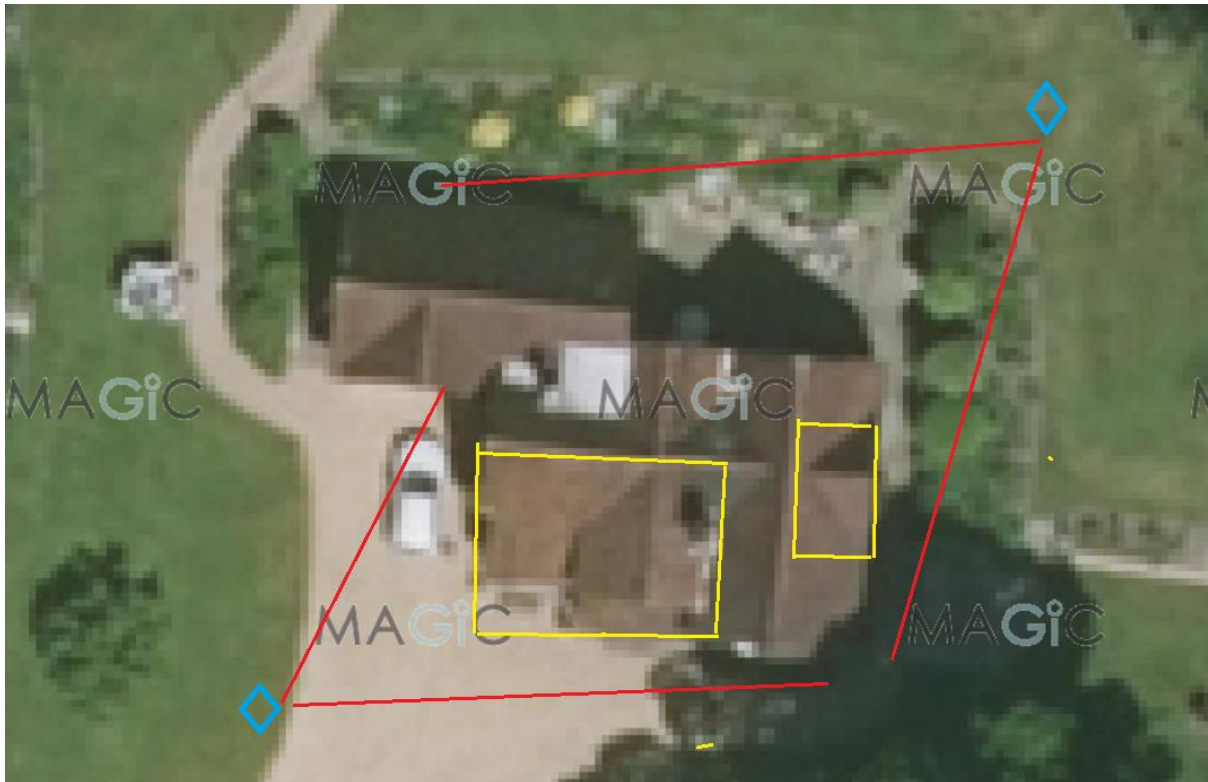
Figure 2. Surveyor locations (blue diamonds) and approximate fields of view (red lines). Approximate areas to be disturbed during works (yellow lines) Image produced courtesy of Magic maps (<http://www.magic.gov.uk/>, contains public sector information licensed under the Open Government Licence v3.0)

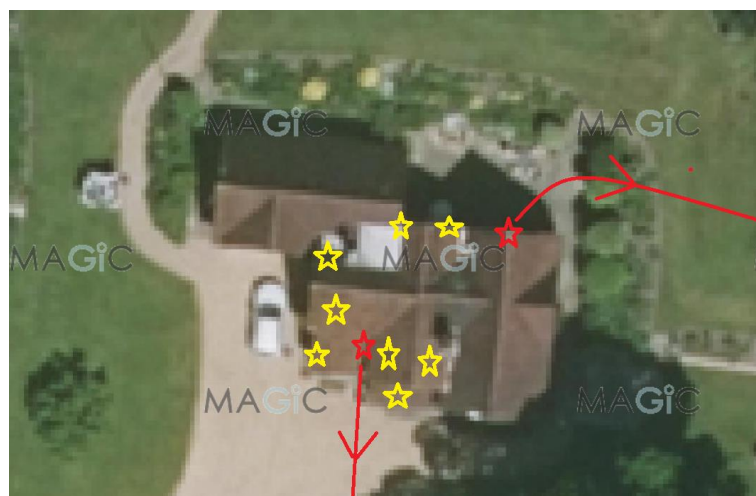
Figure 3. Emergence locations, general lay. Red stars denote maternity roost entrances with Soprano Pipistrelles to north-east and Brown Long-eared southern elevation central. Red lines indicate flight path to

adjacent woodland cover. Yellow stars are indicative of general areas used as day roosts by both Common and Soprano Pipistrelles and a single *Myotis* species of bat. The roost locations on the northern elevation will not be affected by the proposed works.

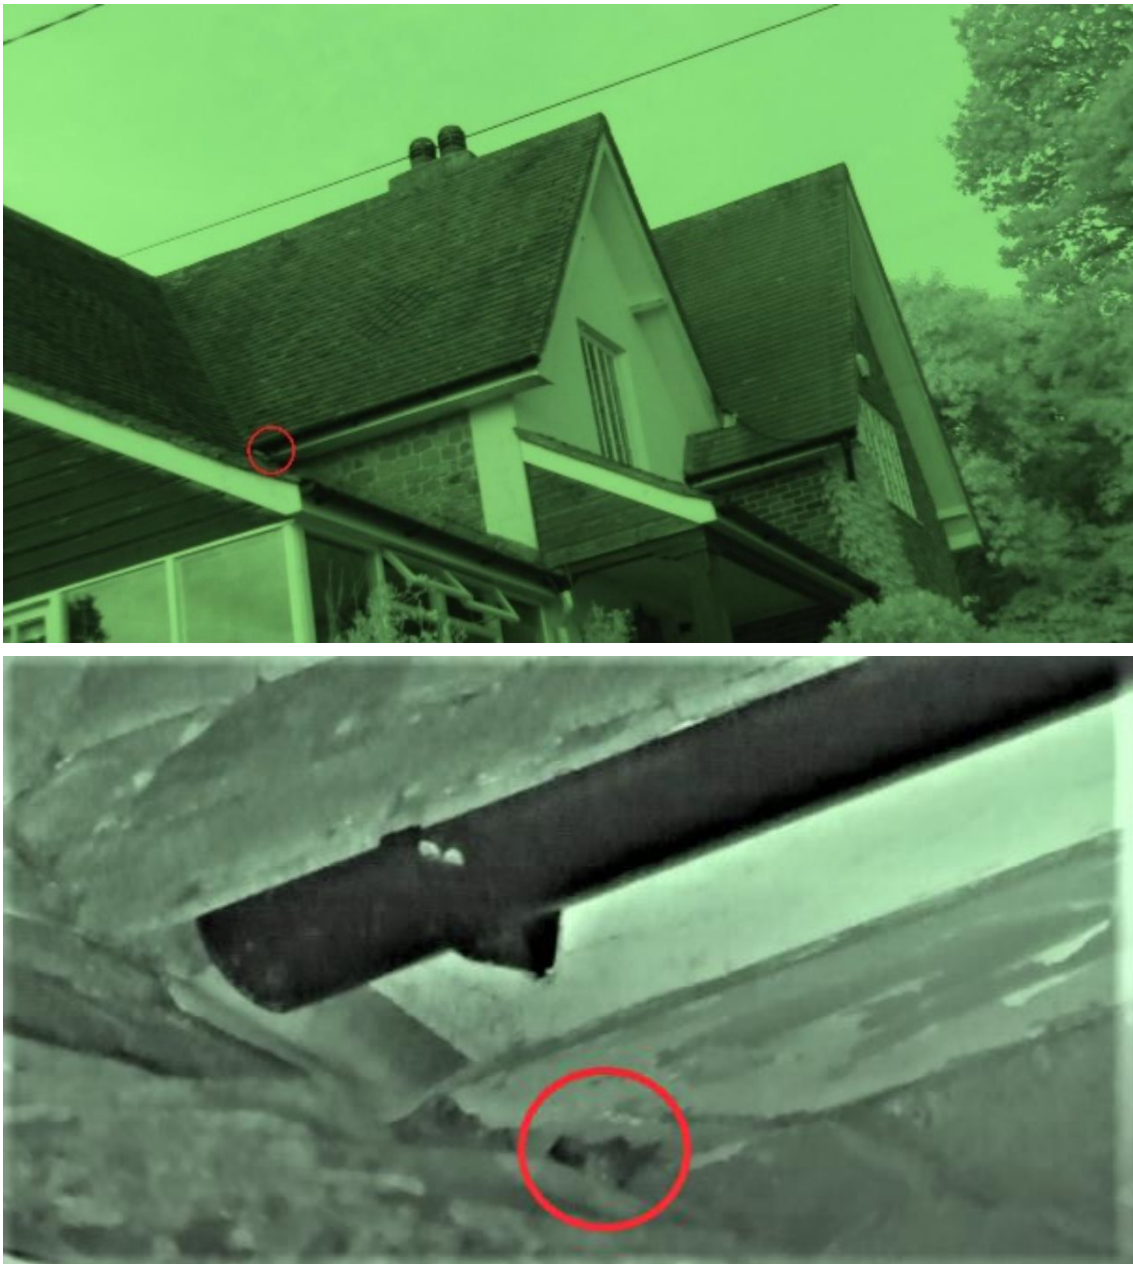
Figure 4. Showing Brown Long-eared bat emergence point at southern elevation. The roost entrance is a small mortar gap at the junction between the main roof valley at a point where it meets the cat-slide roof and abutting the original stone walls, under the soffit and gutter. In the close up, a Brown Long-eared bat can be seen in the roost entrance at point of emergence.

- 4.10 The development will result in the alteration and temporary disturbance of the roof void used by a Brown Long-eared bat maternity colony and this must be mitigated for. The primary access point to the roof void used by the Brown Long-eared bats will be lost to the development and must be compensated for. The proposals will also cause the loss of three day roosting areas for two common species of bat (Common & Soprano Pipistrelle), namely the cat-slide roof, the south-facing pitch of the main roof above it and the clay-tiled porch, for which adequate mitigation / compensation will be required. The house also supports a large maternity roost of Soprano Pipistrelle bats in a soffit box on the northern elevation (north-east corner) and several additional day roosting areas for individual, or small groups of, Soprano Pipistrelle bats and a single *Myotis* species of bat. However, under the current proposals these areas will not be directly or indirectly affected provided that any recommendations pertaining to these roosting areas are followed.

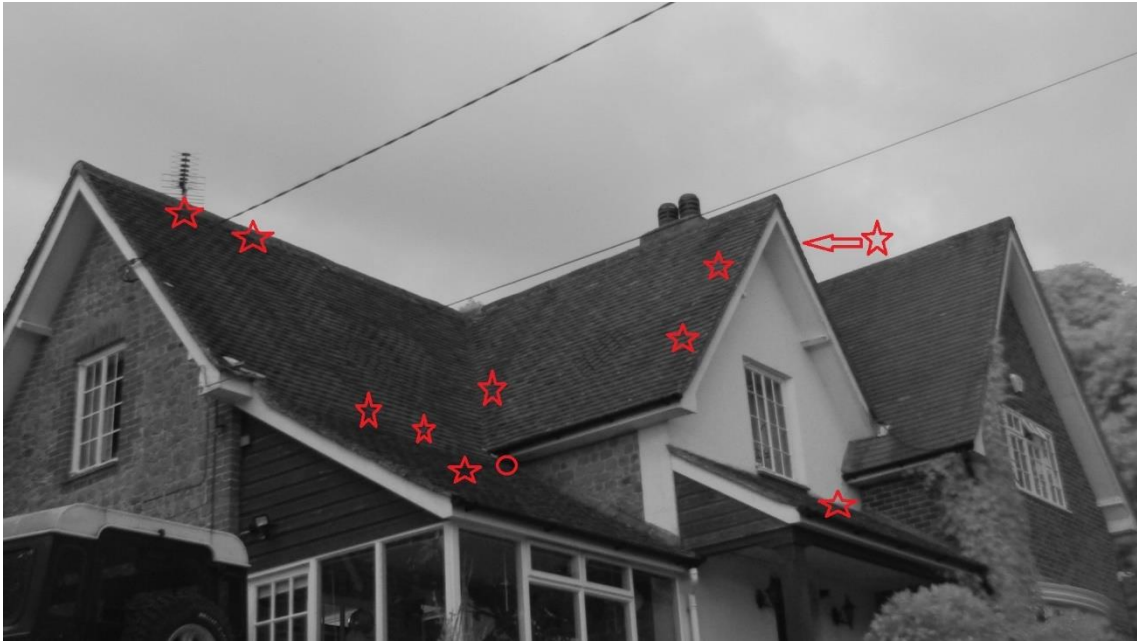
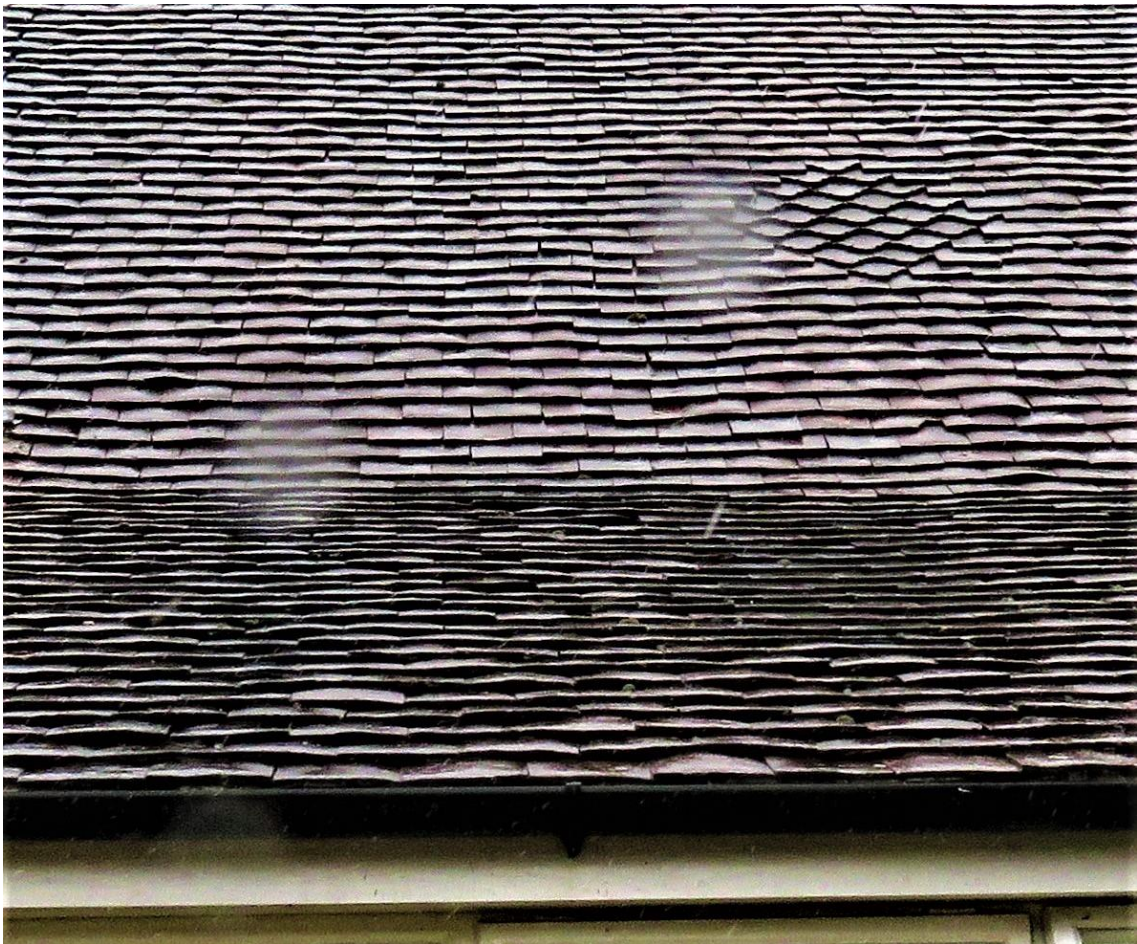
Figure 5. Showing emergence locations of Common Pipistrelles (red stars), and later several Soprano Pipistrelles in relation to Brown Long-eared roost entrance (red circle). Also, inset showing multiple tile gaps in this area.

- 4.20 Common Pipistrelle roosts were detected under traditional clay roof tiles of the southern elevation main roof section, cat-slide roof below and porch. As these areas will be stripped to facilitate the proposed new front extensions and altered porch these roost areas will be lost, albeit temporarily, as salvaged tiles, or traditional heritage replacements will be re-instated on the roof of the proposed new extension and porch. It is important that tiles that will allow bat access, such as traditional clay tiles with an 'eyebrow' convex profile are used.

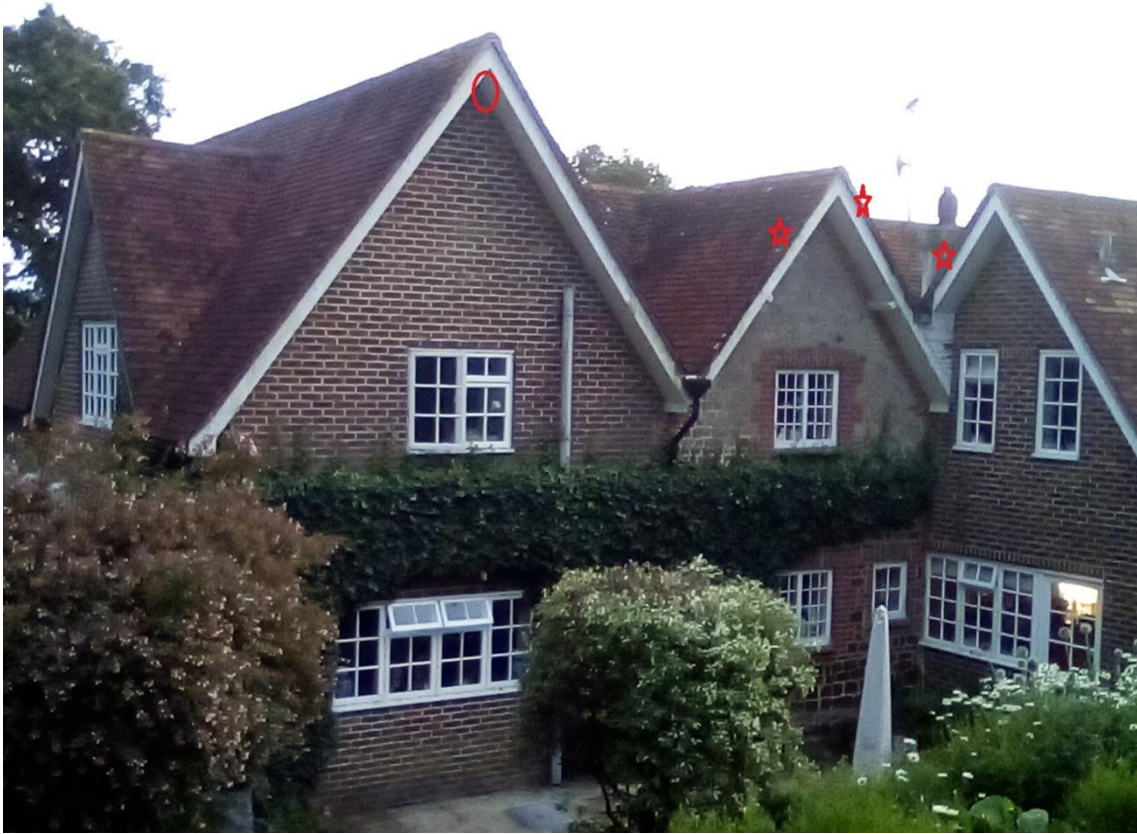
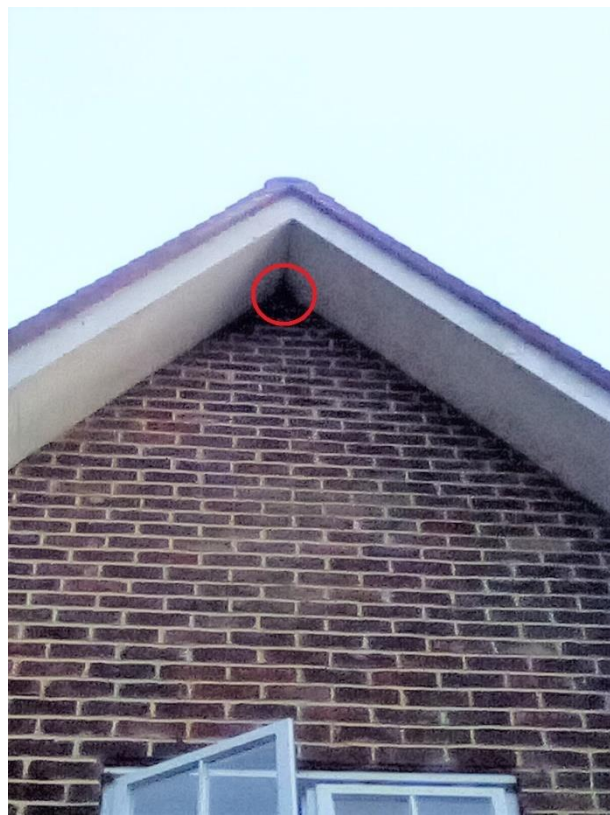
Figure 6. Showing roost entrance of Soprano Pipistrelle (red circle) maternity roost in soffit box apex on northern elevation. Red stars denote additional emergence locations of Soprano Pipistrelle and a single *Myotis* species of bat. These roost locations will not be affected by the proposed works.

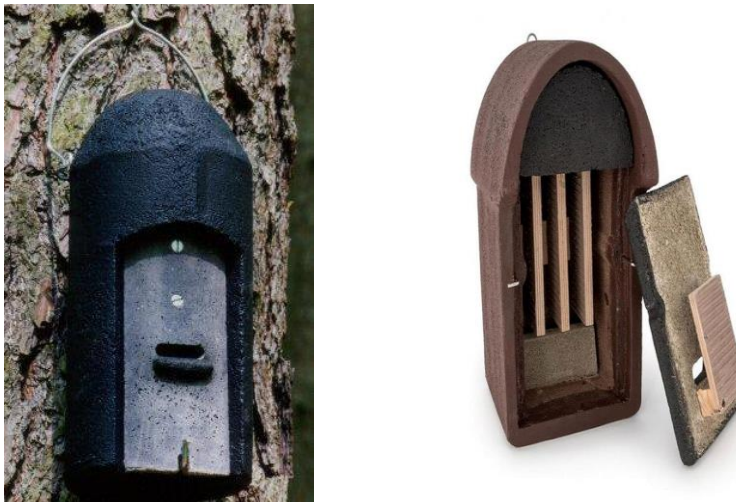
Figures 7 & 8. The Schwegler 1FD Bat Box (L) or alternative CJ Wildlife Large Multi-chamber Woodstone Bat Box (R) to be established on site.

- 4.12 A Schwegler 1FD Bat Box* (developed specifically for smaller bats such as pipistrelle species, but can also accommodate Brown Long-eared bats) is required to accommodate any bats discovered during the works. This will be established on a mature tree or similar away from light spill and preferentially on an existing flight line. This model is recommended for its insulation and long-term durability (<https://www.nhbs.com/1fd-schwegler-bat-box> (*If the make and model of bat box recommended is not available retailers such as NHBS will have the in-house expertise to advise upon a suitable alternative. NHBS have previously advised that the CJ Wildlife Large Multi-chamber Woodstone Bat Box is a suitable alternative that is currently in stock.)

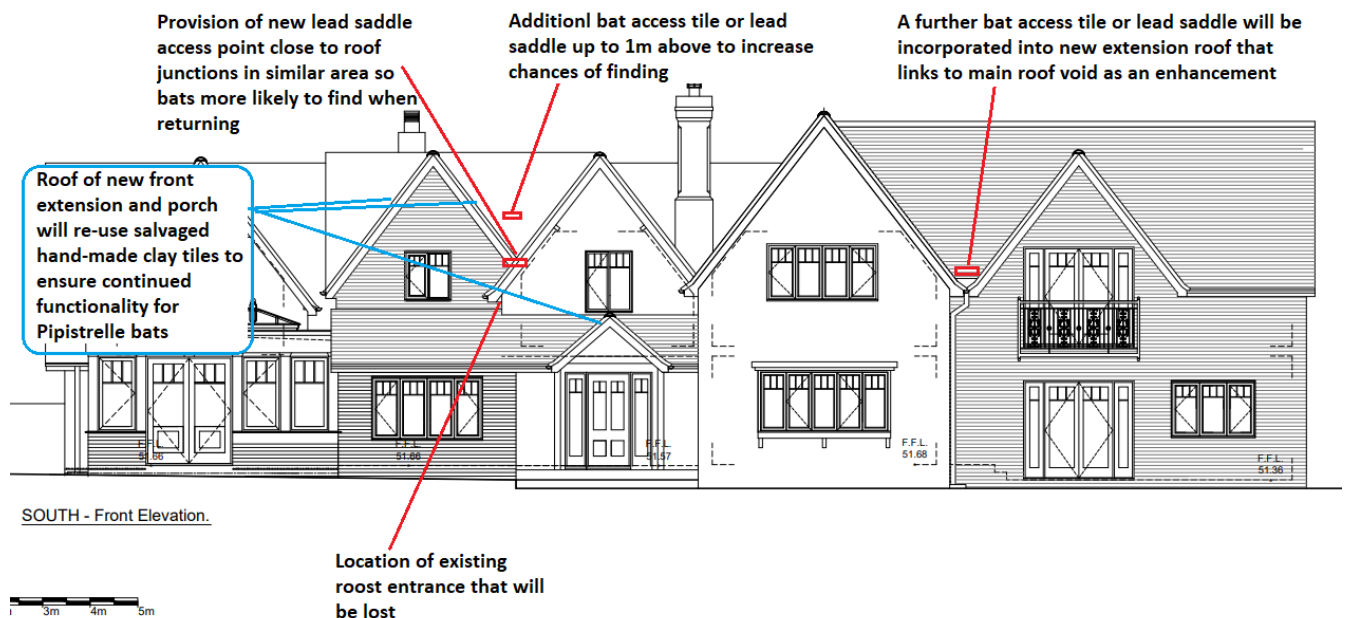
Figure 9. Proposed mitigation / compensation. All recommended roost access locations are approximated pending further discussions with the architect.

- 4.17 The proposed new two-storey front extension will be a new gable end to mirror the adjacent, existing gable end to the immediate east. This will emerge from the existing cat-slide roof and the new ridge will key into the roof covering (and void) of the main house. **This will result in the loss of the existing Brown Long-eared roost entrance. As compensation, a new roost entrance will be provided as close to the position of the original entrance as is practicable.** It is recommended that as compensation a lead saddle access point will be fitted as indicated on the below plan. A weather-tight lead saddle access point into the roof void will be formed near the base of the valley where the roof junctions meet. Additionally, a clay bat access tile will be fitted in to the roof covering up to one meter above this to increase the likelihood of bats finding the entrance/s on their return. Any felt liner will be cut away, folded back and secured to ensure unobstructed access. As a further enhancement, and to increase the chances of continued use of the roost, a further bat access tile or lead saddle will be incorporated into the south facing pitch of the proposed new extension that will tie in to the existing roof void. Continued use will be monitored for in 2023 and 2025.
