Holwell Farm, Ozleworth, Wotton-under-Edge,
Gloucestershire, GL12 7QB

Preliminary Ecological Appraisal & Dusk Emergence Survey for Bats

For: Millar Howard Workshop

Document Date: 28th October 2021

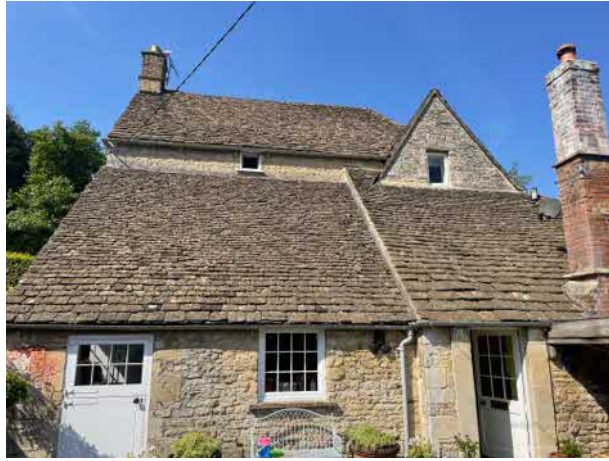
Photograph 4: House – kitchen lean-to roof.

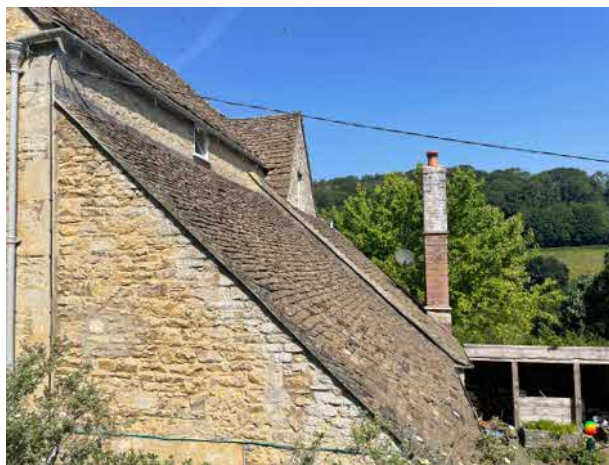
Photograph 5: House – kitchen lean-to roof – south elevation.

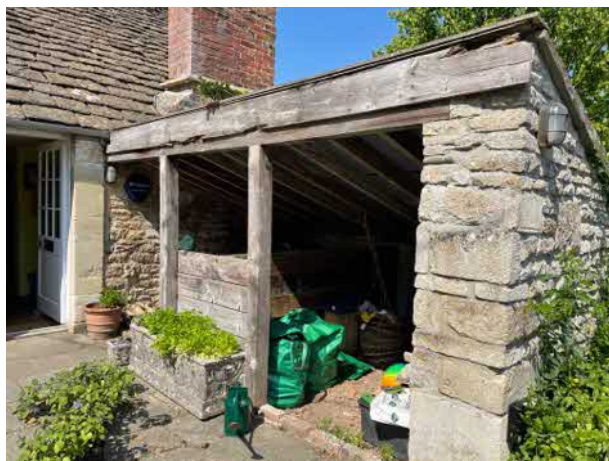
Gaps behind the fascia board on the log store. No evidence of bats such as staining, or droppings below but the gaps led to the main void between the slates and plastic membrane, which could not be fully inspected.

Photograph 6: House – log store.

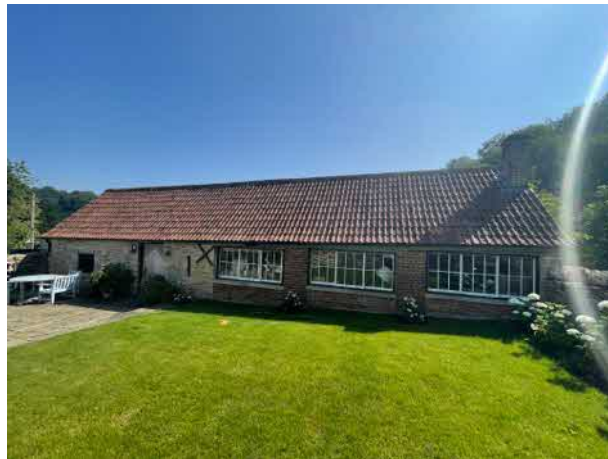
Photograph 7: Annex – west elevation.

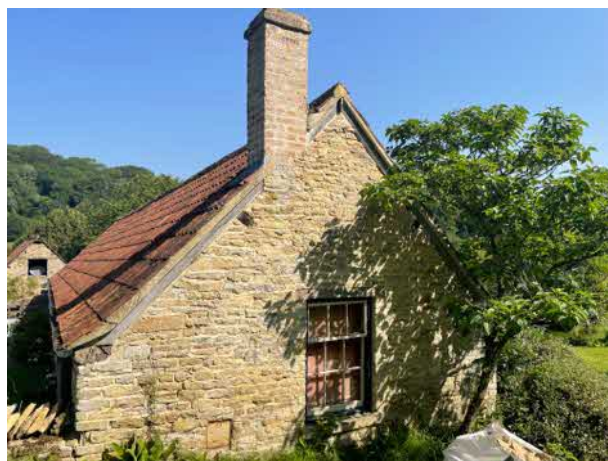
Photograph 8: Annex – south elevation.

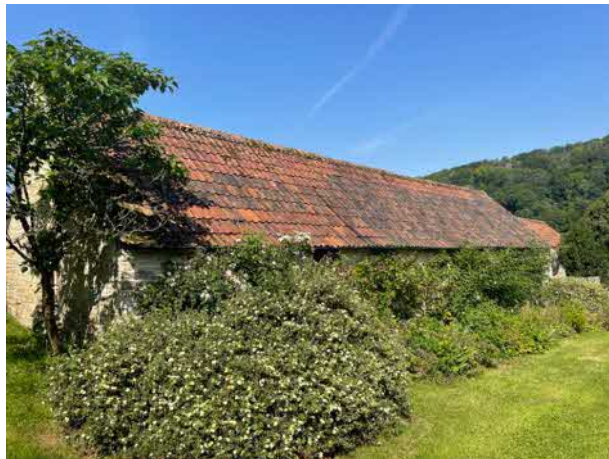
Photograph 9: Annex – east elevation.

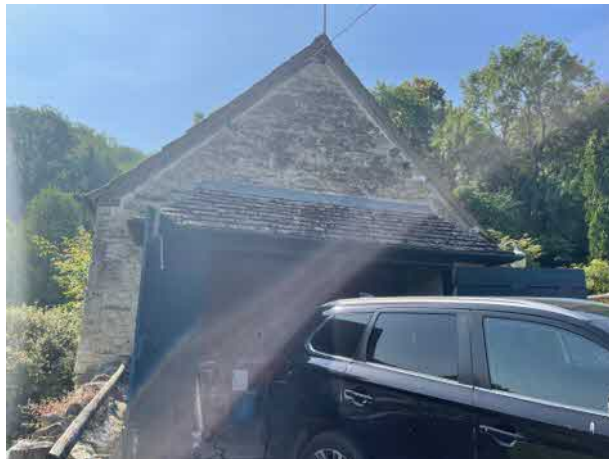
Photograph 10: Annex – north elevation.

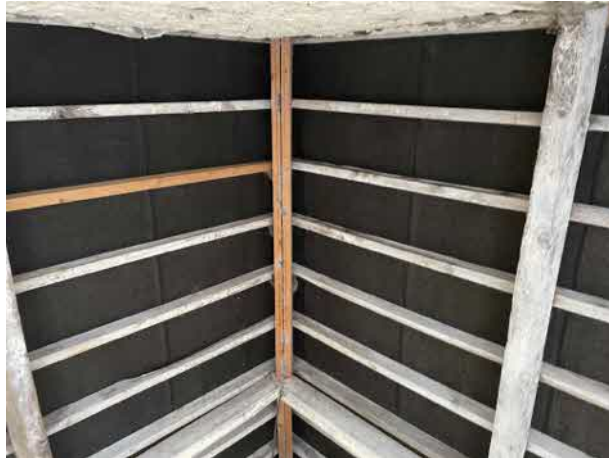
The interior is occupied with a garage, approximately one third, with the remainder being an open art studio with vaulted ceilings. The bitumen felt lining is visible in the garage where there is no ceiling; there are no enclosed roof voids, the roof supported by traditional roof timbers.

Photograph 12: Annex – garage roof interior.

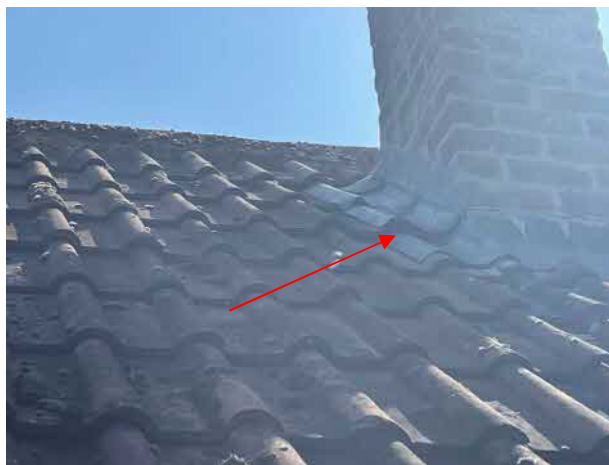
Gaps in the eaves between the wall plates and tiles. No evidence of use such as staining but a full inspection of these kinds of features is not possible.

Photograph 13: Annex – gaps under tiles.

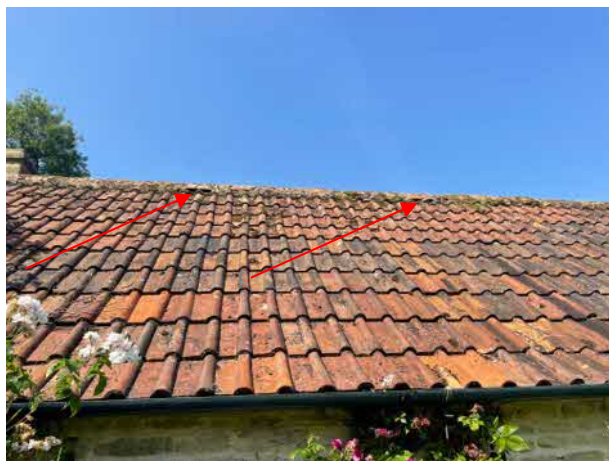
Small number gaps in ridge mortar. No evidence of use such as staining but a full inspection of these kinds of features is not possible. Ridge vents also present but these are sealed with mesh.

Photograph 14: Annex – gaps under ridge tiles – vent left (meshed) missing mortar right.

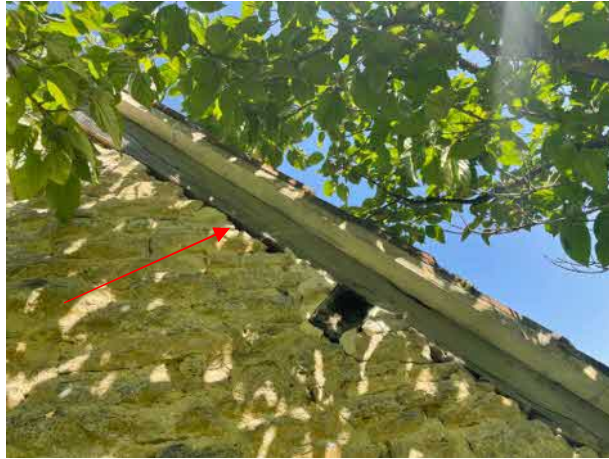
Gaps under the end exposed rafter on the south gable roof verge. No evidence of use such as staining but a full inspection of these kinds of features is not possible.

Photograph 15: Annex – Gaps on the south gable roof verge.

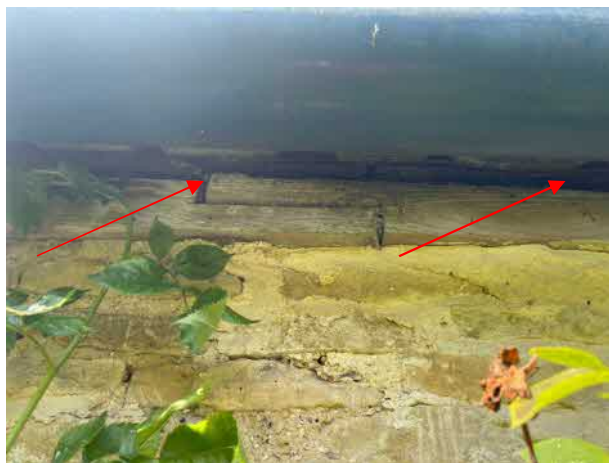
Photograph 16: Annex – gaps in the eaves.

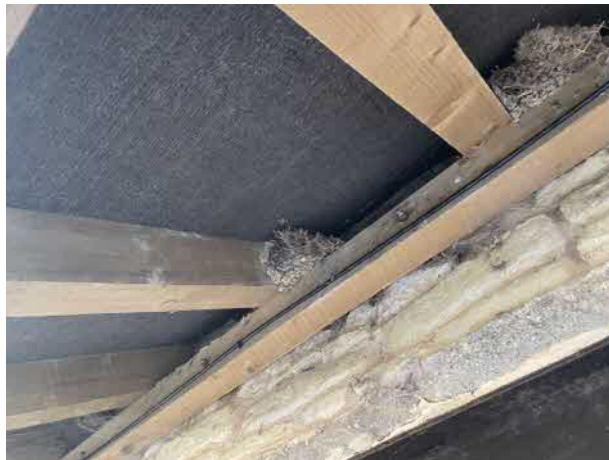
Birds – Nesting habitats on/in the buildings and a number of Swallow nests were recorded in the garage. Details of appropriate mitigation are given.

Photograph 17: Swallow nests under the canopy above the garage doors.

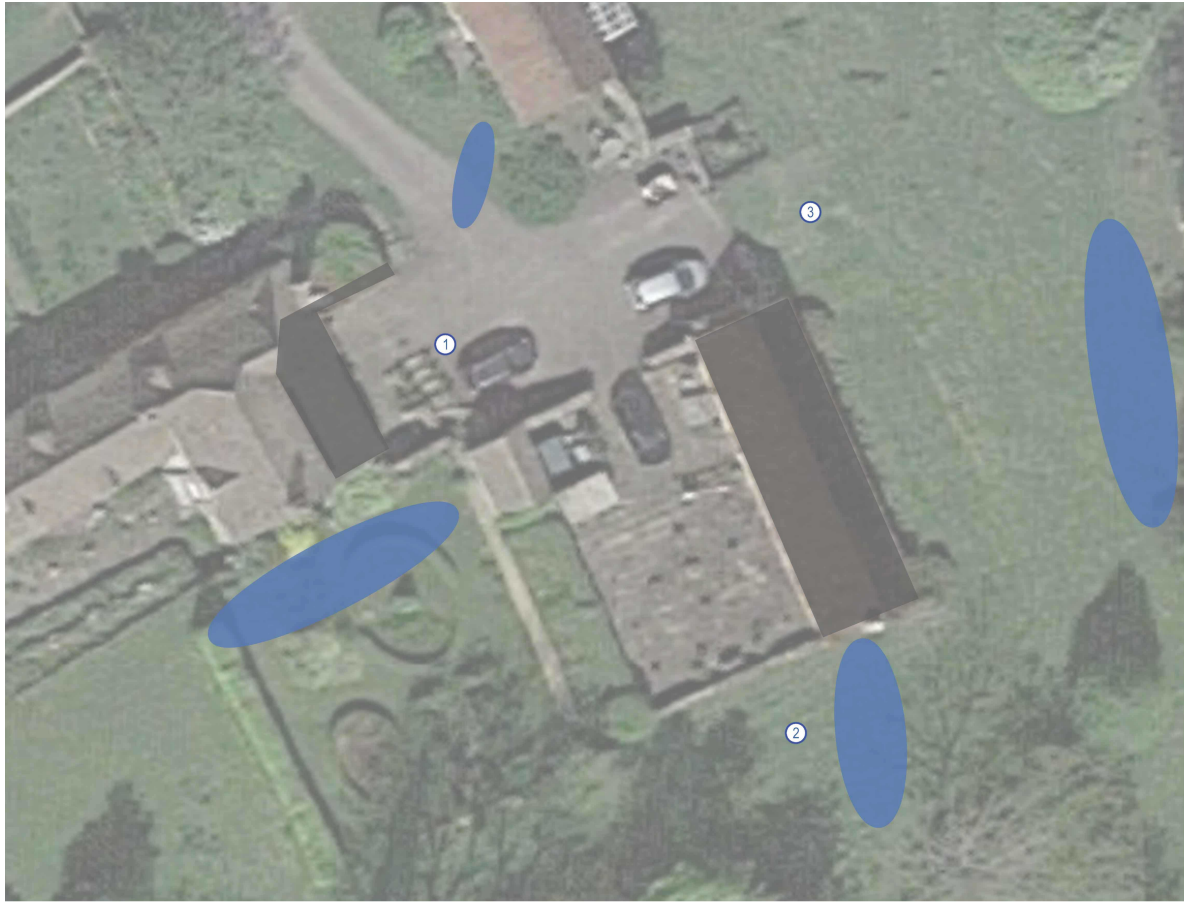
Plan 1 – Dusk Emergence Survey Results

- 4.1 No bats were recorded emerging from, or entering the buildings during the survey.
- 4.2 During the dusk survey the following species were recorded foraging and/or commuting over the course of the survey.

- 4.3 No bats were recorded emerging from, or entering, the surveyed buildings during the survey and it is therefore concluded that roosting bats were absent from the buildings at the time of the survey. The presence of a maternity roost can be ruled out with a high level of confidence and although individual bats could roost at any time, the present surveys indicate general absence.
