BAT, BARN OWL & NESTING BIRD SURVEY AT

Weaver's Farm Barn, Cabus

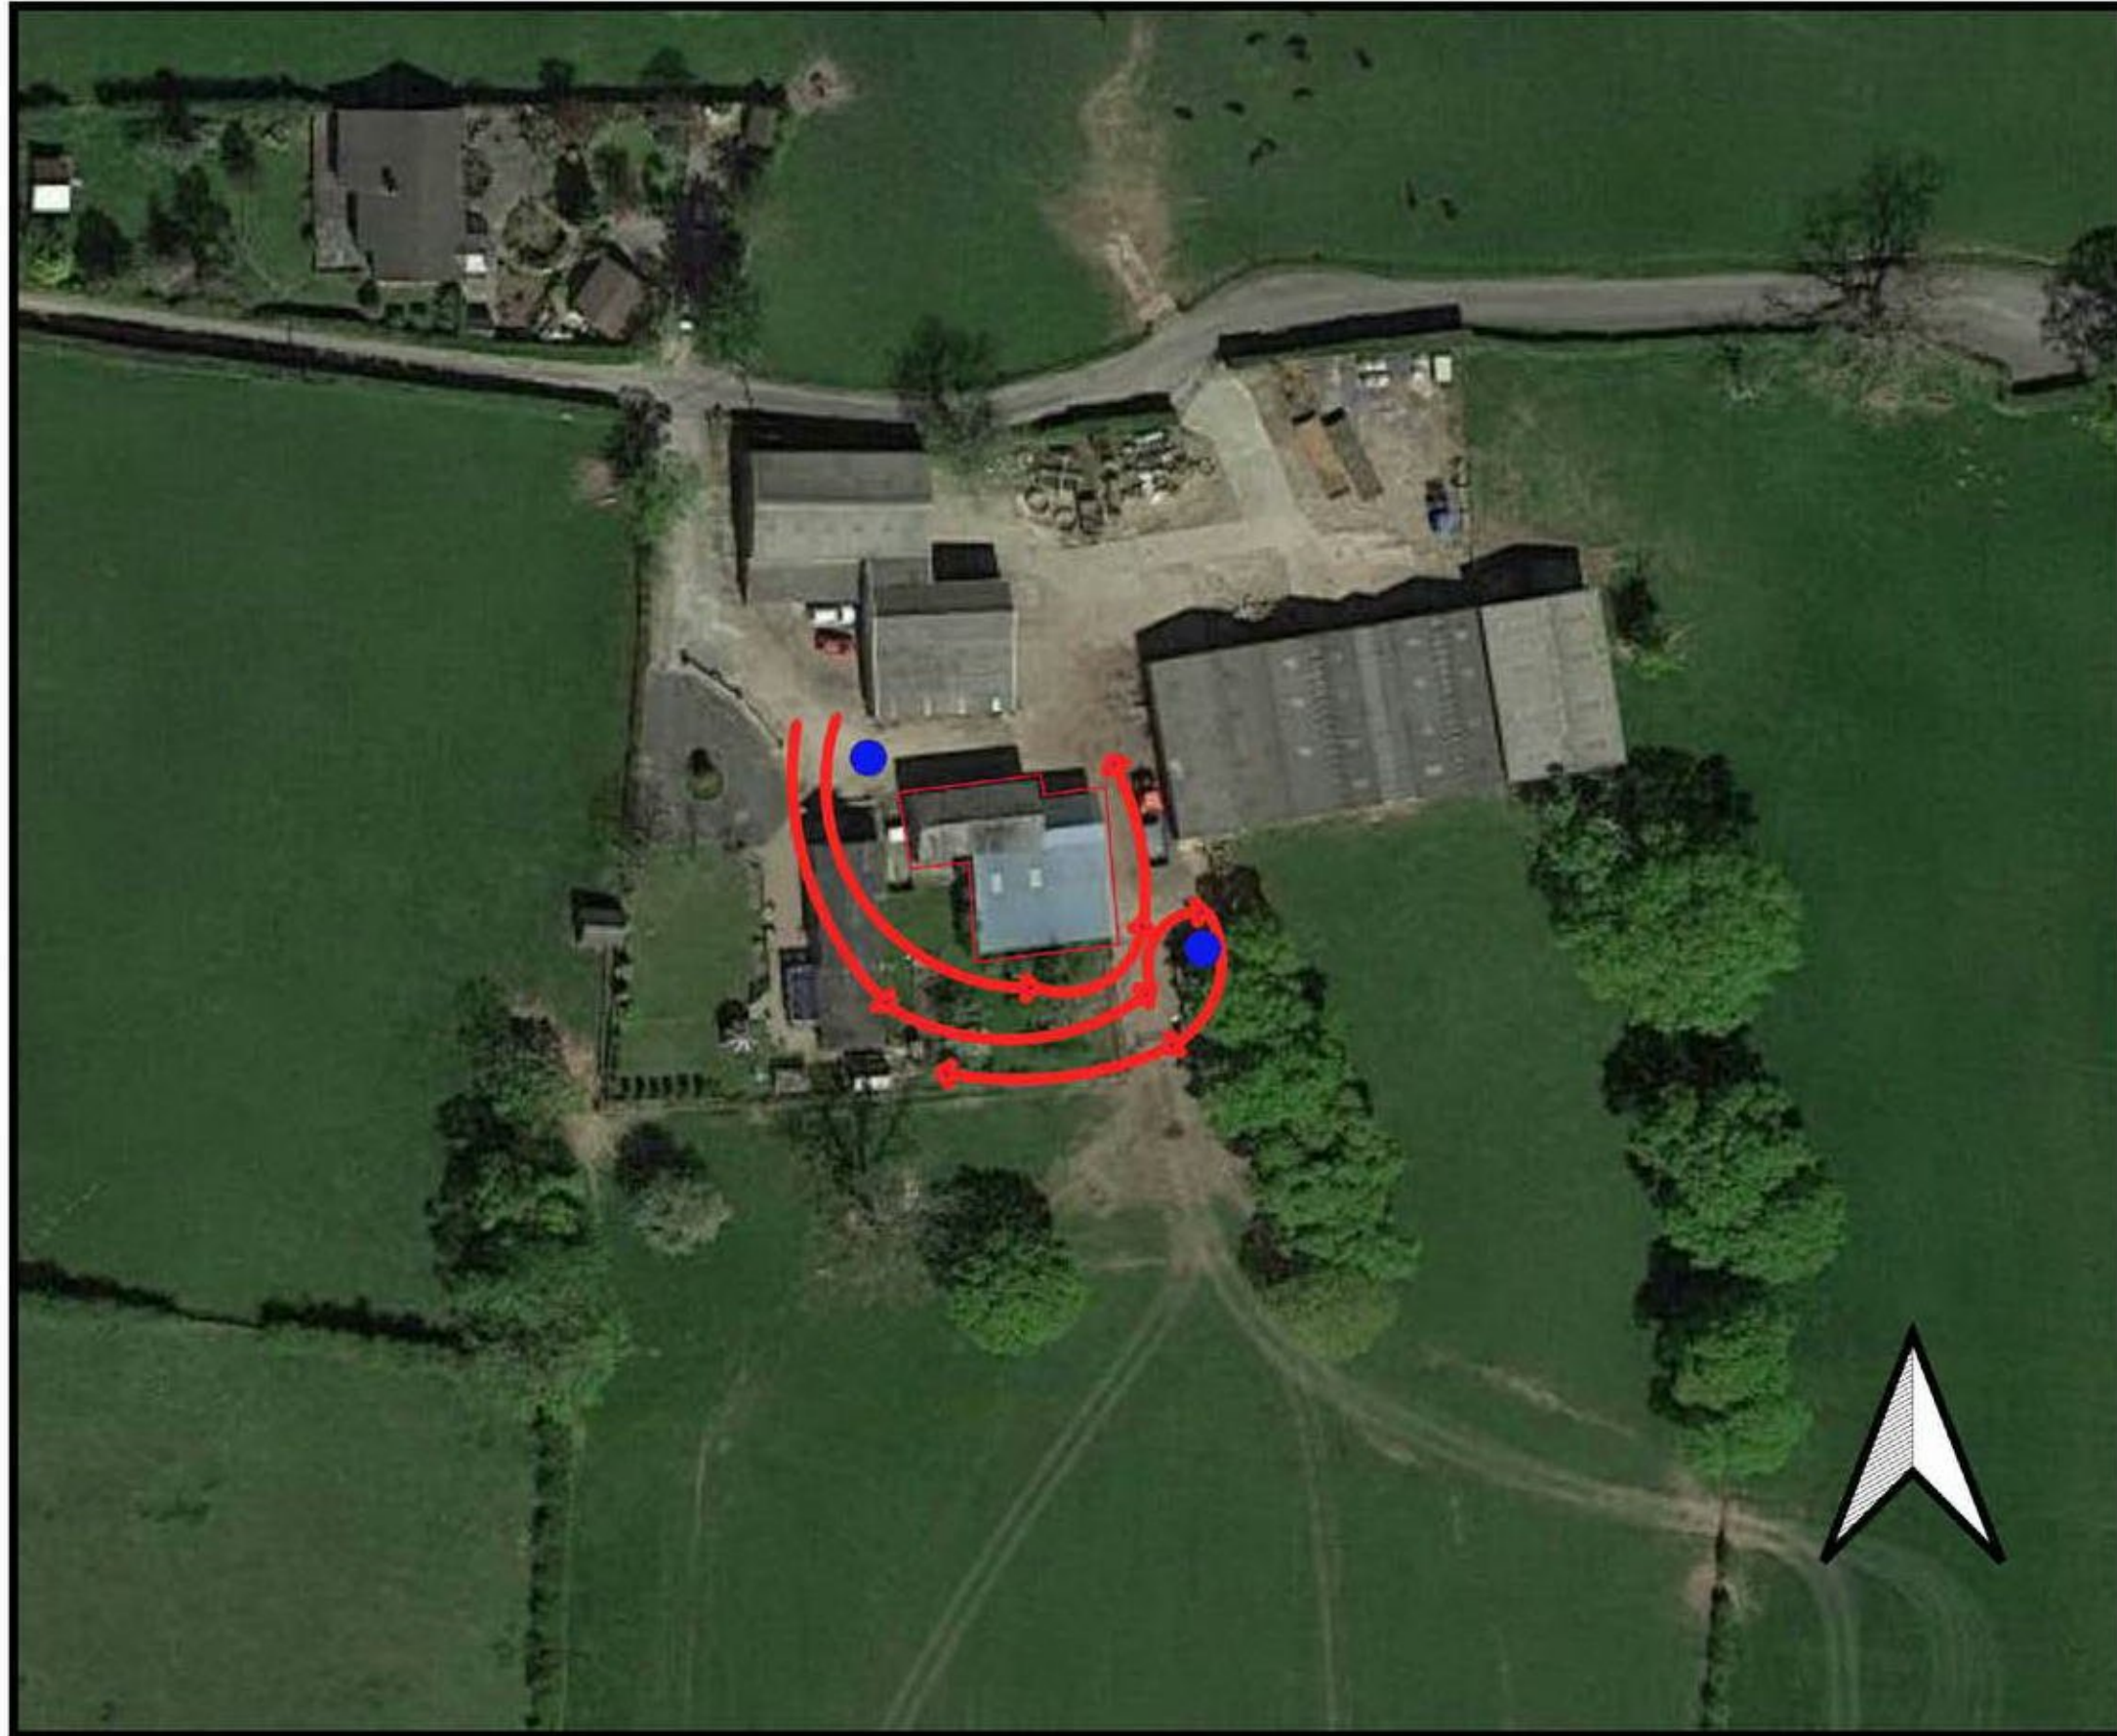
Figure 6
Bat Activity

Bat activity is plotted on Figure 6.

- Site Boundary
- Surveyor Location
- Common Pipistrelle

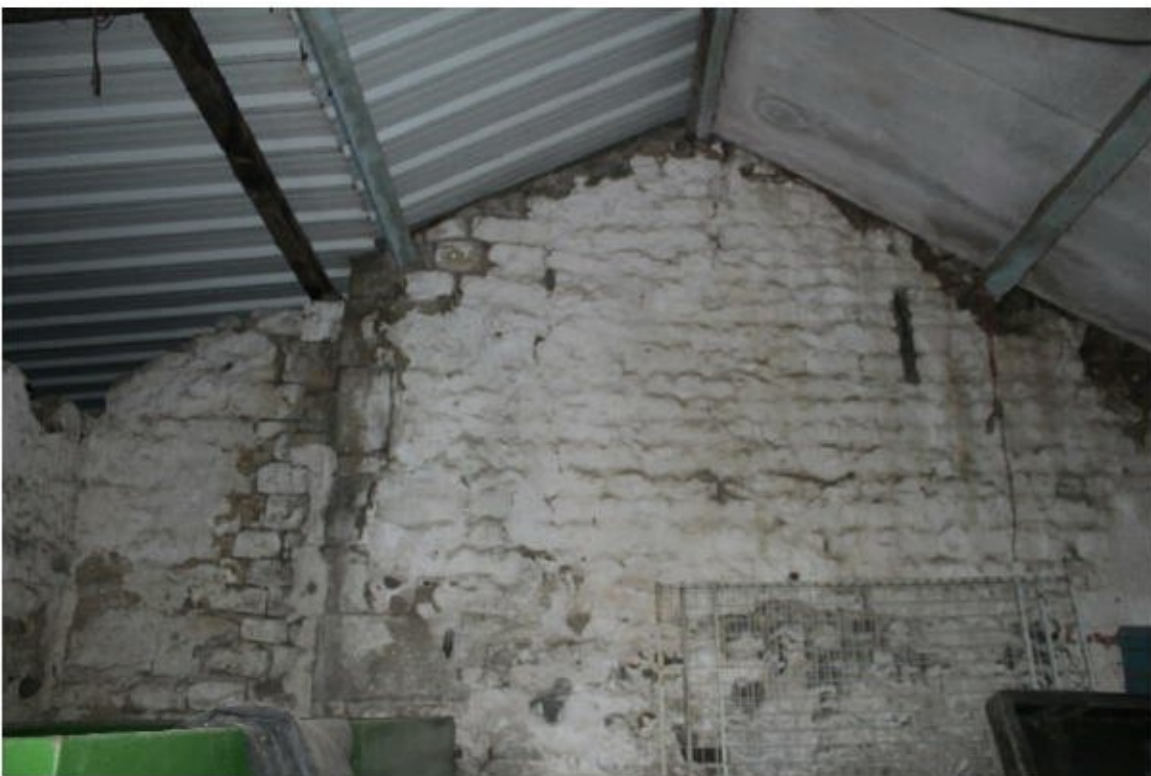
There were no separate roof voids. Timber beams in the roof were found to be in good condition with no rot or splits suitable for roosting or hibernating bats, although bats may be able to access gap between old roof timbers. The unlined roof meant the barn was slightly draughty. No indications of use by bats could be found.

Unlined roof
Roof timbers in good condition
Walls sealed
Ventilation holes partially blocked

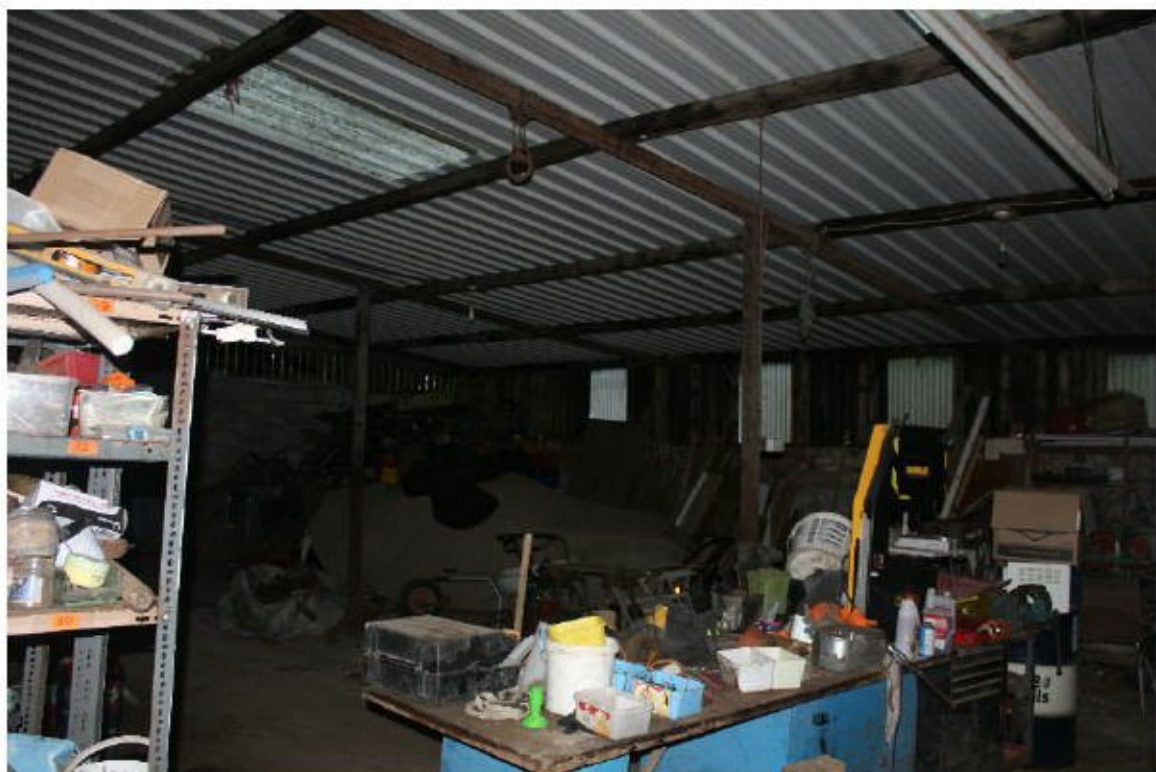
East extension with corrugated metal roof and stone walls, with no indications of use by bats.
