# 37A Great Cumberland Place, London W1

## Historic Impact Assessment

Prepared for The Portman Estate

Issue Date 20.09.2021

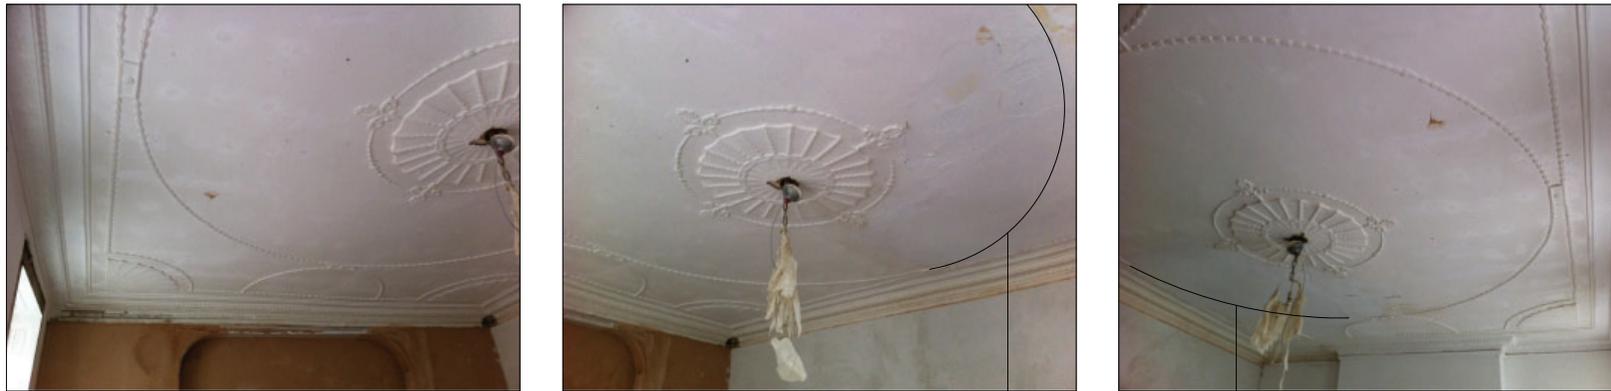
### METHOD STATEMENT:

- specialist to attend the site and carry out a survey, assessing the condition of the damaged plasterwork
- template to be taken from the curvature of one of the still existing corners to obtain the correct shape for a new moulding
- small section of the ceiling detail to be removed, with no interference to the existing ceiling bed, for copying and replicating
- specialist to make up a silicone rubber mould to match the existing removed section
- new sections to be cast in traditional fibrous plaster (casting plaster & hessian) and fixed onto the ceiling using a specialist adhesive, replacing the existing damaged section of the ceiling and in line with the curvature of the template taken previously
- ceiling to be repainted

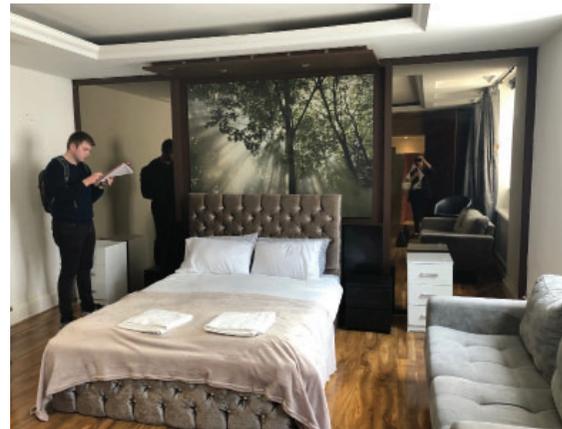
From a site inspection the bedroom on lower ground floor LG.01 has contemporary joinery with mirrors and artwork lining this wall which would account for some depth building out this wall. Please refer to fig 26. This work is not indicated in applications 11/08133/FULL and 11/08134/LBC and no records have been found on the planning portal.

Fig 26 Photograph of LG.01 taken 24th August 2021

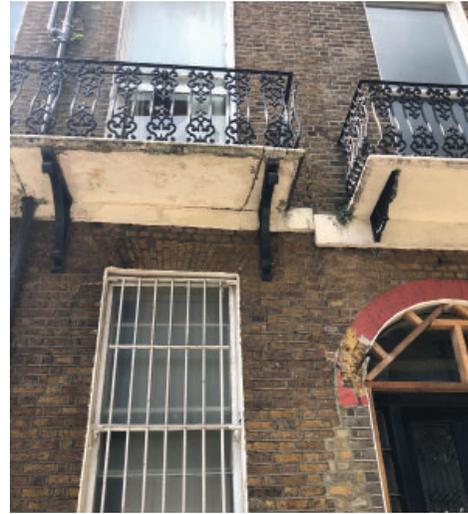
Photograph 1 - Front elevation 37a & door of no.37  
August 2021

From inspection the stock brick on the Great Cumberland Place elevation is in poor condition. Cracking is visible in the masonry. The ground floor window cill nearest adjacent to the main entrance door of no.37 is badly cracked and the render applied to the window reveals is in poor condition. The first floor window aperture is also badly cracked and the render has fallen away from the soffit of the opening. The slab of the cantilevered balcony has deep cracking from front to back. The pipework is corroding and the metal railings are badly damaged on the corner. In general the facade is in poor repair on this side.

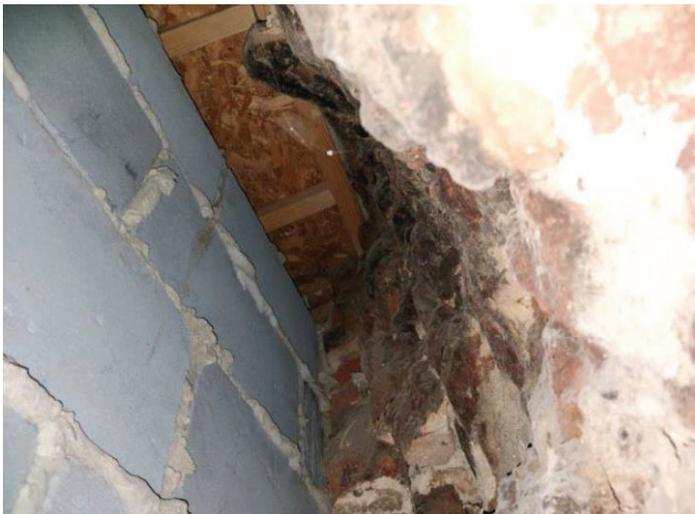
Photograph 7 - Basement bedroom - taken from no37 behind wall - August 2021

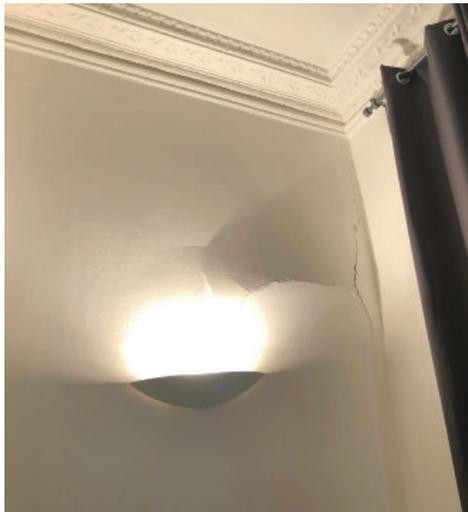
On the RHS to the chimney breast there is evidence of cracking. The plaster is coming away from the wall and appears to be live in areas. There is also cracking at lower level around the sockets on this side. A closer inspection shows the plaster work is pink on the edge of the crack where the wall has been opened up suggesting the wall has been finished with gypsum plaster. The decorative plaster work repaired in 2011 is all intact but there are cracks to the LHS of the chimney breast.

Photograph 10 - Ground Floor Sitting Room - Crack to RHS of chimney breast - August 2021

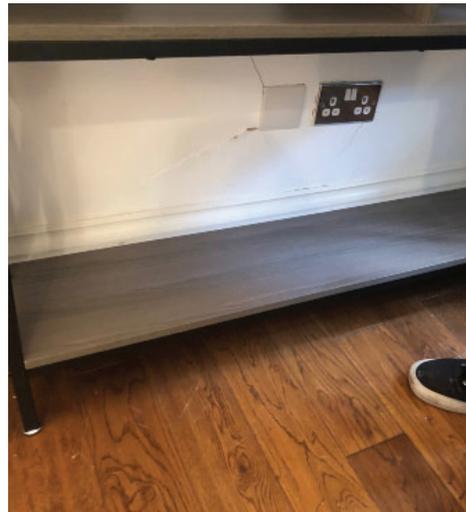
Photograph 11 - Ground Floor Sitting Room - Crack to RHS of chimney breast - August 2021

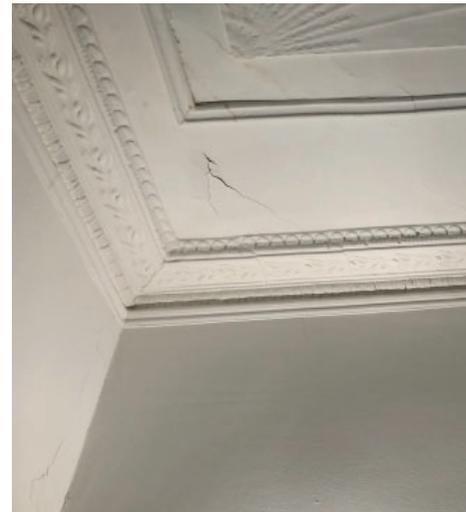
Photograph 10 - Ground Floor Sitting Room - Cracks in ceiling - August 2021

At ground floor level the masonry is in very poor condition when viewed from no 37 Great Cumberland Place internally. A section of plaster has been removed to investigate the masonry and the Structural Engineer has advised that the current structural condition cannot be resolved by using localised ties and that rebuilding in this area is necessary. On 37a side the plasterwork is cracked and live. There is cracking further back into building on the ceiling also.

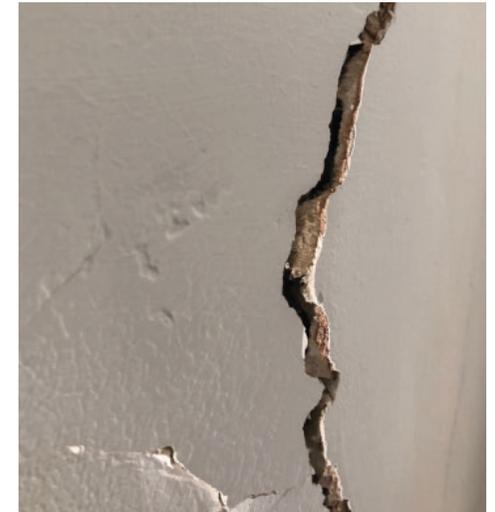
Photograph 10 - Ground Floor Sitting Room - Close up of cracked plaster - August 2021

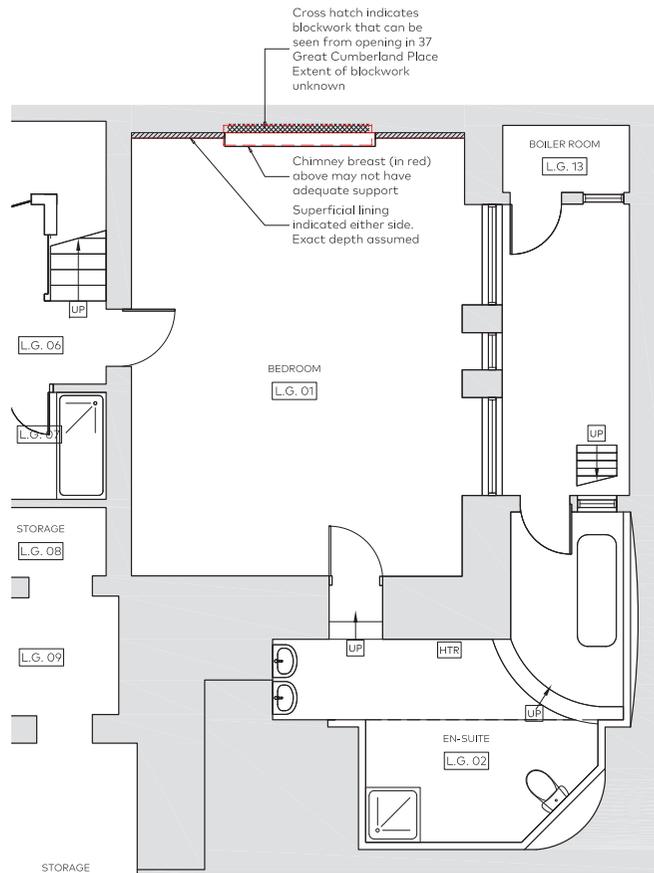
Fig 27 - Diagrammatic sketch of current arrangement at Lower Ground Floor

Please refer to figure 27 for a diagrammatic plan indicating the chimney breast at ground floor superimposed over the lower ground floor. We have also allowed for the skin of blockwork (rear view of this can be seen from investigative works in 37 Great Cumberland Place).

Although not specified explicitly in any of the works indicated on the historic floorplans these findings would suggest that the existing chimney breast at lower ground floor has been removed or has been altered in a way that does not provide adequate work to the chimney breast above.

The damage and movement of the wall is too great for typical masonry repairs, and as such it is recommended to prop the wall just below first floor level (with the props extending down to the basement), take down the damaged length of wall and rebuild. The chimney breast on the no. 37A side should be reinstated to support the breasts above, and as part of the works a chimney breast is proposed to be constructed on the no. 37 side at basement level only. The wall should be built to a full thickness throughout, and the new chimney breasts should be built in. The no. 37A basement chimney breast should be built up to the underside of the ground floor breast.
