Bat Survey Report

The Mill, Gurney Slade

October 2021

Project: **ETH21-126**

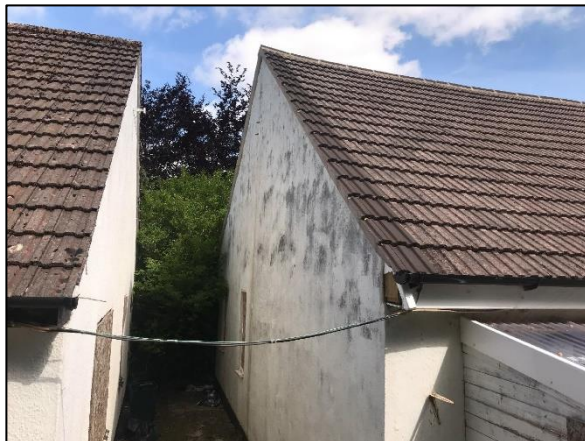
Photo 3 gable end and roof of B1

The tiles and ridge tiles (Photo 3) were all tight and in a good structural condition providing no potential roosting features (PRFs) and the chimney and vents were all tight, were lined with led, which was flush with the tiles providing no opportunities for bats.

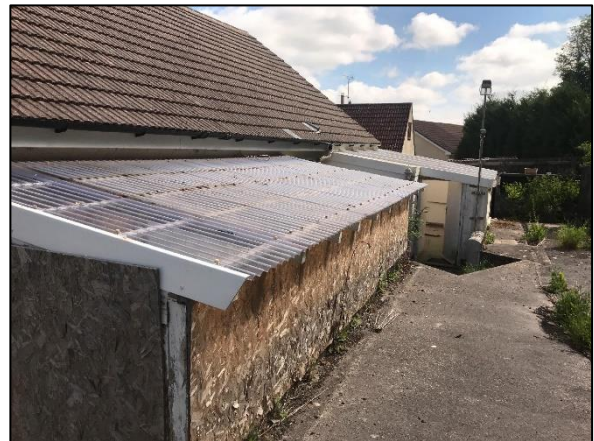
Photo 4 southern aspect and lean-to structure of B1

The porch (photo 4) located to the south contained multiple access points and was assessed to be freely accessible for bats. The lean-too structure was constructed of timber and corrugated PVC resulting in the lean-to be light and exposed, thus providing poor conditions for bats.

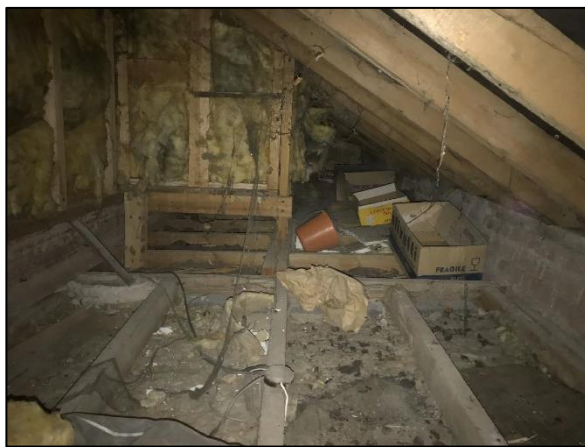
Photo 5 attic void in B1

The loft void (photo 5) within the structure was mainly built into for additional living space. Accessed from a storage room at the east gable, was access to attic voids on the northern and southern aspects of the dwelling. These attic voids were constructed from wooden purlins, rafters', and fabric sarking. There were a few gaps present where roof meets external wall. But generally, the attic voids were dark with minimal light ingress. There were abundant cobwebs within the attic voids and rat droppings and a dead rat was located within the roof.

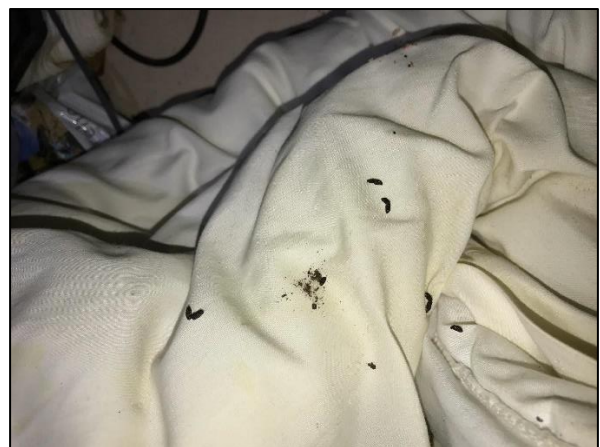
Photo 6 Droppings in southern attic void of B1

There were <5 droppings located on a shelf of the storage room that led to the north and southern attic voids. A further <5 droppings were found in the southern loft void (Photo 6). The droppings were assessed to be relatively fresh and were indicative of LHS horseshoe bats droppings.

Overall, due to presence of fresh droppings, the building assessed to hold high potential for bats.

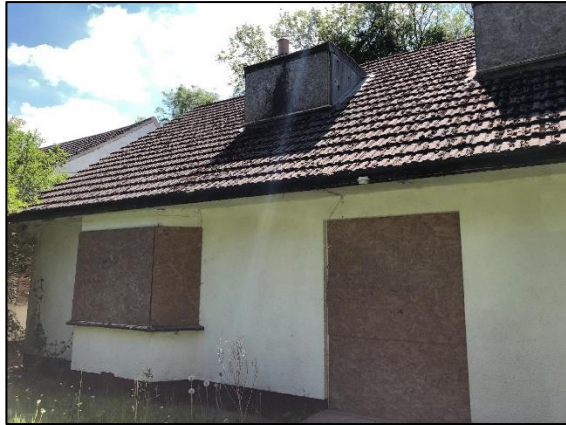
Photo 5 northern elevation of B2

Building 2 (B2) was a chalet bungalow to the west of B1, constructed of rendered blockwork, with composite tiles, two chimneys, and two dormers of the northern elevation (photo 5). The building was in a good structural condition with no visible external PRF's for bats.

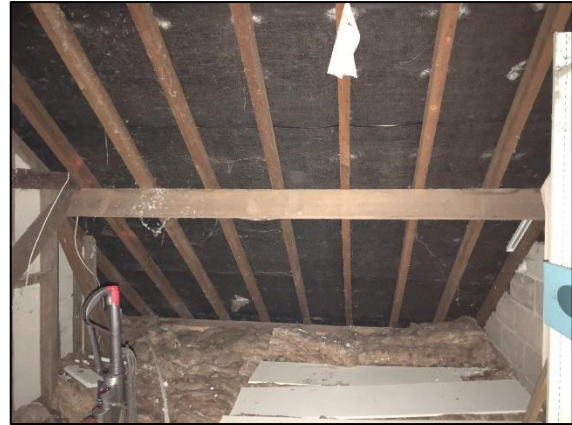
Photo 6 attic void in B2

Most of the loft void within this structure has been built into for additional living space. However, there were exposed timbers within the unconverted void area under the eaves, including rafters, purlins, and ridge beam (photo 6). There was bitumen felt sarking present between the tiles and beams which was in a good condition. The loft was dark and there was no light ingress into the loft. The soffits between the external walls and the roof space were all in a good structural condition providing limited potential for bats.

Overall, there was no evidence of bats within the loft such as droppings or live specimens and the building was assessed to be in a good structural condition. Therefore, it was considered that B2 provided negligible potential for bats.

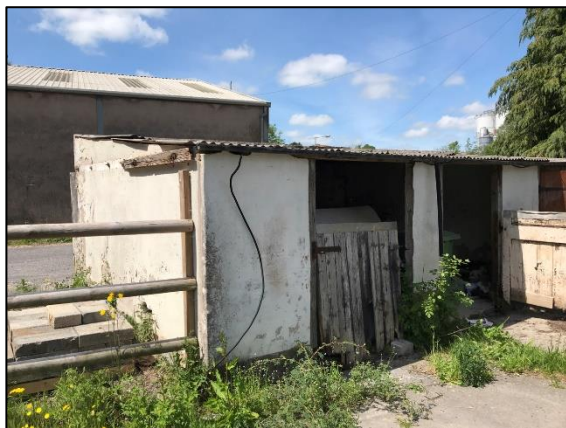
Photo 7 Stables B3

The internal inspection identified a single dropping in the open stables (photo 7) and approximately 5 droppings within the dog kennel (photo 8). The droppings were found under the timbers and although partially disintegrated, were indicative of LHS horseshoe bats.

Whilst the building was assessed to have had limited roosting features, however with presence of therefore B3 was assessed to hold low potential for bats.

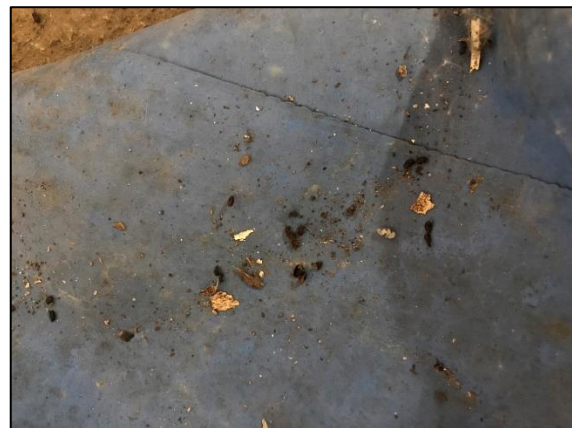
Photo 8 Droppings within dog hutch area of B3

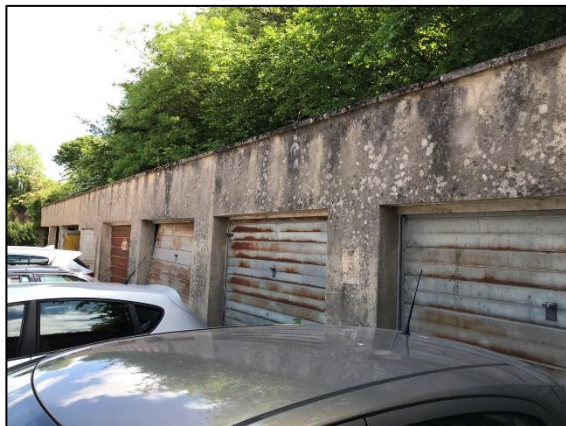
Photo 9 Garages B4D – B4H

B4G: Garage with metal door. Accessible, use to store vintage car. There were gaps between walls and roof blocked with foam. There was plastic sheeting on car. However, there no droppings were identified following a full search on ground, on the plastic sheeting, and on the bonnet of the car.

B4H: Garage with metal door. Accessible, was in a similar condition to the other garages. There was a gap between the northern wall and the roof. However, no evidence was identified within the structure.

Overall, the stables to the east of the structure, B4A to C, were assessed to hold moderate potential to support roosting bats whereas the garages to the south, B4D to H were assessed to provide negligible potential for bats.

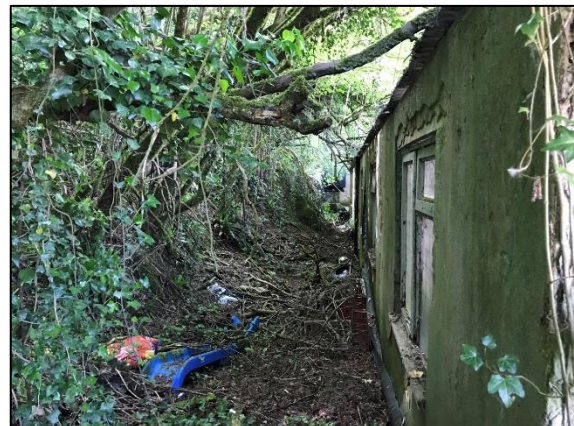
Photo 10 rear of garages B4D – B4H

B4D: unit with double wooden doors, which was of a similar condition to B4C. There was also a gap between the external wall and the roof on the northern aspect. However, no evidence of bats was identified within this structure

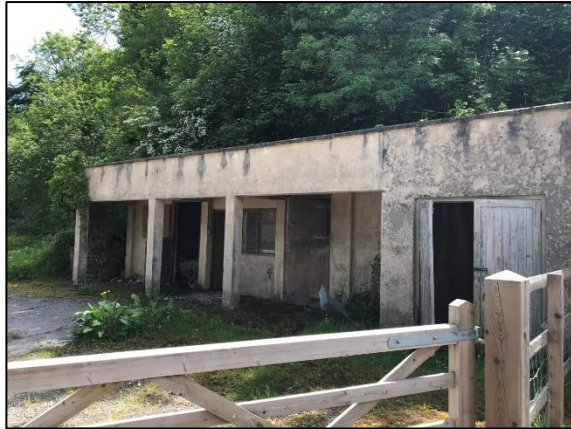
Photo 11 Stables B4A – B4C

The subunit with stable doors, furthest to the east, B4A, contained approximately 30 droppings indicative of LHS horseshoe. No bats were observed during pre-survey inspections; however, a single LHS horseshoe bat was recorded emerging from B4A during the first emergence survey, 30th of June, approximately 30 minutes after sunset.

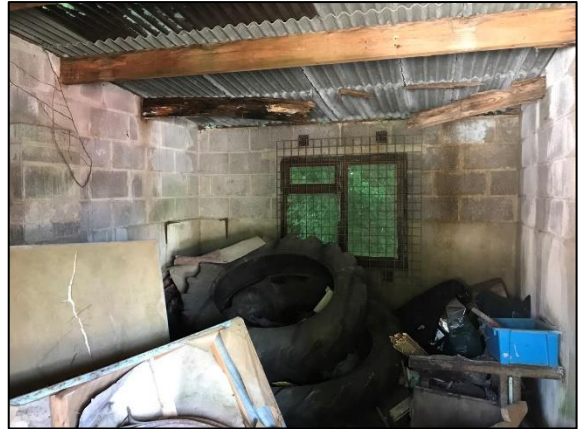
Photo 12 Internal B4B

B4B: unit with stable door and was also used for storage. The door was noted to be closed and roofing was tight with limited PRF's identified. There was no evidence of bats.

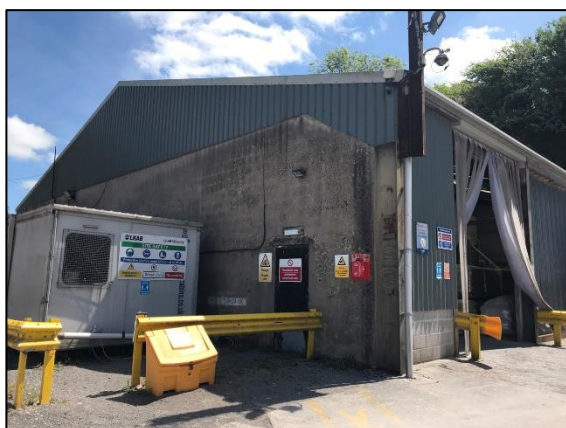
Photo 13 B5 external

Building 5 (B5) was in active use as a warehouse and was used for storing materials for the quarry. The structure was constructed of iron framework, corrugated metal sheeting, and block work.

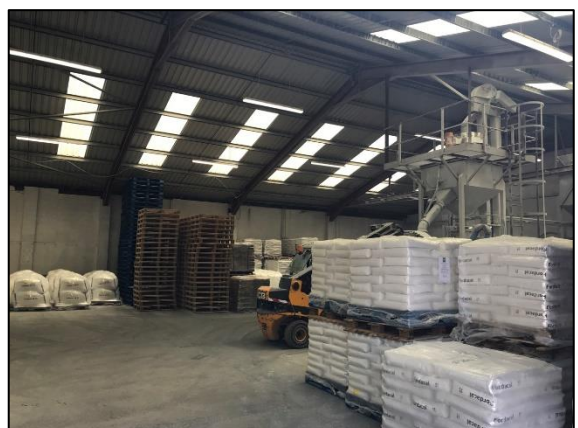
Photo 14 Internal B5

There were skylights present within the roof of the structure resulting in high light levels within the structure. This alongside high levels of the disturbance provided the assessment that B5 provided poor conditions for bats and as such was assessed to provide negligible potential for bats.

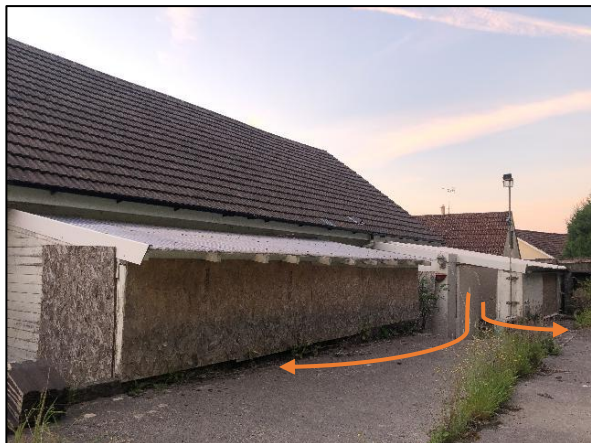
Surveyor were positioned at locations 1 and 2 (ref to figure 9). Three LHS horseshoes were recorded light sampling and emerging from the front door of B1. It was assessed that there was a maximum of three bats recorded emerging from the structure from around 20 minutes after sunset. There were also high levels of common pipistrelle activity on the eastern gable of the structure and two common pipistrelles were recorded emerging, then later re-entering the eastern gable of the house where tiles had been removed (due to asbestos removal works).

Photo 15 Light sampling and LHS emergence/re-entry from lean-to porch of B1 - 30th June, 14th July and 3rd August 2021

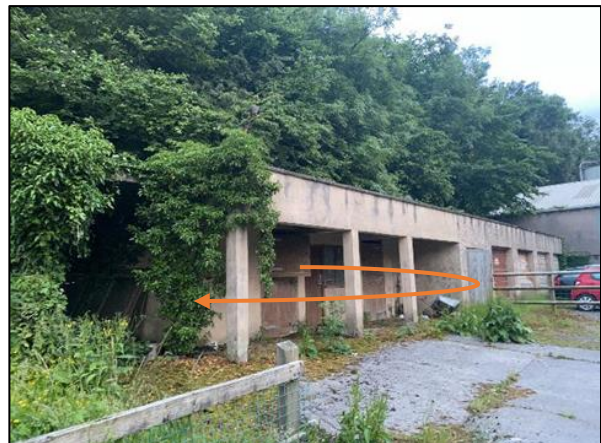
Photo 16 Light sampling and LHS emergence from B4, 30th June 2021

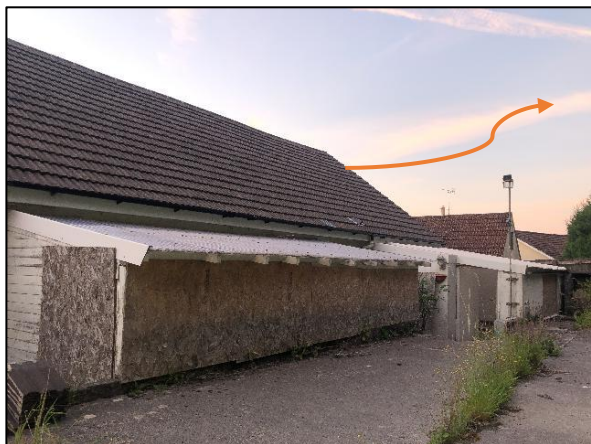
Photo 17x CP emerged/re-entered from removed tiles, 3rd August 2021

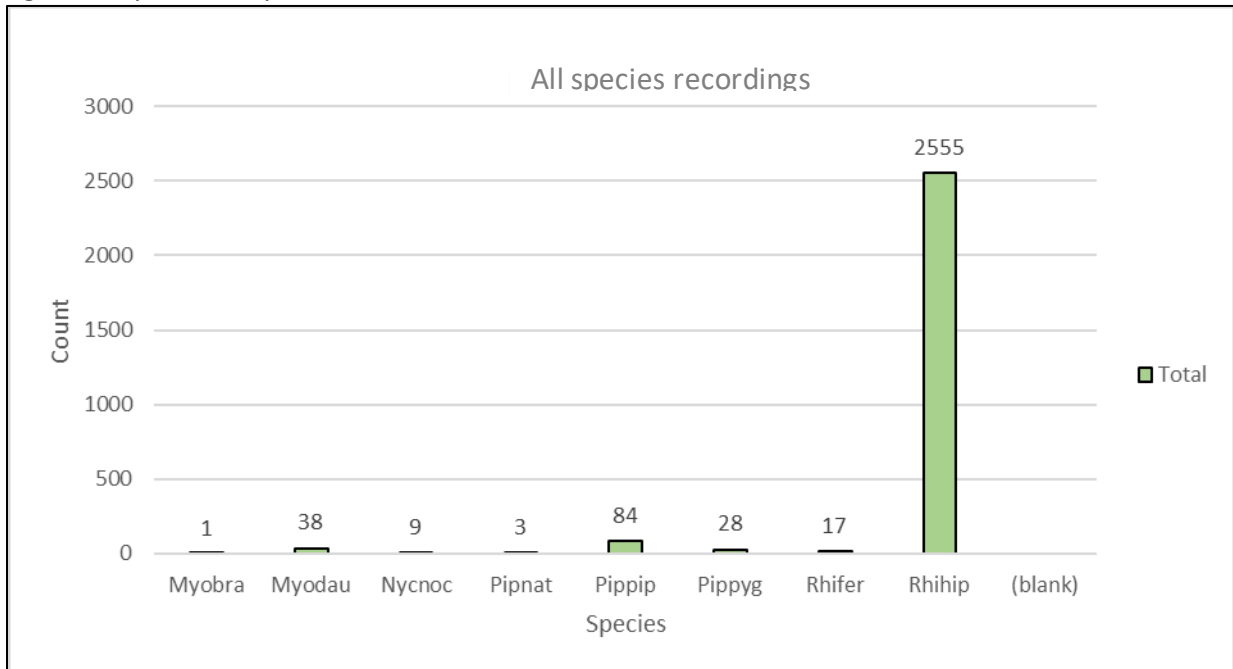
Figure 10 Species composition

A single static detector was deployed within the loft of B1 on two separate survey periods. The first period was conducted between the 30th of June and the 14th of July 2021 and the second period was undertaken between the 3rd and 18th of August 2021. The majority of the recordings within B1 were of LHS horseshoe bats within the dwelling and calls were returned throughout the static recording period with no peak in night activity indicative of a night roost suggesting that B1 is a day roost for horseshoe bats (see figures 10 and 11).

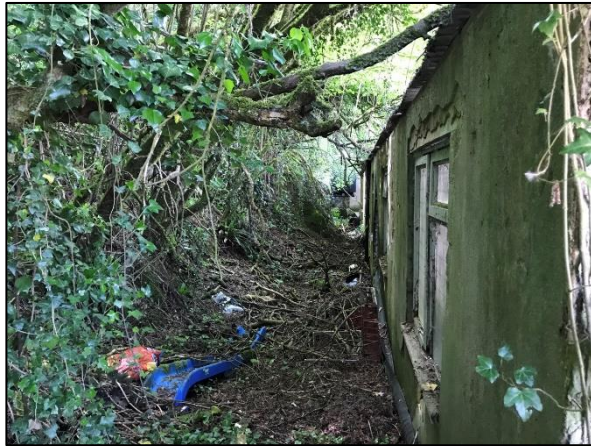
Photo 17 overhanging hazel

The trees to the rear of B4 were checked for their potential to support roosting bats. The trees within this section were comprised of multi stemmed hazel, were young, were in a good condition with no visible features for bats.

It is anticipated that there will be light pruning works required to the trees to the rear of B4 to facilitate the works. These trees were comprised of young multi-stemmed hazel with no PRF's suitable for bats. The trees do provide suitable nesting habitat for birds, therefore recommendations to avoid impacts on breeding birds are provided in Section 7.3.

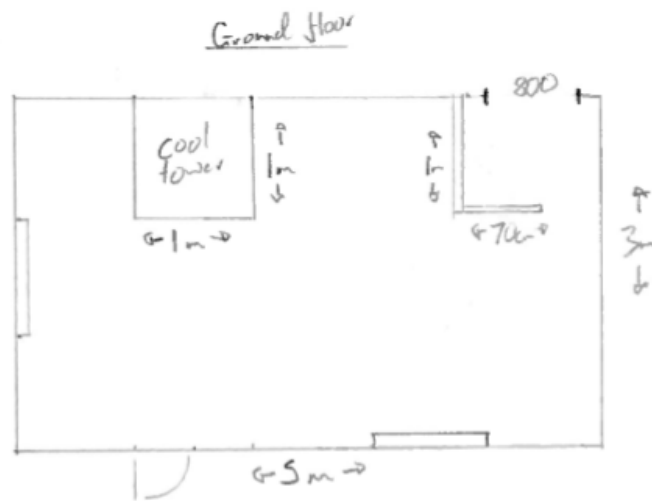
Ground floor design:

- Turnback to reduce light into building
- Cool tower for bats
- Simple roosts on walls for crevice dwelling bats
- Open and un-cluttered on ground floor

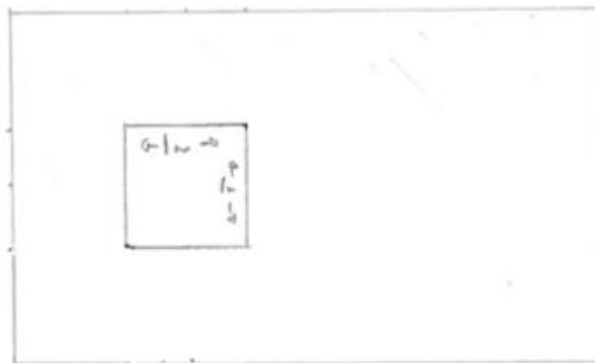
Ceiling level

Gap for flight lines into loft void.
Loft floor to be insulated and boarded

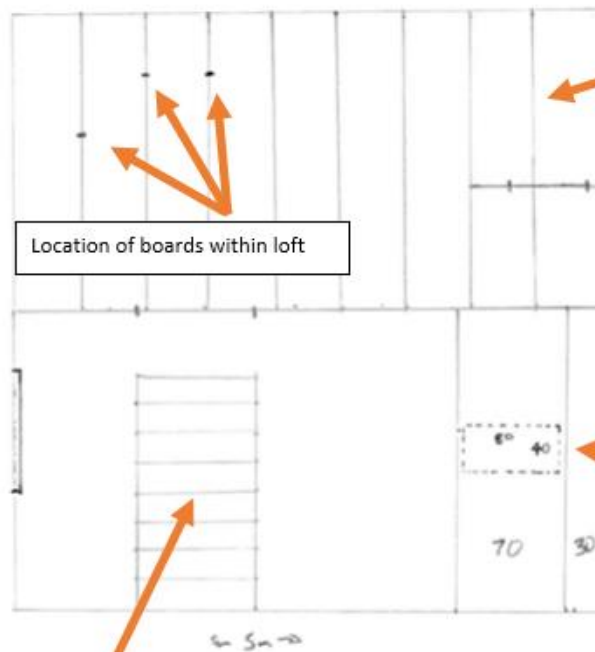
Side view of bat house

Location of hot box in loft

Location of boards within loft

Bat entrance and turn back located in north east corner of building

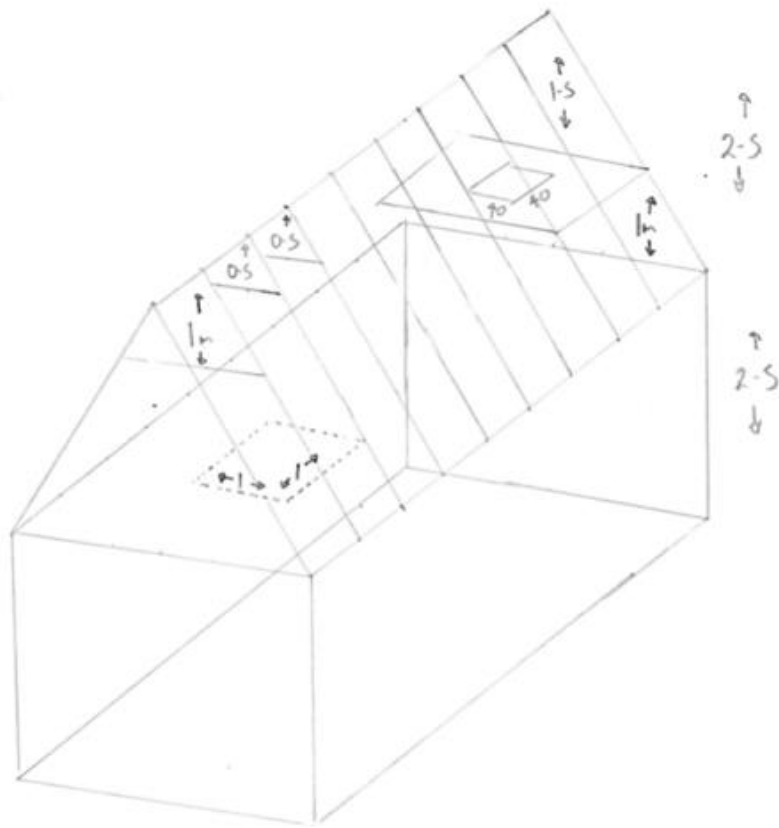
Cool tower – Simple construction of breeze blocks, sand and timber sheeting.
