Restoration works at The Mill, Clee St Margaret,
Specialist Bat Assessment

Prepared by CRC Ecology Ltd on behalf of Yeat Investments
Report number – cc-74715102021

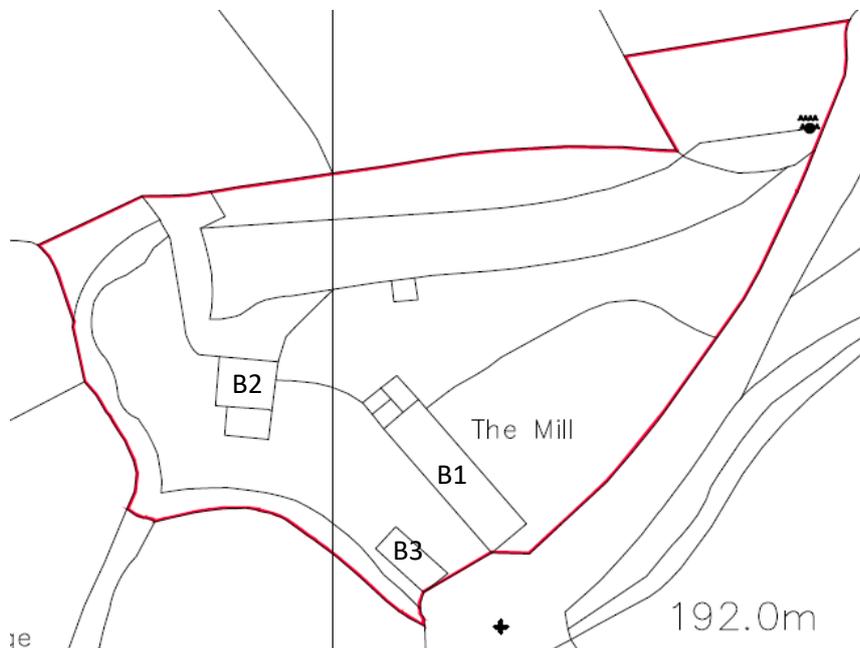
Figure 1. Reference numbered buildings within the redevelopment plans

Building 1 is the main house and has an adjoining barn and pig sty to the northern end. The main building is of stone and timber construction with clay tiles. The adjoining barn is of timber construction with a more recent gable wall of breeze block construction. The building has a small cellar located to the southern end and a loft space the length of the main house. Building 2 is an old corn mill with mill workings maintained within. The construction is the same as the main house with stone and timber and clay tiles although the building is in a state of collapse. The building has three floors with step/ladder access between each floor. Building 3 is the old bakery. The building is split into two with a bread oven situated within the southern end and a northern shed /storage area. The building is of stone/brick and timber construction with a slate roof.

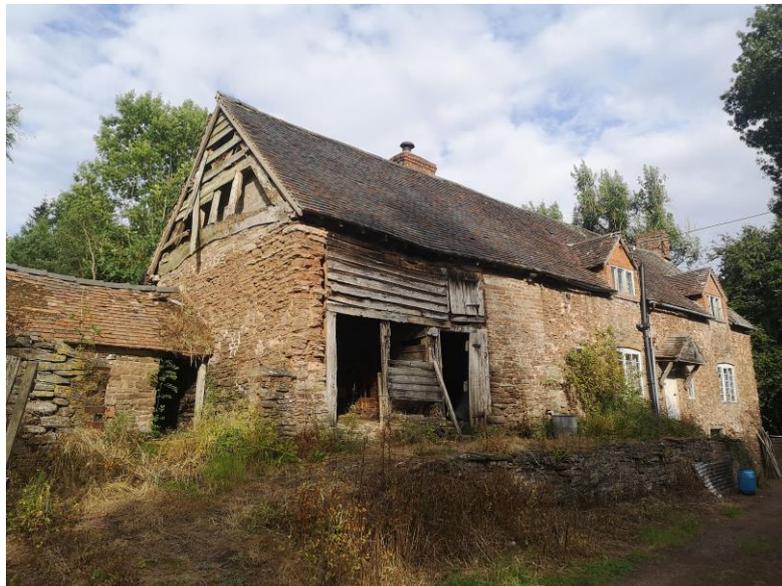
Figure 2 – north western aspect of B1

The main house had many features that were suitable to roosting bats. The northern gable end with exposed timbers and gaps in the mortar of the stone walls presented features suitable for a range of species. Gaps along ridge tiles and slipped tiles also presented high value features.

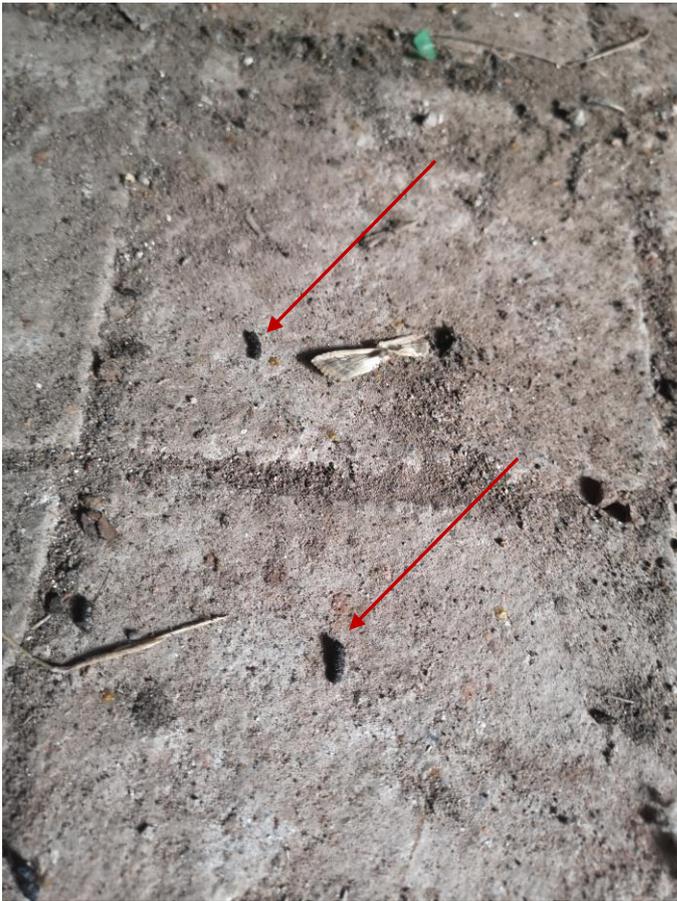
Figure 3 – droppings scattered within internal barn structure of B1.

The barn, connected to the main house at the northern end, presented good features to include gaps under the ridge tiles and a lined roof along with gaps within the stone walls. A range of bat droppings circa 50+ were noted, scattered across the stone floor and walls of this structure (figure 3). Droppings pending DNA analysis.

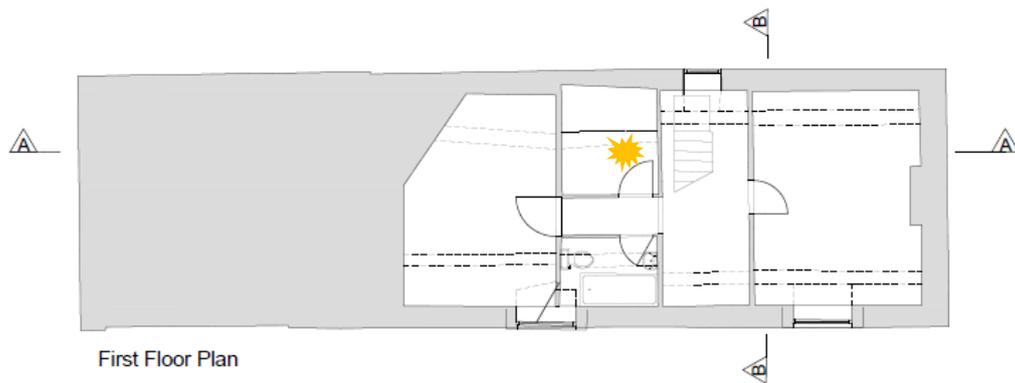
Figure 4 – B1 first floor layout showing position of droppings

The main house appeared to be water tight with roof and windows intact. The upstairs bedroom central to the house had a small gap in the ceiling leading to the loft space and door wedged open. The main bedroom to the northern part of the house had a loft hatch open. Droppings were found within the central small bedroom (figure 4) circa. 100+ with fresh droppings noted. Droppings appeared to represent a feeding or roosting perch for a Lesser-horseshoe bat. Droppings were of size and shape to that from a Lesser-horseshoe Bat (figure 5).

On further inspection of the loft space a single Lesser-horseshoe bat LHB was seen hanging from the roofing felt central to the building. Scattered droppings were also present within the loft space of size and shape to that from a LHB and of numbers representative of that of a single bat roosting.

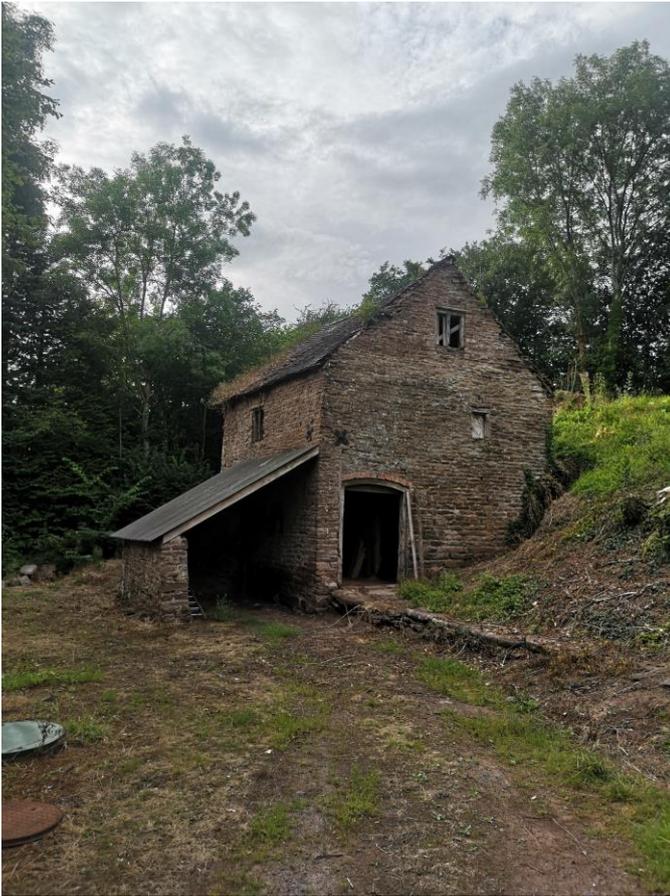
Figure 6 – B2 The mill building - southern aspect

The mill building is of historic value with the mill workings still present. The three storey building (figure 6) has a variety of high value features suitable to a variety of species of bat to include slipped and broken tiles, timber frame with notable gaps. Internally, the mill structure presents many holes and gaps that bats could exploit (Figure 7).

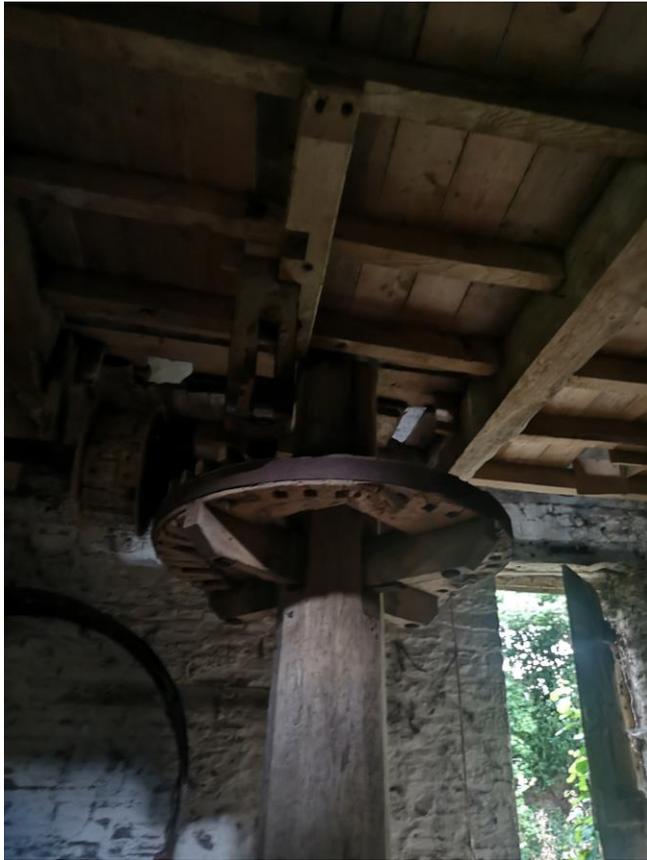
Figure 7 – Internal mill feature with exposed timbers with suitable roosting opportunities for bats

The building has holes within the roof structure with partial collapse and therefore water damage to the lower floors is evident with partial collapse. The mill has exposed timbers with suitable roosting potential within both for summer roosting and possible winter hibernation.

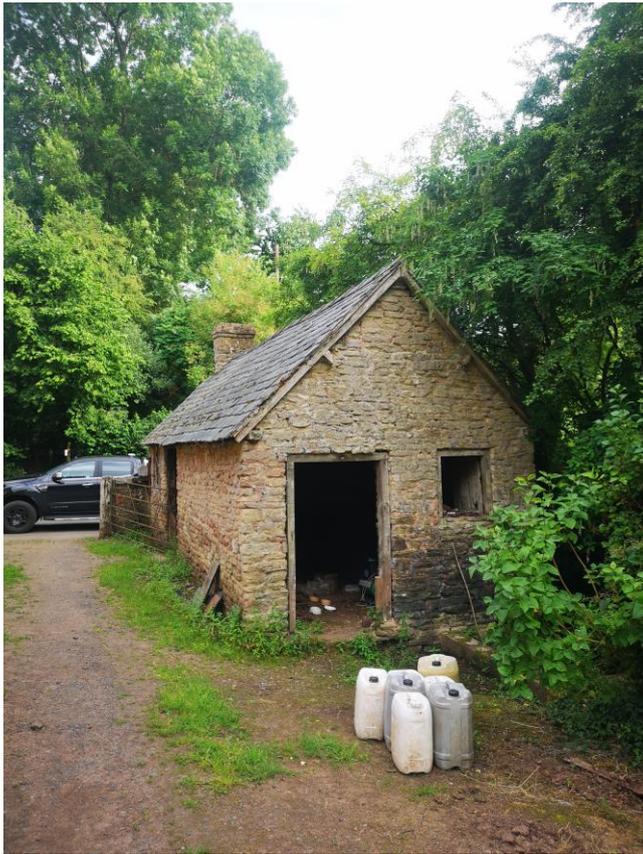
Figure 8 – northern aspect of B3 showing gaps along the gable end

The bakery differs from the other buildings, having a slate tile roof which is not lined. The building does, however, offer other opportunities with small gaps along the ridge tiles and gable end timbers as can be seen in figure 8.

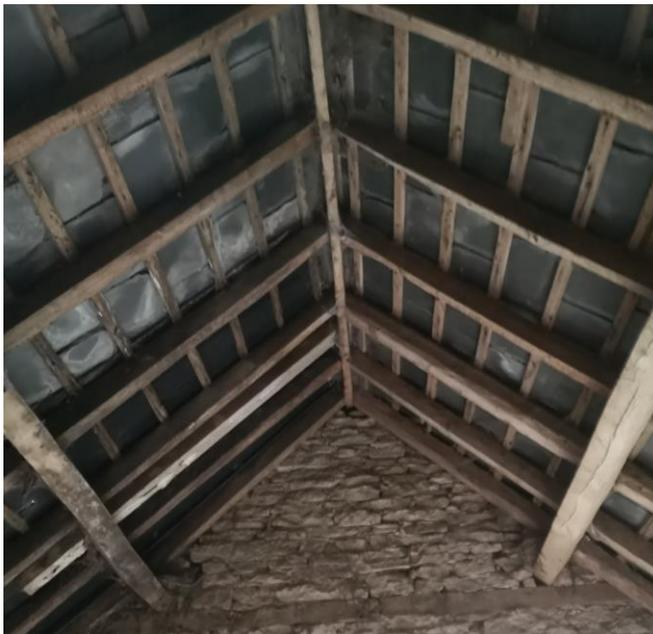
Figure 9 – internal picture of northern gable end with gaps in mortar.

Internally, the building is split into two rooms with the bread oven situated within the southern section. Both areas present suitable roosting features along the roof line where timbers meet the stone walls and where mortar has dropped out (figure 9).

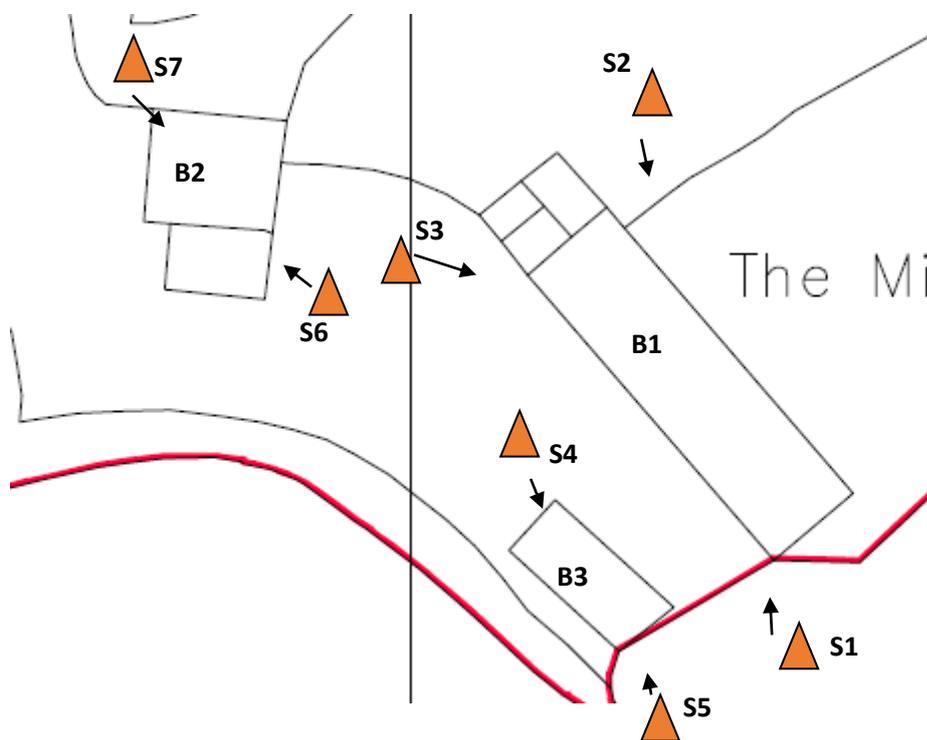
Figure 10 – Surveyor

positions during activity surveys of each building.

Surveyor positions were generally static, although notes were taken of activity across the three buildings during individual building surveys.

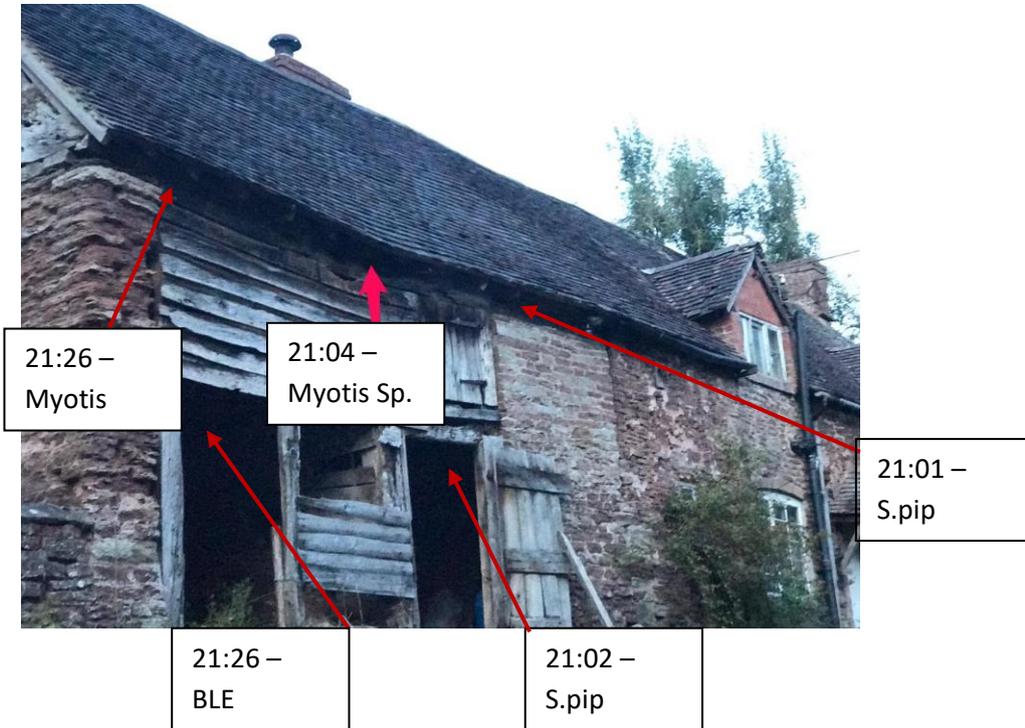
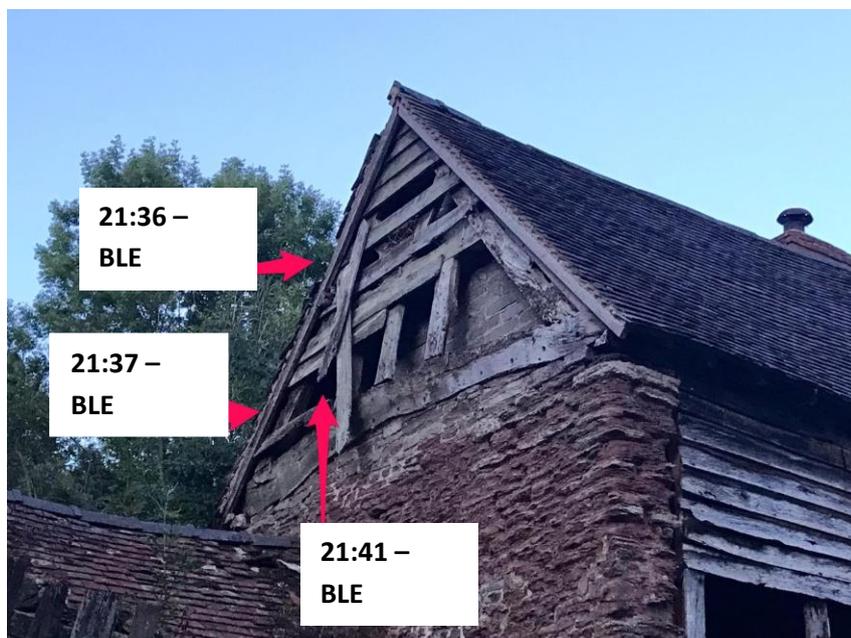
Figure 11. Emergence noted

S3	Yes 3 x species	<p>A total of at least 7, possibly 8, species were recorded during the survey; common pipistrelle <i>Pipistrellus pipistrellus</i> and soprano pipistrelle <i>Pipistrellus pygmaeus</i>, noctule <i>Nyctalus noctula</i>, Leisler's Bat <i>Nyctalus leisleri</i> (confirmed from recording), Brown long-eared <i>Plecotus auritus</i>, Barbastelle Bat <i>Barbastella barbastellus</i> Natterer's bat <i>Myotis nattereri</i> and a myotis species unconfirmed.</p> <p>The first bat recorded was a soprano pipistrelle at 21.01 (approximately 6 minutes after sunset).</p> <p>A total of two soprano pipistrelle bats were seen to emerge from the eaves of the timber barn with the second only one minute later 21:02. One more pass was recorded during the survey at 21:07. A common pipistrelle was HNS at 21:10. A single noctule pass 21:09 was recorded and then a Leisler's bat at 21:25, 21.45 HNS.</p> <p>A myotis species 21:20 was noted to emerge from eaves of the barn nearby to where the soprano pipistrelle had exited. At 21:24 a single barbastelle call was recorded at 21:24.</p> <p>At 21:26 a brown long-eared bat BLE was seen to emerge western</p>

<p>doorway gap. At the same time a Myotis sp or possible BLE not confirmed emerged from the eaves of the timber barn also.</p> <p>At 21:36 a BLE was seen to emerge from the NW gable end and then at 21:37 and 21:41 another BLE was seen to emerge also from the timbered gable end.</p> <p>The last bat recorded was a Myotis sp.22:10 HNS.</p>
--	---

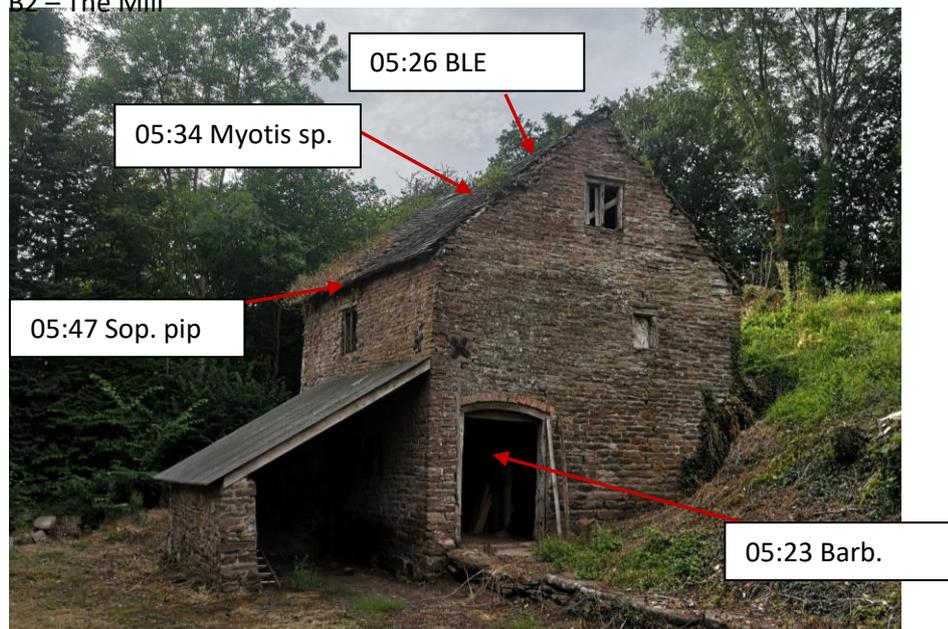
B2 – The Mill

Surveyor	Recorded Returning to roost	Comments (Heard not seen HNS)
S6	None although swarming noted.	<p>A total of at least 5, possibly 6, species were recorded during the survey; common pipistrelle <i>Pipistrellus pipistrellus</i> and soprano pipistrelle <i>Pipistrellus pygmaeus</i>, Brown long-eared <i>Plecotus auritus</i>, Natterer's bat <i>Myotis nattereri</i>, Barbastelle Bat <i>Barbastella barbastellus</i> and a myotis species unconfirmed.</p> <p>A total of three common pipistrelle passes were recorded during the survey with the latest being 05:25 approx. 25 minutes prior to dawn. The soprano pipistrelle was noted foraging 04:41 and then noted swarming around the roof top of the mill from 05:39 – 05:47.</p> <p>BLE foraging calls noted 05:31 and seen to swarm around the roof and ridge at 05:36.</p> <p>A myotis species was heard to forage between 05:25 and then swarming around roof between 05:36 and 05:38.</p> <p>A Natterer's bat was noted 05:29 HNS.</p> <p>A barbastelle was HNS at 04:54.</p> <p>The last bat noted was a soprano pipistrelle bat swarming around the mill building but then left site in a south westerly direction 05:55.</p>

S7	Yes. 4 x species	<p>A total of at least 5, possibly 6, species were recorded during the survey; common pipistrelle <i>Pipistrellus pipistrellus</i> and soprano pipistrelle <i>Pipistrellus pygmaeus</i>, Brown long-eared <i>Plecotus auritus</i>, Natterer's bat <i>Myotis nattereri</i>, Barbastelle Bat <i>Barbastella barbastellus</i> and a myotis species unconfirmed.</p> <p>A total of three common pipistrelle passes were recorded during the survey with the latest being 05:03 approx. 50 minutes prior to dawn. The soprano pipistrelle was not heard foraging throughout the survey and only noted swarming around the roof top of the mill and returning to roost 05:47.</p> <p>BLE were seen to be flying around inside the building around 04:46 and again at 05:00. Foraging calls noted outside 04:54 and 05:04 and seen to swarm around the roof and ridge at 05:16. 2 x BLE went to roost at 05:26 under ridge tile.</p> <p>A myotis species was heard to forage between 04:49 and with 4 returning to roost between 05:34 and 05:38 within the tiles and ridge.</p> <p>A Natterer's bat was noted 05:13 HNS.</p> <p>A barbastelle was heard at 04:54 as a brief pass. A second pass towards the house was seen and heard at 05:18. At 05:23 a single barbastelle was noted entering the southern doorway and is thought to have gone to roost.</p> <p>The last bat noted was a soprano pipistrelle bat swarming around the mill building but then left the site in a south westerly direction 05:55.</p>
