Preliminary Bat Roost Assessment Report

**Wilcroft Barn,
Wilcroft Farm,
Pecket Well,
Hebden Bridge HX7 8QY**

19.07.2021

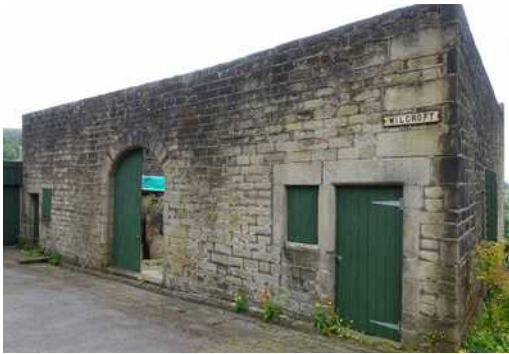
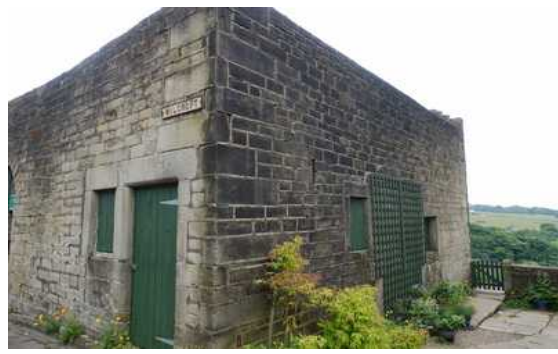
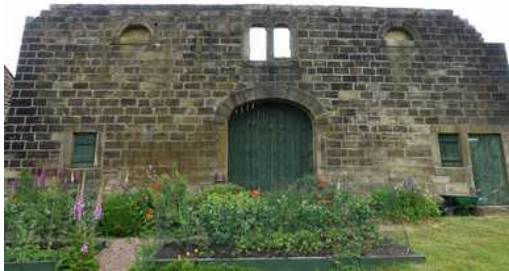
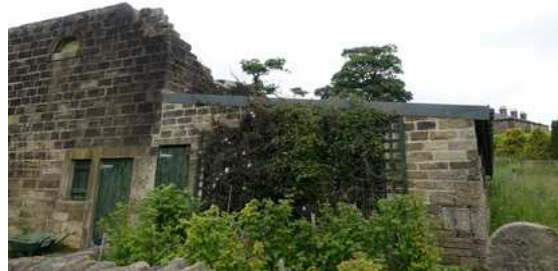
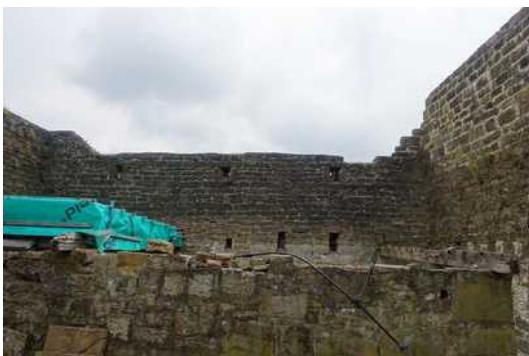
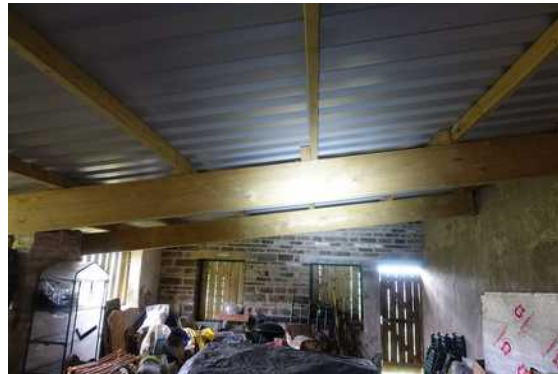
The property consists of a detached stone built barn with a missing roof and exposed interior. A single storey corrugated metal roofed lean to is present on the eastern gable. External walls are generally well pointed with some cavities, cracks, gaps or crevices present.

Roof slates and timbers are missing, the main barn is open to the elements with considerable light and weather penetration.

The building can be considered to offer negligible to low roosting bat potential.

The property was assessed as offering negligible to low roosting potential with large gaps and crevices associated with slots exterior walls. The lack of a roof is likely to reduce suitability to roosting bats due to light and water penetration.

No physical evidence of bats in the form of droppings, feeding remains, grease marks or urine splashing, was recorded on or around the building despite suitable horizontal surfaces being present and undisturbed.
