Monitoring Visit: 4 of 4

Monitoring Plus Report

Owners name	Mrs. Julia Oakley	Suspected cause	To be advised	Monitoring type	Levels & Cracks
Address	9 Rudlands Ipswich Suffolk IP8 3RQ	Principal area of damage	To be advised	Installed	24/10/2020
Home phone		Damage category	To be advised	No of visits / weeks	4 @ 8.7
Work phone		Surface geology	To be advised	Completion date	
Correspondence address		Feedback from last visit	0		
Comment	Max movement 23.7 Focal area 24/4/21 - Visits completed as instructed.	Sketch showing location of monitoring points			
		<p>Points 7 & 8 Long screws</p> <p>Conservatory</p> <p>Garage</p> <p>Crack B</p> <p>Crack A</p> <p>EXT</p> <p>No 9</p> <p>1 (ref)</p> <p>Front Elevation</p>

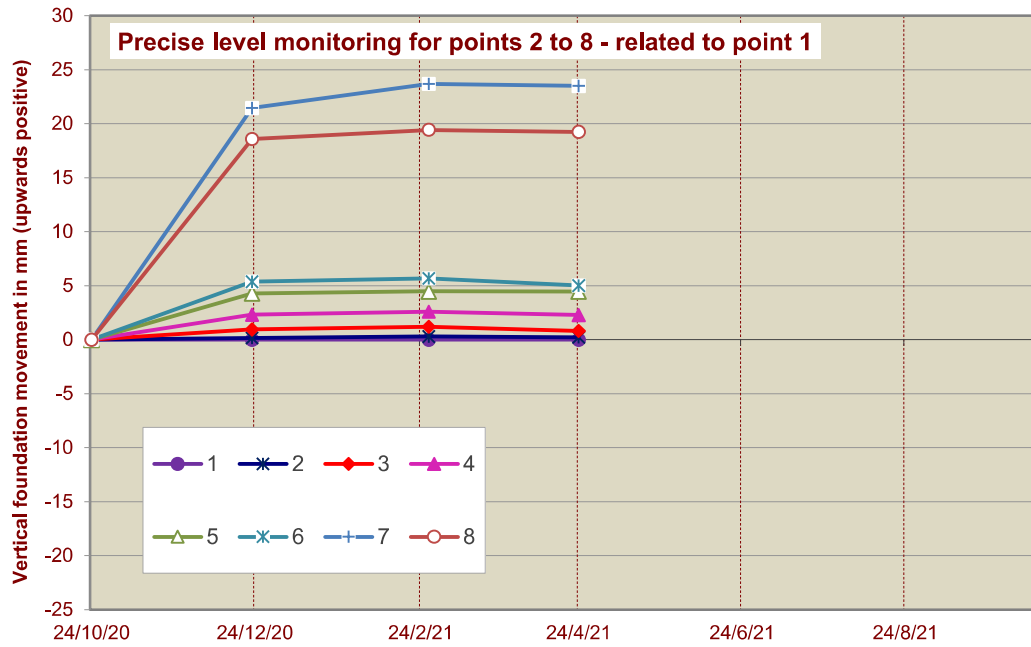
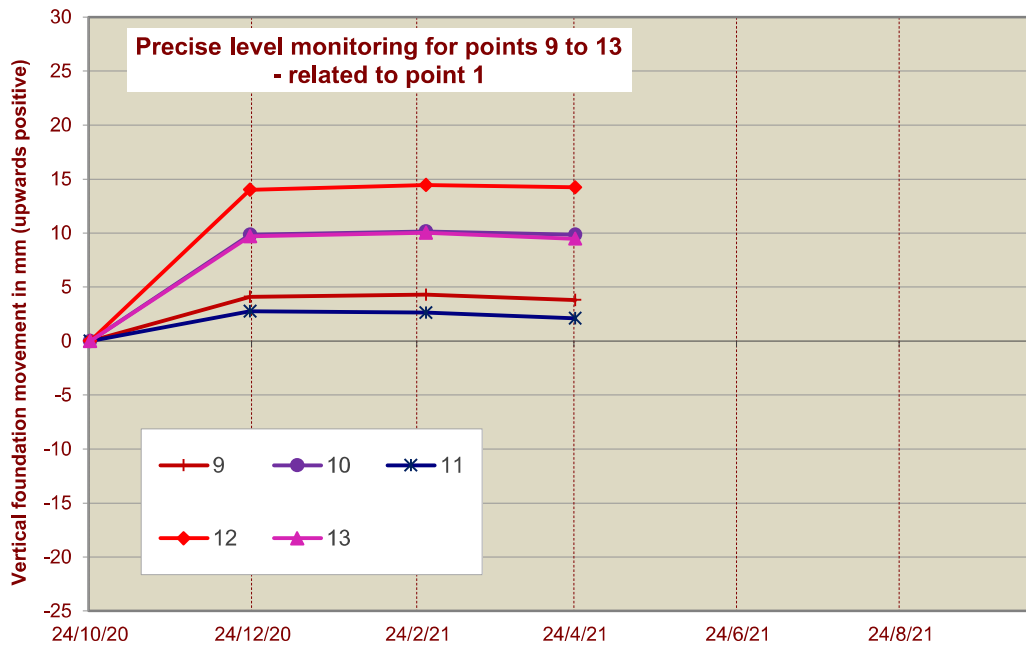
Level monitoring results

Survey: By: Date:	1 CV 24/10/2020		2 CV 23/12/2020		3 CV 27/02/2021		4 CV 24/04/2021		5	
Point ID	levels mm	chngs mm	levels mm	chngs mm	levels mm	chngs mm	levels mm	chngs mm	levels mm	chngs mm
1	1000.00	0.0	1000.00	0.0	1000.00	0.0	1000.00	0.0		
2	1007.17	0.0	1007.32	0.1	1007.46	0.3	1007.38	0.2		
3	1004.08	0.0	1005.02	0.9	1005.26	1.2	1004.88	0.8		
4	996.67	0.0	998.99	2.3	999.26	2.6	998.95	2.3		
5	990.52	0.0	994.79	4.3	995.00	4.5	994.98	4.5		
6	993.63	0.0	998.99	5.4	999.30	5.7	998.65	5.0		
7	963.16	0.0	984.60	21.4	986.84	23.7	986.67	23.5		
8	806.36	0.0	824.94	18.6	825.78	19.4	825.61	19.2		
9	738.12	0.0	742.22	4.1	742.41	4.3	741.93	3.8		
10	1093.81	0.0	1103.66	9.9	1103.97	10.2	1103.68	9.9		
11	1119.77	0.0	1122.52	2.8	1122.39	2.6	1121.88	2.1		
12	1085.02	0.0	1099.04	14.0	1099.48	14.5	1099.25	14.2		
13	1180.03	0.0	1189.74	9.7	1190.06	10.0	1189.51	9.5

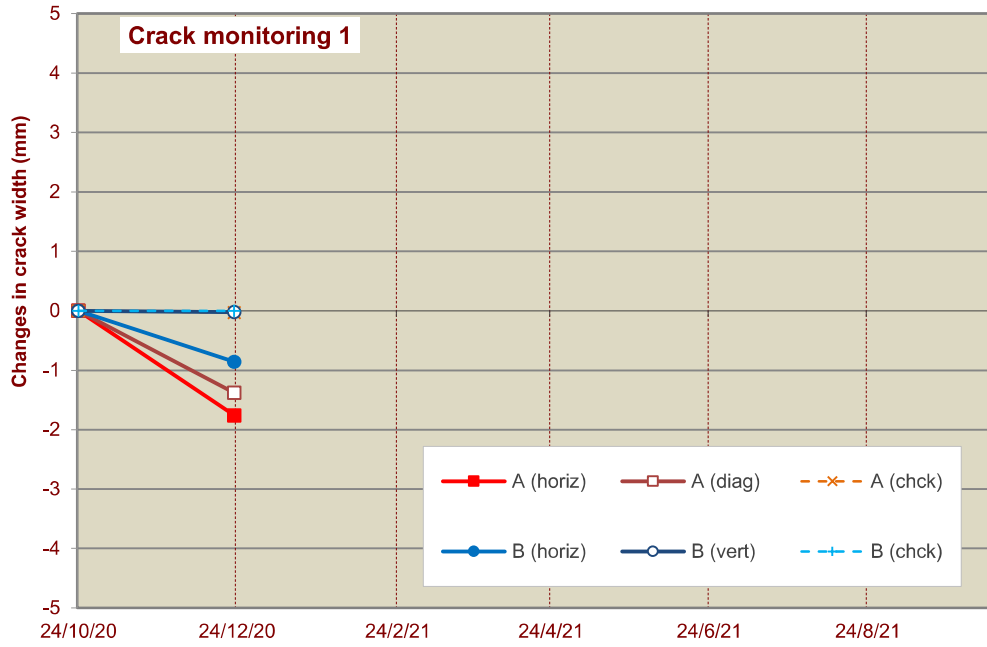
Crack monitoring results

Survey: By: Date:		1 CV 24/10/2020	2 CV 23/12/2020	3 CV 27/02/2021	4 CV 24/04/2021	5	
Point ID	Initial widths mm	<i>chngs</i> <i>mm</i>	<i>chngs</i> <i>mm</i>	<i>chngs</i> <i>mm</i>	<i>chngs</i> <i>mm</i>	<i>chngs</i> <i>mm</i>	
A (horiz)	4.5	100.91	0.0	99.15	-1.8	#N/A	#N/A
A (diag)		129.80	0.0	128.42	-1.4	#N/A	#N/A
A (chck)		77.13	0.0	77.10	0.0	#N/A	#N/A
B (horiz)	2.8	78.66	0.0	77.80	-0.9	#N/A	#N/A
B (vert)		73.68	0.0	73.66	0.0	#N/A	#N/A
B (chck)		108.29	0.0	108.29	0.0	#N/A	#N/A

A (horiz)	Demec triplet, internal, crack below landing window
B (horiz)	Demec triplet, internal, crack above landing window
