Monitoring Visit: 3 of 4

Monitoring Plus Report

Owners name	Mrs. Julia Oakley	Suspected cause	To be advised	Monitoring type	Levels & Cracks
Address	9 Rudlands Ipswich Suffolk IP8 3RQ	Principal area of damage	To be advised	Installed	24/10/2020
		Damage category	To be advised	No of visits / weeks	4 @ 8.7
		Surface geology	To be advised	Completion date	
		Feedback from last visit	0		
Home phone		Sketch showing location of monitoring points			
Work phone					
Correspondence address					
Comment					
Max movement	23.7				
Focal area					
	0

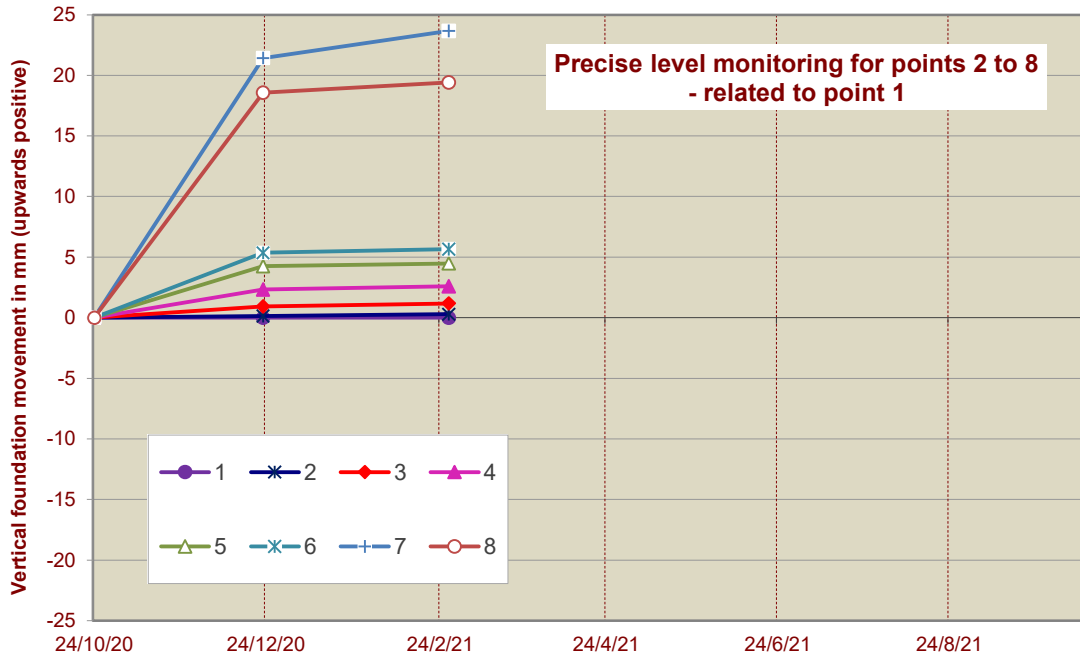
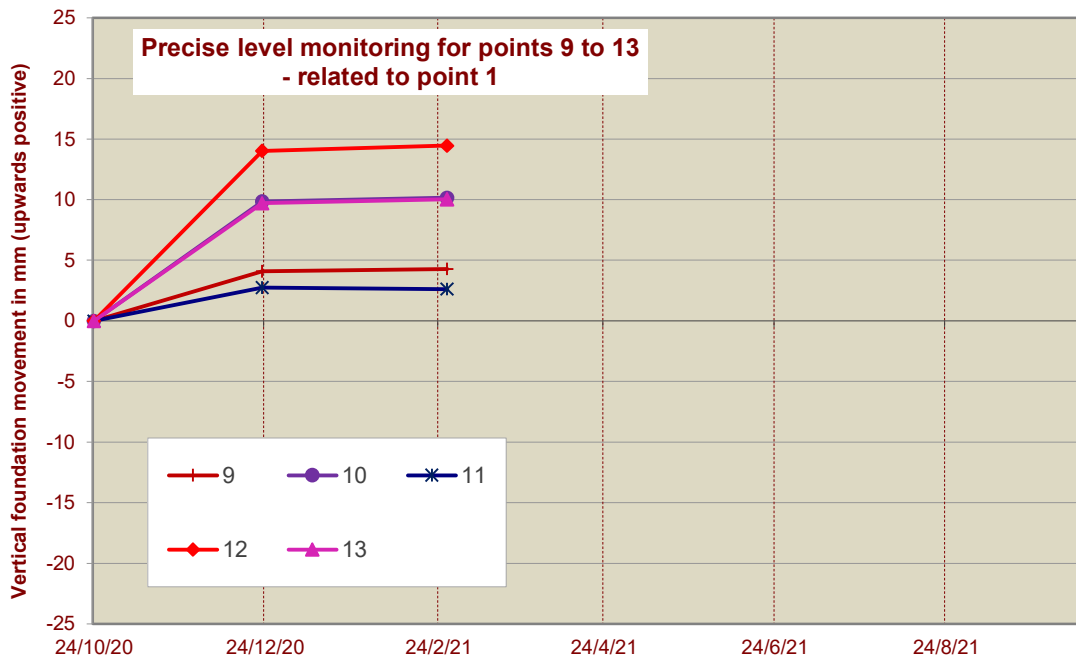
Level monitoring results

Survey:	1		2		3		4		5	
By:	CV		CV		CV					
Date:	24/10/2020		23/12/2020		27/02/2021					
Point ID	levels mm	<i>chngs</i> <i>mm</i>	levels mm	<i>chngs</i> <i>mm</i>	levels mm	<i>chngs</i> <i>mm</i>	levels mm	<i>chngs</i> <i>mm</i>	levels mm	<i>chngs</i> <i>mm</i>
1	1000.00	0.0	1000.00	0.0	1000.00	0.0	1000.00	0.0	1000.00	0.0
2	1007.17	0.0	1007.32	0.1	1007.46	0.3				
3	1004.08	0.0	1005.02	0.9	1005.26	1.2				
4	996.67	0.0	998.99	2.3	999.26	2.6				
5	990.52	0.0	994.79	4.3	995.00	4.5				
6	993.63	0.0	998.99	5.4	999.30	5.7				
7	963.16	0.0	984.60	21.4	986.84	23.7				
8	806.36	0.0	824.94	18.6	825.78	19.4				
9	738.12	0.0	742.22	4.1	742.41	4.3				
10	1093.81	0.0	1103.66	9.9	1103.97	10.2				
11	1119.77	0.0	1122.52	2.8	1122.39	2.6				
12	1085.02	0.0	1099.04	14.0	1099.48	14.5				
13	1180.03	0.0	1189.74	9.7	1190.06	10.0

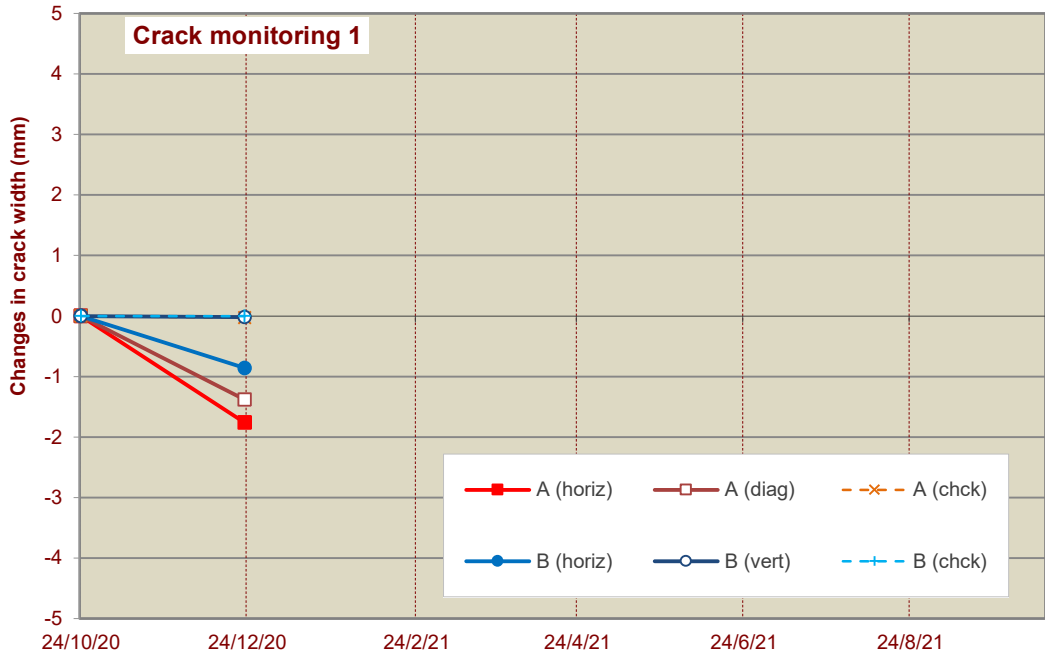
Crack monitoring results

Survey: By: Date:		1 CV 24/10/2020		2 CV 23/12/2020		3 CV 27/02/2021		4	5
Point ID	Initial widths mm		<i>chngs mm</i>		<i>chngs mm</i>		<i>chngs mm</i>	<i>chngs mm</i>	<i>chngs mm</i>
A (horiz)	4.5	100.91	0.0	99.15	-1.8		#N/A		
A (diag)		129.80	0.0	128.42	-1.4		#N/A		
A (chck)		77.13	0.0	77.10	0.0		#N/A		
B (horiz)	2.8	78.66	0.0	77.80	-0.9		#N/A		
B (vert)		73.68	0.0	73.66	0.0		#N/A		
B (chck)		108.29	0.0	108.29	0.0		#N/A

A (horiz)	Demec triplet, internal, crack below landing window
B (horiz)	Demec triplet, internal, crack above landing window
