**MR & MRS HERITAGE**

**BEACH VIEW  
MAWGAN PORTH TR8 4DB**

**SINGLE UNIT PRELIMINARY INVESTIGATION  
REPORT**

**Contract: C61594**

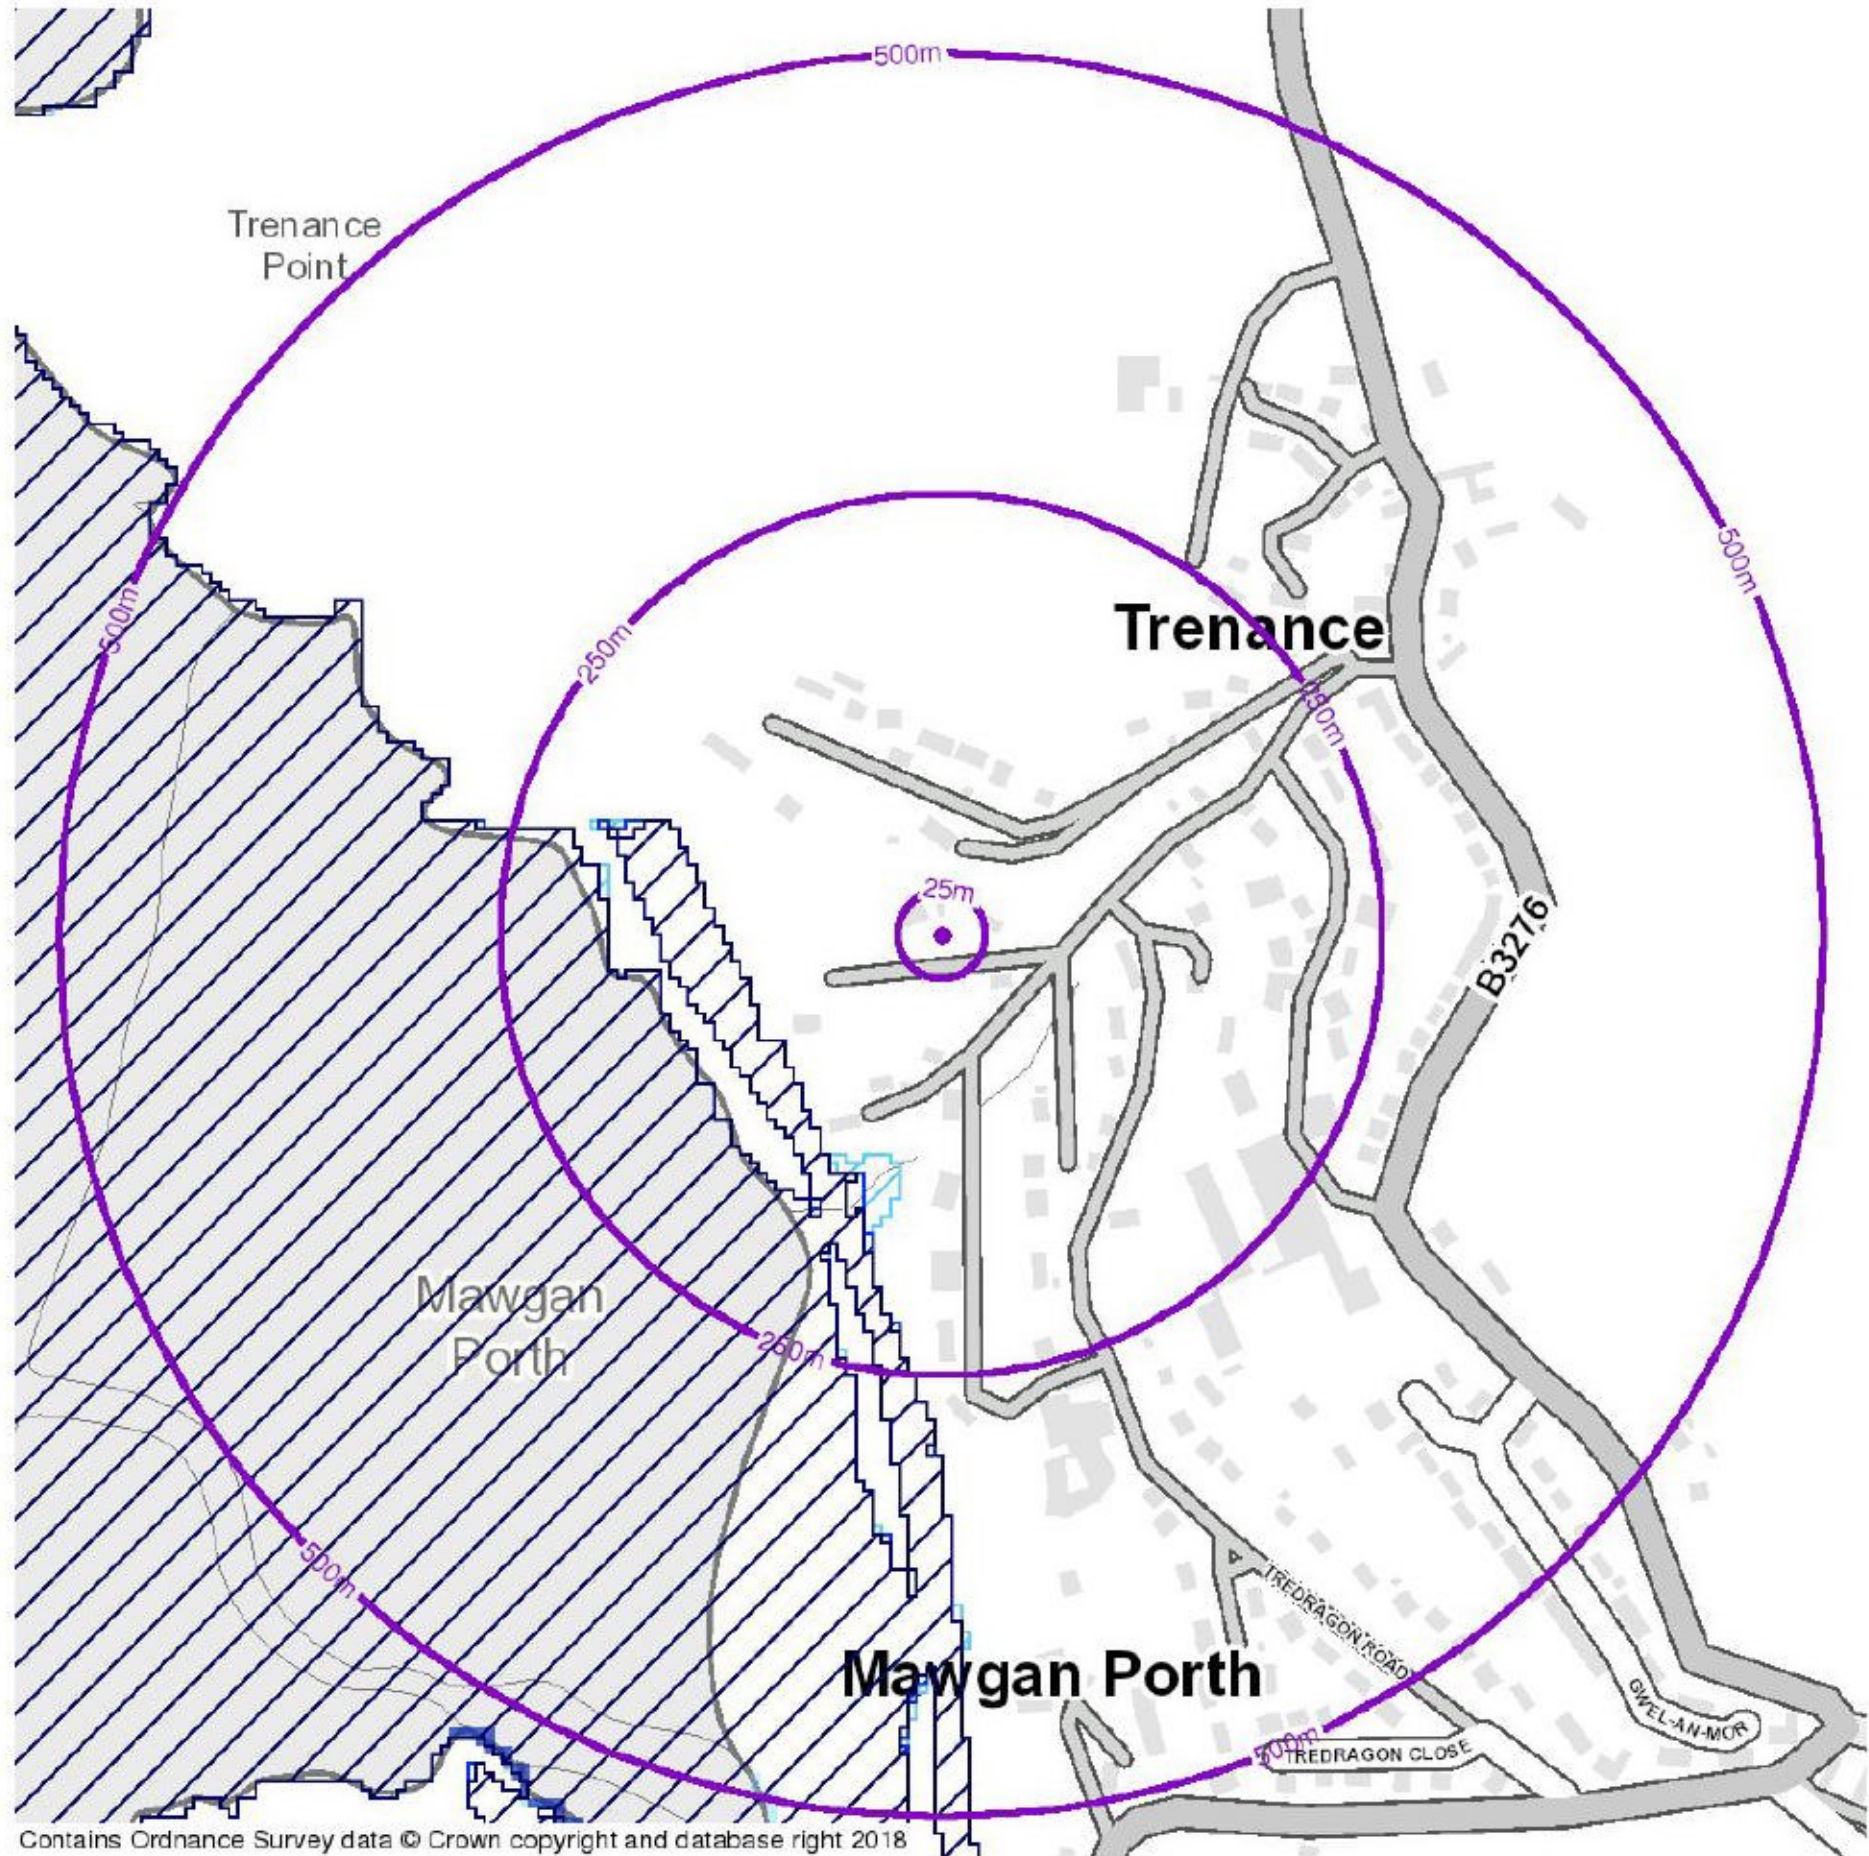
### Section 2a and 2b: River and Coastal Flood Map

The map detailed below shows the location of potential river and coastal flood risk. The potential risk has been modelled on the basis of an event occurring on average every 75, 200 or 1000 years.
