**BAT AND BARN OWL SURVEY OF
BEACH VIEW, TRENANCE, MAWGAN PORTH, CORNWALL**

O.S. Grid Ref: SW 8495 6784

Spalding Associates (Environmental) Ltd were instructed to carry out a Bat and Barn Owl survey by Mr C Heritage on the property Beach View, Trenance, Mawgan Porth, Cornwall. The current proposal for the site is to demolish the existing house and garage and build a new dwelling in its place.

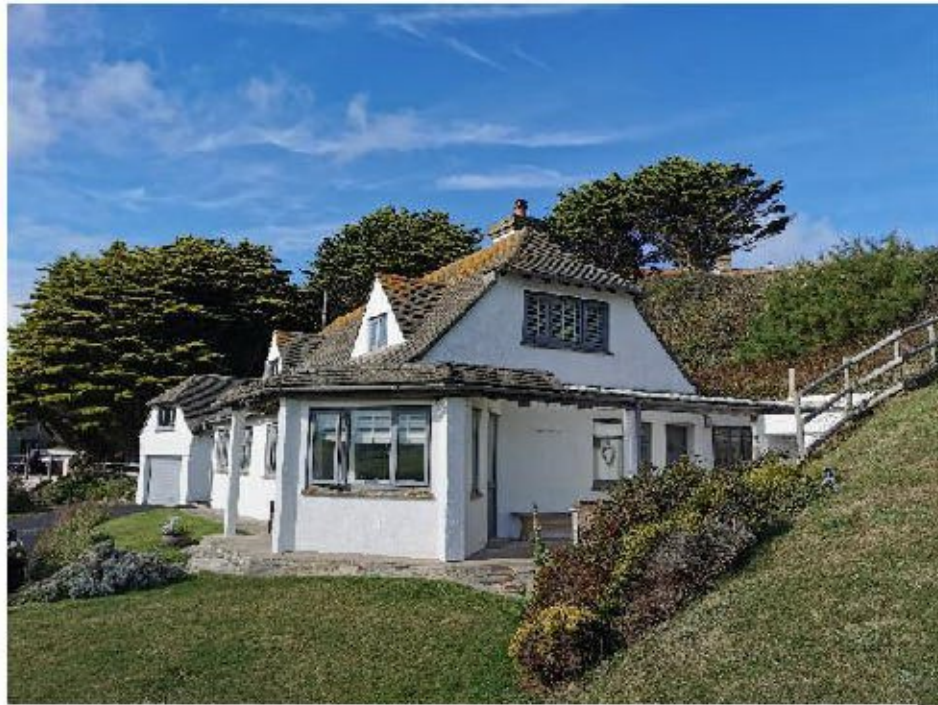
Image 1. Beach View house

The buildings surveyed were a dormer bungalow, with rooms built into the roof space, and a detached garage. The external finish of both buildings is a cement render with concrete roof tiles. The roof is pitched with short hips at both gable ends. The wooden rafters and soffits extend over the eaves at the front and back of the building approximately 400mm.

There is a single storey extension on the front of the house with a single pitch roof with lead flashing into the main building. Joined to this extension around the north side of the building is a lean to with a transparent Perspex roof. To the rear of the property is another single storey extension with a bitumen felt covered flat roof. There is a rendered chimney on the roof with lead flashing.

The roof space has two dormer windows built into front and one into the back of the house. The rooms built into the roof space have resulted in relatively small voids in the front and back of the property and there is a small void below the ridge which runs the length of the building. The south-western roof voids were sealed internally and therefore inaccessible. However, the void at the northern side of the building and south-eastern void could be accessed.

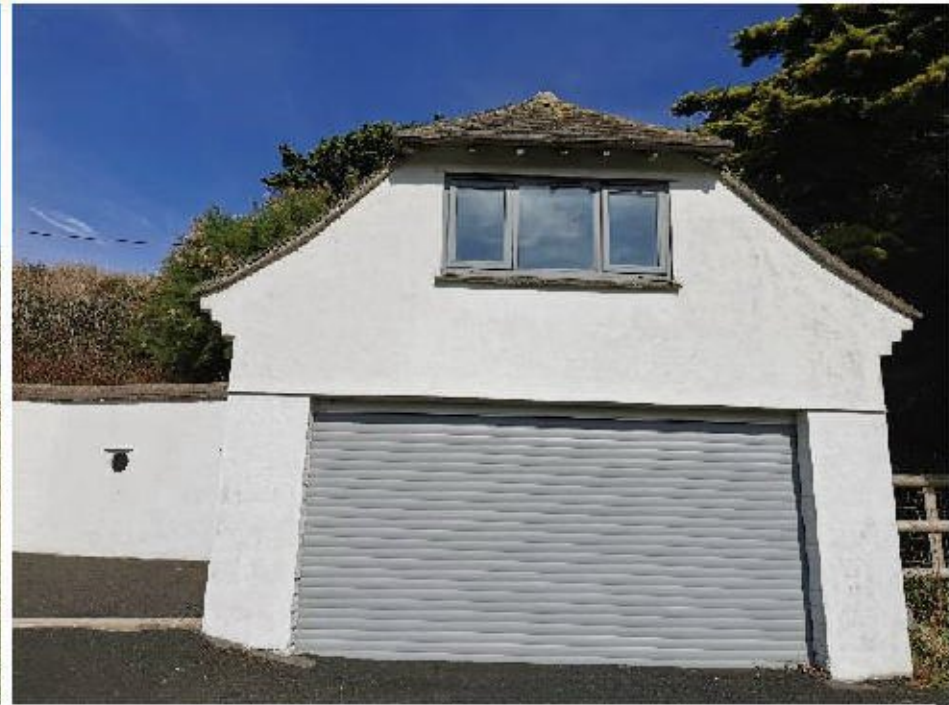
Image 2. Garage

The garage is a one and a half storey building of similar construction. It is rendered with a pitched roof and concrete roof tiles. The eaves have an overhang of approximately 200mm. Both the house and garage are built into the hillside with the ground rising steeply to the north.

The garage was well sealed around the soffits and roof with the tiles in good condition and none missing. There was a single Swallow *Hirundo rustica* nest found on the ground floor of the garage on a metal joist supporting the first floor. The eaves of both buildings provide potential for nesting swallows and house martins.

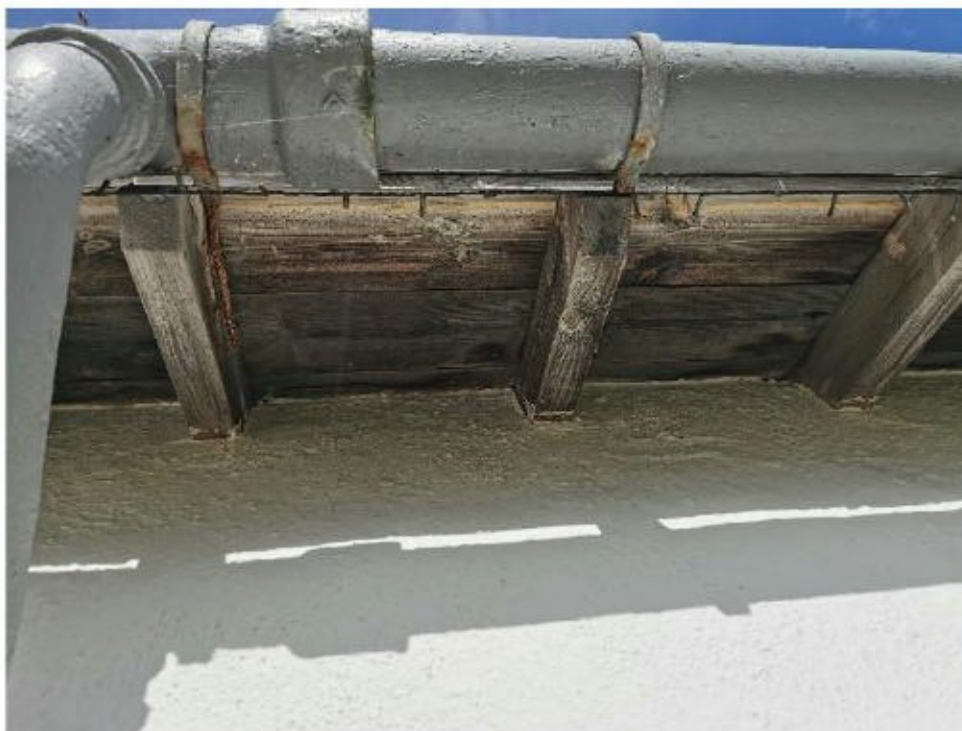
Image 3. Soffits of main building

The dwelling at Beach View was generally well sealed with few entry points into the roof space for roosting bats. The render came up to the soffits at the front of the house with no gaps (Image 3). A single potential entry point was identified on the single storey extension (Image 4). On the front of the house the roof and ridge tiles are generally tight, but a couple of individual tiles have lifted, creating

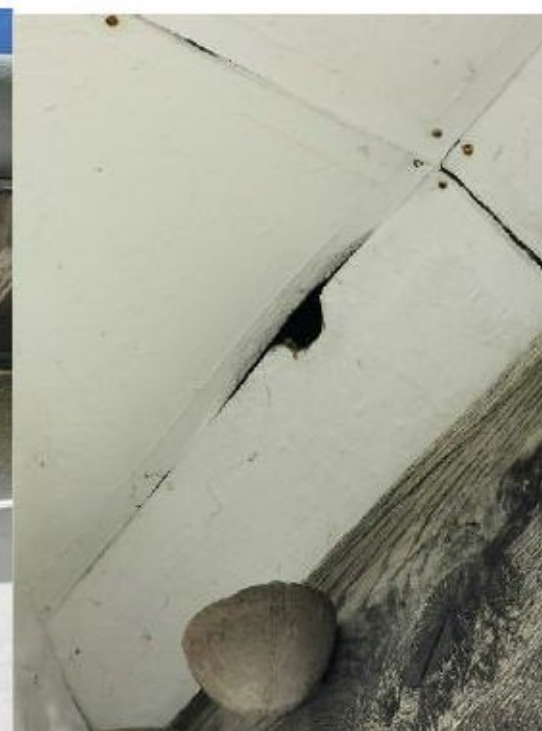
Image 4. Potential entry point towards the west of the building

enough space for bats to enter. At the back of the house there were a couple of missing tiles which also creates potential entry points. The lead work was in good condition and tight to the tiles.

As no evidence of the use of this building by roosting bats was found, no further survey work is necessary and the proposed works can proceed, subject to planning, with a low risk of disturbing/harming roosting bats or damaging or destroying a bat roost. The building was assessed as having negligible potential for roosting bats partly due to its structure and partly because of its location.

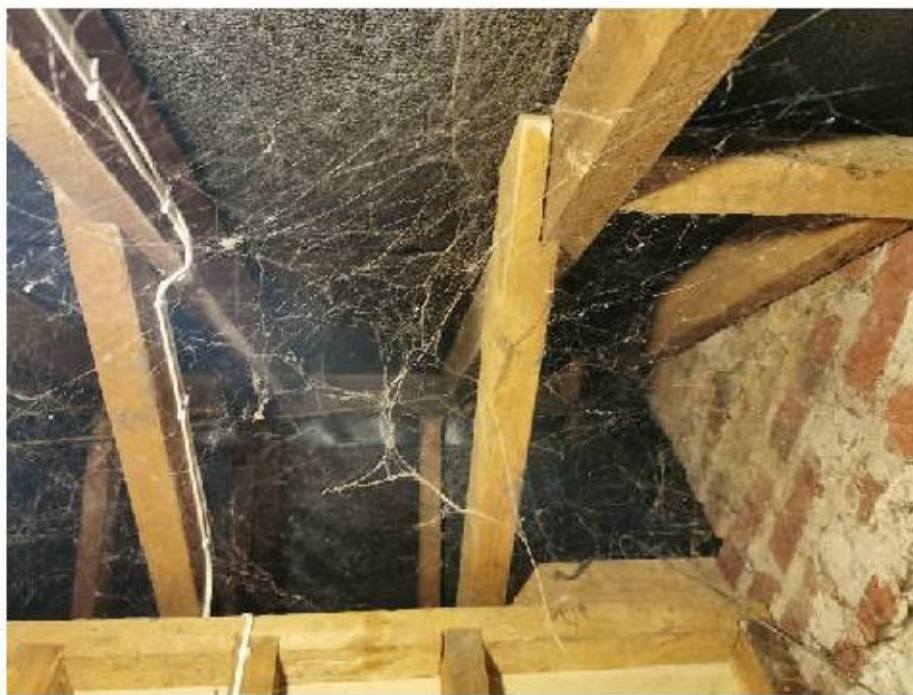
No evidence of the use or occupation of the house or garage by roosting bats was discovered during the survey. Although no access could be gained to the south-west roof voids due to internal boarding, no evidence of bats was found within the accessible sections. The east side of the roof space was full of cobwebs which is an indication that bats are not roosting there and there was evidence of rodent droppings both rats and mice on the floor further reducing its potential. The garage was very open and light with no evidence or potential for roosting bats.

Image 5. Cobwebs in roof space

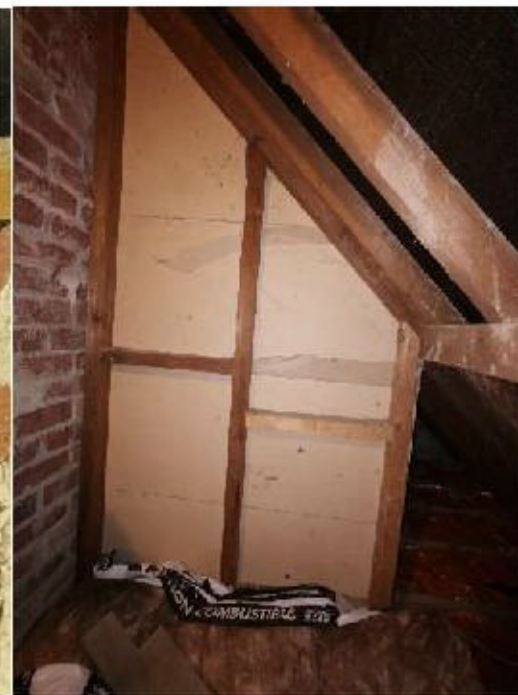
Image 6. Dormer on east side fully inspected

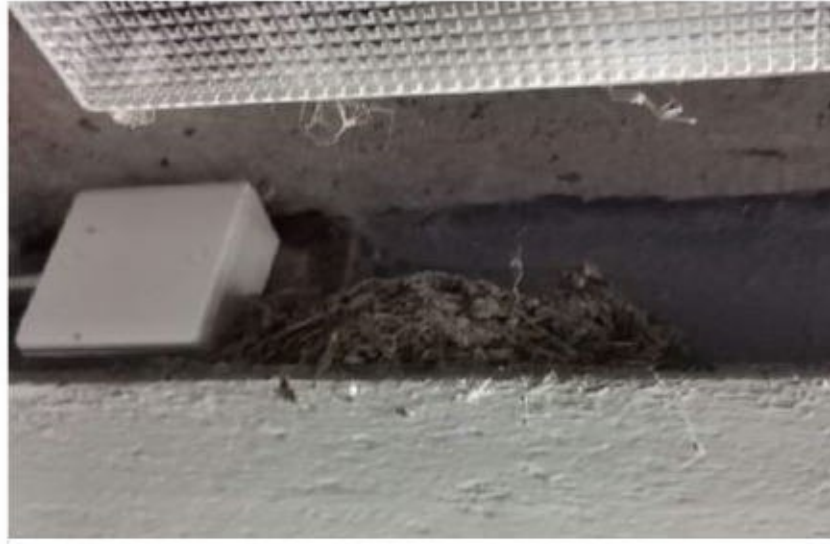
There was a single old Swallow nest found inside the garage on a ledge (Image 7).

Image 7. Swallow nest in garage

If the buildings are to be demolished during the nesting bird season (March – August) a careful inspection of the garage and inaccessible roof spaces should be carried out to check for nesting birds. If nesting birds are discovered works should wait until the nested chicks have fledged the nest. This is because birds are protected by law while nesting.

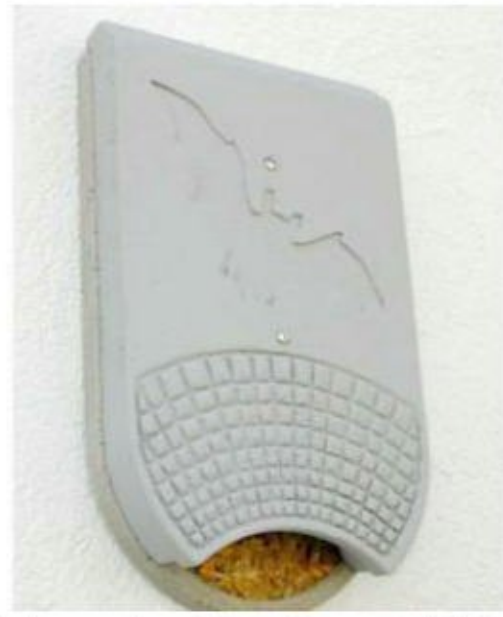
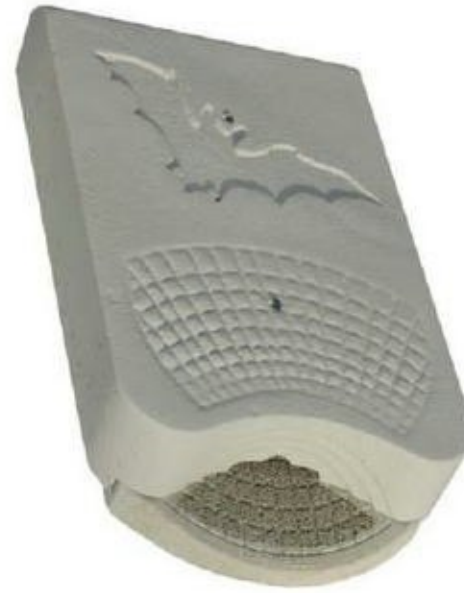
**Schwegler Bat Roost 1FQ
(summer only)**

**Schwegler 1WQ
(summer and Winter Bat
Roost)**

Figure 2: Examples of Schwegler bat boxes appropriate for bolting onto buildings.

However, if the owners were interested in creating opportunities in the future for bats to use the new building an externally mounted bat box could be mounted onto an exterior wall. An alternative would be to provide access to the roof void. However, in this case Type 1 bitumen felt must be used as bats can get entangled in modern woven fibre membranes. An example of how access could be achieved would be to space off fascia boards slightly to allow opportunities for bats to gain access particularly on warmer southern elevations.

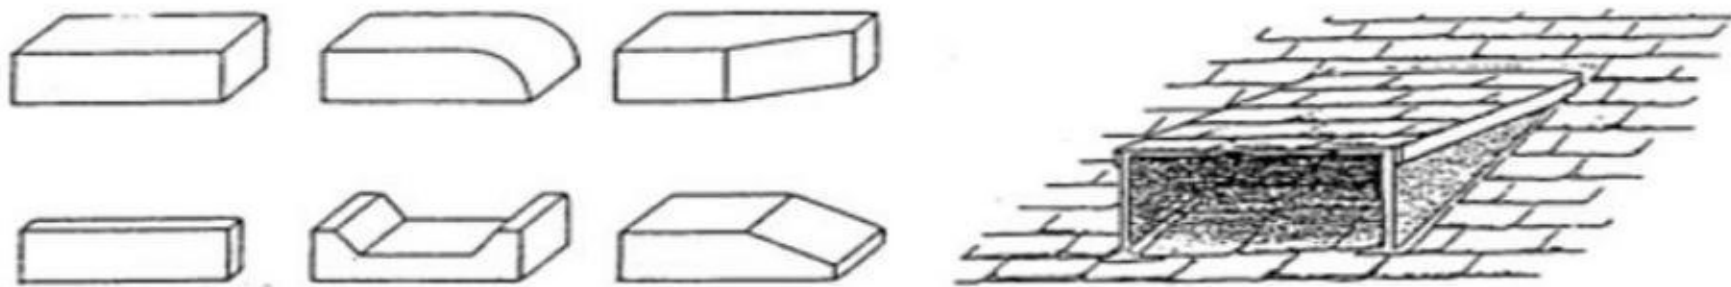
Walling bricks for creating bat access points. A standard brick is shown top left

For most species of bat only small holes or slots are needed and this helps to prevent birds from getting in. A Gap of 20mm wide by 50mm long is often adequate. The ideal position is between the soffit and the wall.

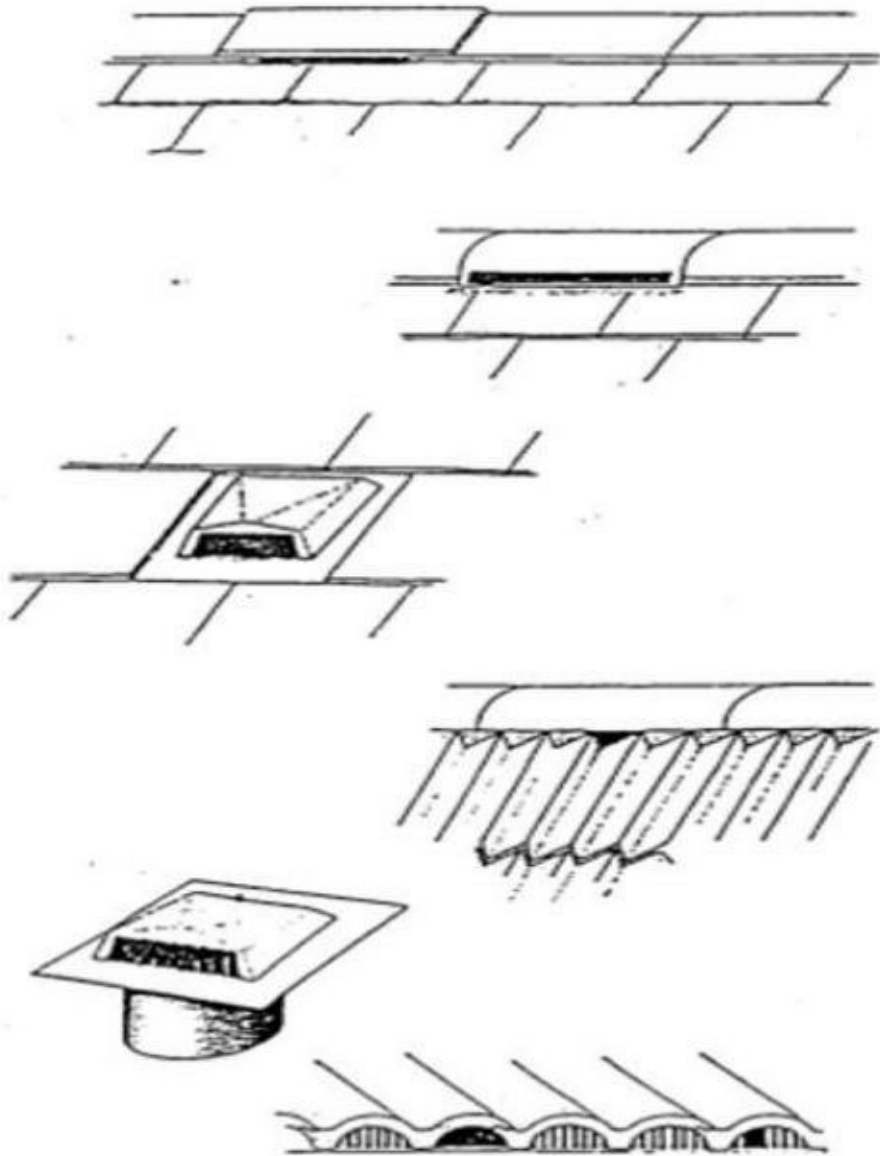
Ridge ventilators can be adapted as bats access points. It may be necessary to remove internal plastic moulding.

Building regulations specify that roofs must have adequate ventilation. This is usually provided at the eaves and so access for bats can be easily incorporated at the same time. Other suitable places for access points are at gable ends, under lead flashing or gaps between tiles or slates.

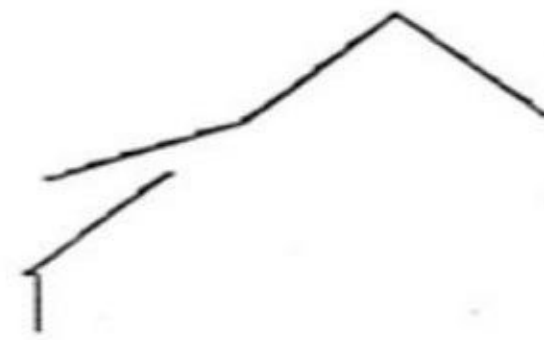
Dormer entrance particularly suitable for horseshoe bats.

Horseshoe bats have more specialised requirements, preferring to fly directly into their roosts. Access openings need to be large enough to allow the bats to fly into the roof.

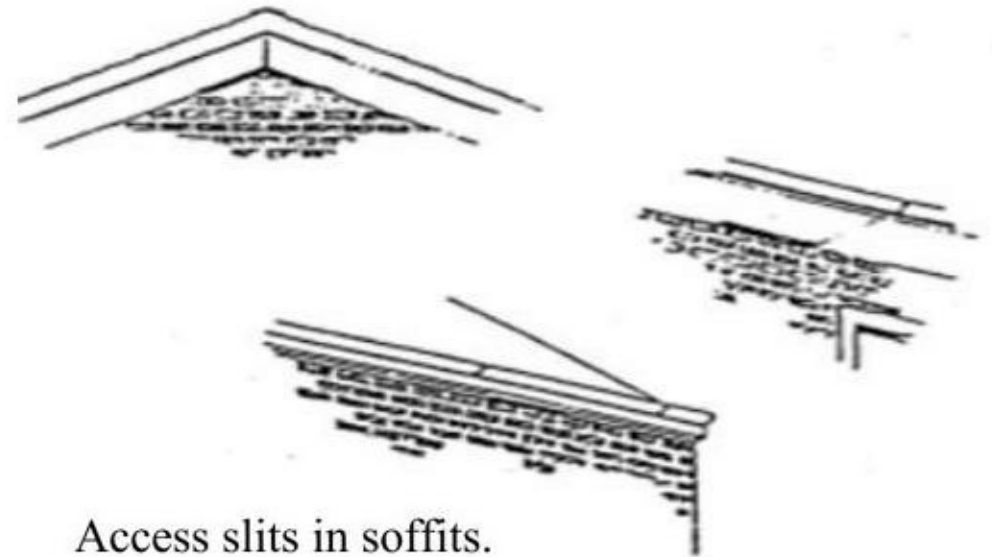
Access slits in soffits.

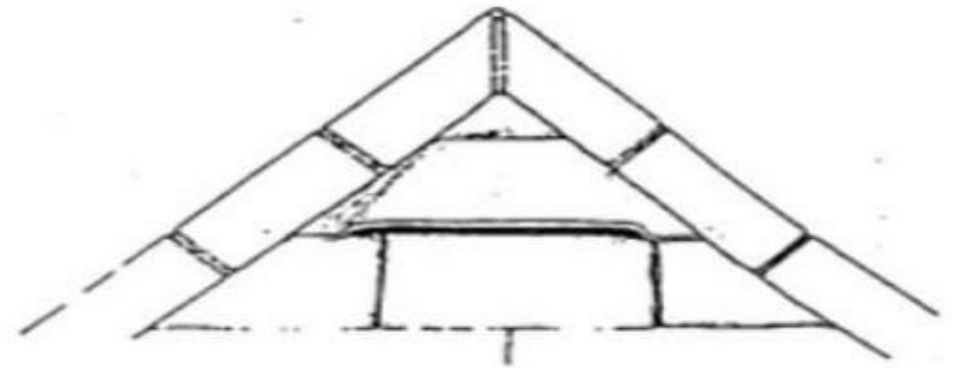
Lead saddle in place of a slate to allow bats access to ridge or roof void.
