**BARNS LANE  
DUNHAM MASSEY**

**FINAL PHASE 2 GEO-  
ENVIRONMENTAL INVESTIGATION, RISK  
ASSESSMENT AND REMEDIATION  
STRATEGY**

**Job Number: LKC 19 1314**  
**Date: September 2019**  
**Client: Edgefold Homes Ltd**

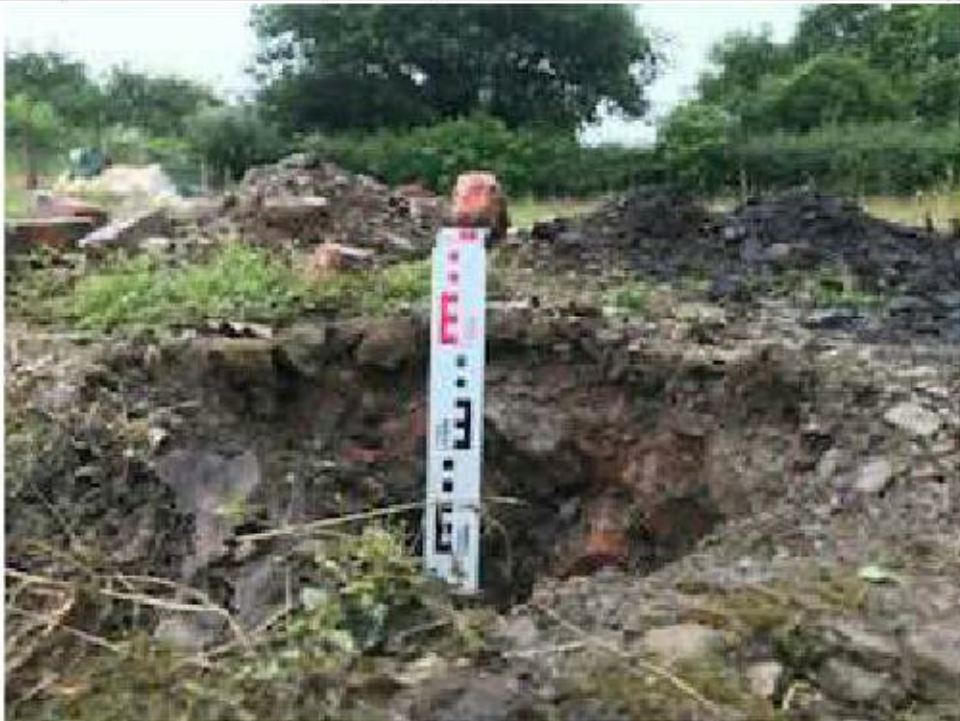
<b>Scale (approx)</b> 1:10	<b>Logged By</b> PP	<b>Figure No.</b> LKC 19 1314.HD101
-------------------------------	------------------------	--

Depth (m)	Sample / Tests	Water Depth (m)	Field Records	Level (mOD)	Depth (m) (Thickness)	Description	Legend	Water
0.00-0.40	D1 PID=0.1ppm				(0.40)	MADE GROUND: Greyish brown slightly gravelly clayey SAND with occasional ash, brick fragments and rare concrete. Sand is fine to coarse. Gravel is fine to medium, angular to subrounded comprising mudstone and sandstone.		
0.40-0.80	D2 PID=0.5ppm				(0.40)	MADE GROUND: Black slightly gravelly clayey SAND with rare brick fragments, ash and slight hydrocarbon odour. Sand is fine to coarse. Gravel is fine to medium, rounded to subangular comprising mudstone and sandstone.		
0.80-1.00	D3 PID=<0.1ppm				(0.20)	Yellowish brown fine to coarse SAND.		
					1.00	Complete at 1.00m

**Remarks**  
Hand dug pit dry.
