BAT, BARN OWL & NESTING BIRD SURVEY AT

83 Garstang Road, Catterall

Author	Flora Whitehead	Date	10/8/21
Checked by	Andrew Gardner	Date	11/8/21
Report Version	1		
Field data entered	<input type="checkbox"/>		
Report Reference	7324

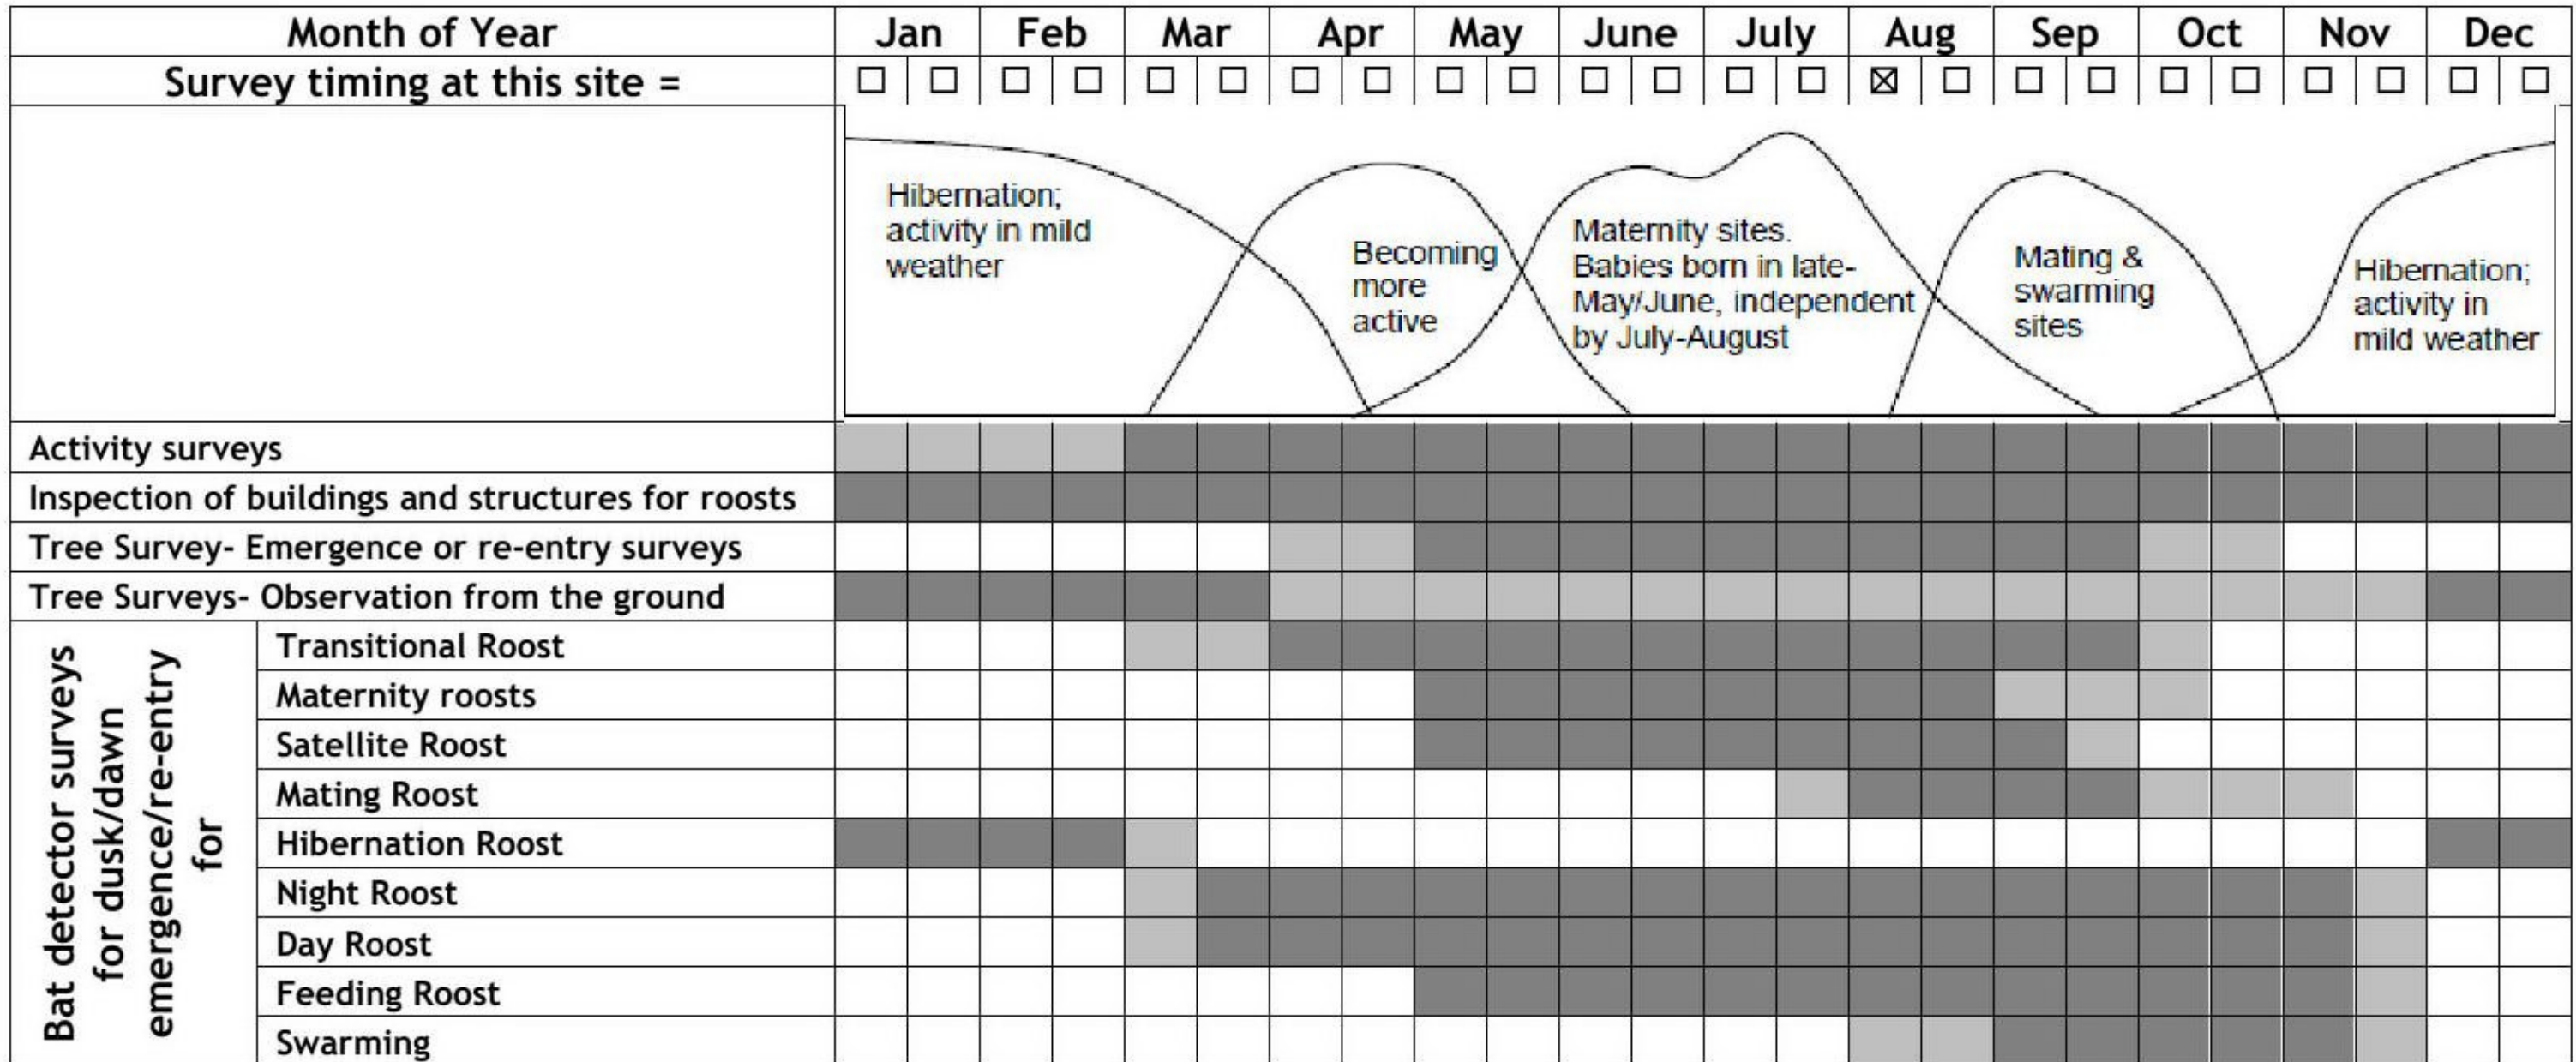
A table showing the timing of the survey in relation to the bat year is shown on Figure 3.

Figure 3 Survey timing in the bat year from Mitchell-Jones (2004).

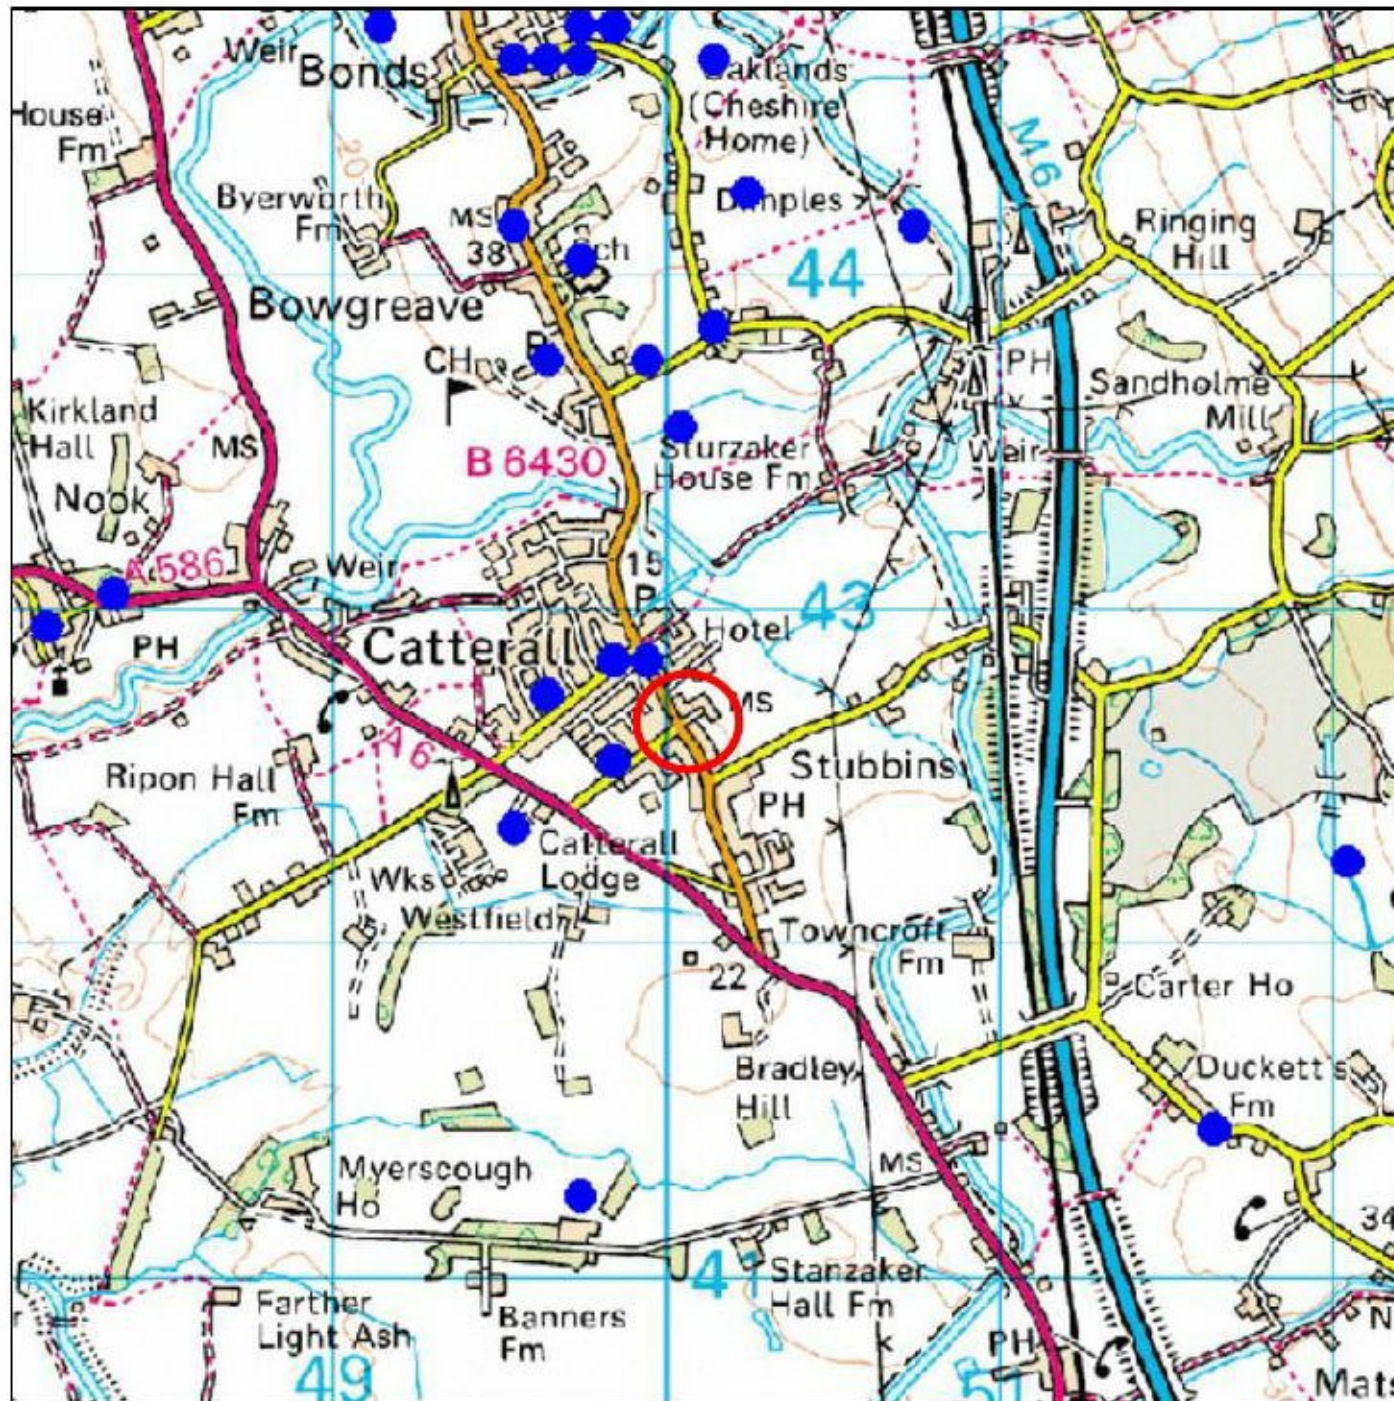
A search of the Envirotech dataset returned 172 records of six bat species within 2km but no records for the site.

Figure 4 Bat records shown in blue, site location circled red.

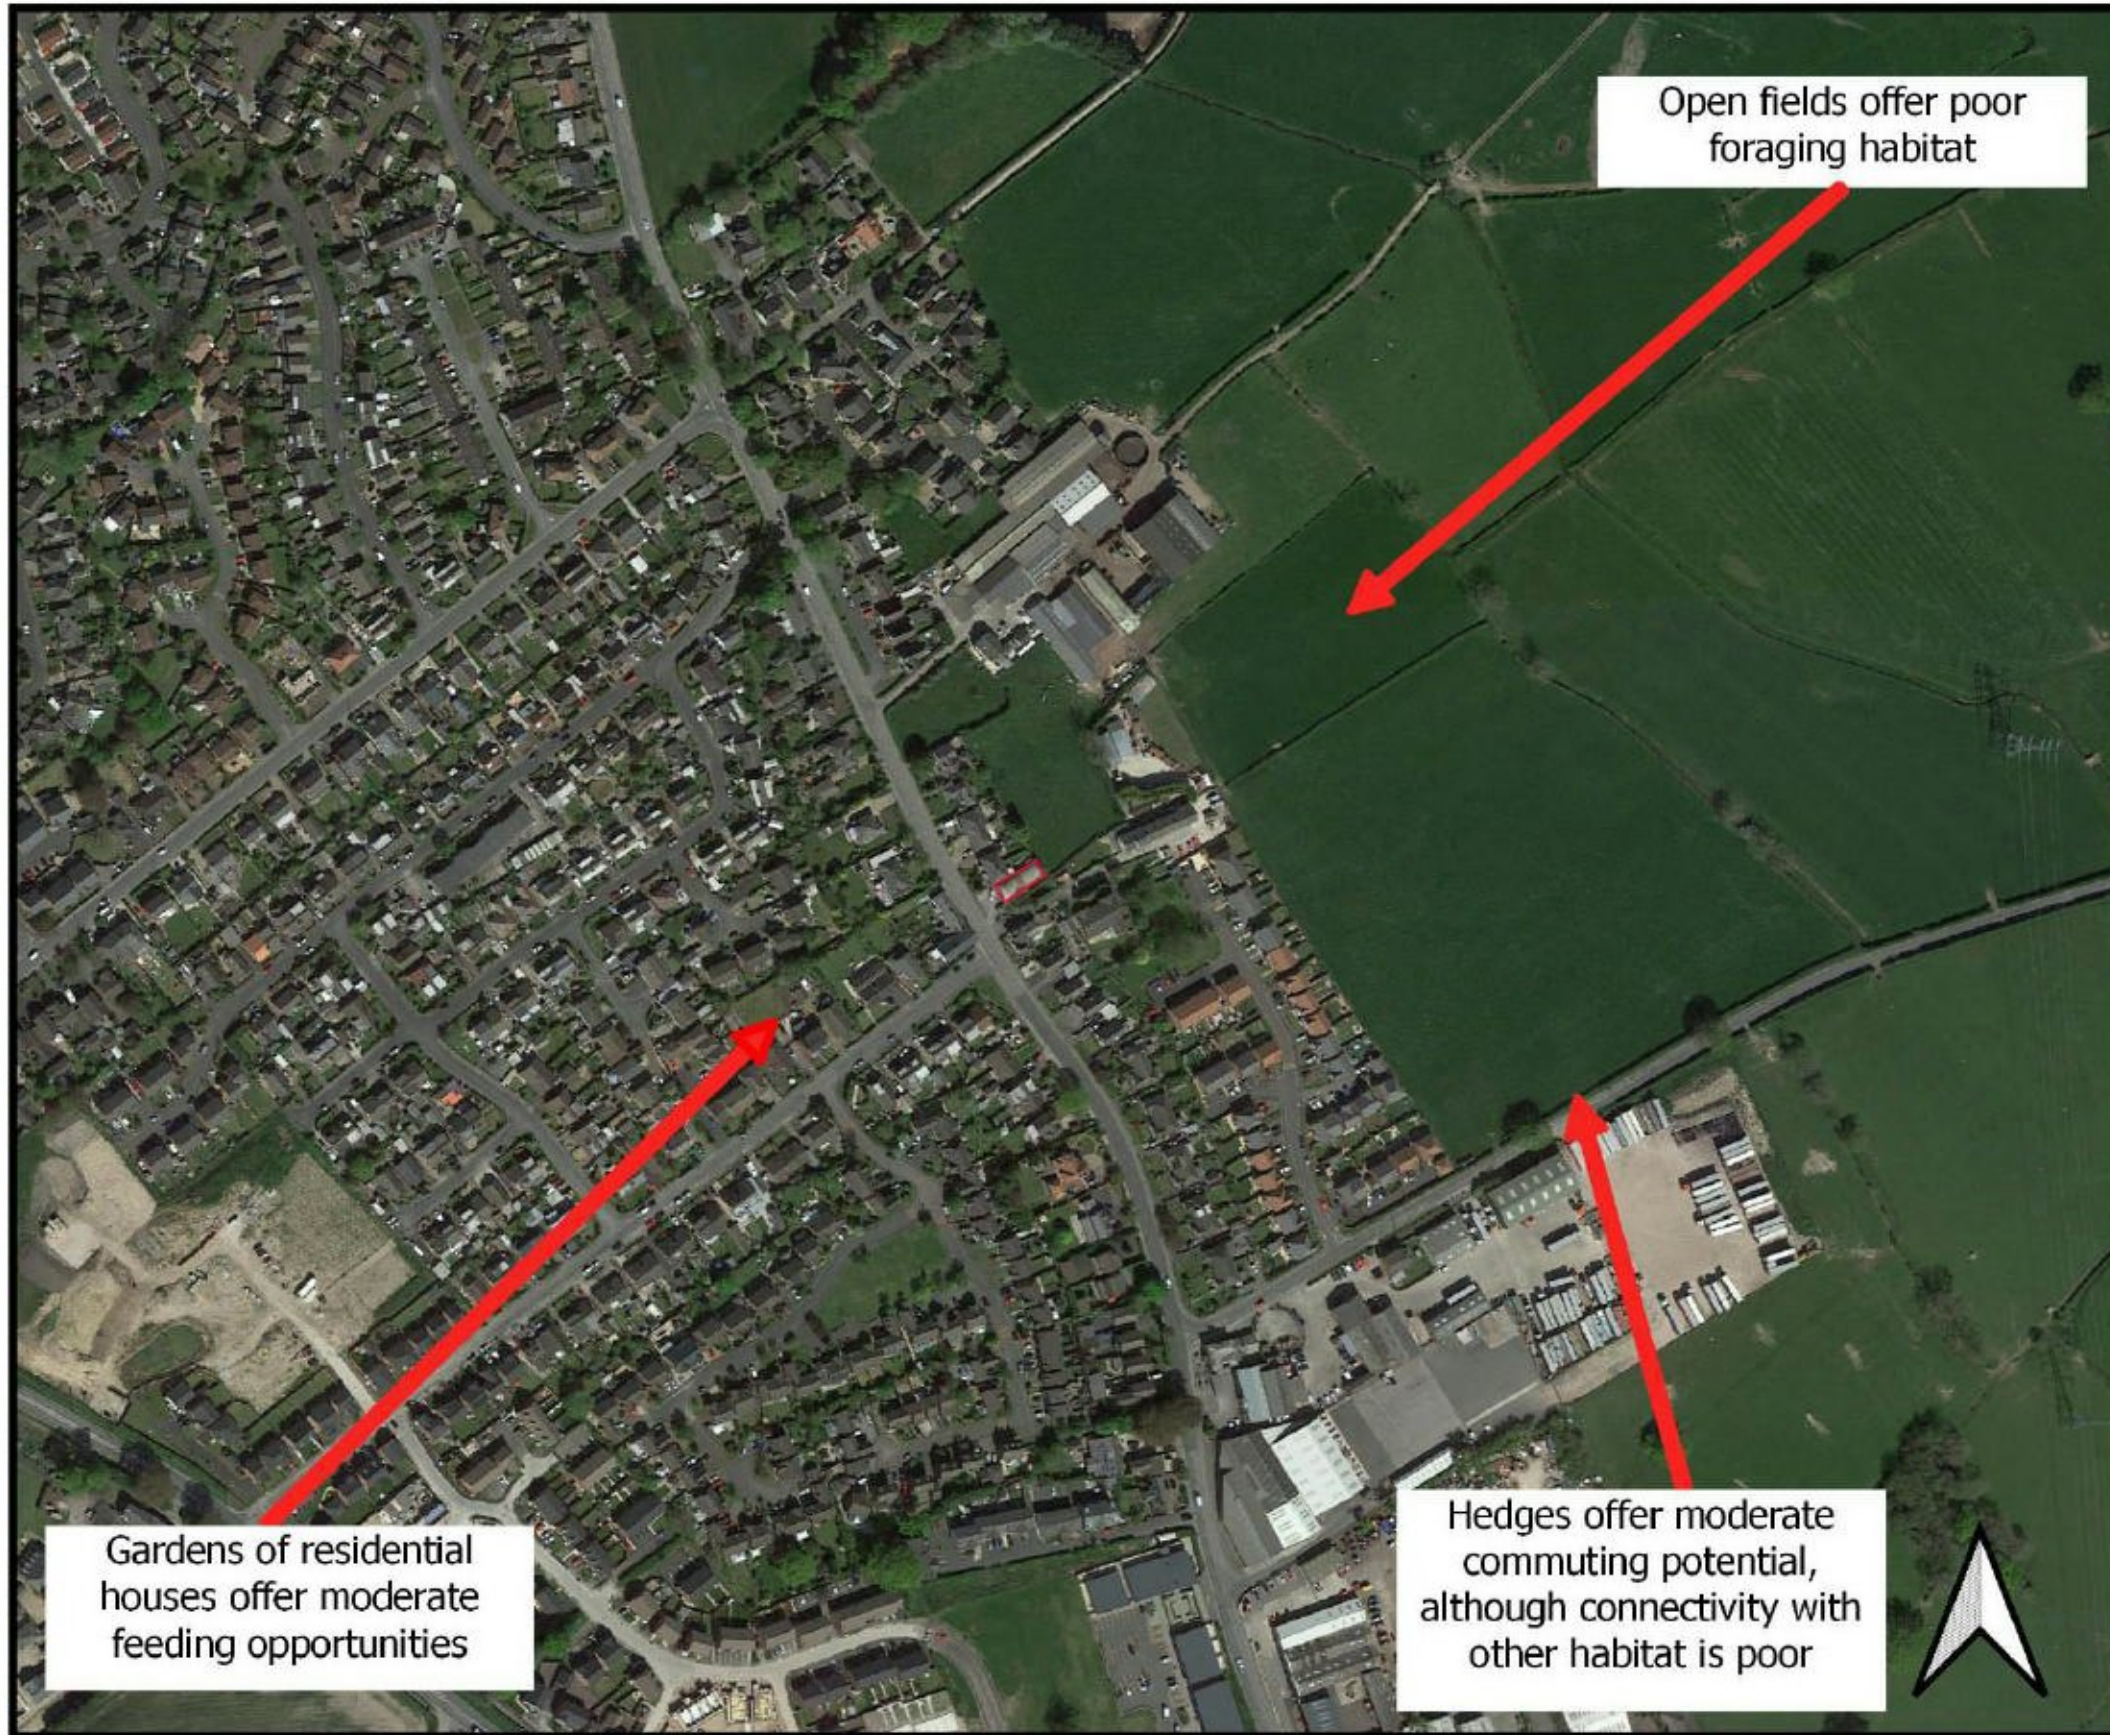
The habitat at and adjacent to the site was assessed from satellite imagery this was then ground truthed, Figure 5.

Figure 5
Habitat Adjacent Site

The habitat on and adjacent to the site identified from satellite images was ground truthed. Details of the habitats found on and adjacent to the site are detailed in Figure 5.

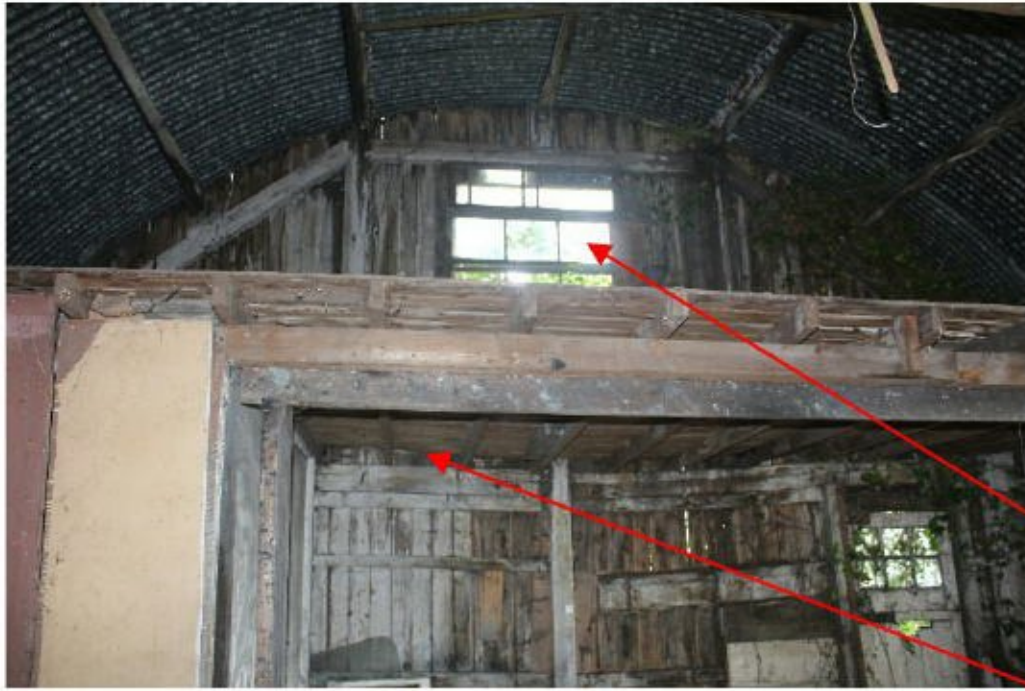
<p data-bbox="1220 2110 1934 2202">Rear elevation obscured by trees, in which birds may nest</p>

Windows to rear

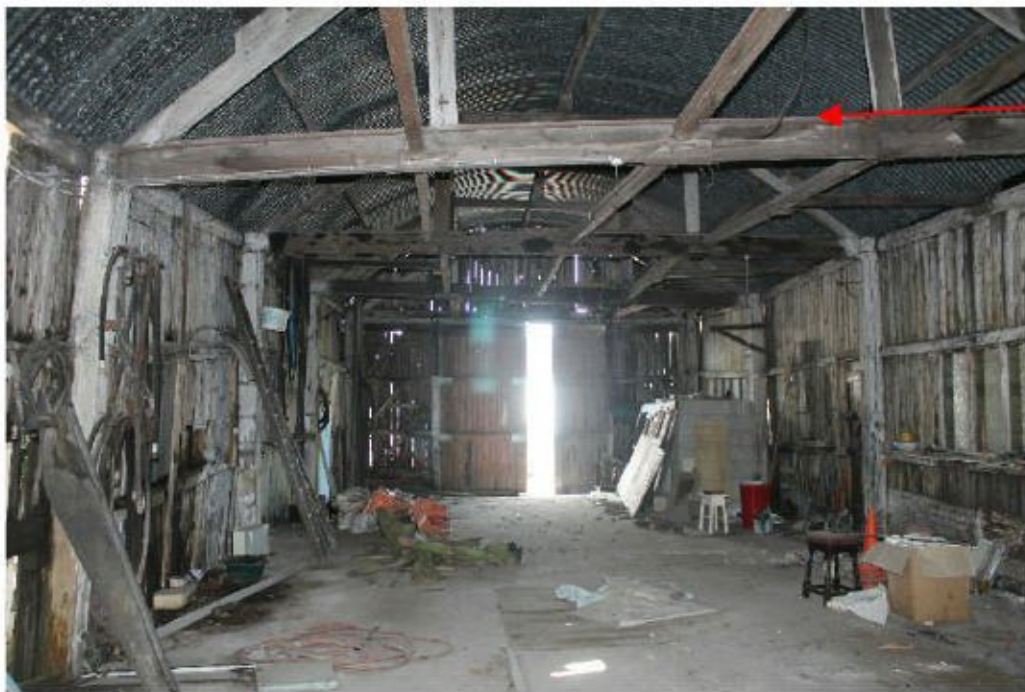
Internal walls offer minimal opportunities for bats

Roof timbers and roof in good condition
