**1-6 May Cottages
39-47 Hollingdean Road
Brighton
BN2 4AA**

**Ground Contamination
Risk Assessment and
Remediation Strategy**

Project Reference: P15063

Report Reference: R14738

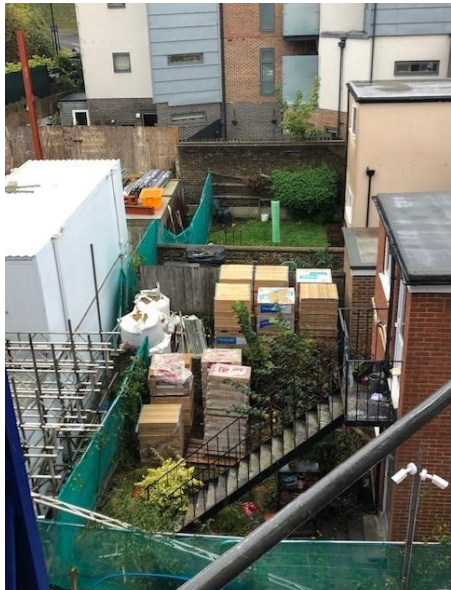
View looking west across rear gardens of residential properties located at 39-47 Hollingdean Road

The site is occupied by a terrace of houses along the northern boundary, with gardens to the south. The southernmost part of the assessment site extends onto the development site which lies to the south and east. This area is currently occupied by prefabricated site offices. The gardens of the houses are being used to store construction materials.

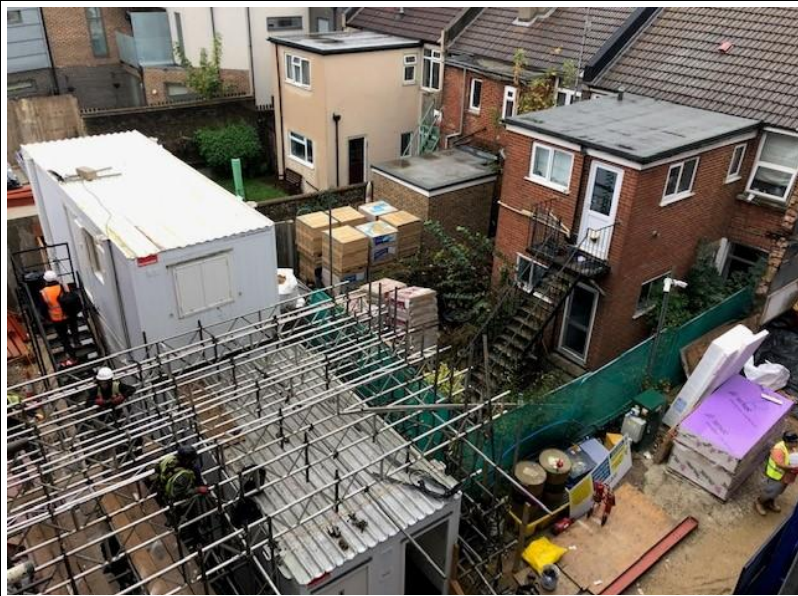
View looking north west across rear gardens of residential properties located at 39-47 Hollingdean Road.

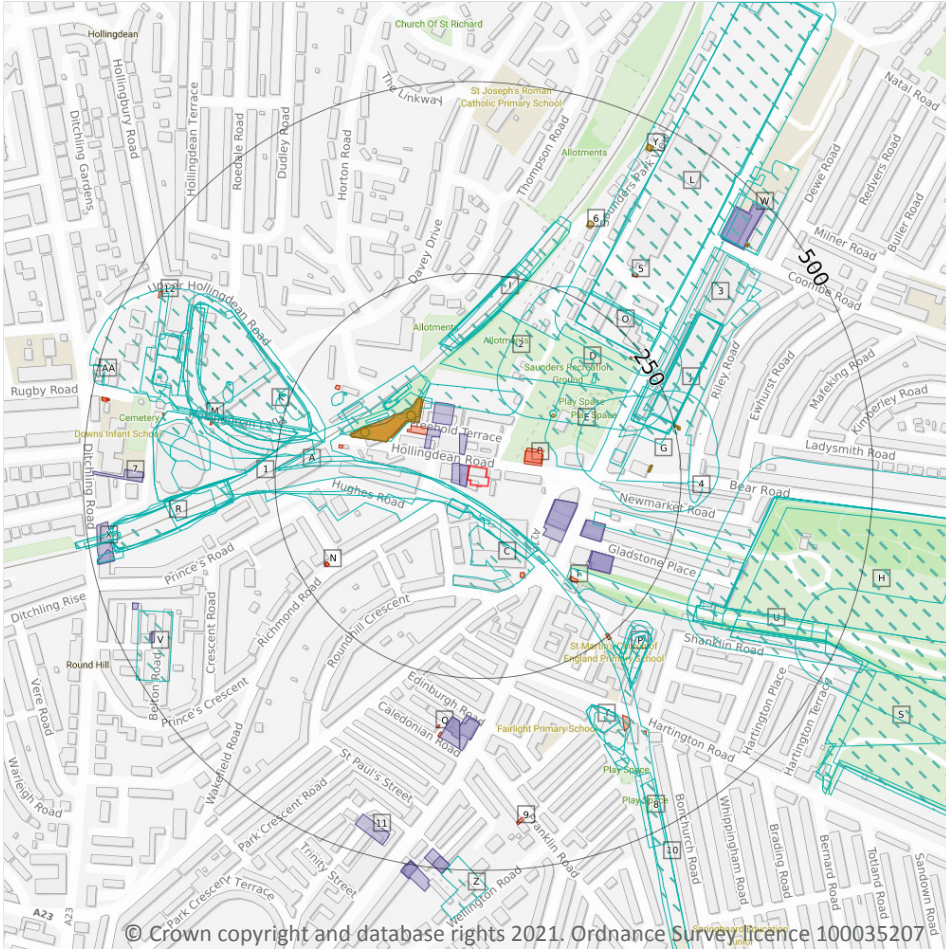
1 Past land use

- Site Outline
- Search buffers in metres (m)
- Historical industrial land uses
- Historical tanks
- Historical energy features
- Historical garages
