CLIENT: IAN SUMMERS  
PROJECT: FLAT 1/00, 26 ATHOLE GARDENS  
DRAWING TITLE: EXISTING WINDOW ELEVATION  
DRAWING STATUS: PLANNING  
DATE: 17-11-17 DRAWING NO: 17054/02A SCALE: 1:20@A3

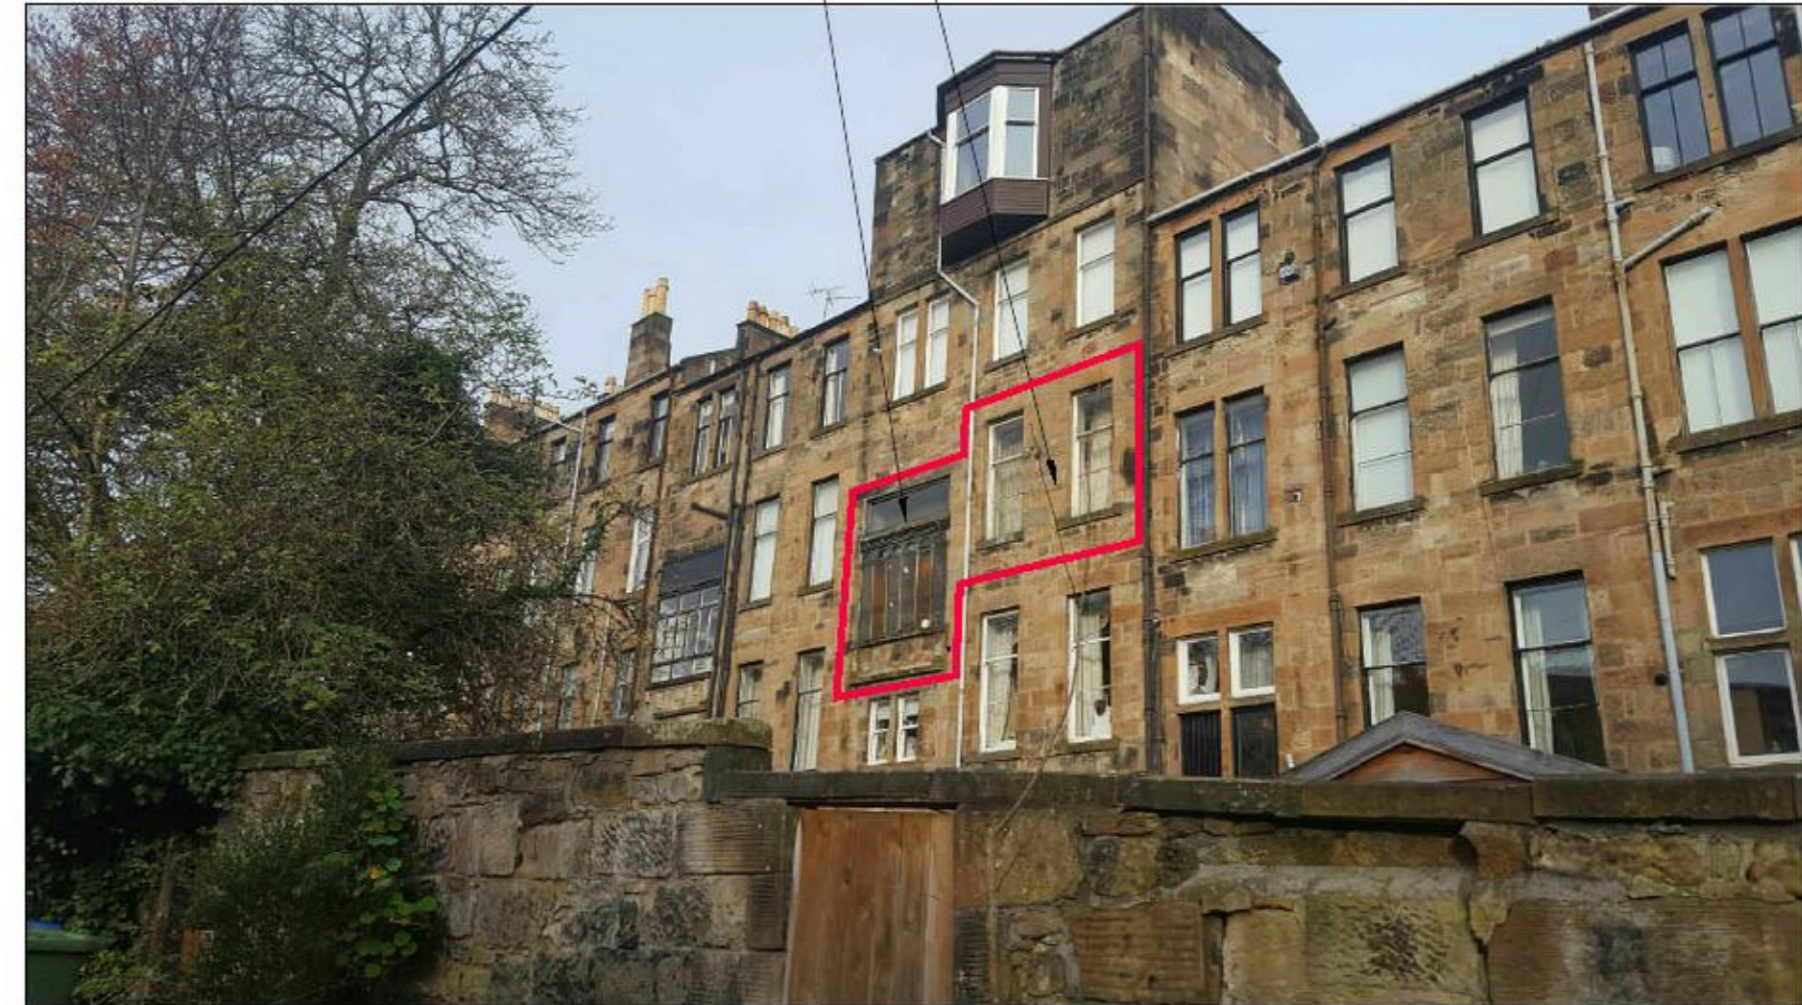
FLAT EXTENTS OUTLINED IN RED  
WINDOW PROPOSED TO BE REPLACED IS WITHIN A STORE AREA OWNED BY MY CLIENT WHICH IS ACCESSED OFF THE STAIR LANDING

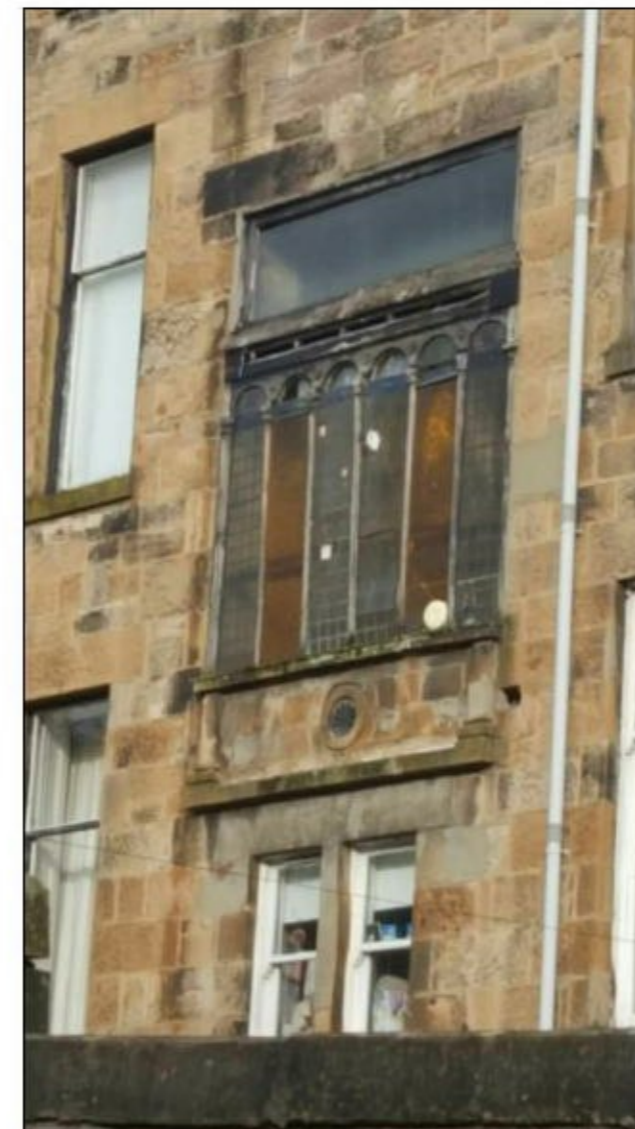
EXISTING VIEW OF REAR ELEVATION

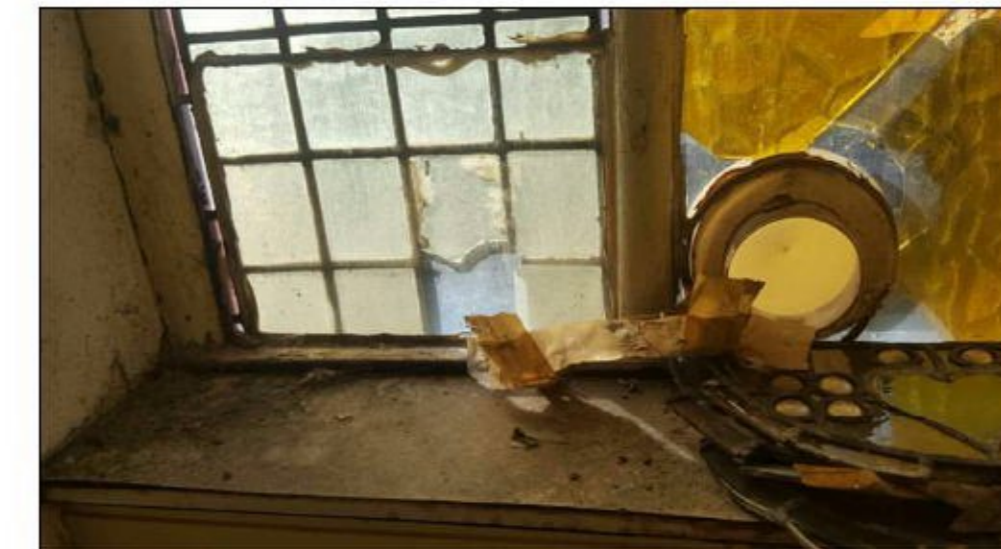
VIEW OF WINDOW

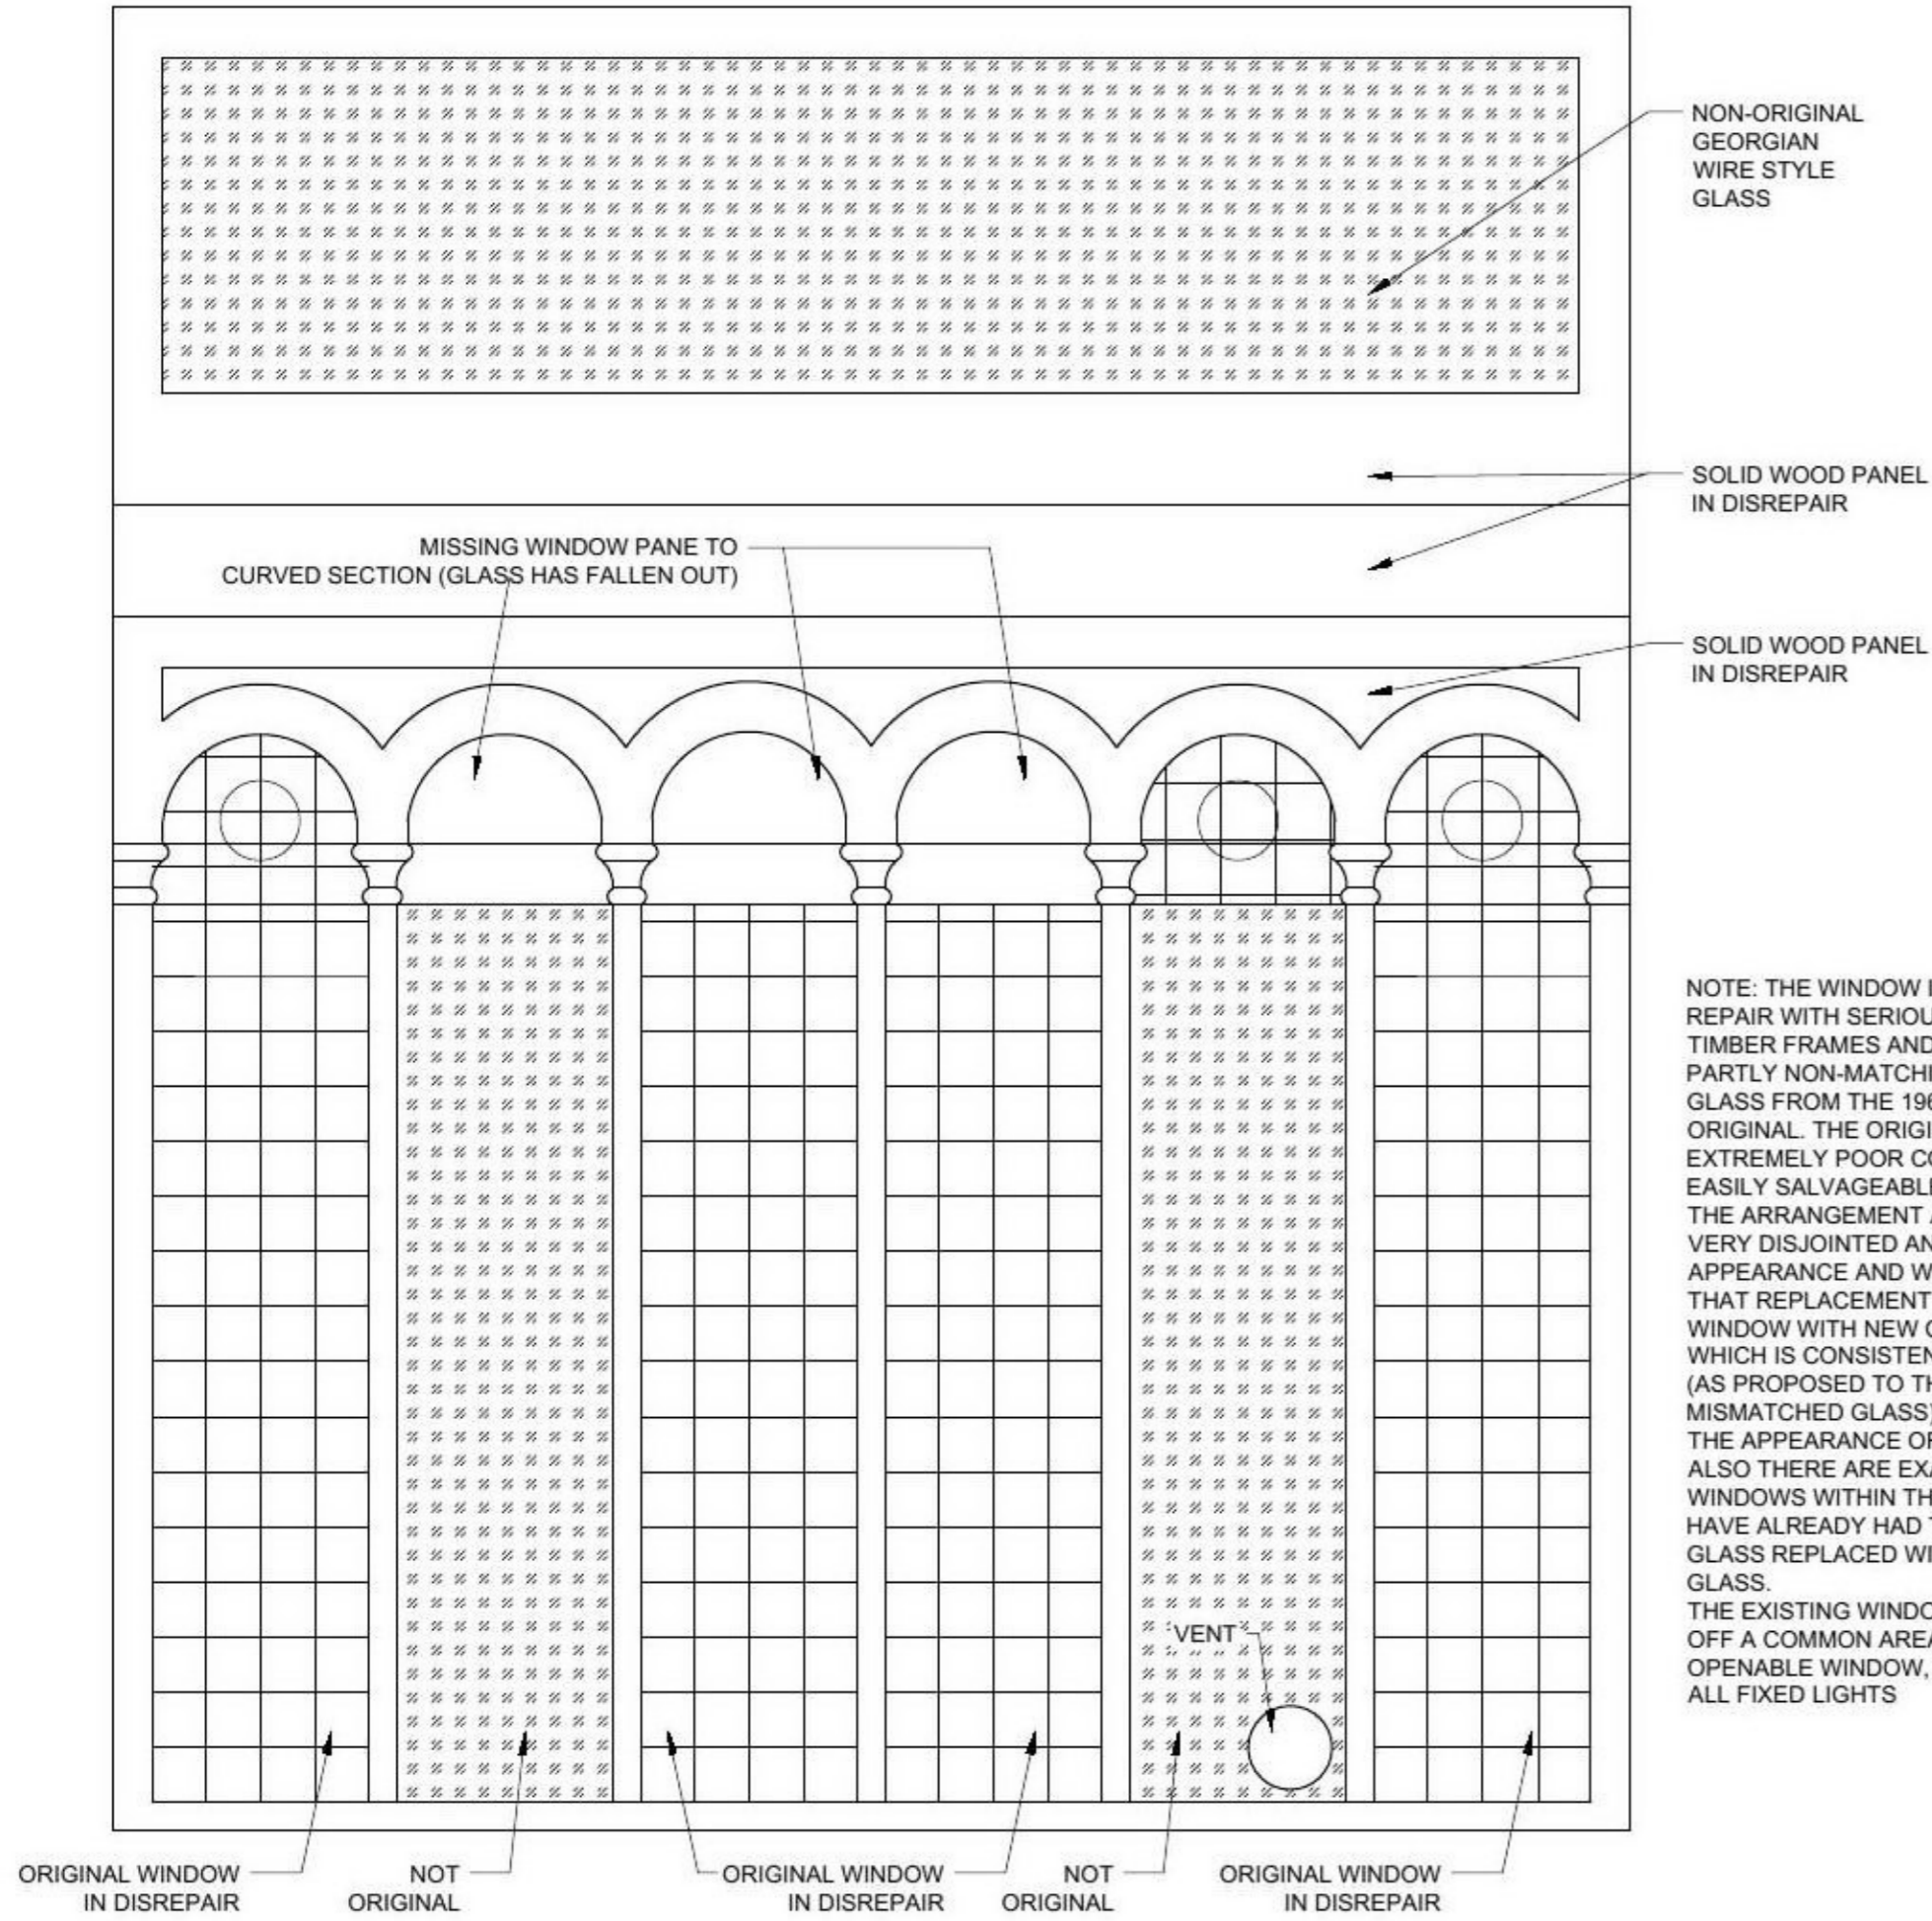
CONDITION PHOTOGRAPH

NOTE: THE WINDOW IS IN VERY POOR REPAIR WITH SERIOUSLY DECAYED TIMBER FRAMES AND GLASS WHICH IS PARTLY NON-MATCHING REPLACEMENT GLASS FROM THE 1960/70S AND PARTLY ORIGINAL. THE ORIGINAL GLASS IS IN EXTREMELY POOR CONDITION AND NOT EASILY SALVAGEABLE. THE ARRANGEMENT AT THE MOMENT IS VERY DISJOINTED AND POOR IN APPEARANCE AND WE WOULD ARGUE THAT REPLACEMENT OF THE WHOLE WINDOW WITH NEW CLEAR GLASS WHICH IS CONSISTENT IN APPEARANCE (AS PROPOSED TO THE EXISTING MISMATCHED GLASS) WOULD IMPROVE THE APPEARANCE OF THE ELEVATION. ALSO THERE ARE EXAMPLES OF SIMILAR WINDOWS WITHIN THE BLOCK WHICH HAVE ALREADY HAD THE STAINED GLASS REPLACED WITH NEW CLEAR GLASS. THE EXISTING WINDOW IS TO A STORE OFF A COMMON AREA AND IS NOT AN OPENABLE WINDOW, THE PANES ARE ALL FIXED LIGHTS
