ARCHITECTURAL SERVICES

SUPPORTING DOCUMENTATION TO ACCOMPANY THE PLANNING APPLICATION FOR THE PROPOSED SINGLE STOREY EXTENSION & INTERNAL ALTERATIONS AT SAWPIT COTTAGE. WESTON UNDER REDCASTLE.

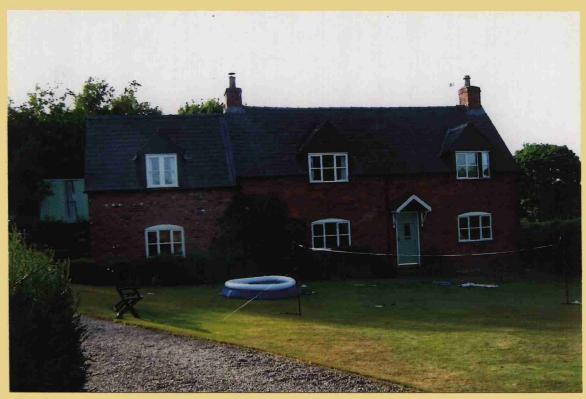
PHOTOGRAPH 1 - GENERAL VIEW OF THE FRONT ELEVATION OF SAWPIT COTTAGE.

Sawpit Cottage is located within the Conservation Area which covers Weston Under Redcastle (refer to 'Appendix B'), but the property itself is not listed. The current building as seen in 'photograph 1' on the cover of this report consists of the original cottage on the right and a late 1990's extension on the left. The original cottage contains quite extensive remnants of timber framing, (refer to photographs 5, 6 and 7 in 'Appendix A'). The ceiling joists which can be seen in photograph 6 are individually chamfered which would suggest a higher status building than just a cottage.

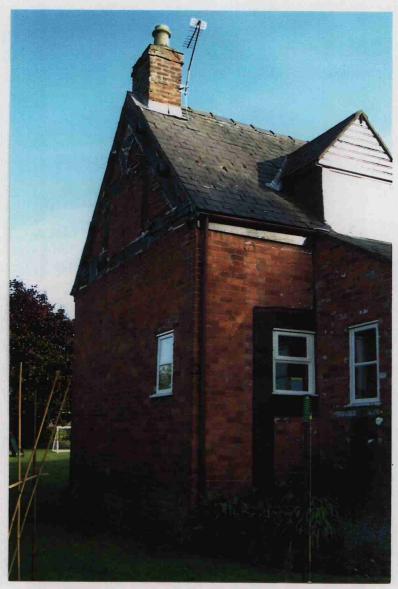
PHOTOGRAPH 2 - GENERAL VIEW OF THE END GABLE WALL OF THE ORIGINAL PART OF THE COTTAGE. IN THE GABLE IS ONLY PART OF THE ORIGINAL TIMBER FRAMED BUILDING WHICH IS EXPOSED EXTERNALLY ALONG WITH THE SMALL SECTION ON THE REAR WALL WHICH CAN ALSO BE SEEN IN THIS PHOTO.

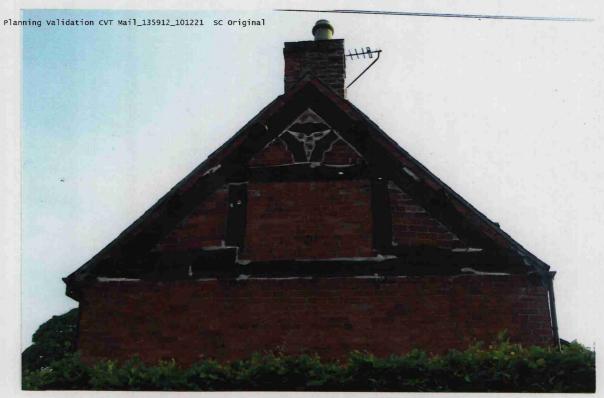
PHOTOGRAPH 3 - DETAIL OF THE EXPOSED TIMBER FRAMING WITH THE END GABLE.

Based upon the quality of the workmanship and the precedent of other buildings which I have worked on, it is my suggestion that Sawpit Cottage could be the remaining wing of a larger house. With the decorative timber framing on the apex of the gable (see photograph 3) which faces the road, I would suggest that this could have been the original frontage. Where the timber framing has been lost and replaced with brickwork which forms the new fronatge seen in 'photograph 1', the brickwork may have replaced an internal wall, which would mean that the rest of the earlier building could have been positioned where the front lawn is.

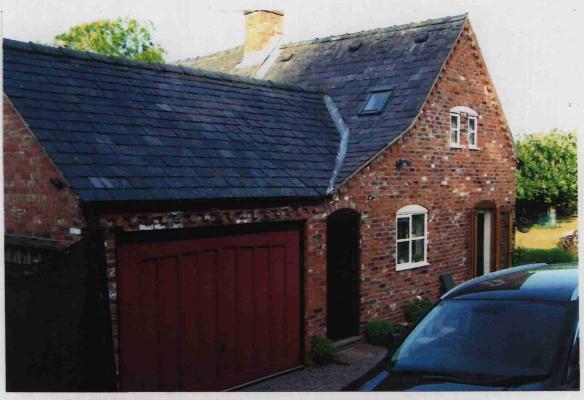
PHOTOGRAPH 4 - GENERAL VIEW OF THE LATE 1990'S EXTENSION AT THE OTHER END OF THE HOUSE.

Planning permission was granted in 1996 for the erection of a two storey extension. A Building Regs Application followed in 1998, so I am assuming that the extension which can be seen in photographs 1 and 4 was constructed in about 1998.

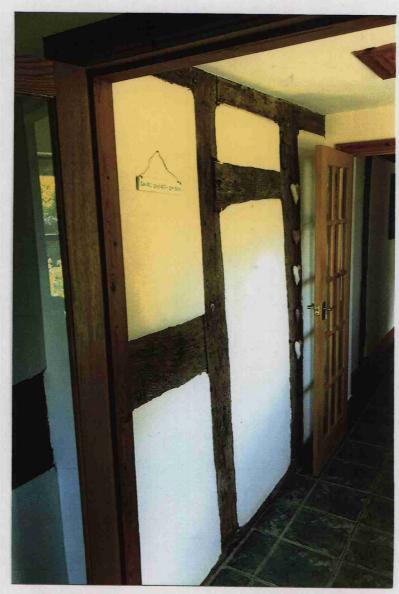
PHOTOGRAPH 5 - DETAIL OF THE TIMBER FRAMING TO THE REAR WALL WHICH IS PRESERVED INTERNALLY WITHIN AN OLDER LEAN TO ADDITION.

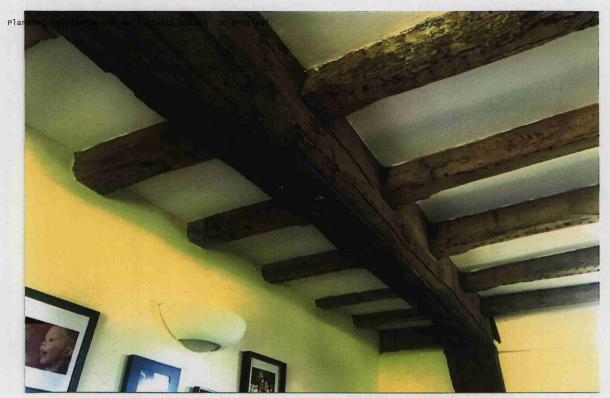
PHOTOGRAPH 6 - DETAIL OF THE CEILING STRUCTURE WITHIN THE CORE OF THE ORIGINAL HOUSE.

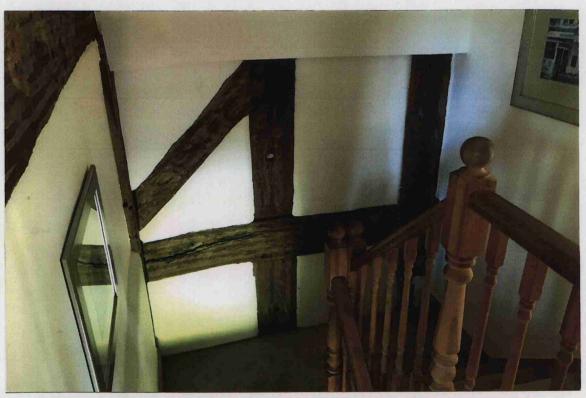
PHOTOGRAPH 7 - DETAIL OF THE ORIGINAL TIMBER FRAMING TO THE REAR WALL OF THE HOUSE AS SEEN FROM THE LANDING LOOKING DOWN THE STAIRS.
