# **St Minver Holiday Park Wadebridge**

## **Tree Protection Plan and Arboricultural Method Statement**

**13th December 2021**

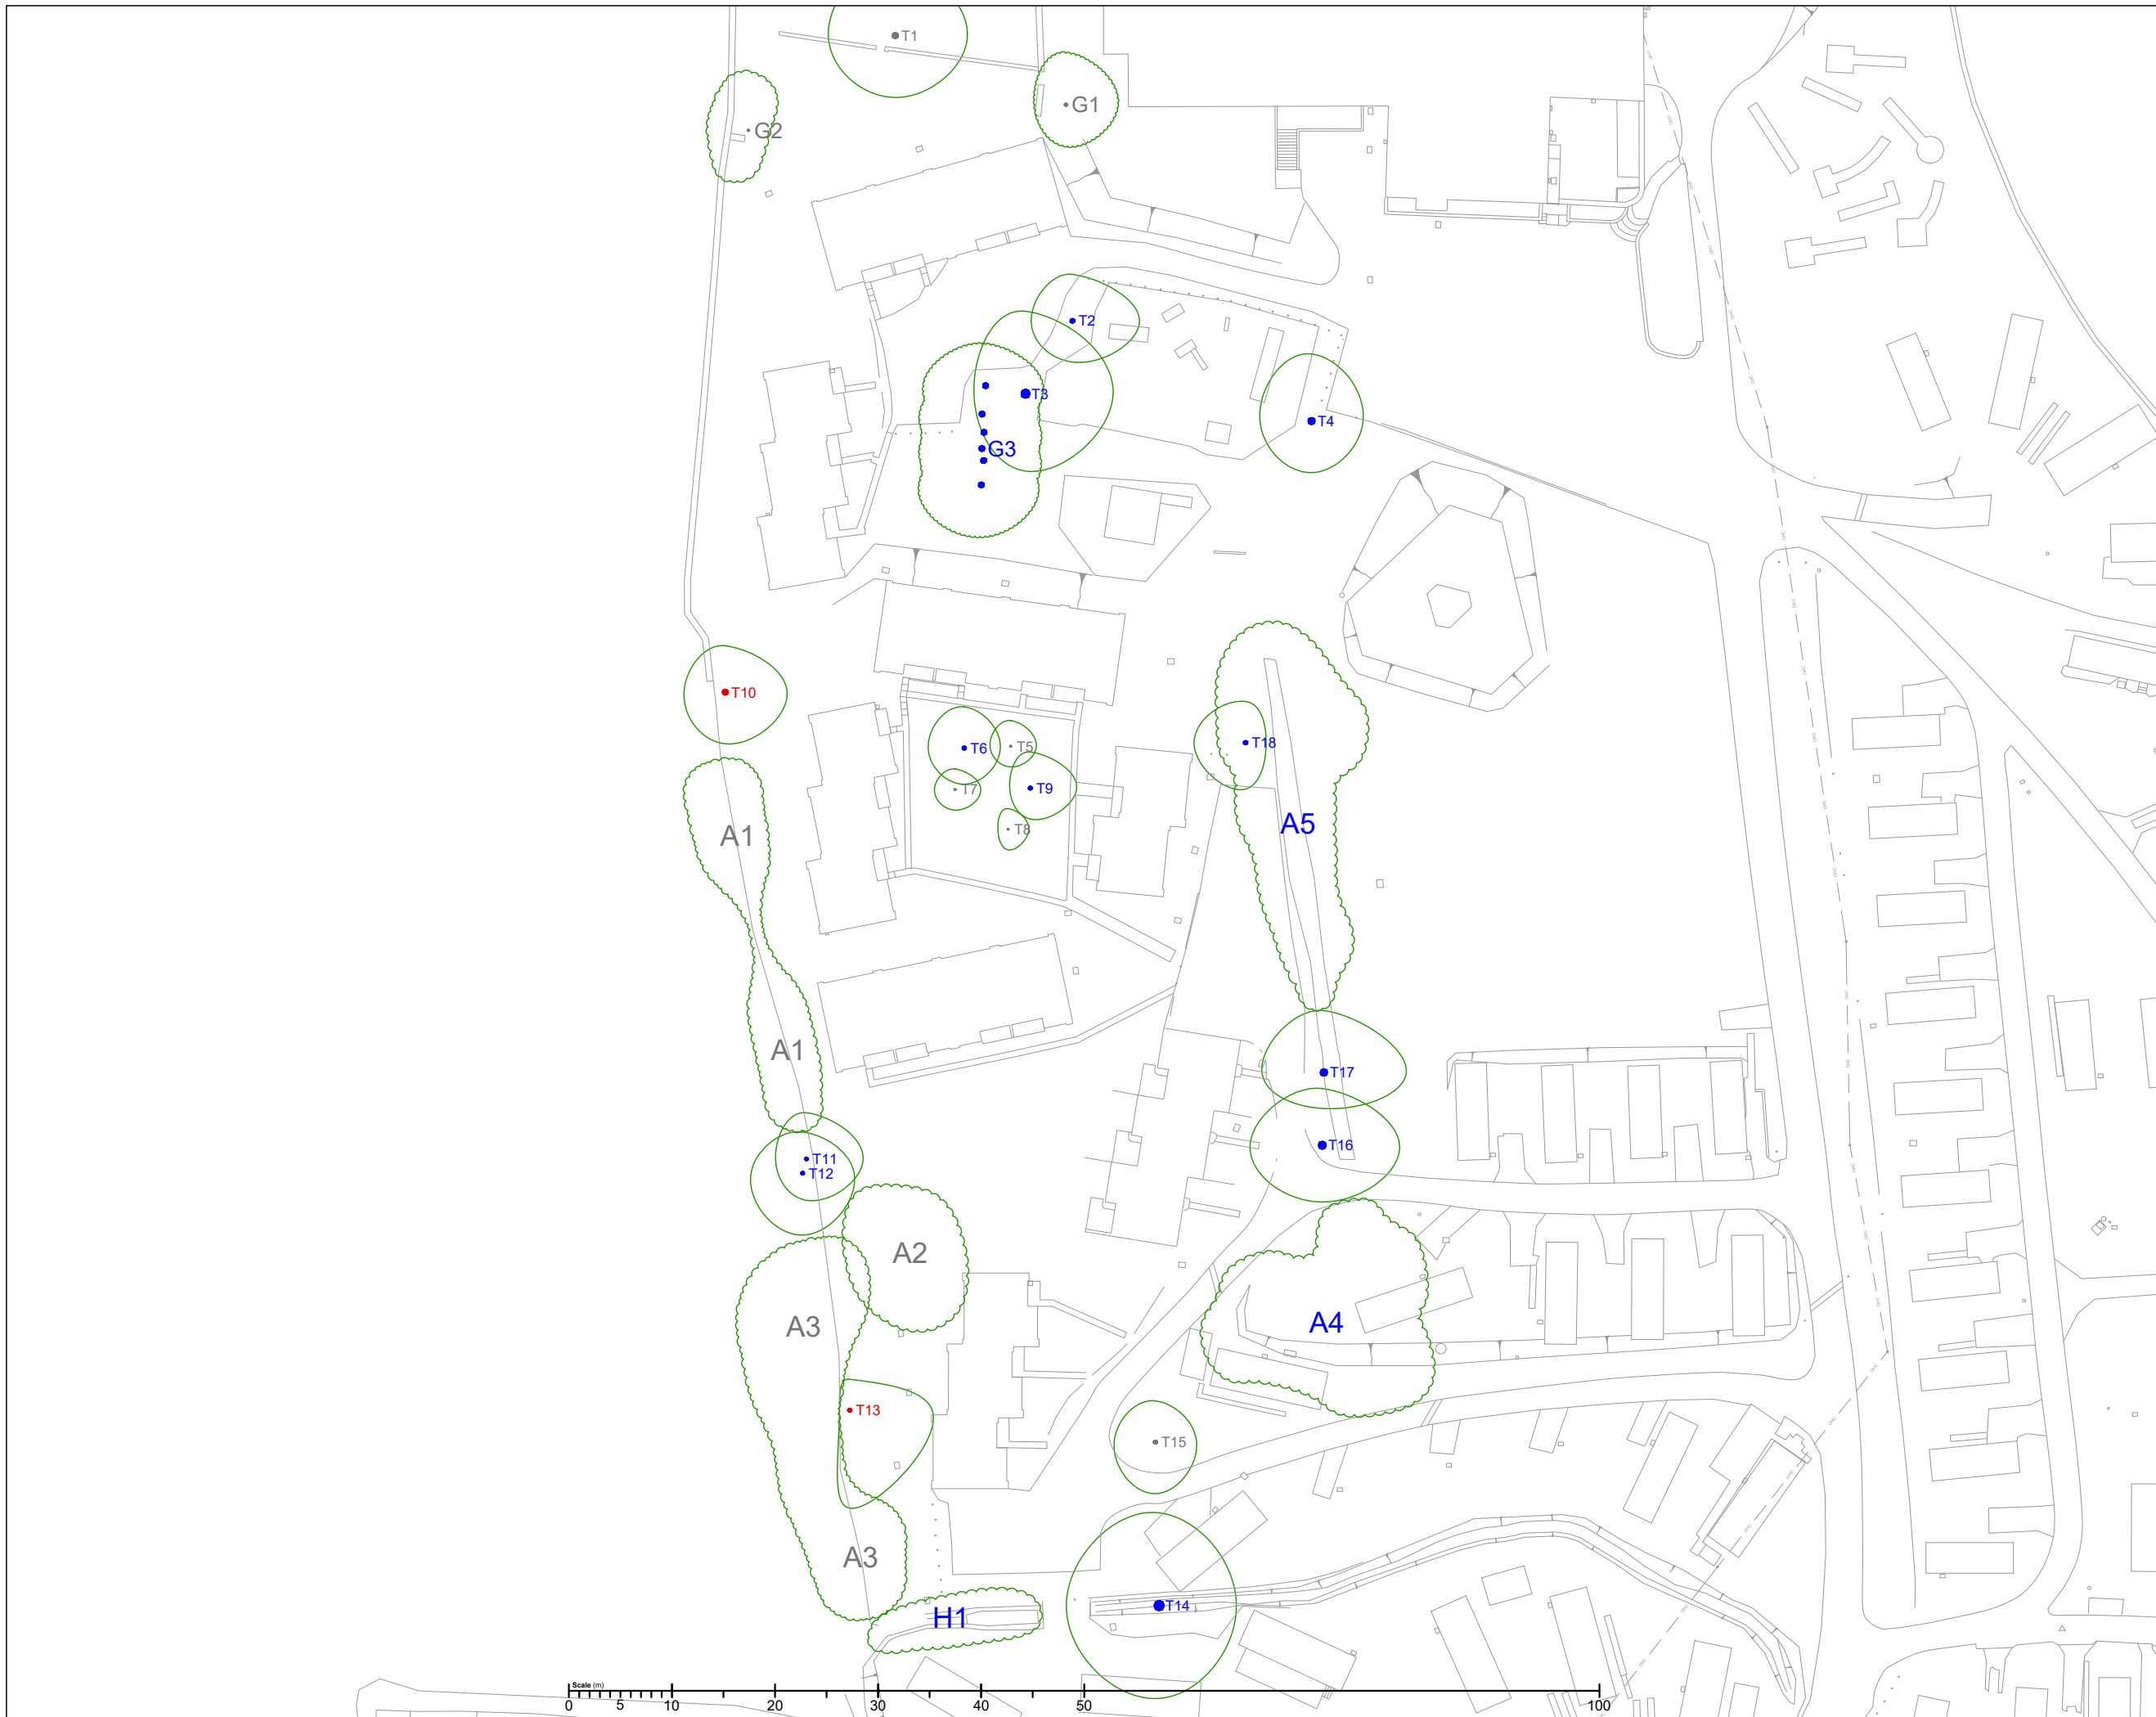
A total of 38 metres of high visibility fencing (see Arboricultural Guidance Sheet AGS105) is also shown on the Tree Protection Plan. The purpose of this is to act as a visual demarcation of the construction exclusion zones where there is considered to be a low risk of damage to retained trees from plant, materials or personnel.

No-dig surfacing is shown on the Tree Protection Plan where an access route crosses root protection areas. This must be installed at the earliest opportunity, utilising a temporary wear course as required for the duration of the construction programme, replacing this with a final permanent wear course on completion of all construction works.

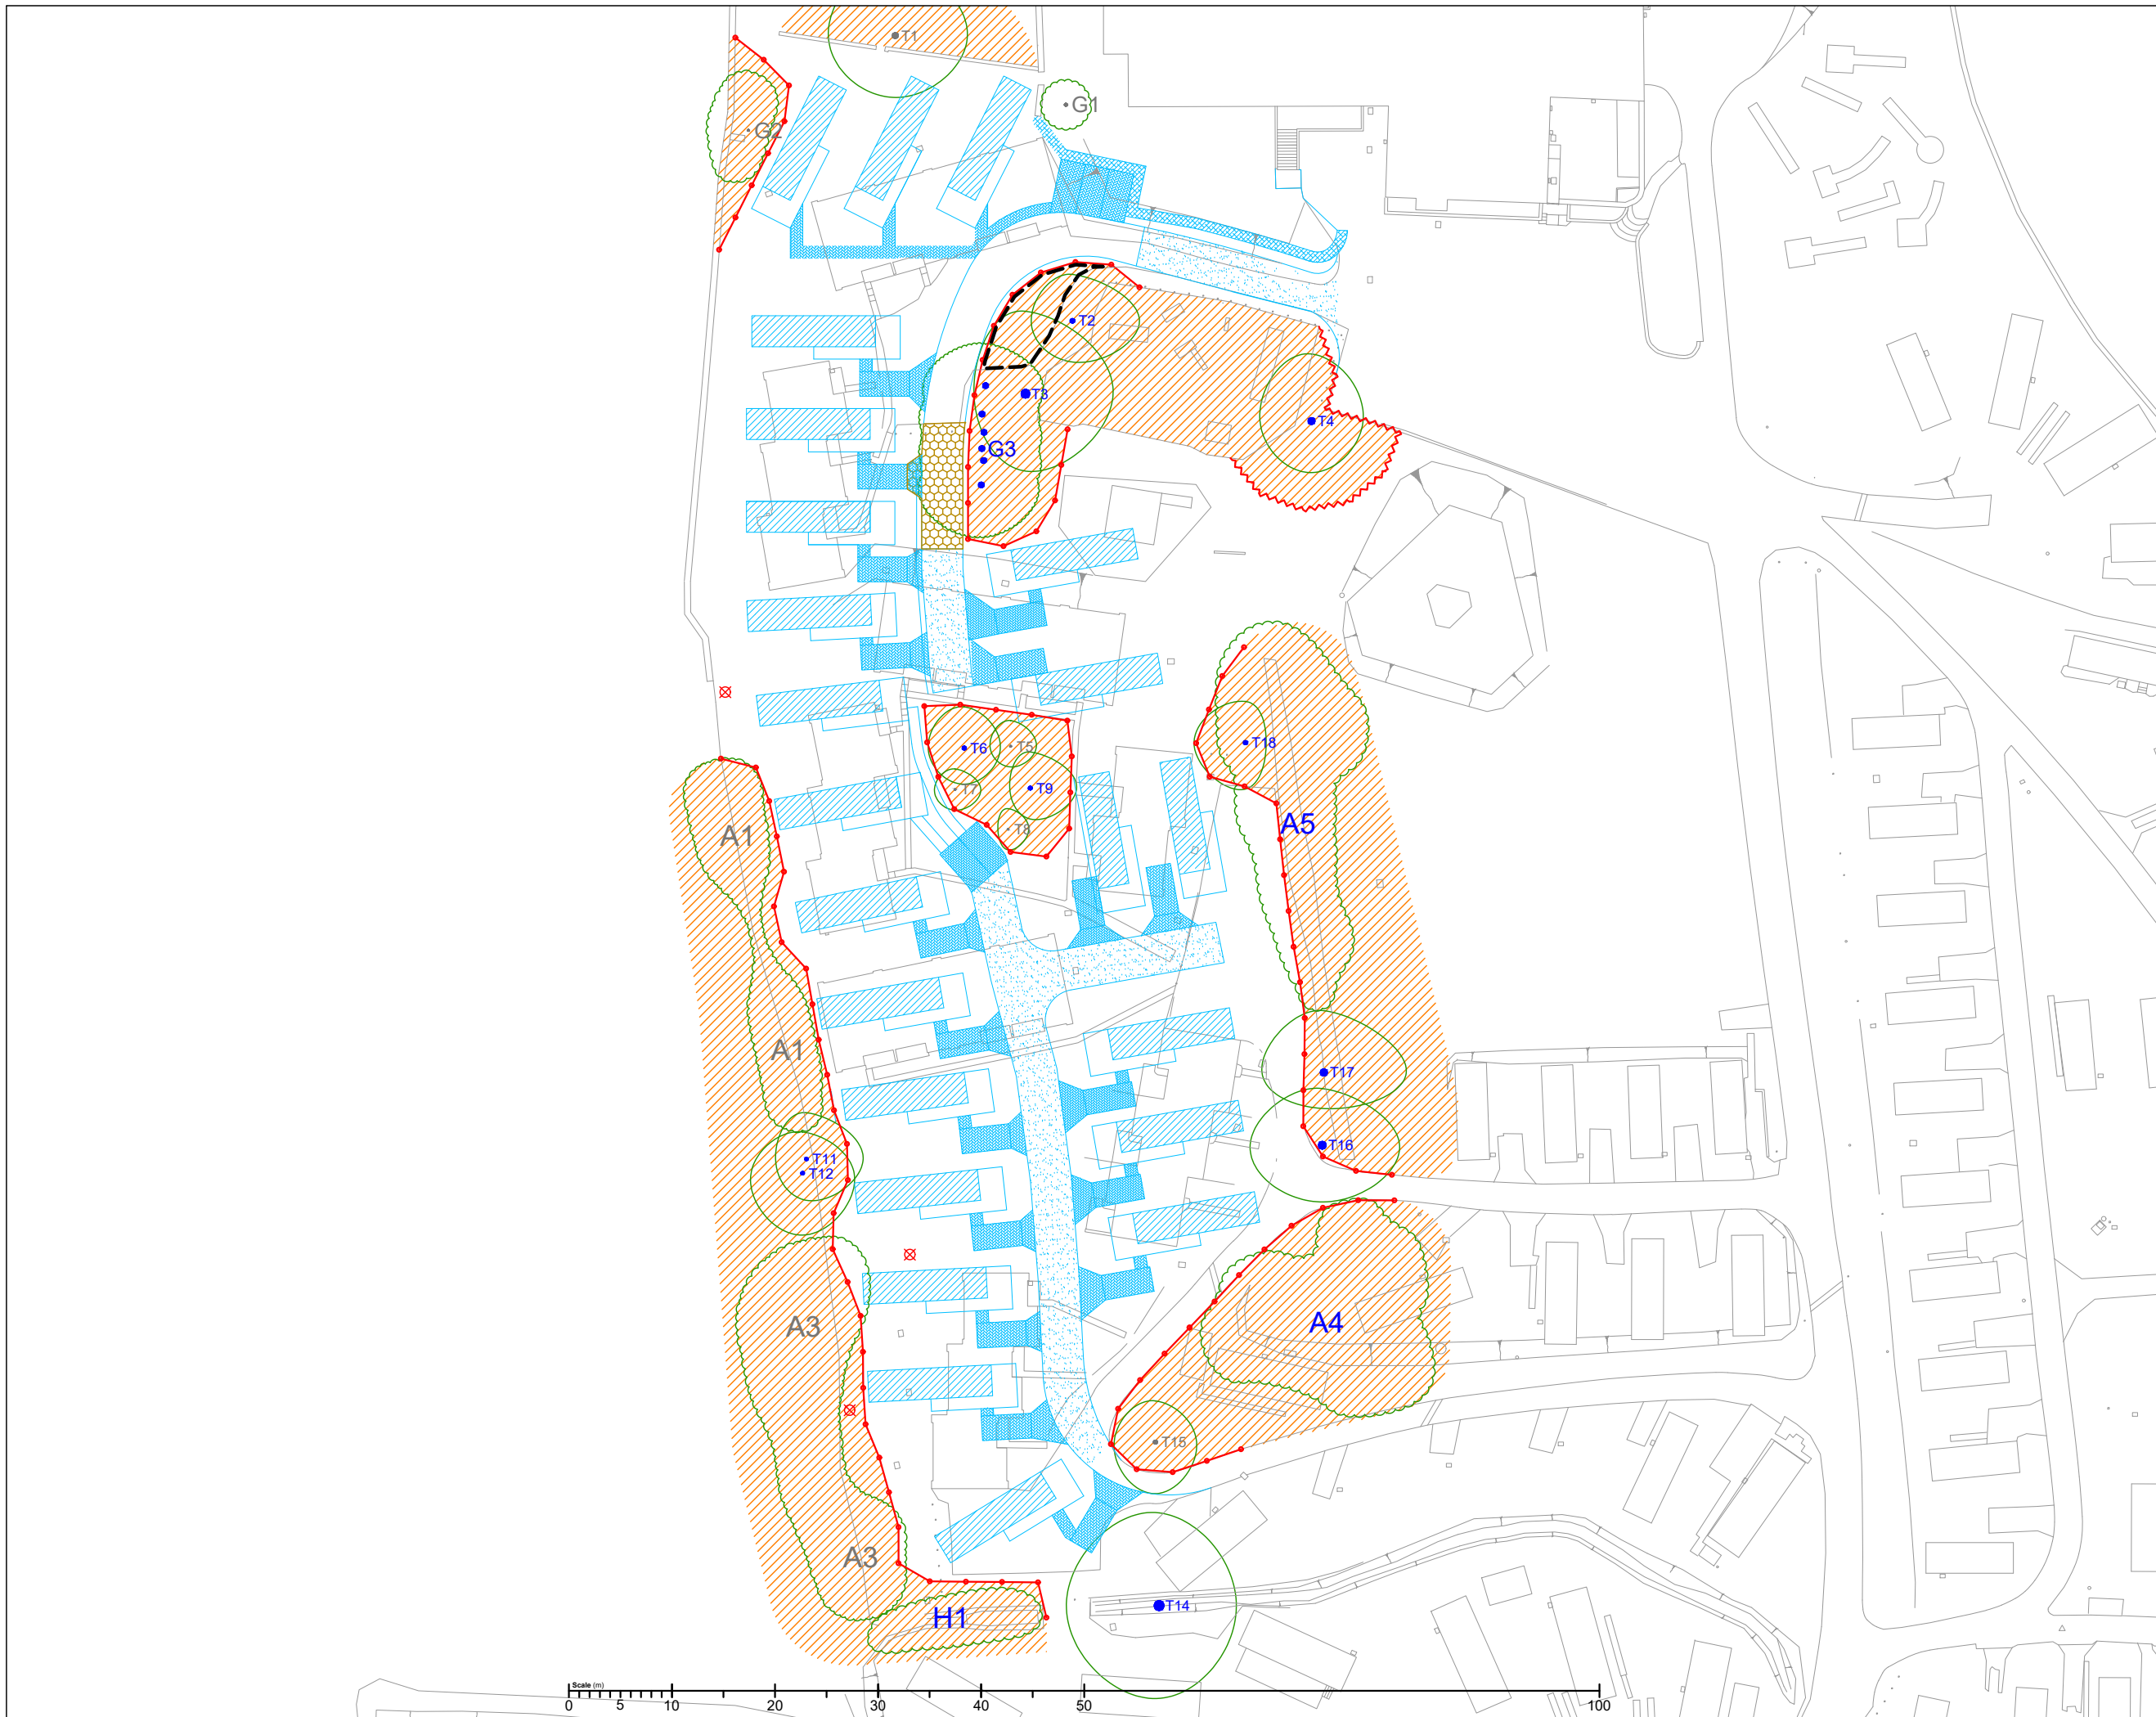
- Protective fencing must not be breached or dismantled at any point during the construction programme without the written consent of the local planning authority.
- Failure to fully comply with this Tree Protection Plan may result in the local planning authority pursuing enforcement action.
- It is the Site Manager's responsibility to ensure that all site personnel, plant and materials remain outside of the Construction Exclusion Zones and protective fencing at all times.

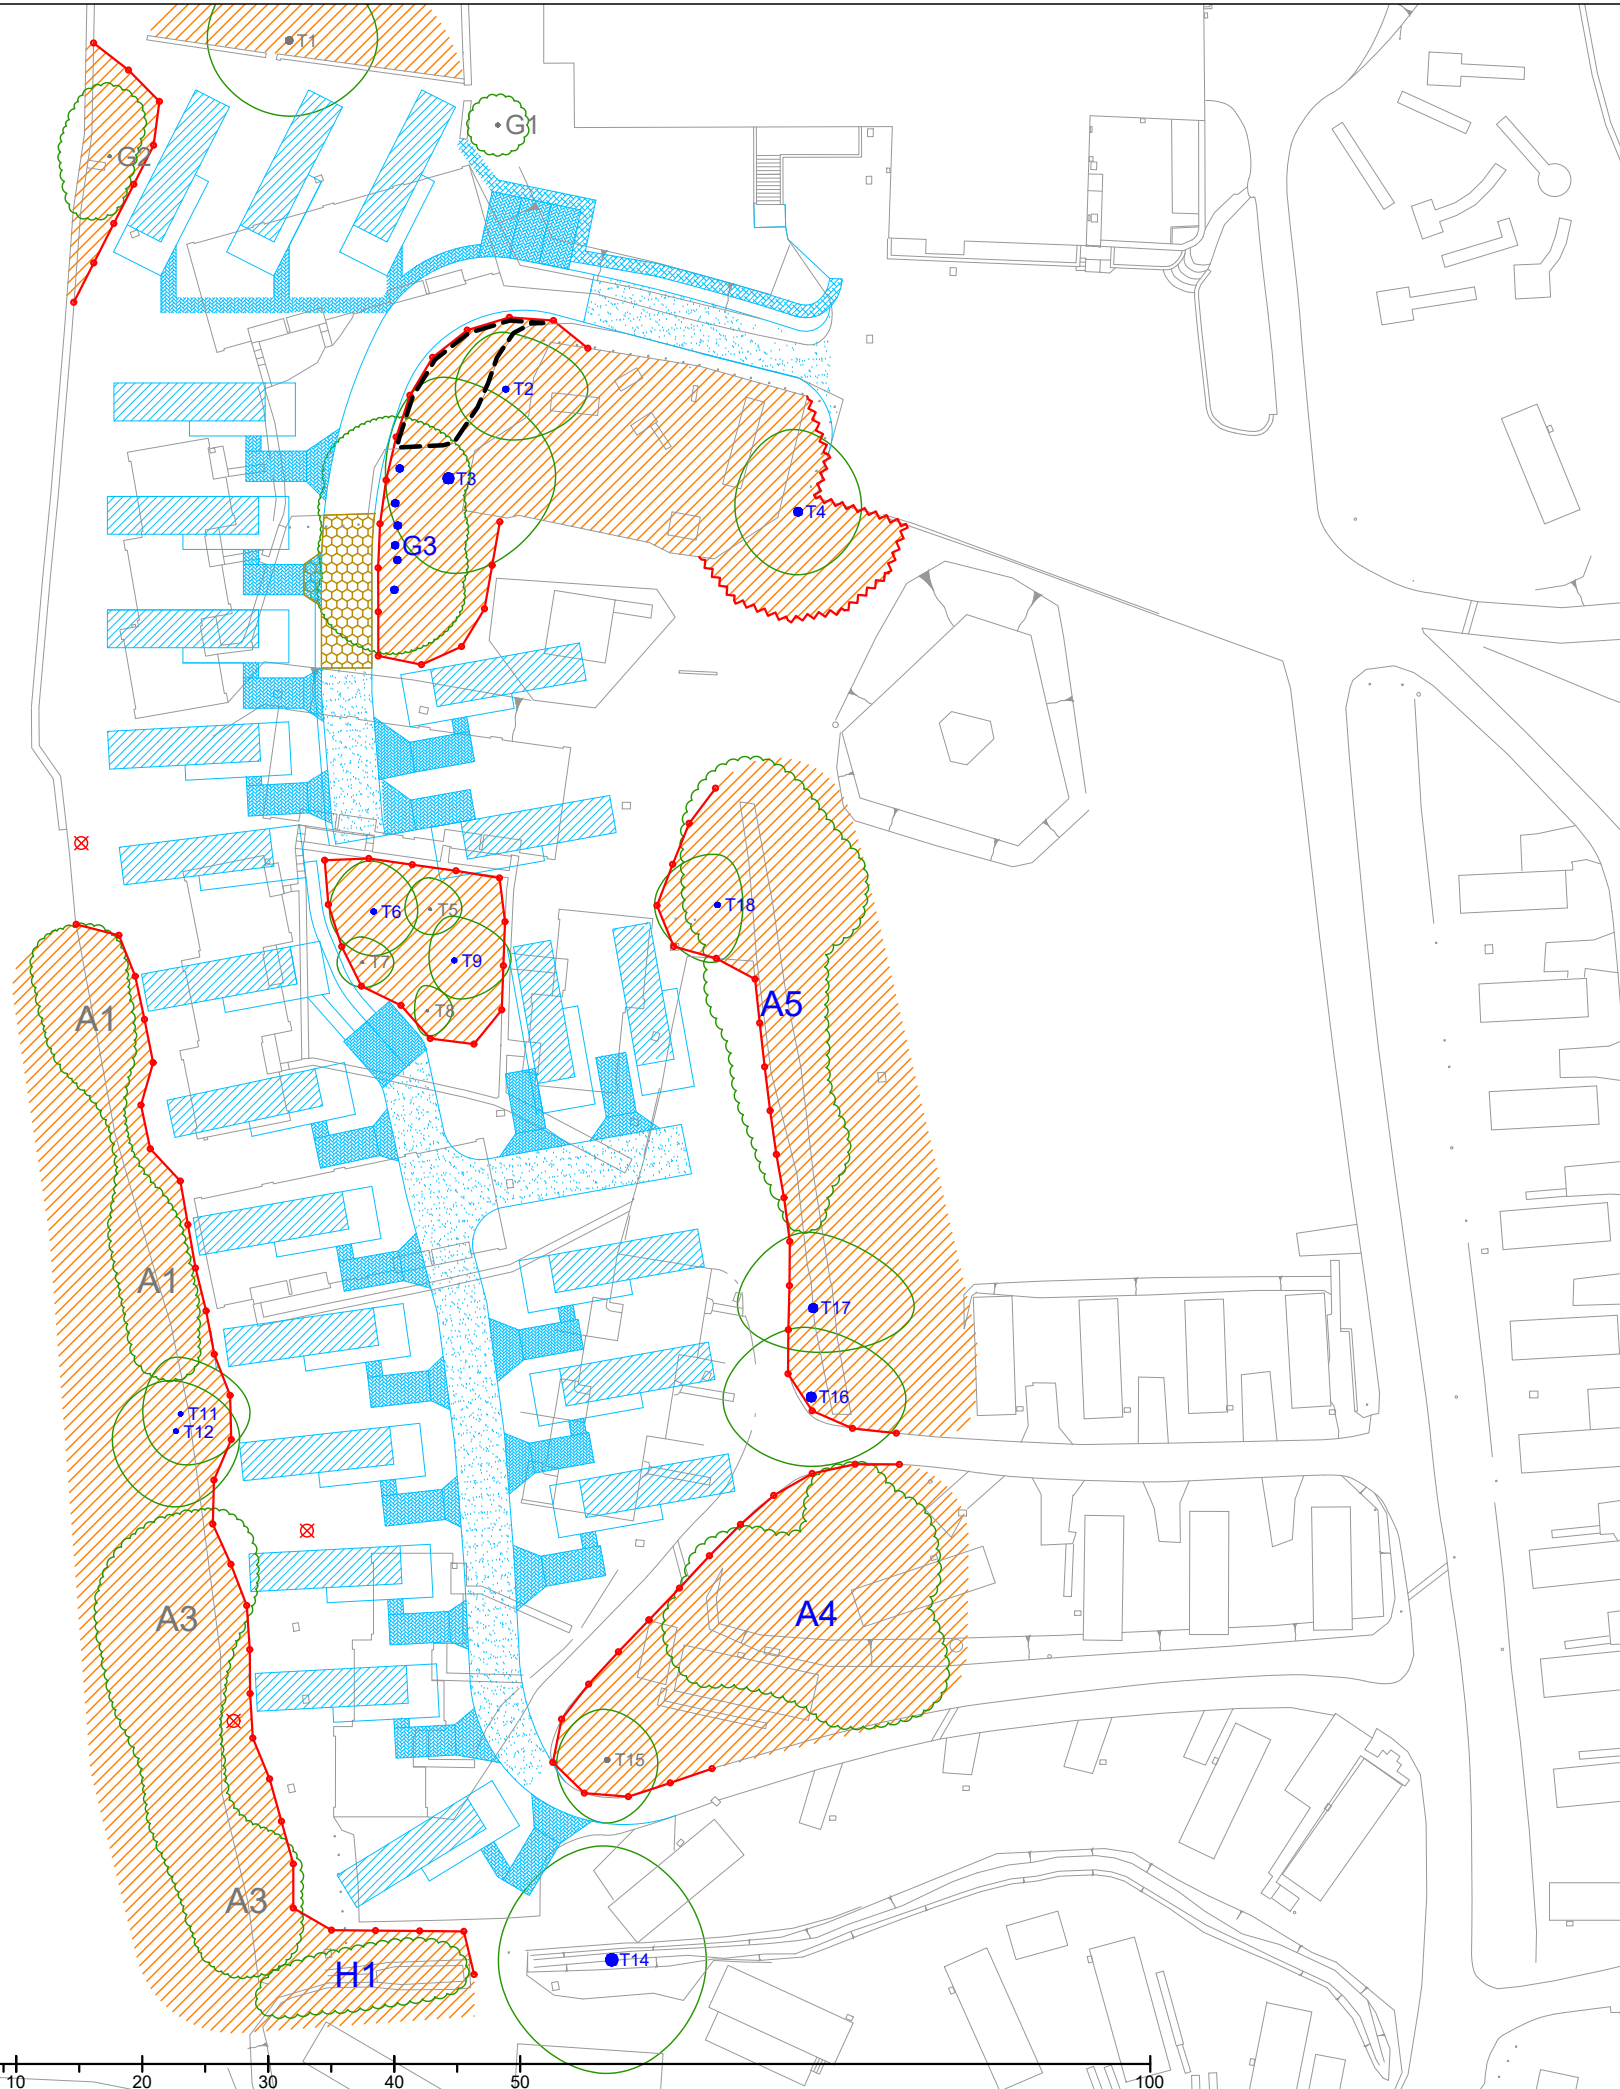
- Protective fencing must not be breached or dismantled at any point during the construction programme without the written consent of the local planning authority.
- Failure to fully comply with this Arboricultural Method Statement may result in the local planning authority pursuing enforcement action.
- It is the Site Manager's responsibility to ensure that all site personnel, plant and materials remain outside of the Construction Exclusion Zones and protective fencing at all times.

An ad-hoc arboricultural inspection programme is shown on the Arboricultural Method Statement Plans. Inspections must be requested by the client, project manager and/or site manager where the project scope changes, or where unforeseen construction activities may present a threat to retained trees on or adjacent to the site. The attached Arboricultural Supervision Record Sheet must be filled in on an ongoing basis and retained on site for inspection by the local planning authority at any reasonable time.

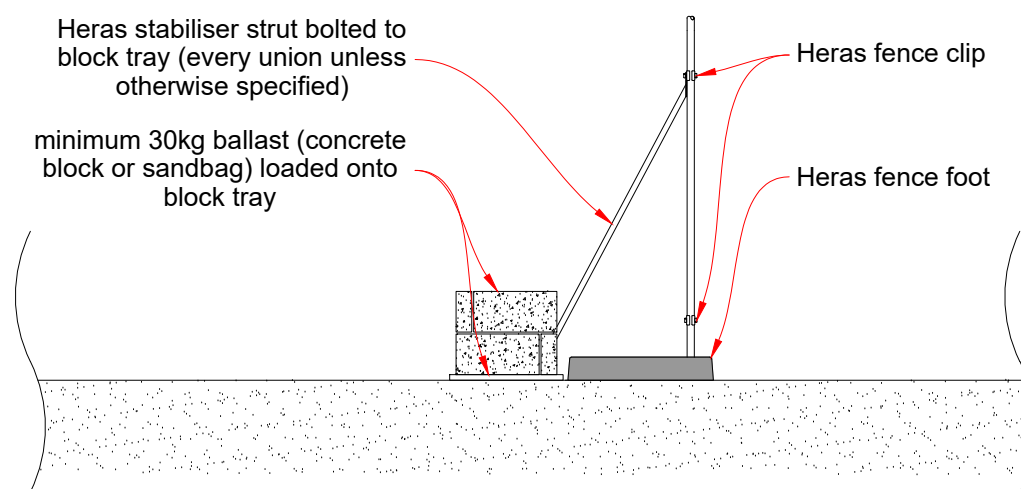
**Back Bracing Cross Section (for use where road pins cannot be driven into the ground)**

- Where it is not possible to use road pins due to hard surfacing or the presence of underground services, a Heras block tray may be used with a minimum of 10kg of ballast (concrete blocks, metal weights or sandbags).

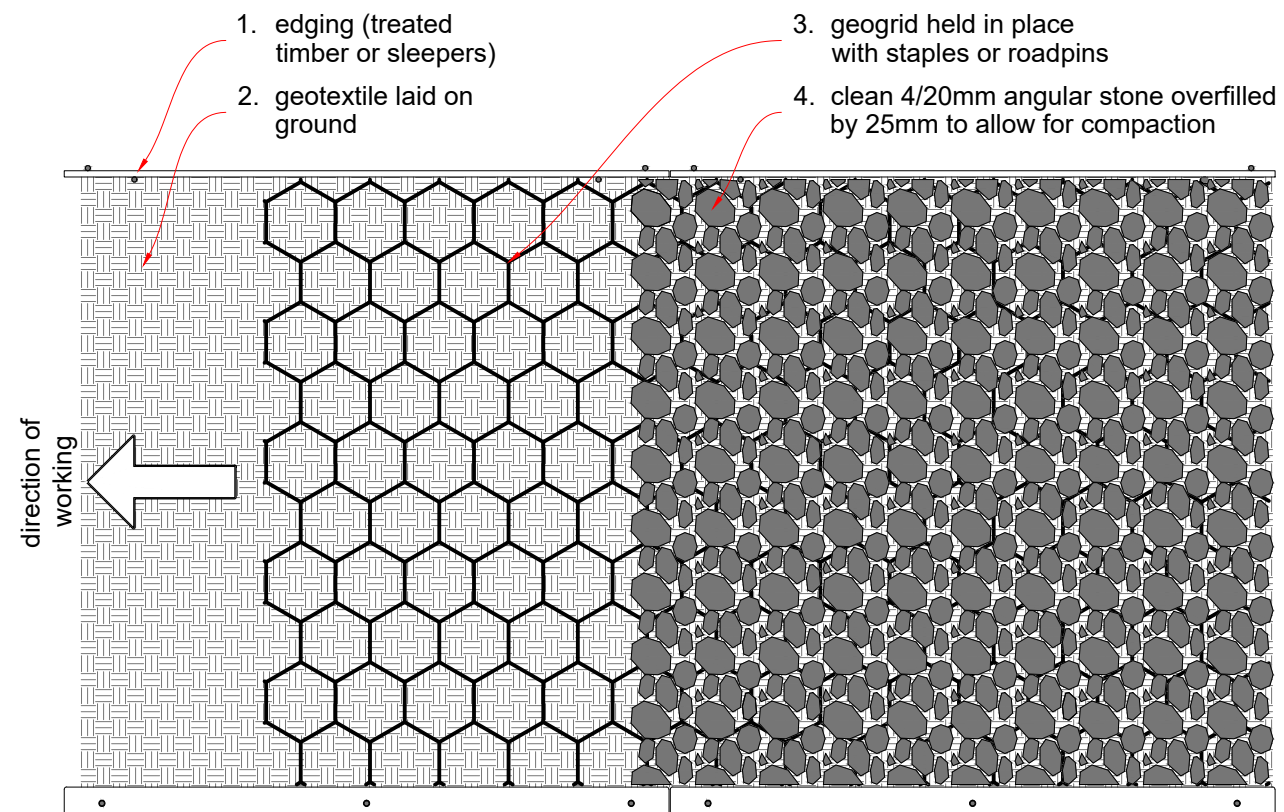
**Plan View of No-Dig Installation**

8. Remove GroundGuards (if fitted) to allow for installation of final wear course.
9. Some tamping down may be necessary to ensure a firm interlock between stones and minimise settlement.

11. Cover the geotextile in a layer of sand and firm down thoroughly.
12. Install the final wearing course, ensuring that any block paving is permeable.

Alternative wear courses including permeable tarmac or resin-bound gravel may be suitable for installation on the stone and geogrid base but will require further arboricultural input to ensure the specification, sub-base and installation method are acceptable.

A suggested specification detail is shown within Arboricultural Guidance Sheet AGS301 though this will need to be reviewed and amended as necessary by a suitably qualified engineer. During the review of this document by the project manager and/or site manager, the site levels will need to be reviewed, noting that no-dig surfacing can typically add 250-300mm to existing ground levels, and surrounding surfaces may therefore need to be amended to match.

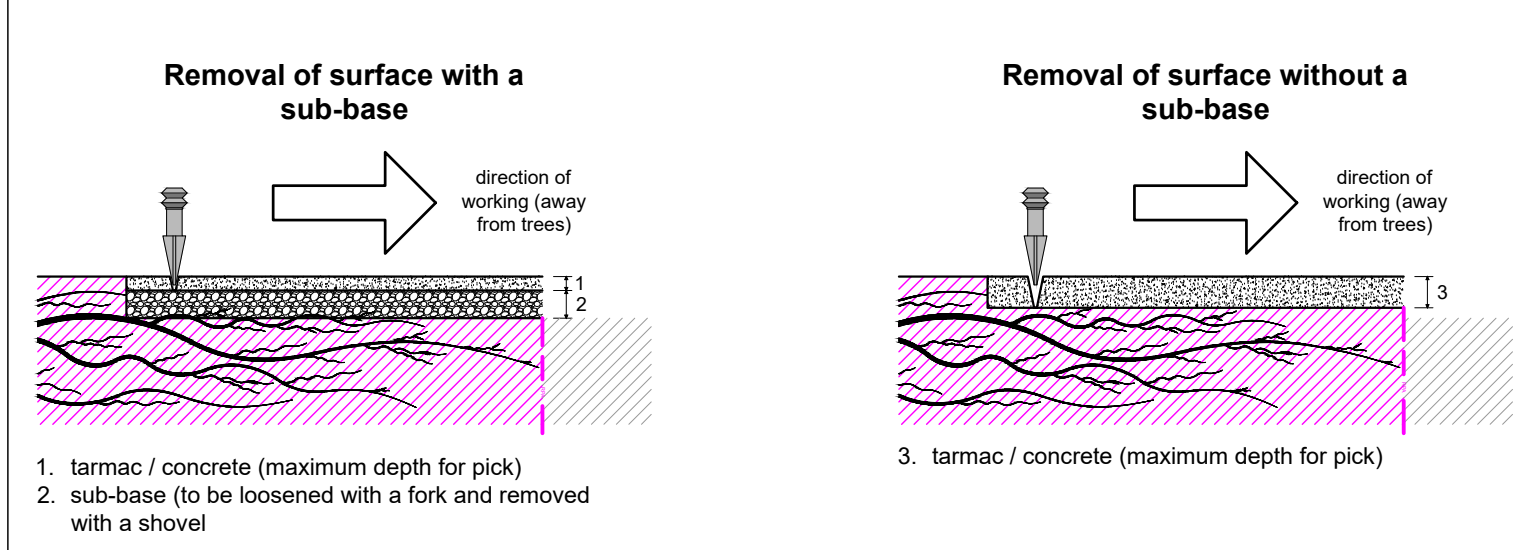
# Removal of Hard Surfaces Near Trees

1. tarmac / concrete (maximum depth for pick)
2. sub-base (to be loosened with a fork and removed with a shovel)

3. tarmac / concrete (maximum depth for pick)
