OUTBUIULDING AT TURVILLE HEATH HOUSE,
TURVILLE HEATH, HENLEY-ON-THAMES, OXON. RG9 6JY

ECOLOGY AND PROTECTED SPECIES APPRAISAL

1st October 2019

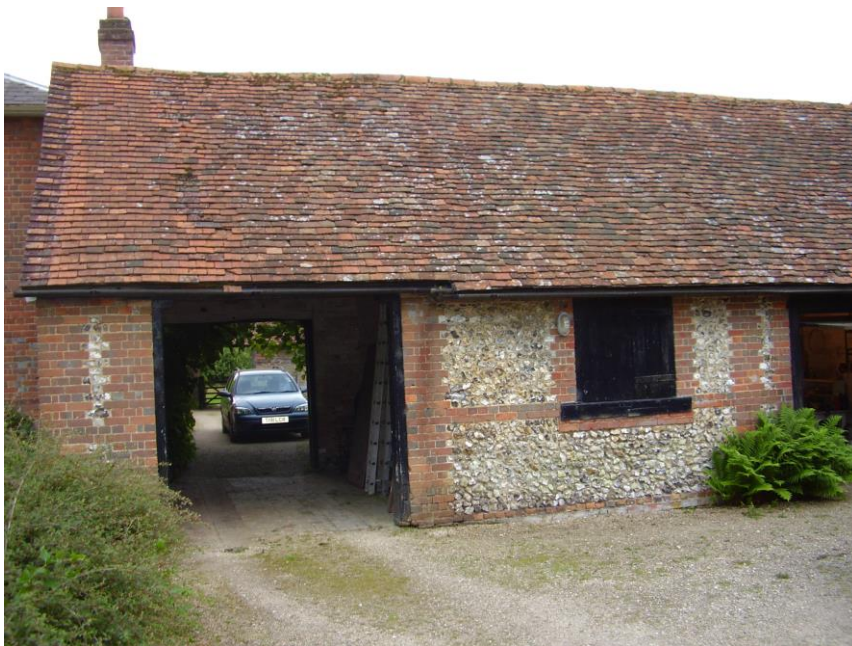
North-east corner

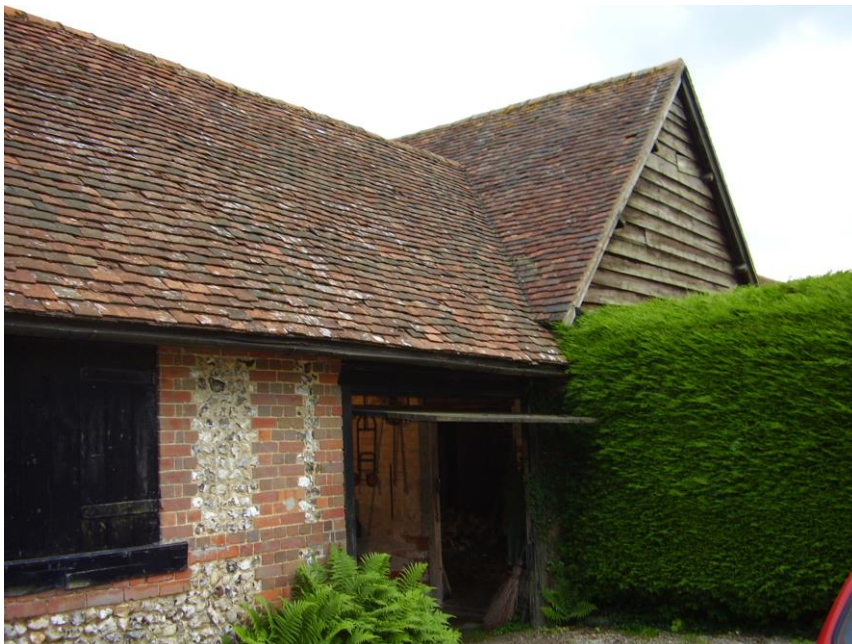
North-west corner

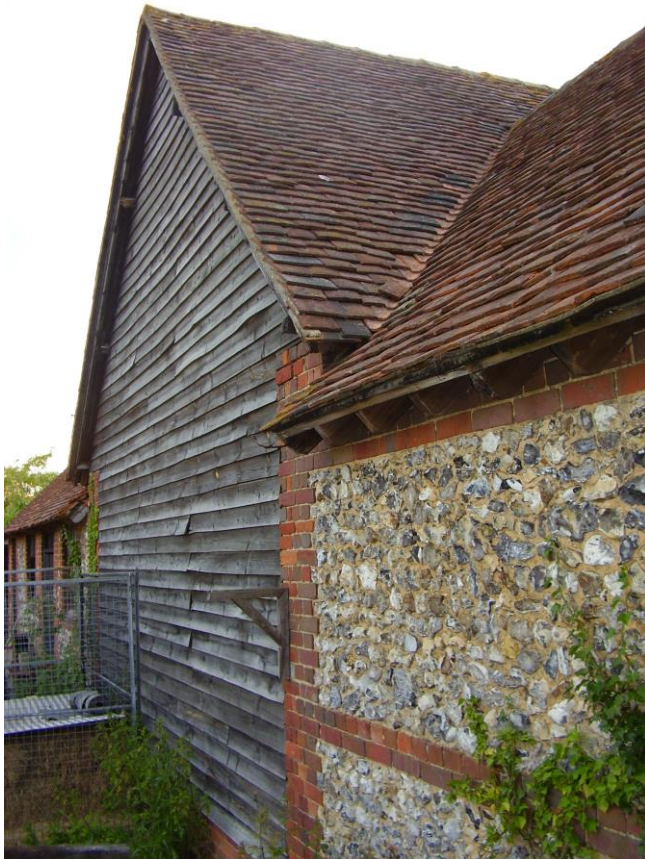
South-west side

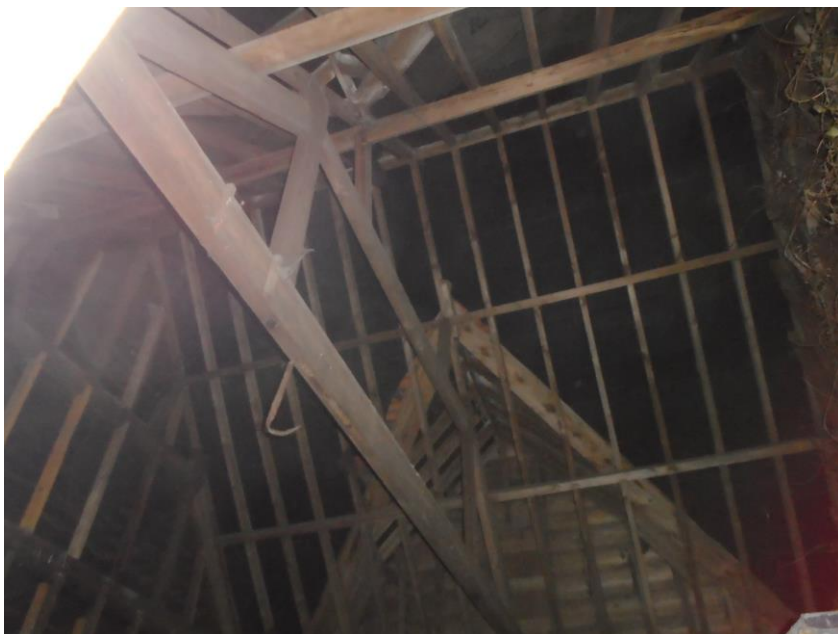
West end interior / roof

The roof structure is softwood beams in traditional rafter and purlin arrangement, with a 'bolt-trussed' Queen post at the west end (see photo above).

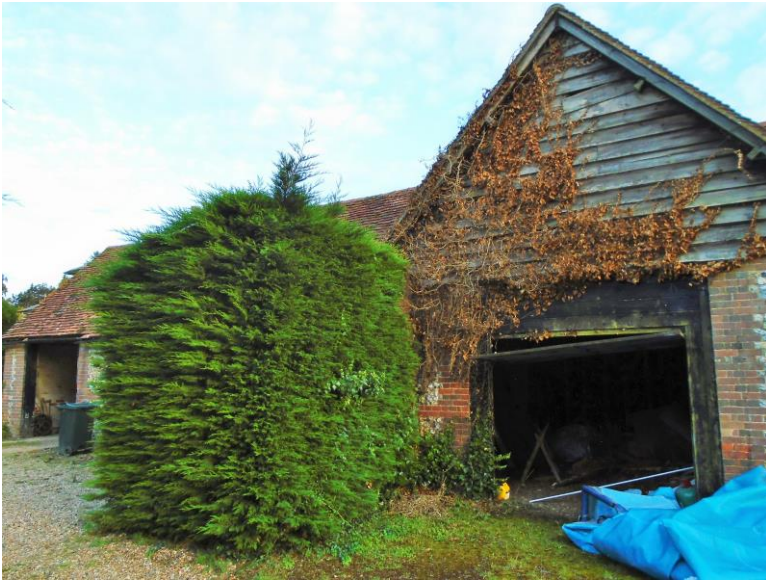
Leylandii hedge + gravel parking

Habitat – No significant habitat impacts will arise from the scheme. No mature trees or any species-rich or high value habitats are present on site, and so none are impacted. The proposed removal of a short stretch of leylandii hedge causes loss of a tiny area of mono-species non-native habitat of low ecology value.

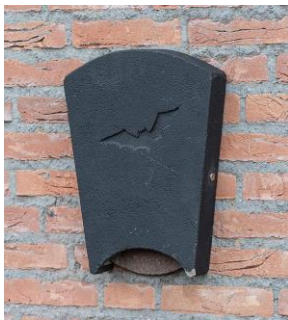
Beaumaris woodstone Maxi box

Roost Provision – The minor roosts for individual pipistrelle, serotine and brown long-eared bats, will be re-created through the erection of suitable crevice-type bat boxes around the external wall-tops at the eastern and northern ends of the building, as shown on the plan of Mitigation + Enhancement. This will involve two bat boxes using the high quality long-lasting ‘woodstone’ and plastic-coated wooden materials – Beaumaris Maxi (x1 box), and Eco Bat Crevice box (x1), which are suitable for these bat species (including serotine, since the Beaumaris Maxi box has a large roost gap). Further suitable crevice roost opportunities for these bats will be created around the renovated featherboard gable / dormer features, where the new wooden barge boards will overlie the featherboards (see plans at the back of this report for locations).
