## Green Hill Farm

## Bat Roost Assessment

<b>Client</b>	Mr Mohammed Hanif Jaffer
<b>Job name</b>	Green Hill Farm, Dymock, Gloucestershire GL18 2AD
<b>Report title</b>	Bat Roost Assessment
<b>Reference</b>	<u>428 Green Hill Farm-Qclass 29-10-21 Final.</u>

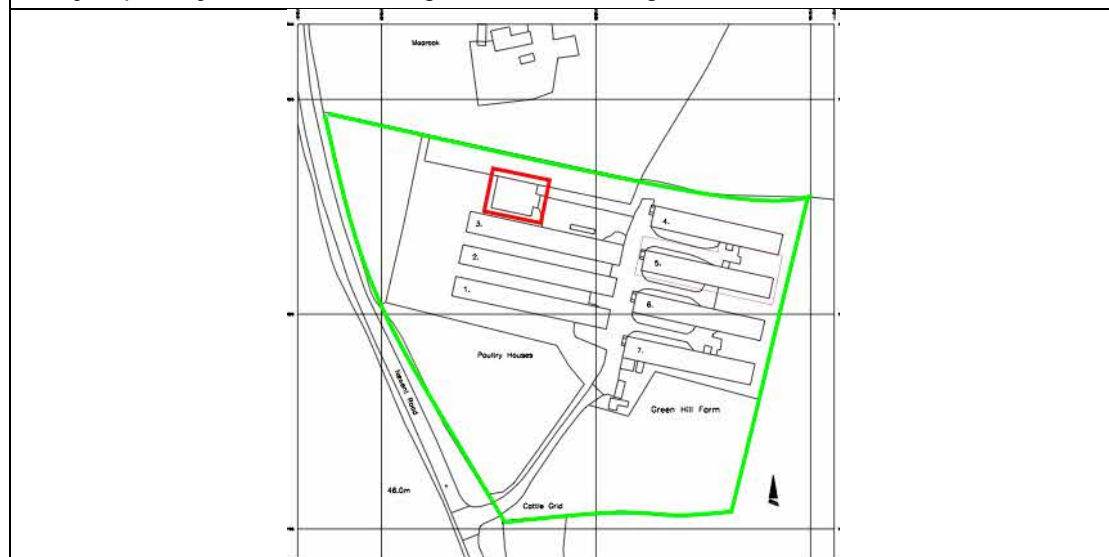
Figure 1. Green Hill Farm land holding defined by the green boundary and showing the array of poultry sheds and other agricultural buildings at the site.

Adapted from drawing 160164/ PL/ 001 produced by Extend Architecture.

The specific project area for this report is the livestock barn outlined in red on Figure 1 (hereafter referred to as 'the barn').

The design and construction of the barn has fundamental limitations for roosting bats because it has a simple metal and timber construction with very few gaps and crevices. The barn forms part of the poultry farm complex of agricultural buildings within the farmyard and is situated at the northern boundary of the site, just north of poultry Barn 3 (shown on Figure 1).

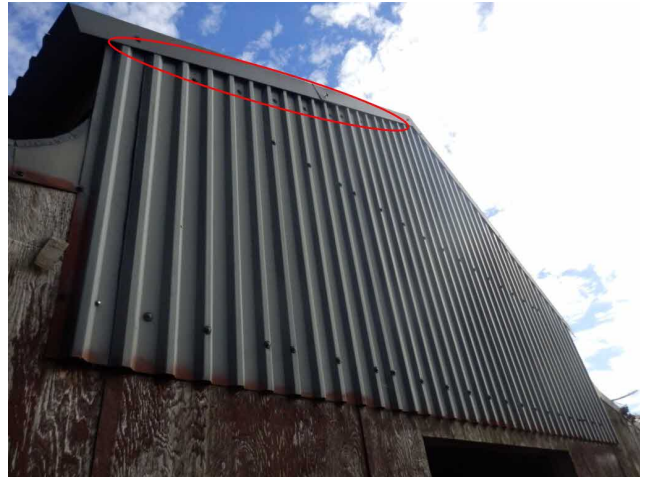
Most cavities present are created by multiple sheets of metal pressed together which is unsuitable for roosting bats, as shown on Photo 3.

Photo 3. Gap under roof overlap

The cavities are created by the indents in the corrugated metal against the flat metal roof overlap at the apex of the roof. Close inspection with a torch and ladder revealed that the suitability for bats to shelter is considered poor because environmental conditions are draughty, light and there is likely to be significant temperature variation because of the poor thermal qualities of the roofing material.

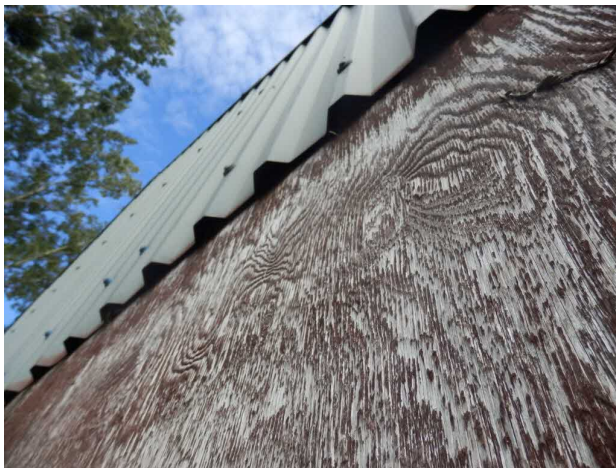
At the rear of the buildings (west gable) there is a gap created where the corrugated metal is pressed against plyboard walls. These cavities were able to be closely inspected and were found to be heavily cobwebbed with no signs of bats present. (Photo 4).

Photo 4. Gap between metal and plyboard

Cavities in this area are considered unsuitable for bats to shelter because of the poor environmental roost conditions and unsuitable materials.

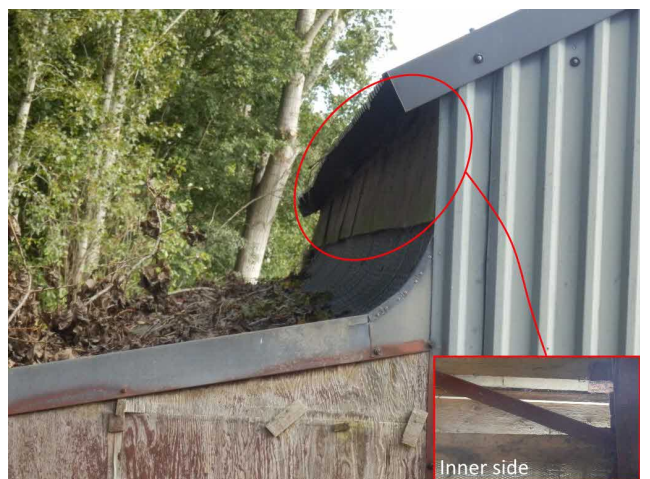
The eaves of the metal roof is overhanging on the northern and southern elevations, as shown on Photo 5.

Photo 5. Overhanging eaves

Close inspection revealed that there is no suitable gaps or crevices that may be utilized by bats, furthermore, the inner side of the wall is lit with natural light and a single skin of wooden boarding offers no shelter. This feature can therefore be discounted as a potential bat roost.

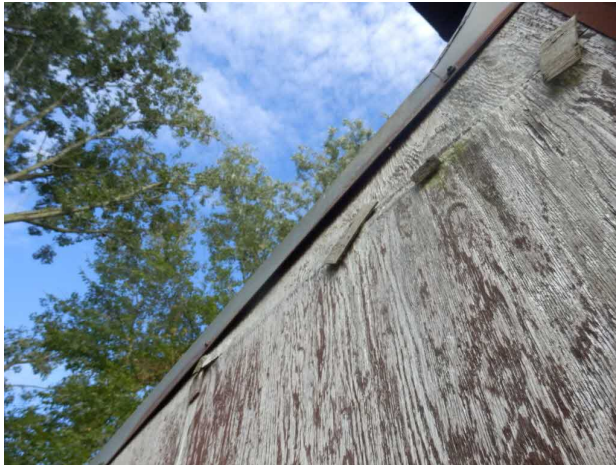
Photo 6. Weather boarding on north gable

A number of small crevice features at the top of the walls were discounted as having meaningful bat roost potential once they had been closely examined (on two visits).

The gap behind the metal weather board at the western gable is less than 1cm. The gap is probably too narrow for bats to use and furthermore, the crevice was covered with heavy cobwebs.

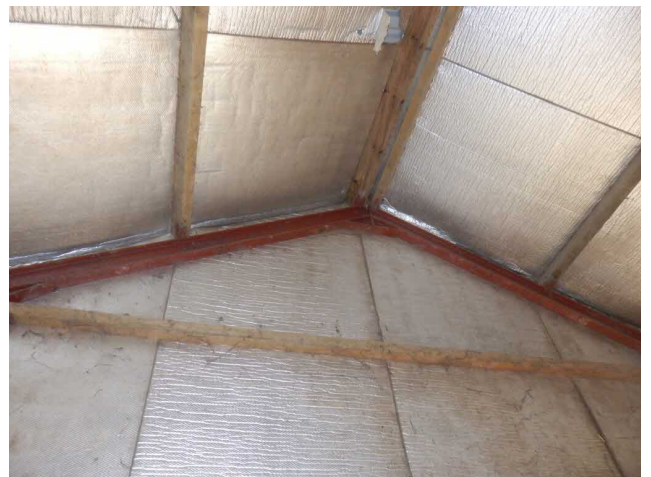
The roof beams are closely pressed against wall, leaving no space behind and the gaps between ridge beams is open and light and could be closely inspected for roosting bats. It does not provide any meaningful roosting opportunities.

Photo 7. Under side of roof and inner side of western elevation.

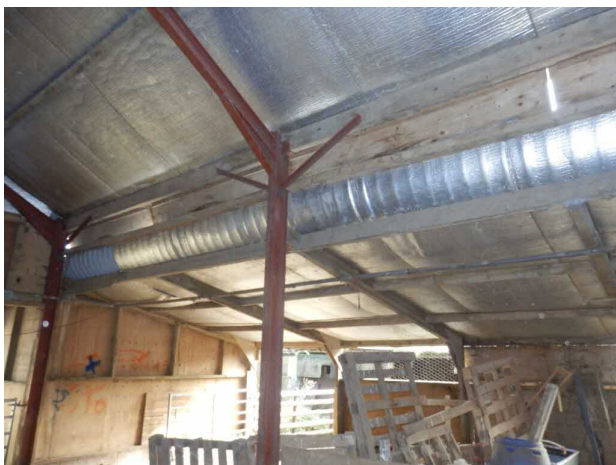
Photo 8. Inner side of north elevation.

The simple metal girder supports and thin single skin fabric of the building offer very few opportunities for roosting bats within the structure of the building. High levels of natural light within the building, open doors and construction materials that create unsuitable environmental roost conditions for bats to shelter combine to provide no meaningful roosting opportunities of significance to the conservation of local bat populations, particularly for day roosting bats.

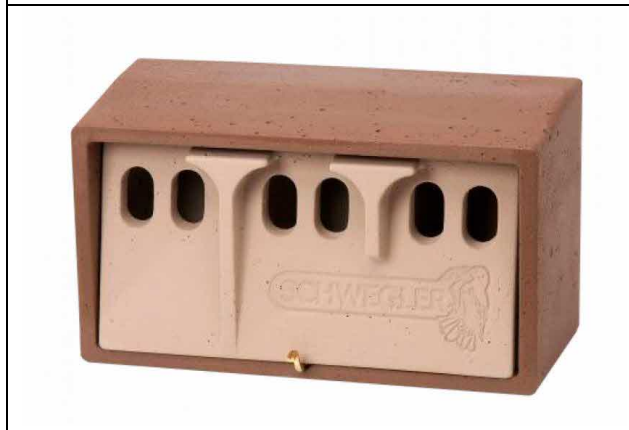
It is recommended that a bird box is provided for house sparrows *Passer domesticus*. These communal-nesting birds are under threat nationally, and the new development provides the opportunity to provide some bespoke nesting habitat for the species. A 'sparrow terrace' could be erected on the wall of building facing towards the open ground to the west or on a southern aspect would benefit from the warming sun. A suitable box, which can be either wall-mounted or integrated into the fabric of the building is the Schwegler 1SP sparrow terrace, as shown in Figure 2 below. The box should be installed at least 2m above the ground.

Figure 2: Example Sparrow Terrace:  
Schwegler 1SP
