RECTORY FARM BUILDINGS,  
MAIN STREET  
LOWER BENEFIELD

HISTORIC BUILDING SURVEY

Prepared for:  
Best Asset Ltd

By Neil Jefferson BSc (Hons) at  
Contour Archaeology  
Edited by Carol Duxbury

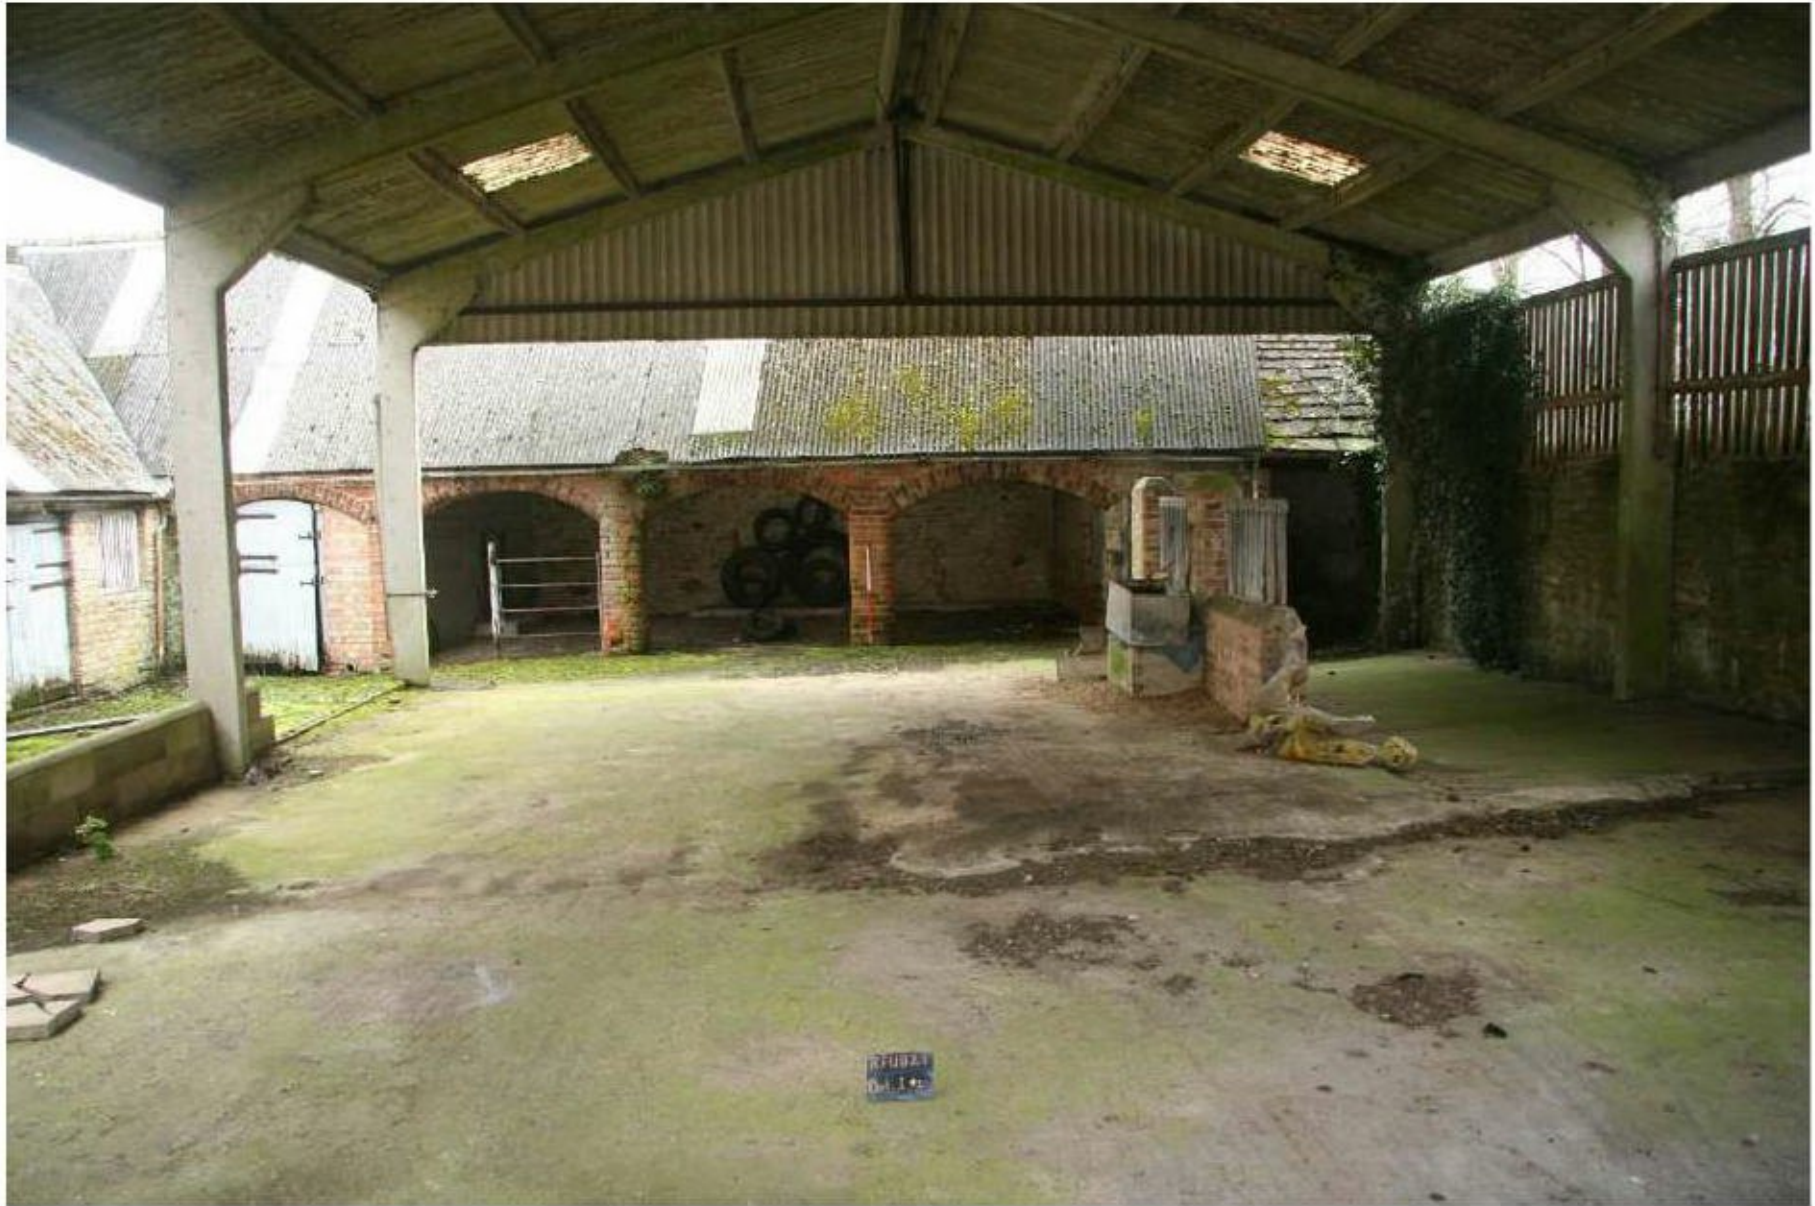
**Plate 1:** Building A elevation 1.

This structure is rectangular in plan, single storey in height. The western wall contains 4 red brick (9" x 3") with lime mortar arches, the northern arch infilled later with a red brick (8.75" x 3") and wood barn door. To the south of the arches there is a brick 8.75" x 3" in Flemish bond with lime mortar built wall and open entrance. The remaining three walls are constructed from limestone and lime mortar. The roof is gabled and under slate on the eastern side and a mixture of corrugated cement/asbestos sheeting on the western side. There is no window on the exterior of this structure.

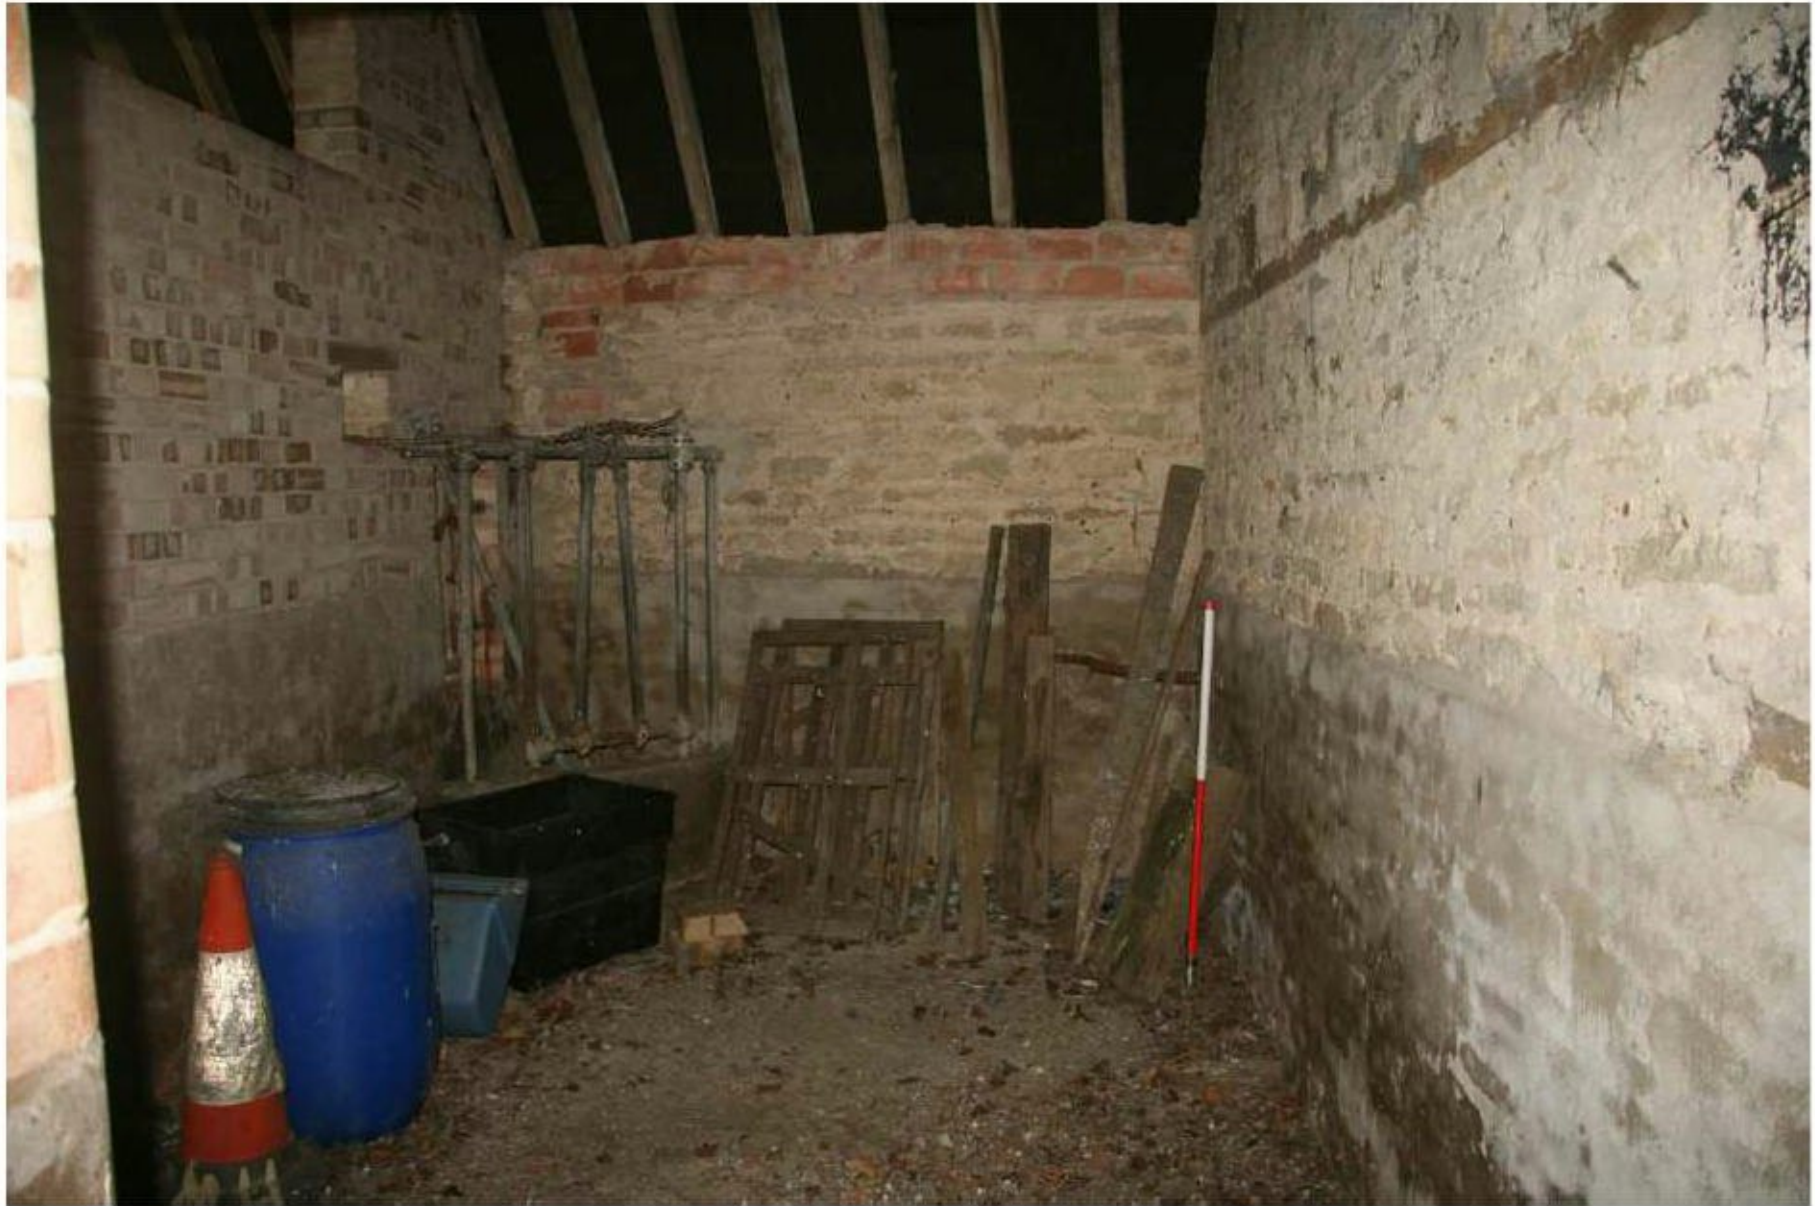
Plate 3: Building A, southern room, looking east

The Southern room is 12.00 sqm in area with a badly worn concrete floor and the lower 1m of the wall has a concrete slip over the brick and stone. The roof is constructed with rafters, collars and butt purlin supported on timber king post trusses. The northern wall of this room is built later and is constructed with red brick (8.75" x 3") with lime mortar constructed in Flemish bond. This wall also contains two openings with metal barred gates. In the northeast corner of the room is a concrete triangular trough.

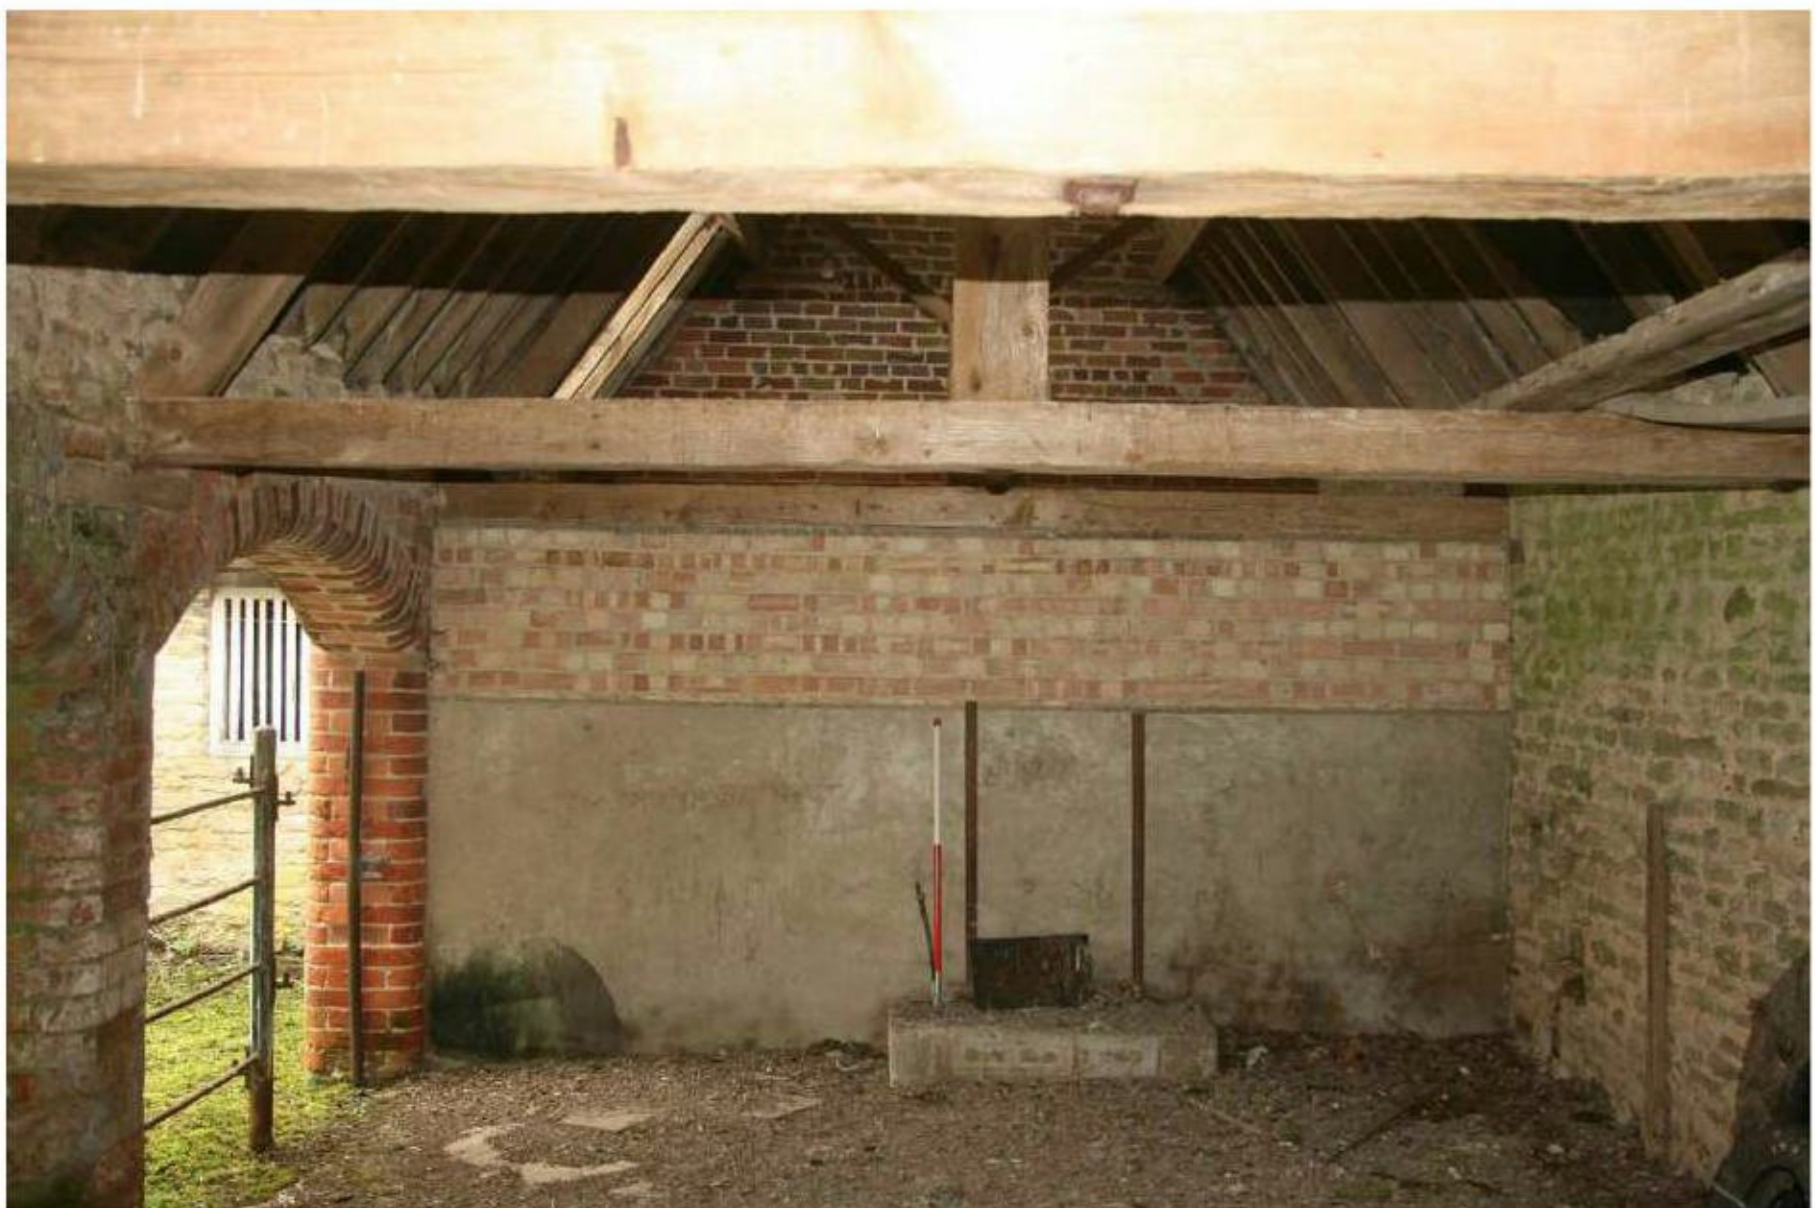
Plate 4: Building A middle room, looking north

The Middle room is 35 sqm in size with a badly worn concrete floor. The roof is the same as above. The northern and southern walls are both later additions constructed in red brick (8.75" x 3") with lime mortar in Flemish bond. The lower 1.5m of the northern brick wall is covered in a concrete slip and has a small concrete platform.

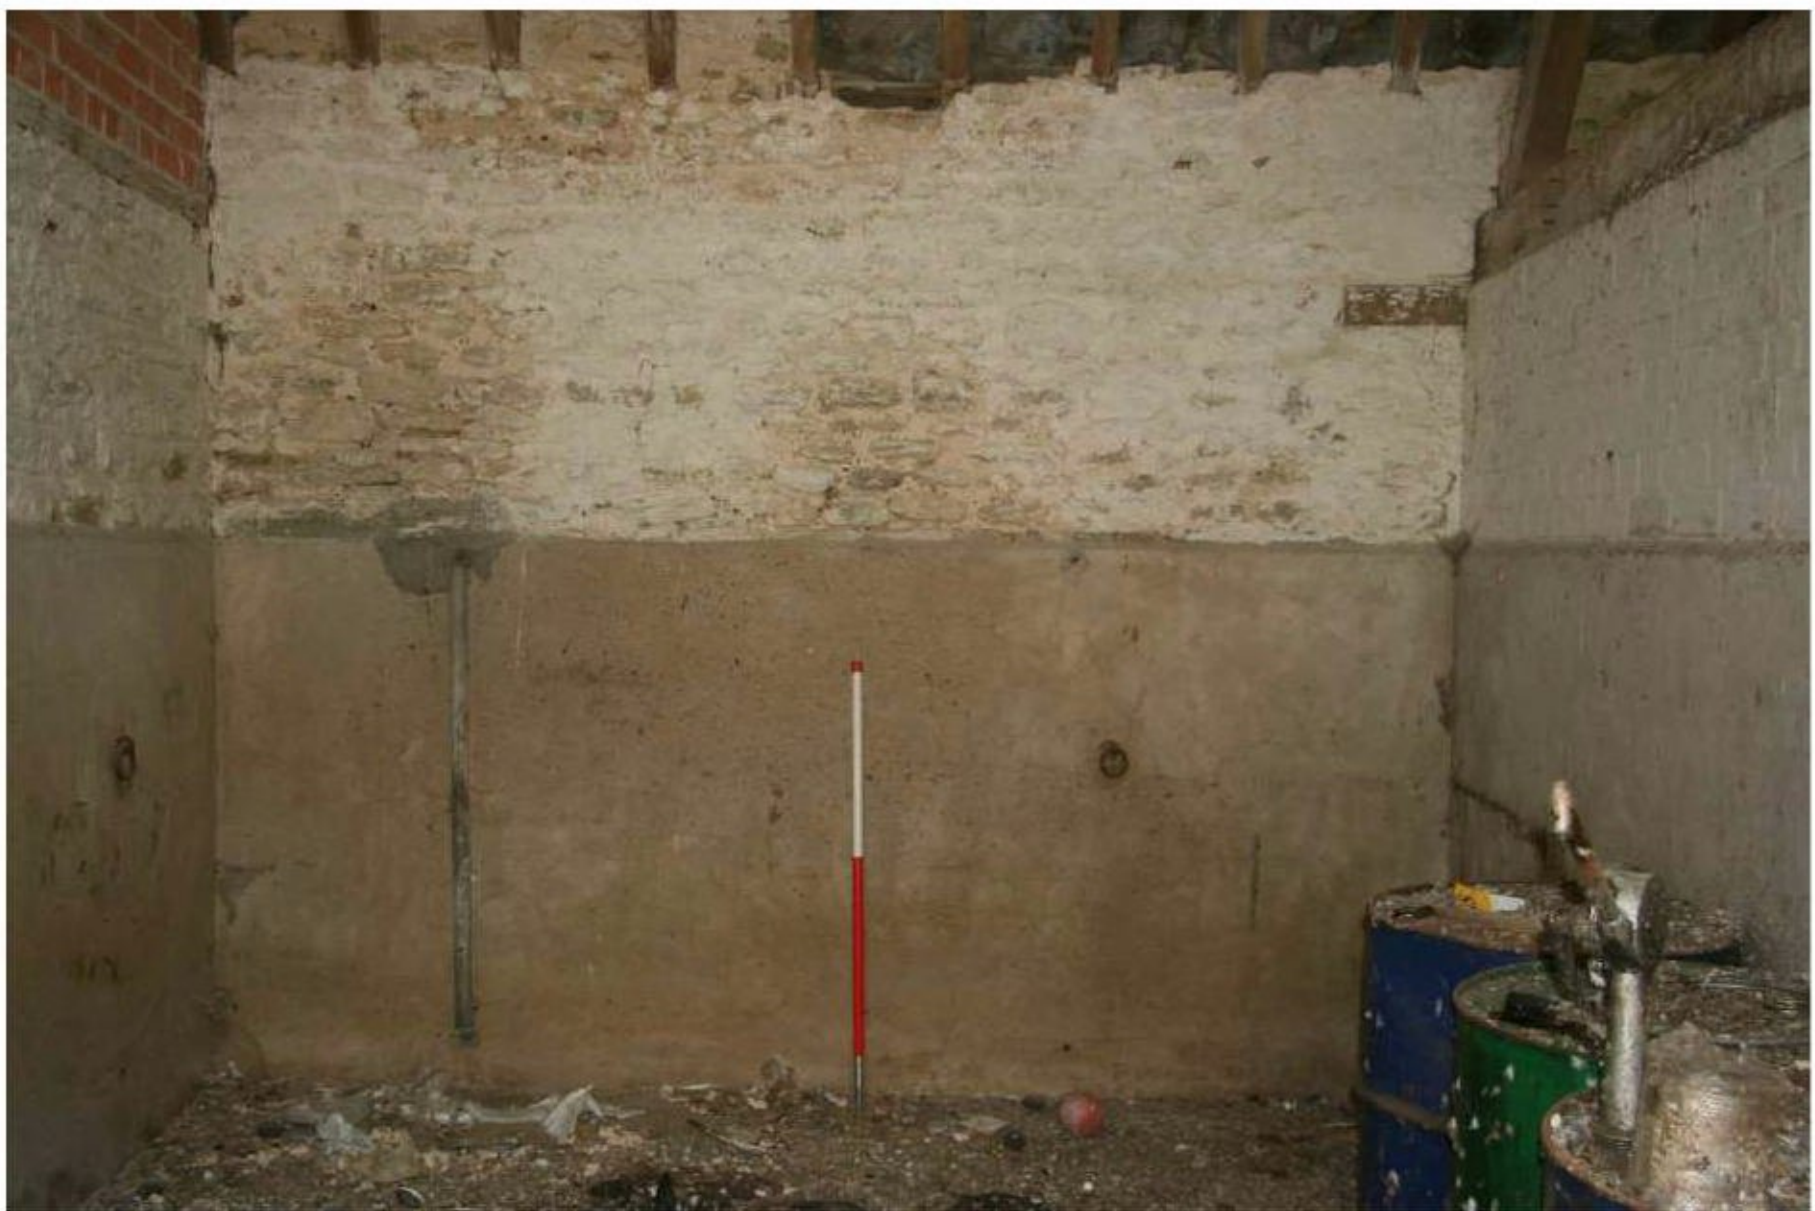
Plate 6: Building A, northern room, looking east

The northern room is 13 sqm in size with a badly worn concrete floor. The roof is the same as above. All the walls are covered in a layer of concrete up to 1.5m from the ground, with metal rings inset into it. The upper part of the northern wall was a red brick (8.75" x 3") with lime mortar constructed in Flemish bond.

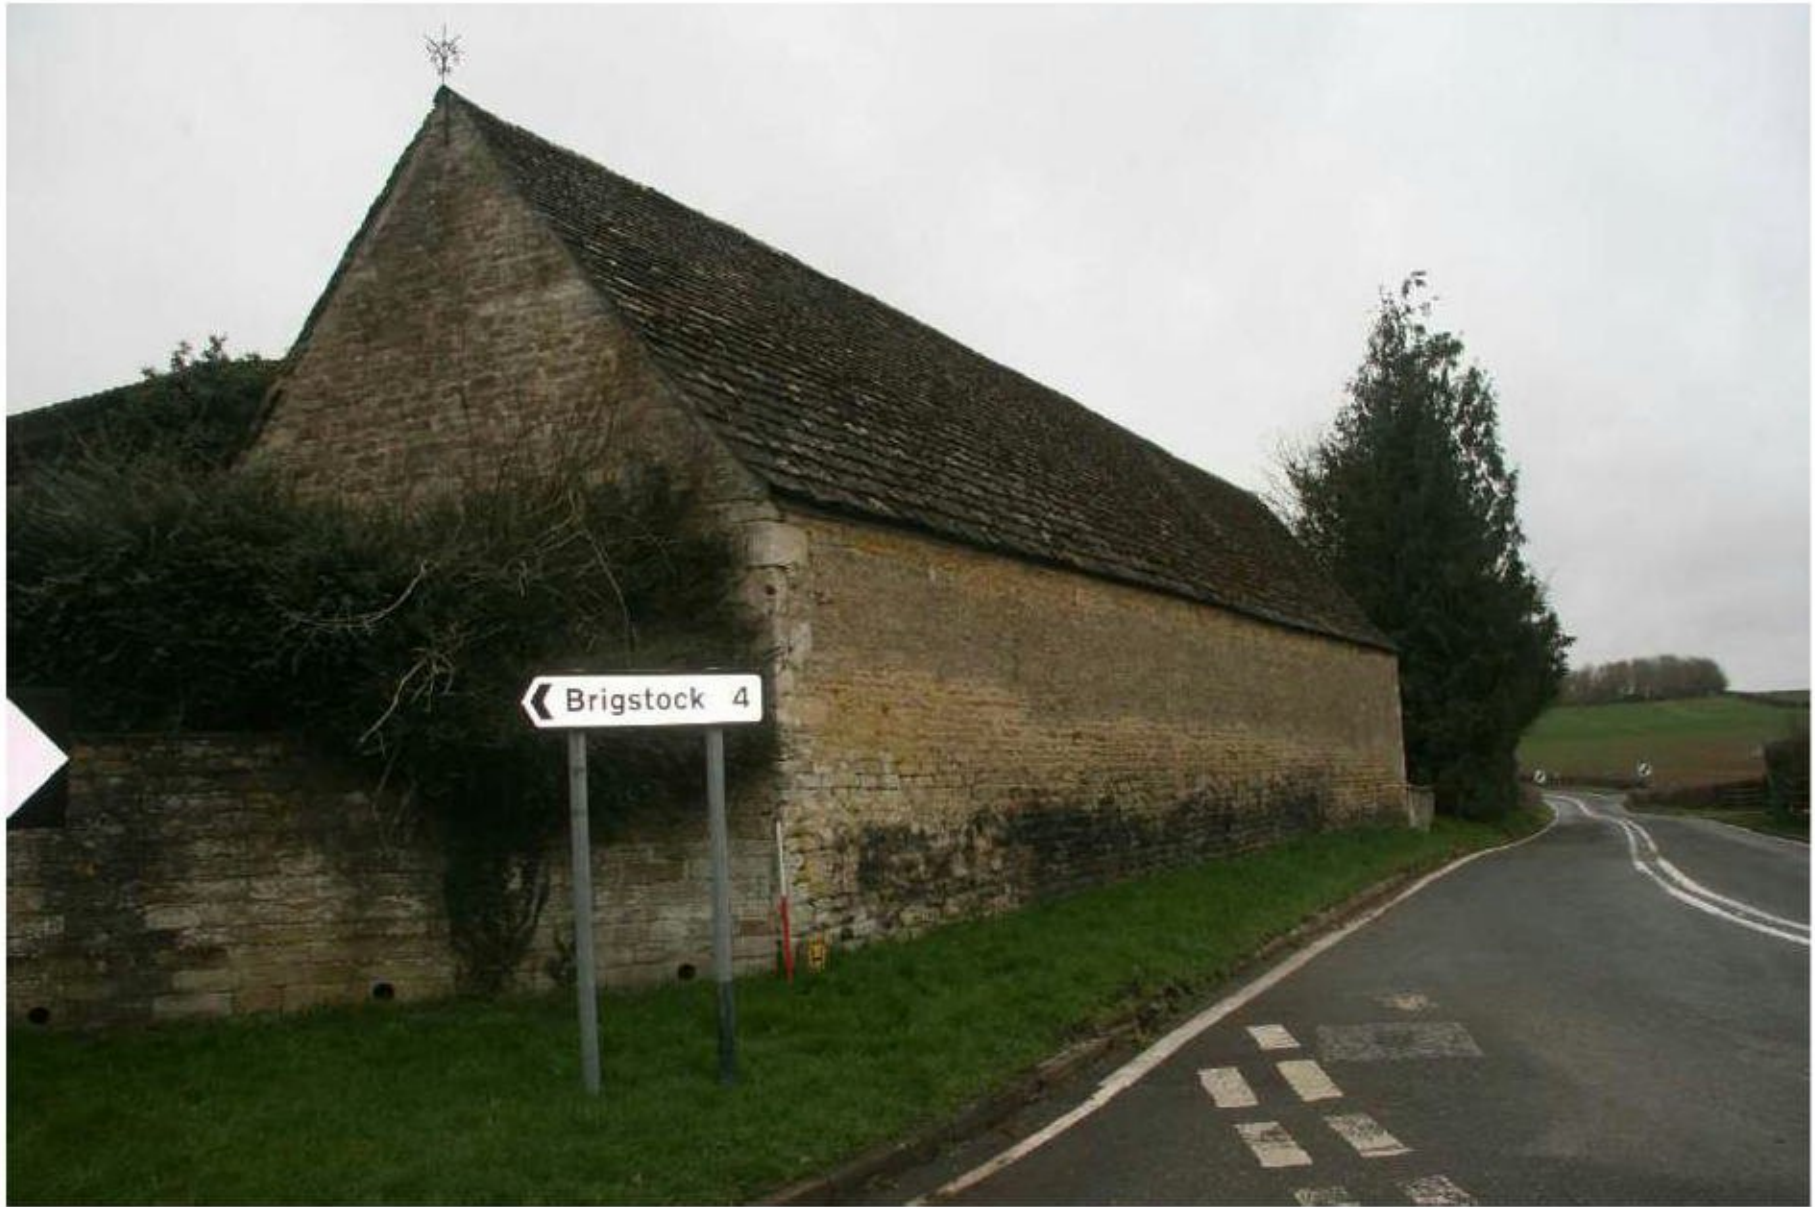
**Plate 7:** Building A and B elevation 2, looking southwest

This structure is rectangular in plan, single storey in height. Its two external walls are constructed from limestone and lime mortar. The northern wall contains a large 2.5m wide x 2.05 high double wooden door. The altered stonework on this wall indicates that this would have been an extra 0.7m wider before the current door. The roof is gabled and under slate and there is no window on the exterior of this structure.

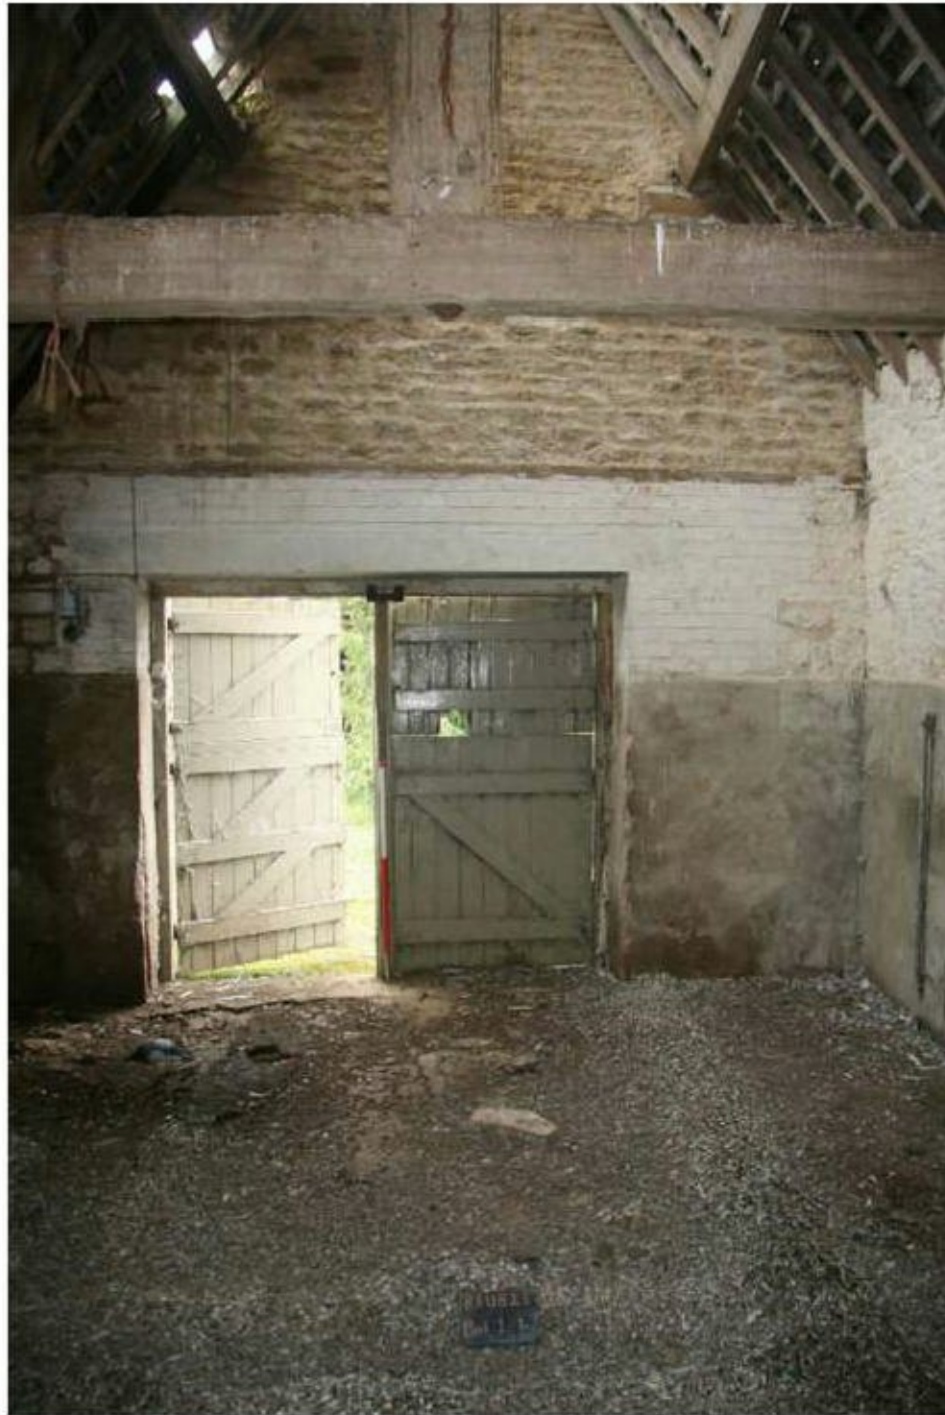
**Plate 9:** Building B, looking north.

Room is 25.00 sqm in area with a badly worn concrete floor and concrete slip (lower 1.5m) over the brick and stone. The roof is constructed with rafters, collars and butt purlin supported on timber king post trusses.

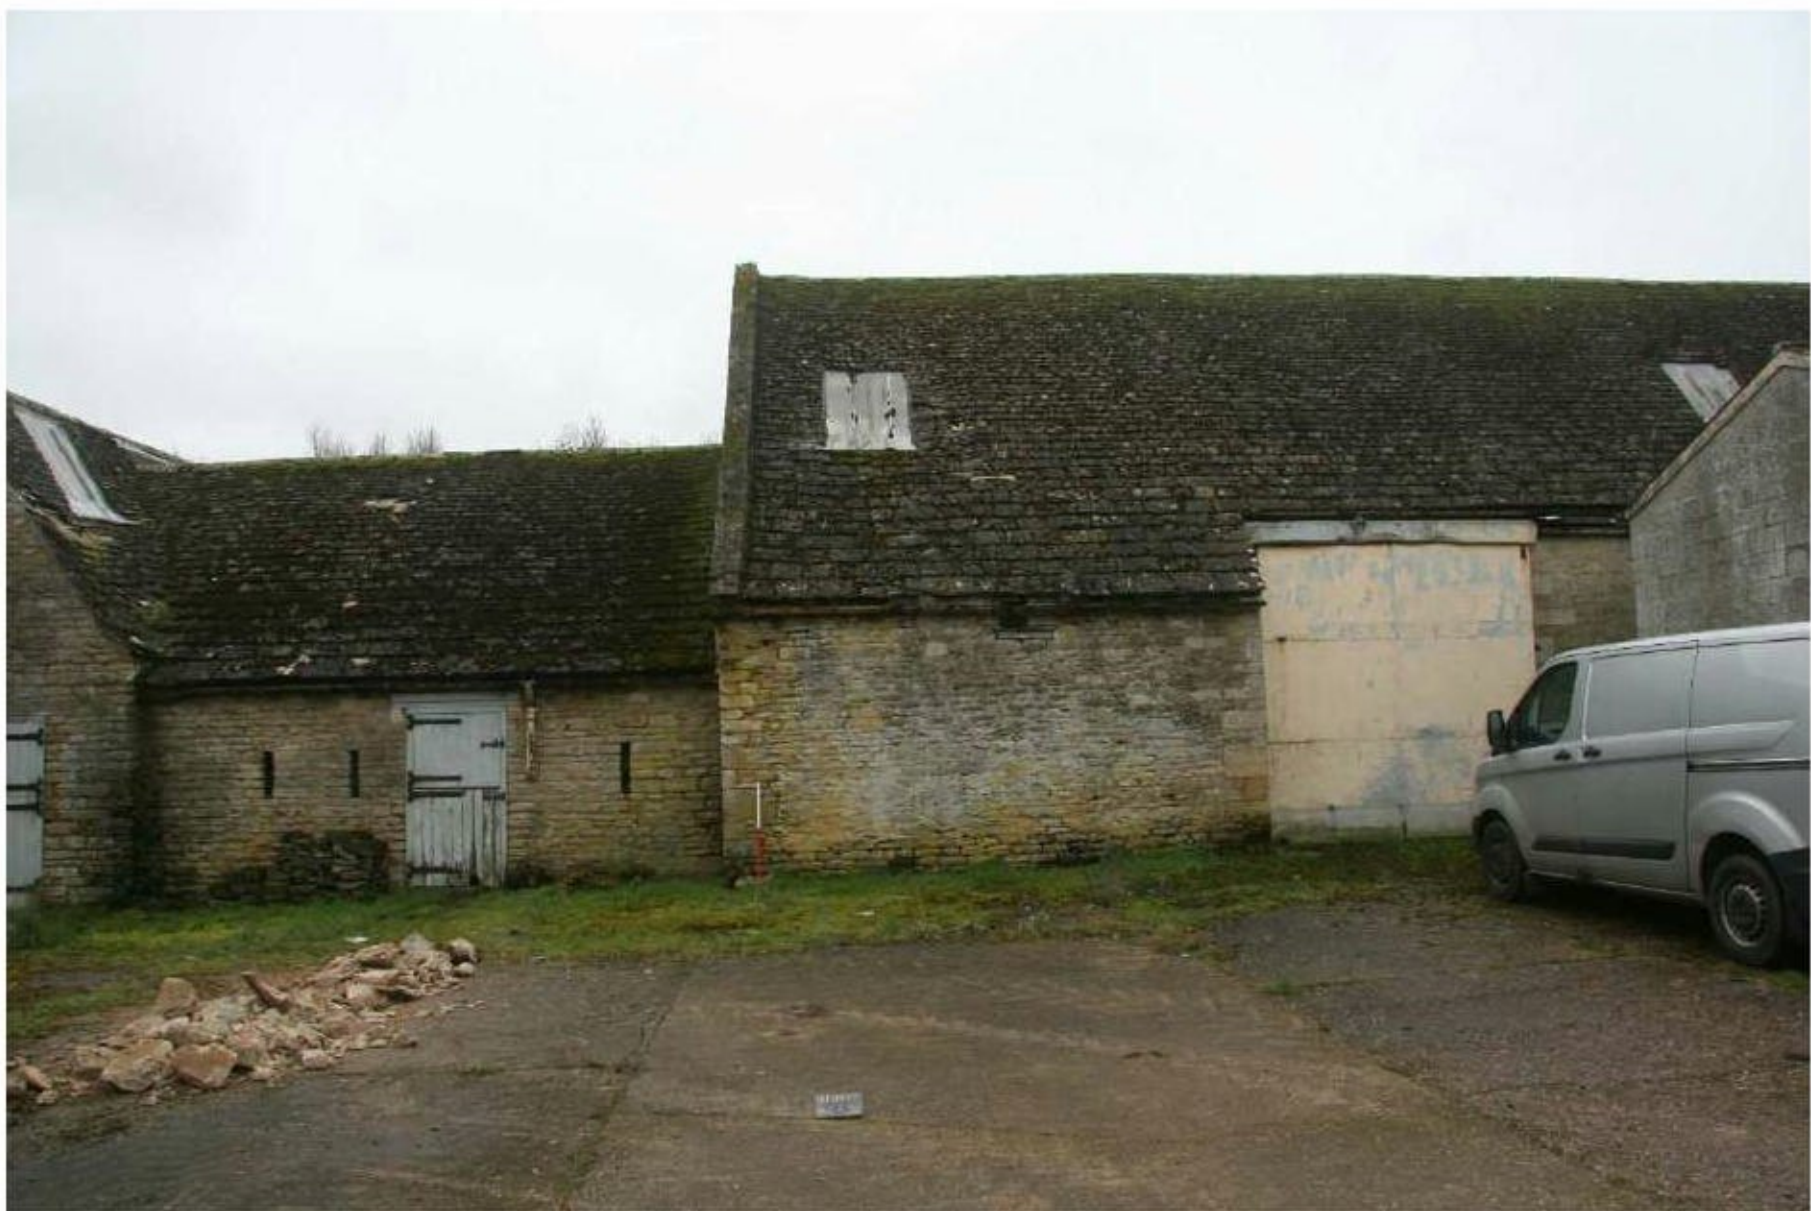
**Plate 10:** Building C and D elevation 4, looking south.

This structure is rectangular in plan, single storey in height. The walls are constructed from limestone and lime mortar. The roof is gabled and under slate on the northern side and a mixture of corrugated cement/asbestos sheeting on the southern side. Along the northern wall there is a wooden stable door with two ventilation slits either side. The centre of the southern wall also contained a stable door but had wooden slatted windows on either side.

This structure is rectangular in plan, single storey c.7.8m height. The walls are constructed from limestone and lime mortar with red brick and cement repairs. The roof is gabled and under Collyweston slate. Six windows have been created in the roof from plastic sheeting. The northern wall contains a large 3.4m wide x 3.5m high sliding wooden door and two ventilation slits. The southern wall has a much smaller sliding wooden door measuring 2.5m wide x 2.5m high. This originally was an arched doorway which was later replaced by a wooden beam with stone in-filling the gap. The western wall contained a small hatch/shoot next to a blocked off doorway, which was infilled with stone and lime mortar.
