RECTORY FARM BUILDINGS,  
MAIN STREET  
LOWER BENEFIELD

HISTORIC BUILDING SURVEY

Prepared for:  
Best Asset Ltd

By Neil Jefferson BSc (Hons) at  
Contour Archaeology  
Edited by Carol Duxbury

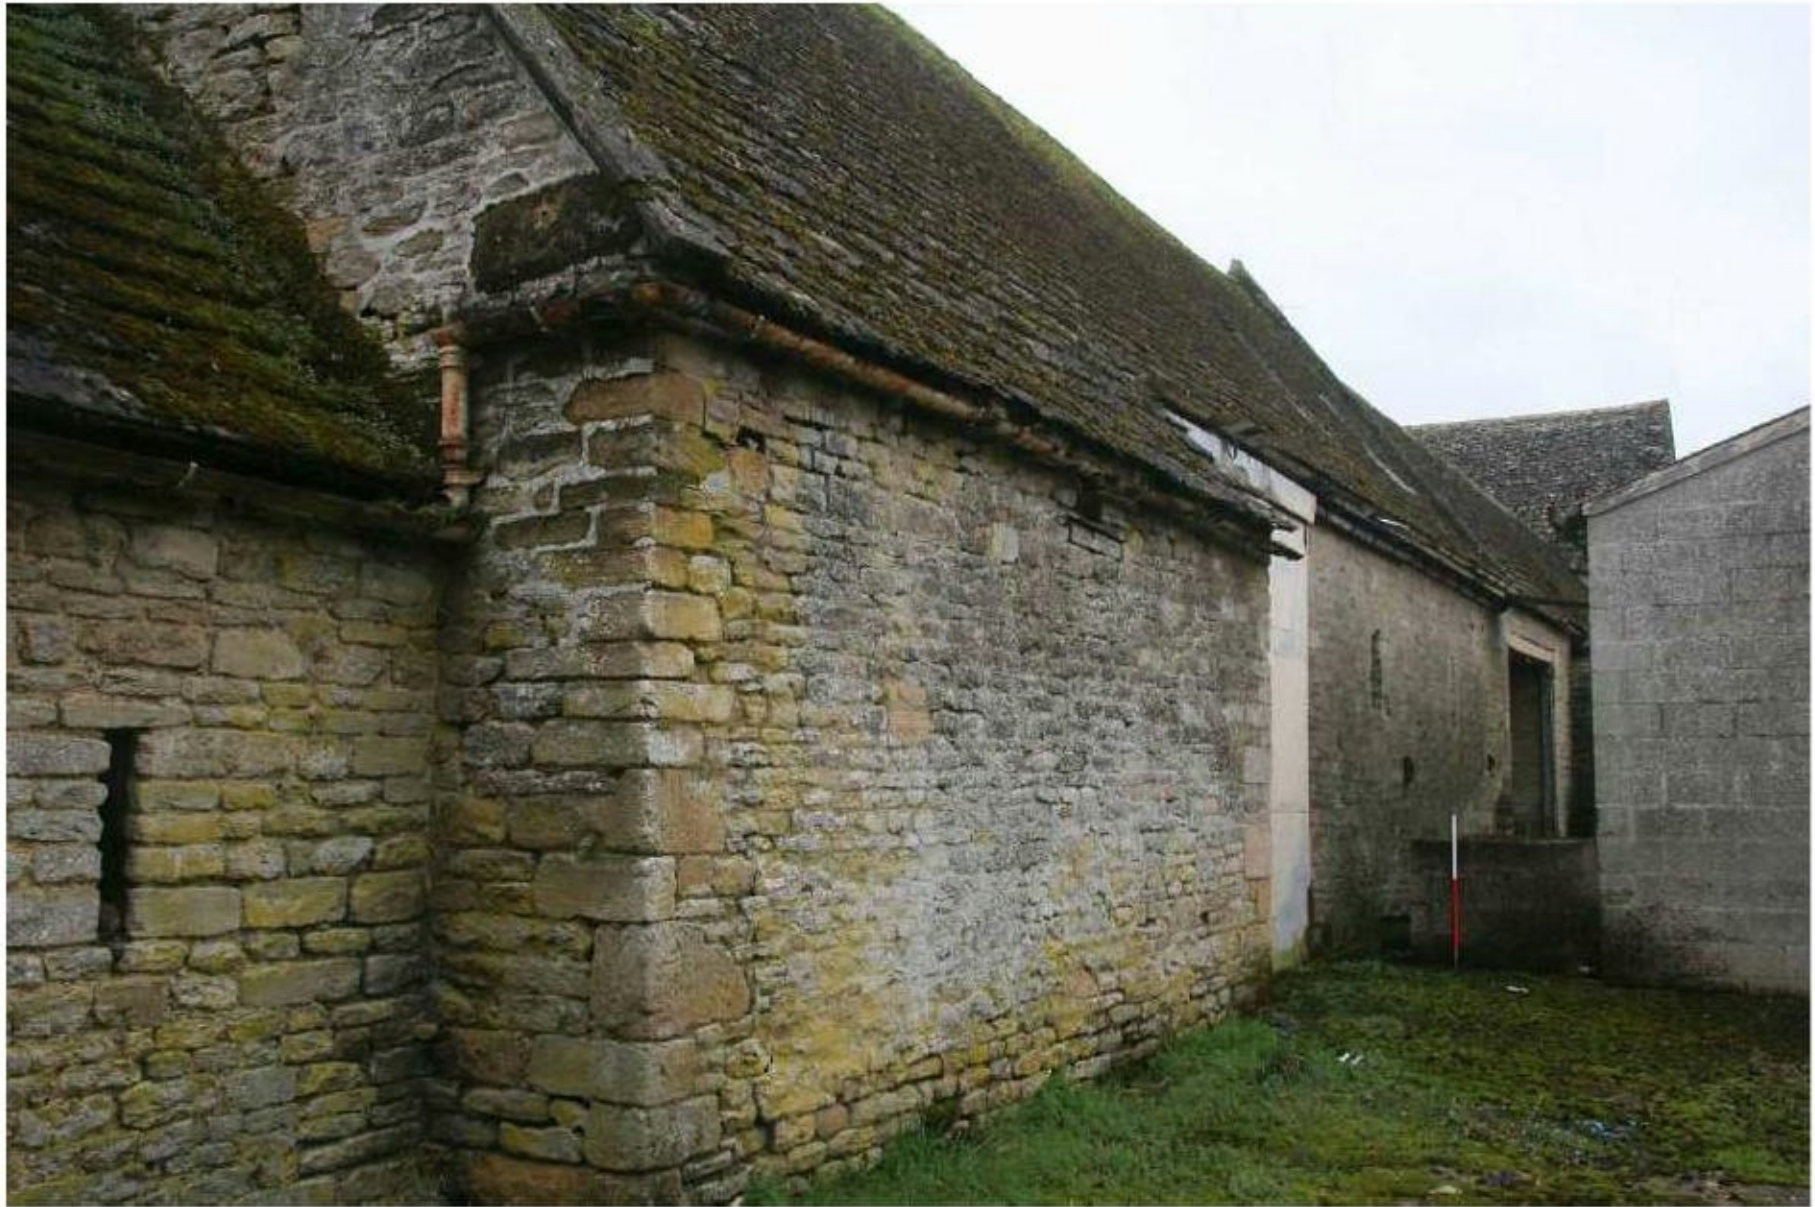
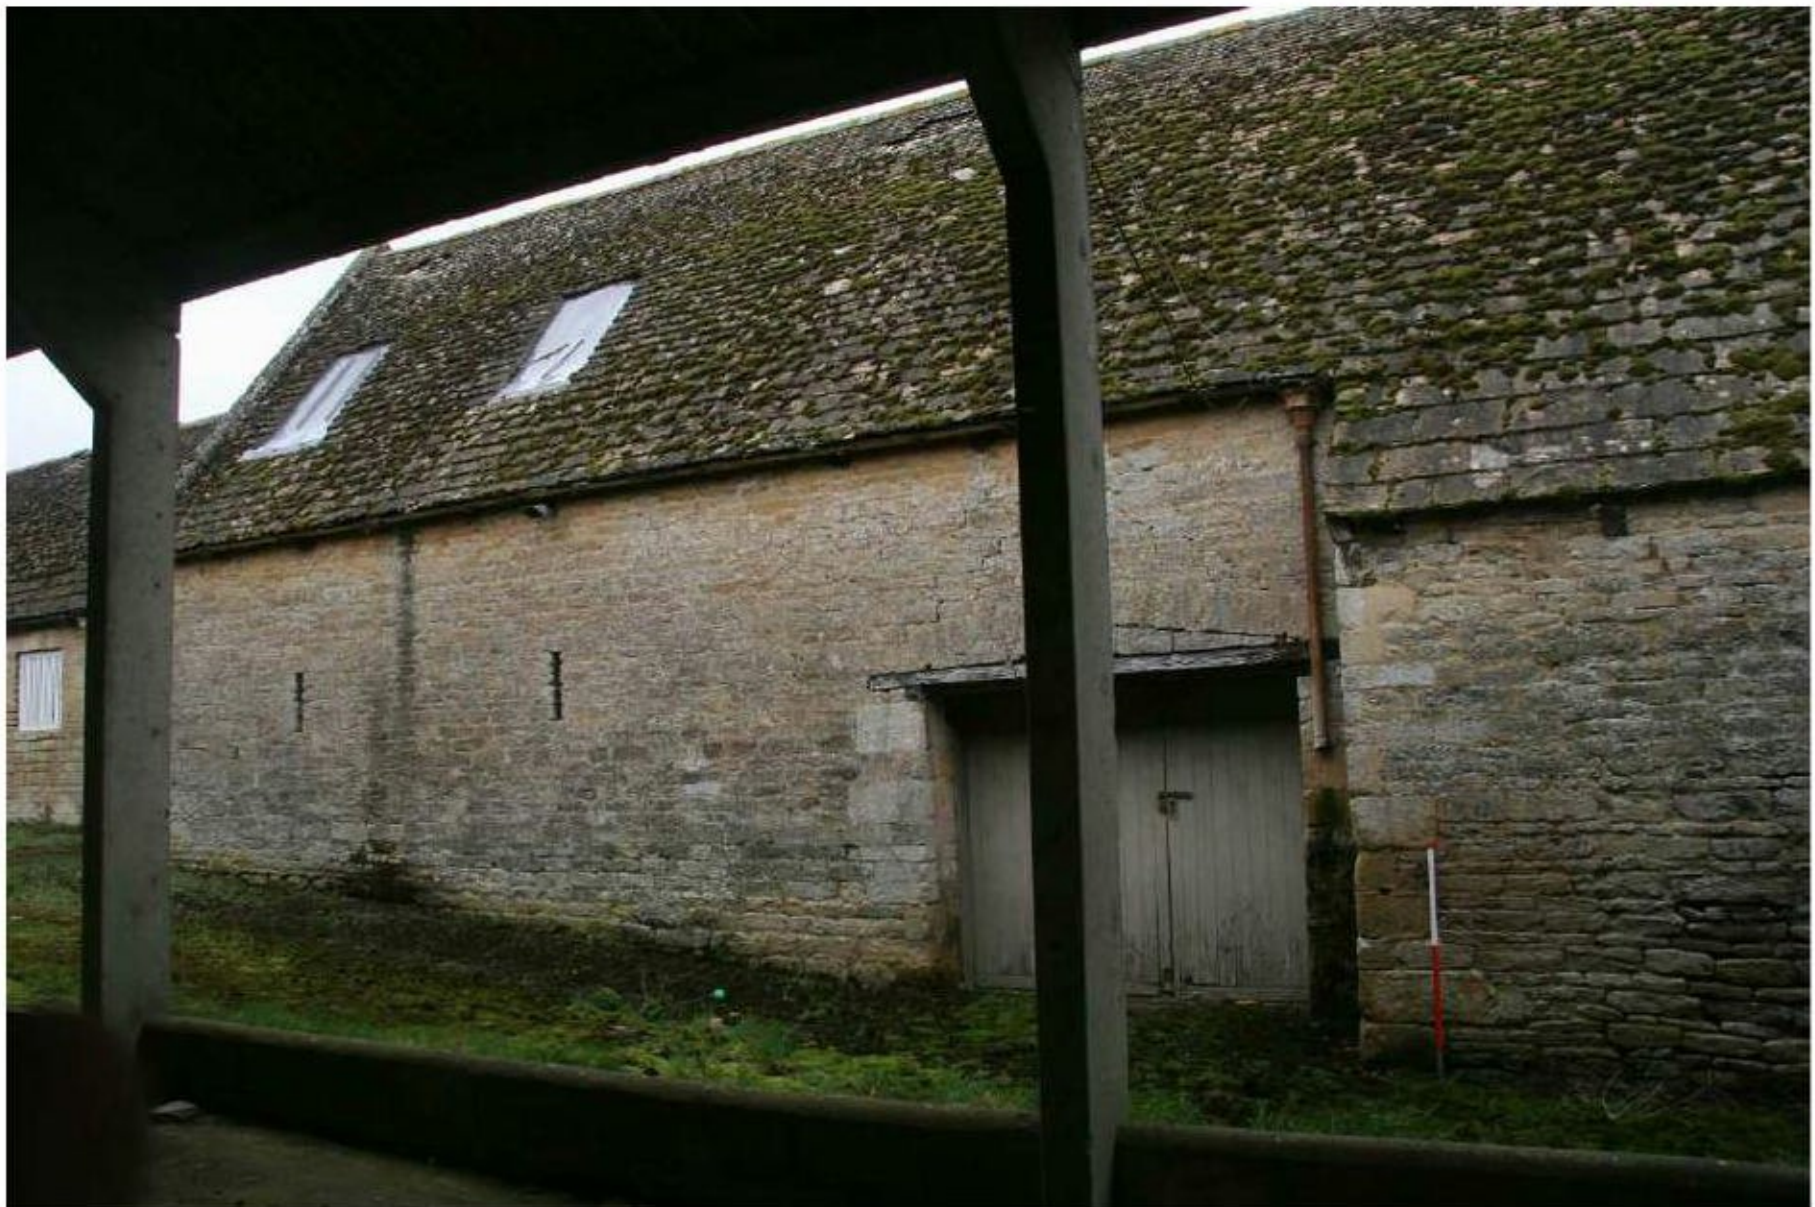
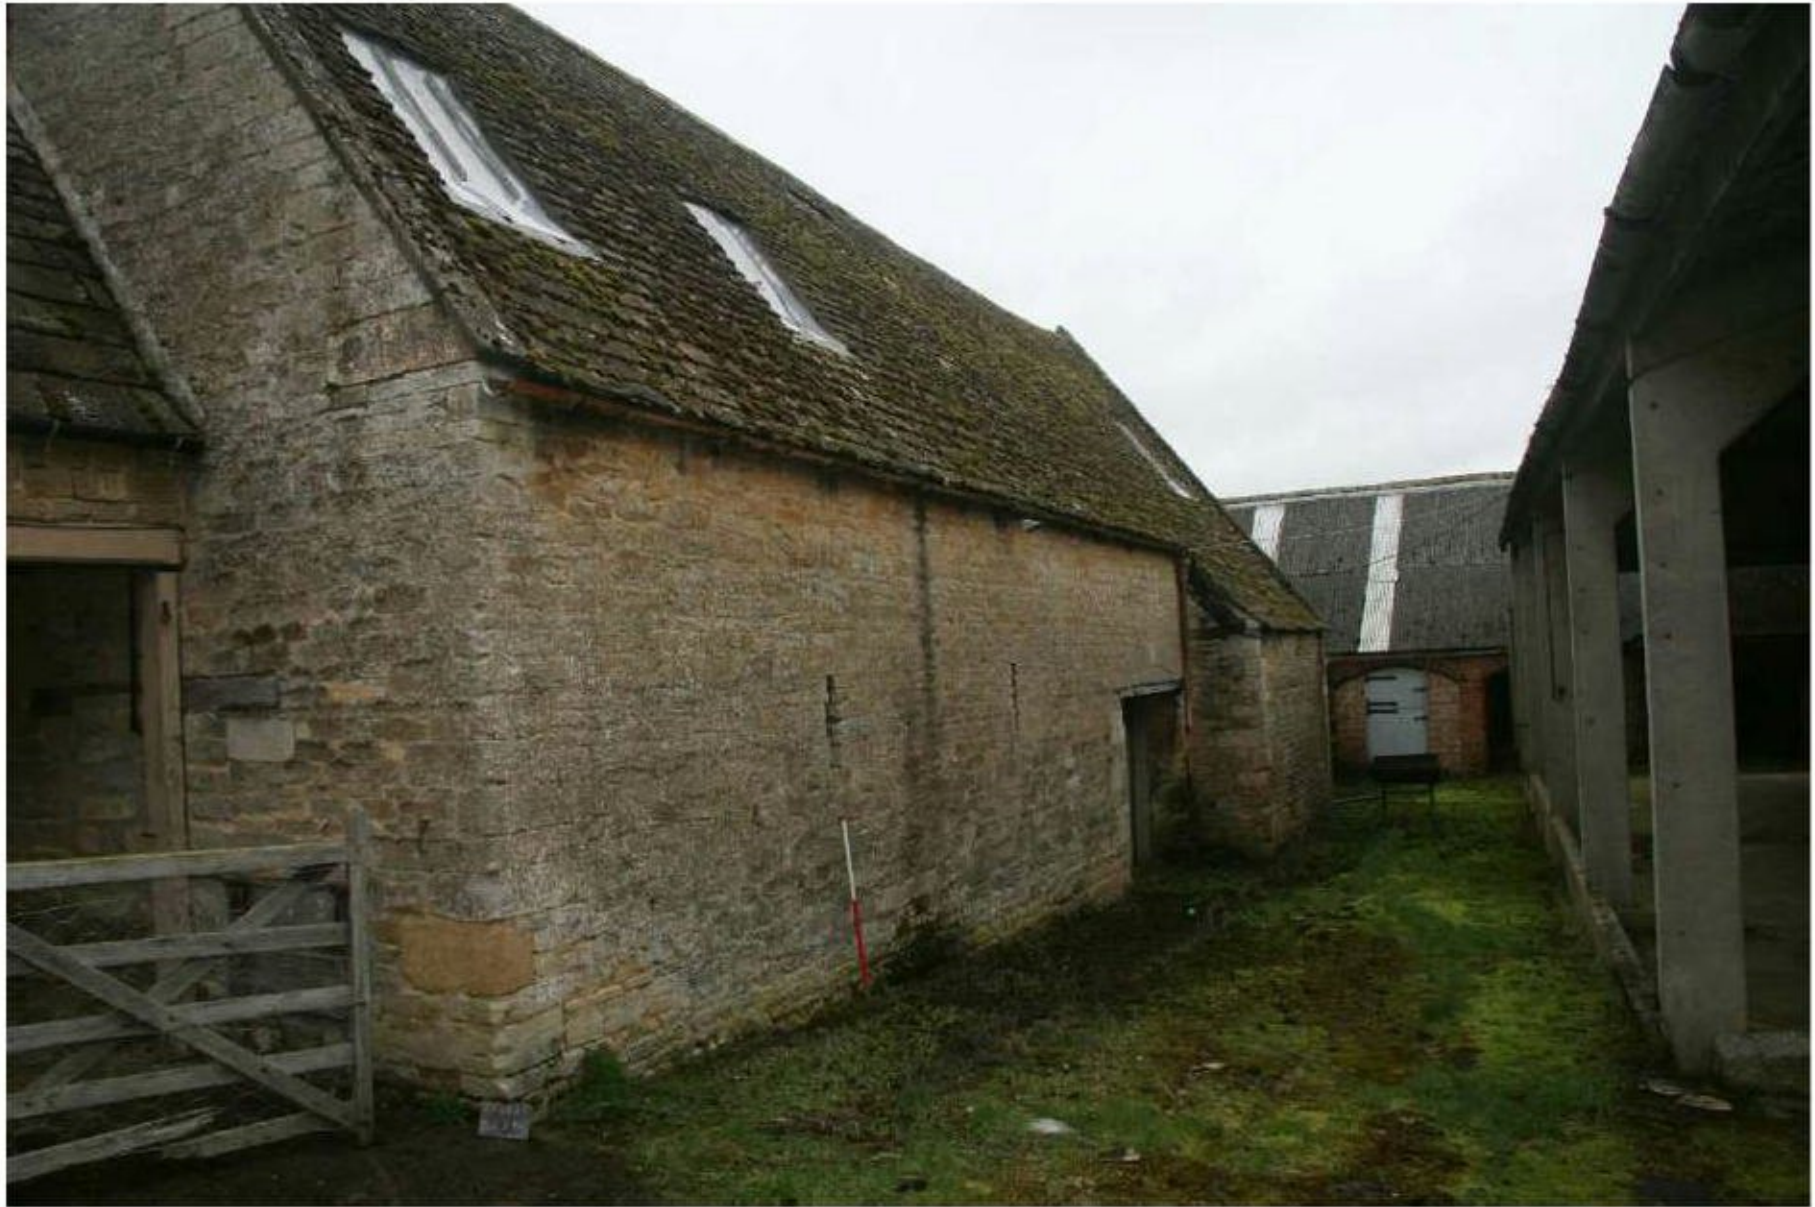
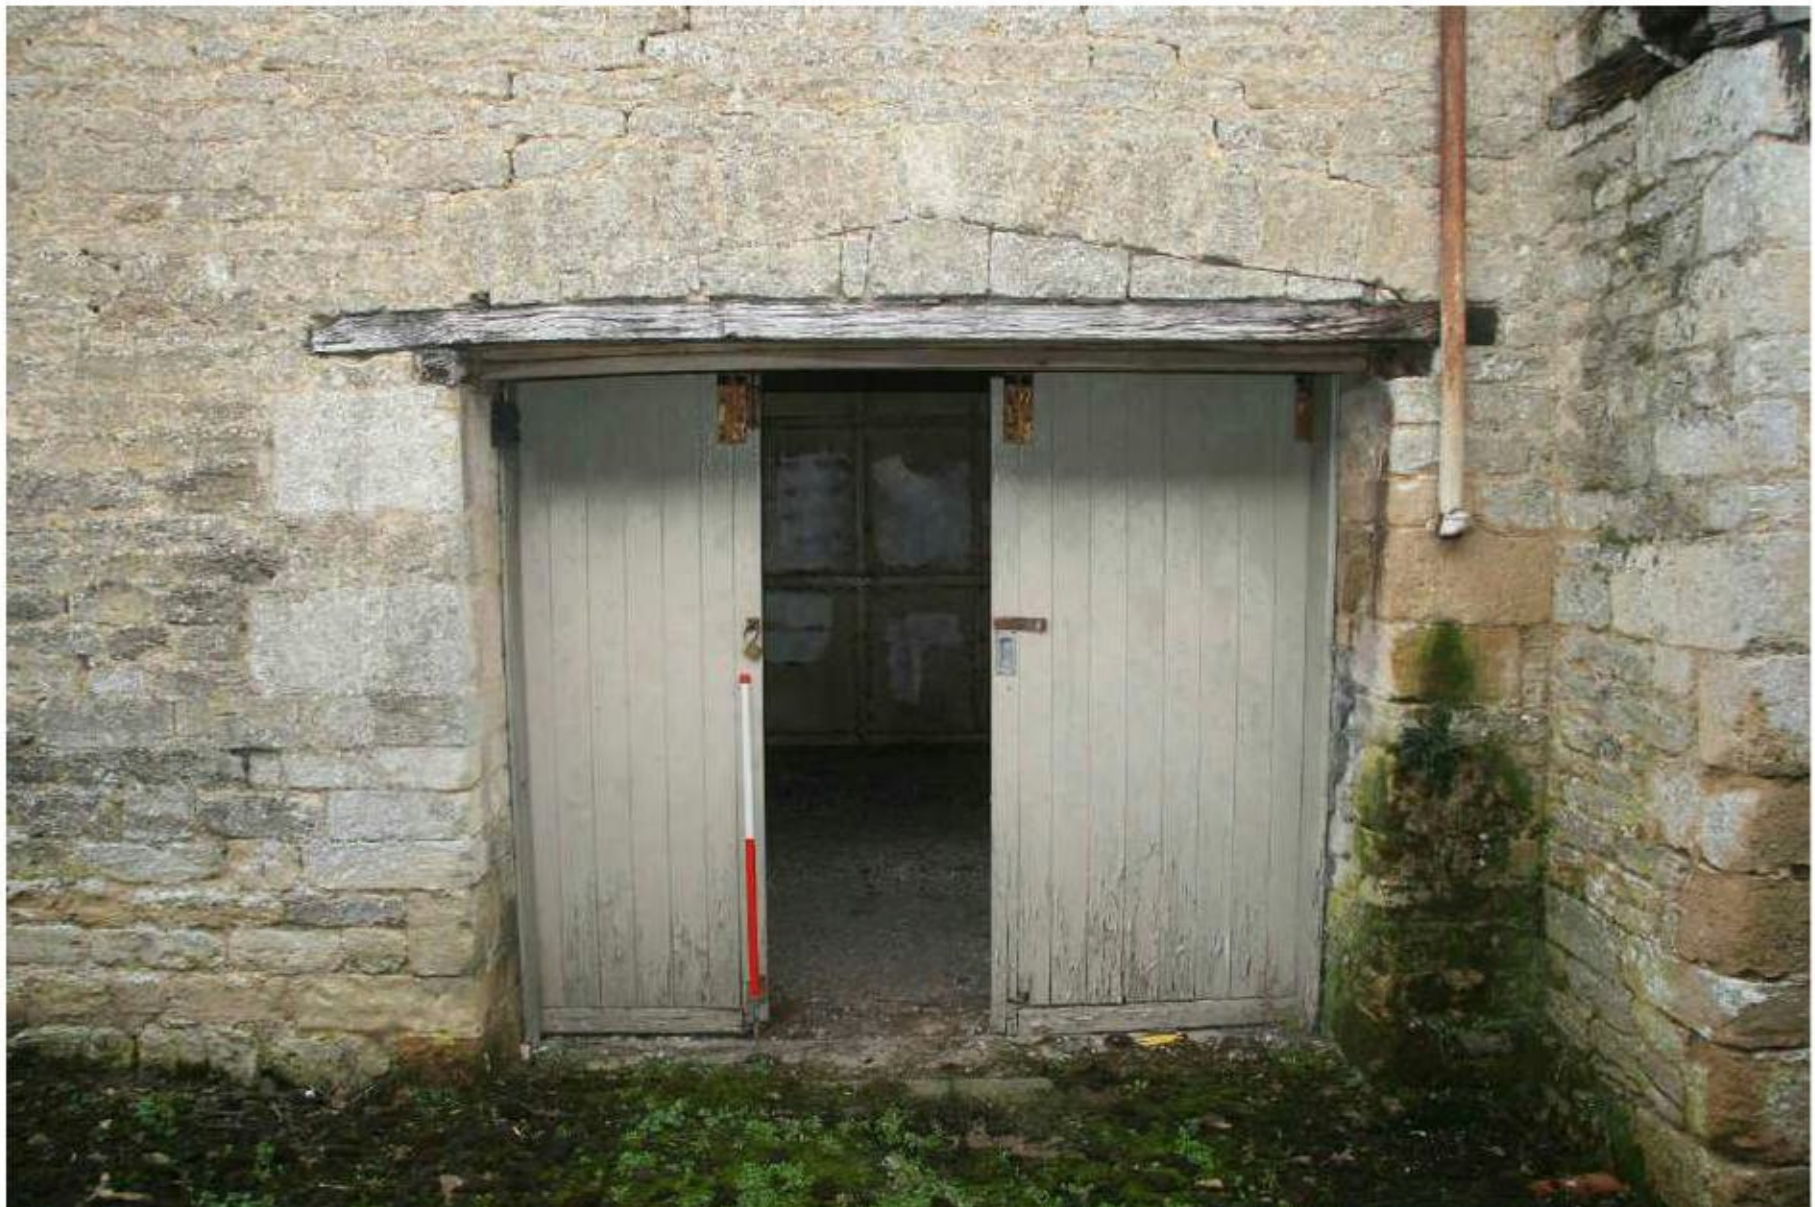
This structure is rectangular in plan, single storey c.7.8m height. The walls are constructed from limestone and lime mortar with red brick and cement repairs. The roof is gabled and under Collyweston slate. Six windows have been created in the roof from plastic sheeting. The northern wall contains a large 3.4m wide x 3.5m high sliding wooden door and two ventilation slits. The southern wall has a much smaller sliding wooden door measuring 2.5m wide x 2.5m high. This originally was an arched doorway which was later replaced by a wooden beam with stone in-filling the gap. The western wall contained a small hatch/shoot next to a blocked off doorway, which was infilled with stone and lime mortar.

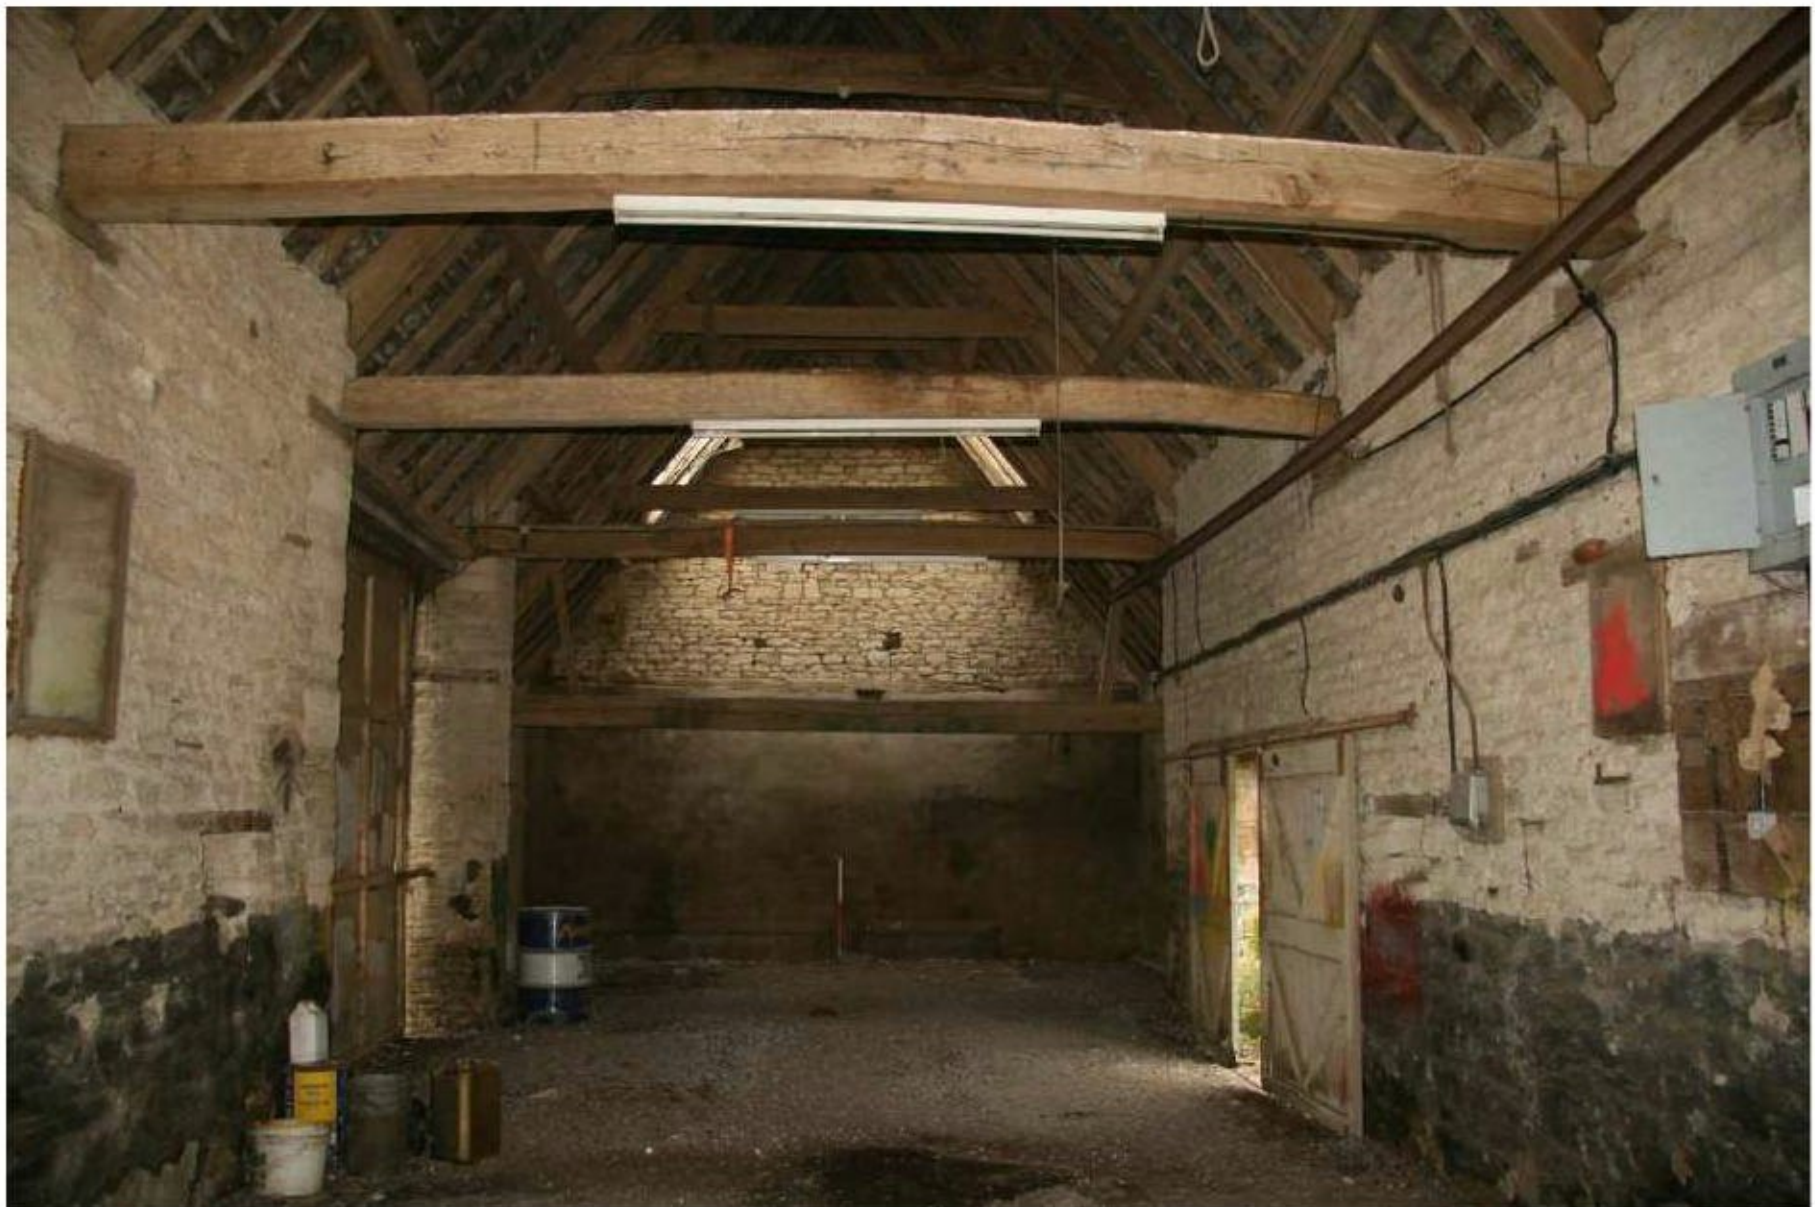
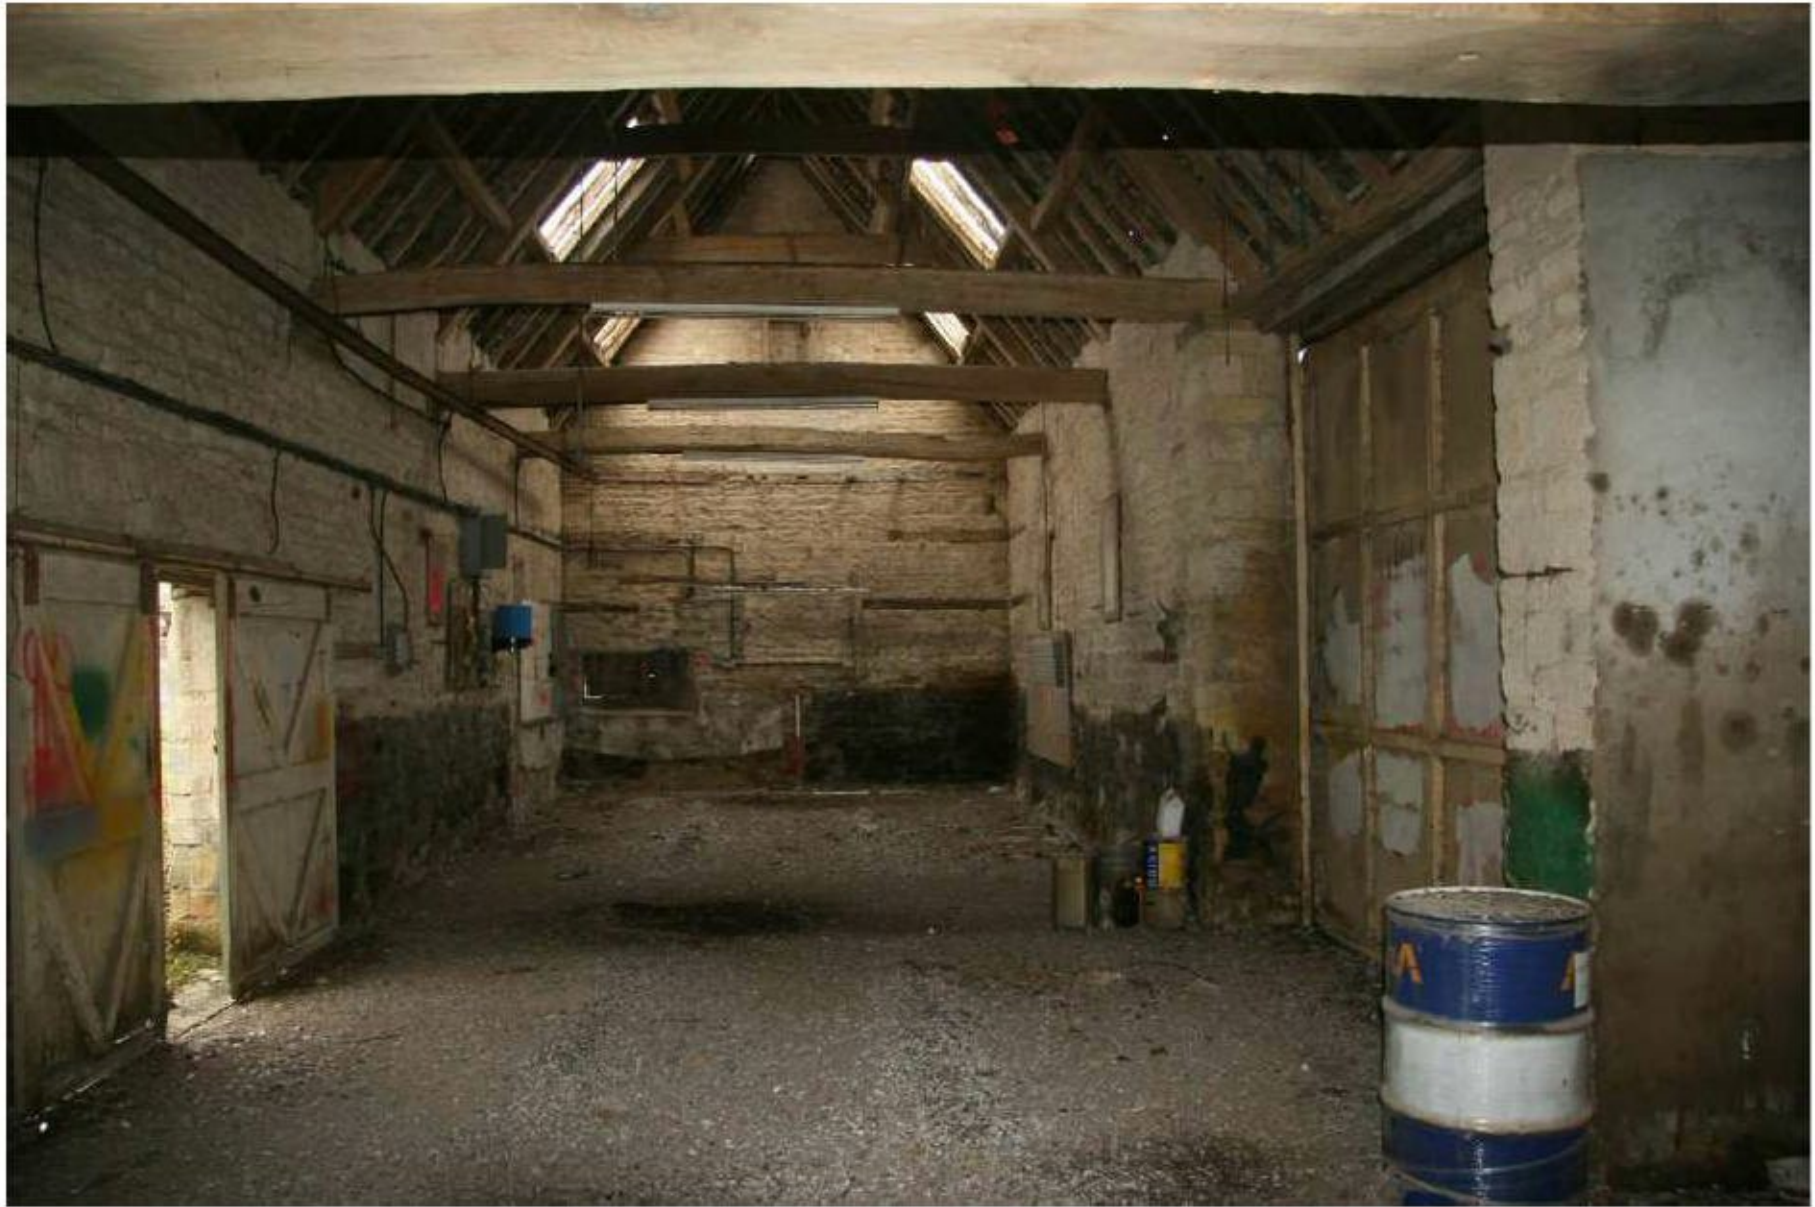
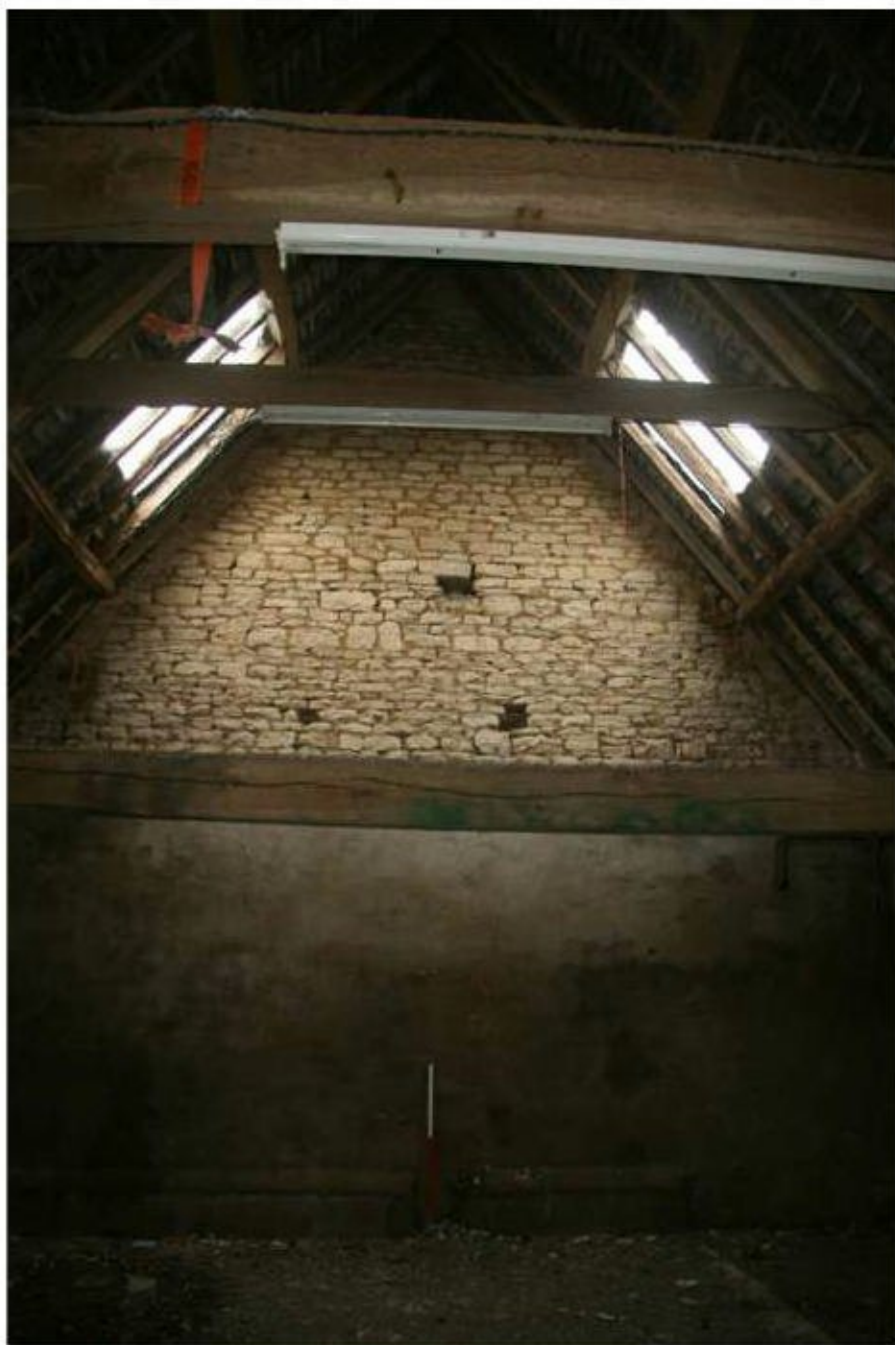
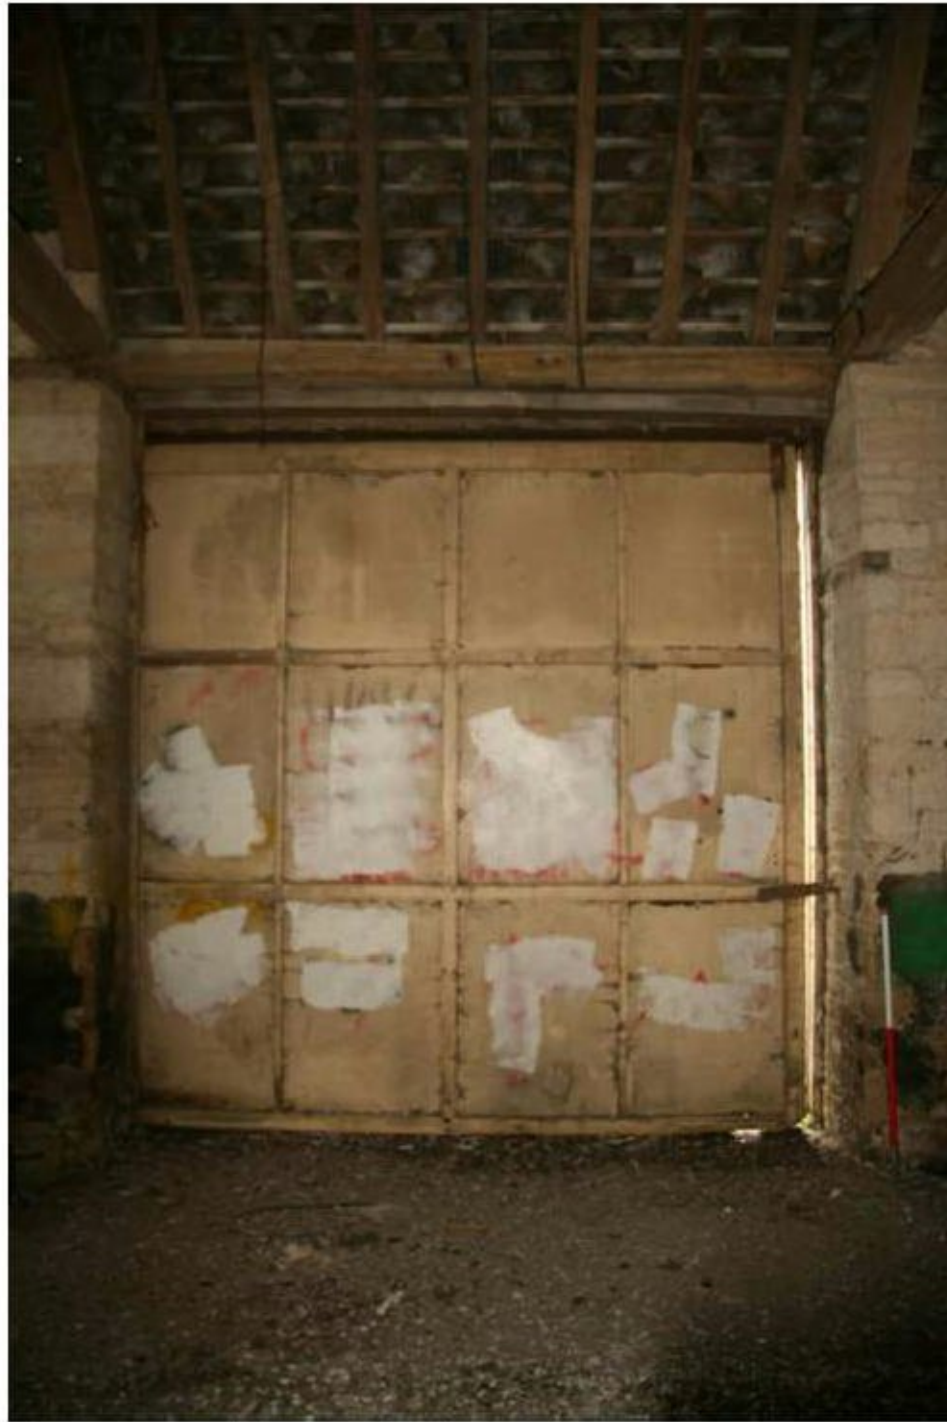
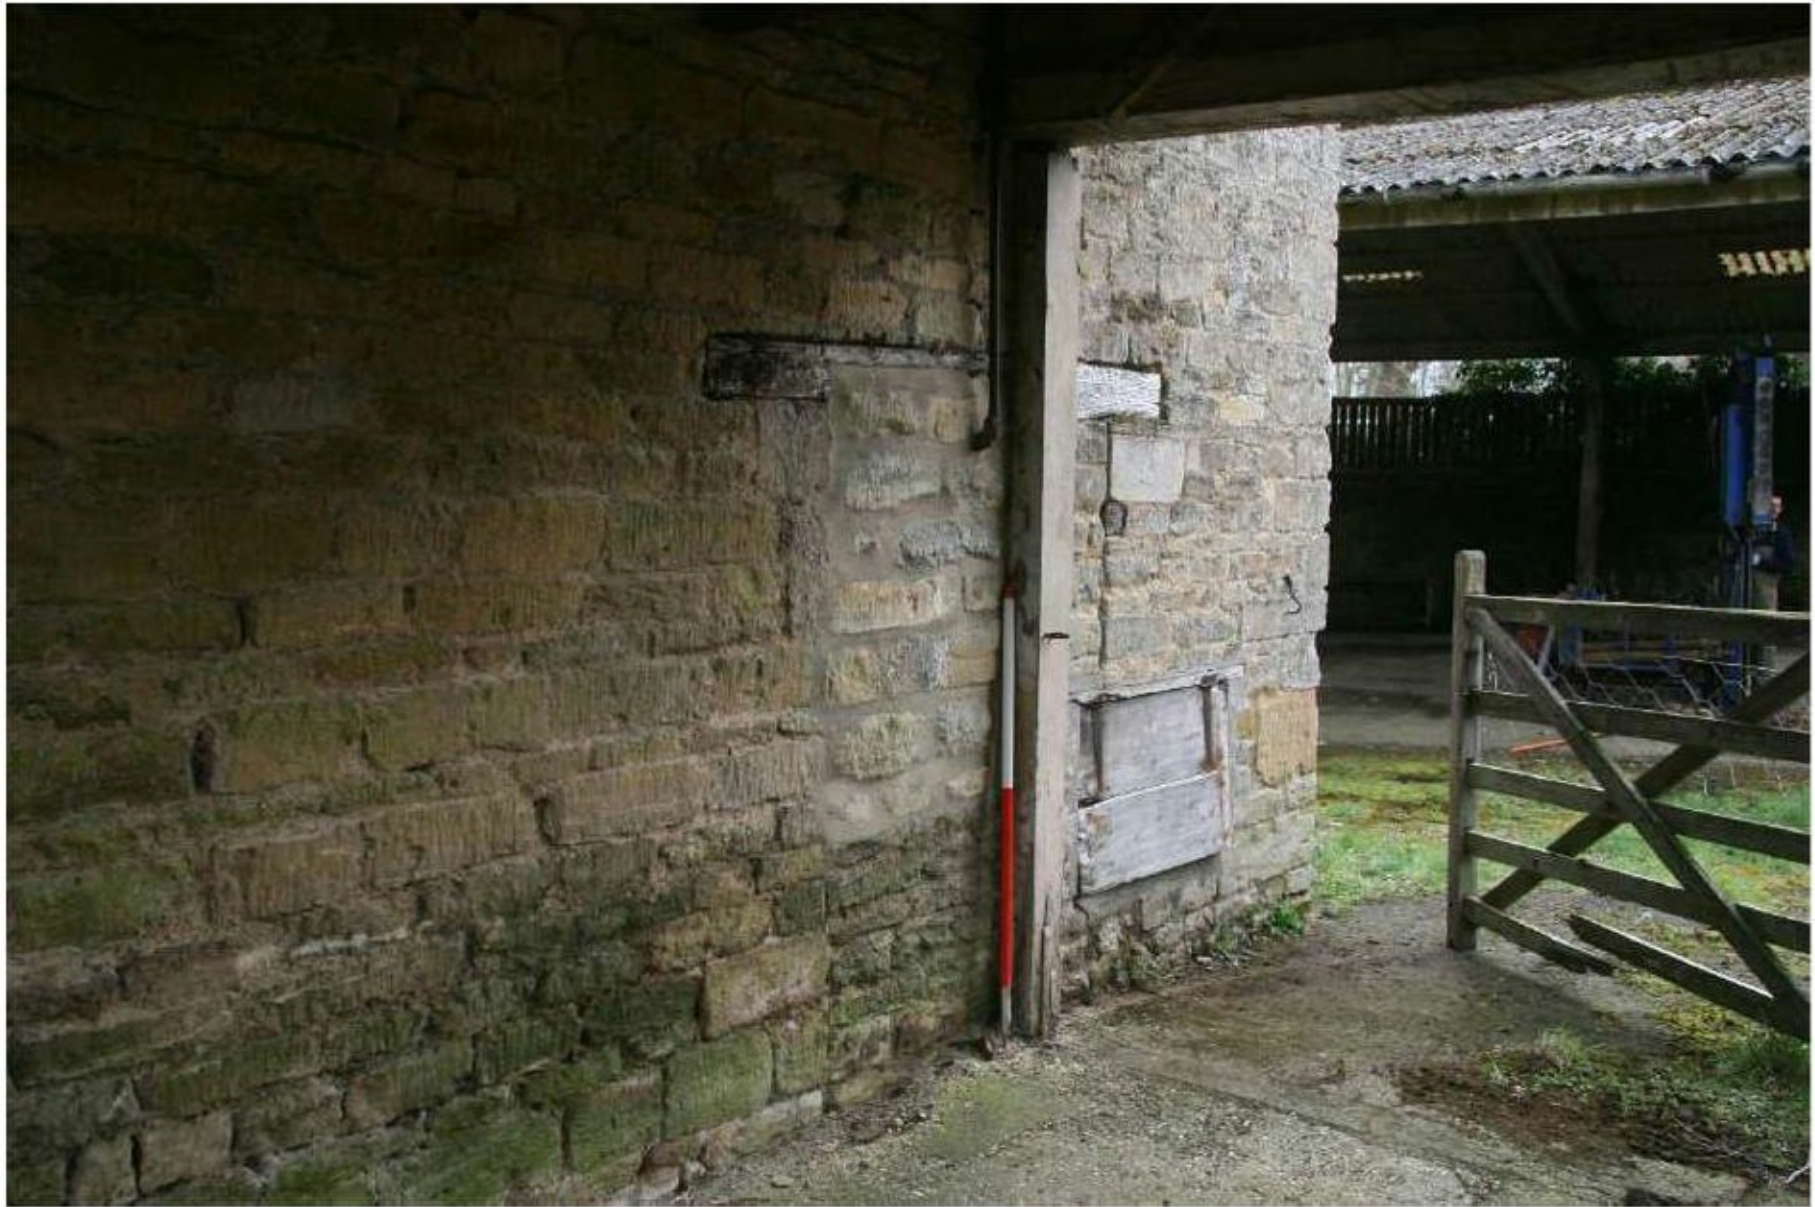
Room is 35.00 sqm in area with a badly worn concrete floor. The roof is constructed with rafters, collars and butt purlin supported on timber king post trusses. In the gable end of the western wall there is a small rectangular door, possibly an access point to the covered walkway on the other side. The eastern end of the building had concrete slip coating the walls on the lower c.3m of the wall.

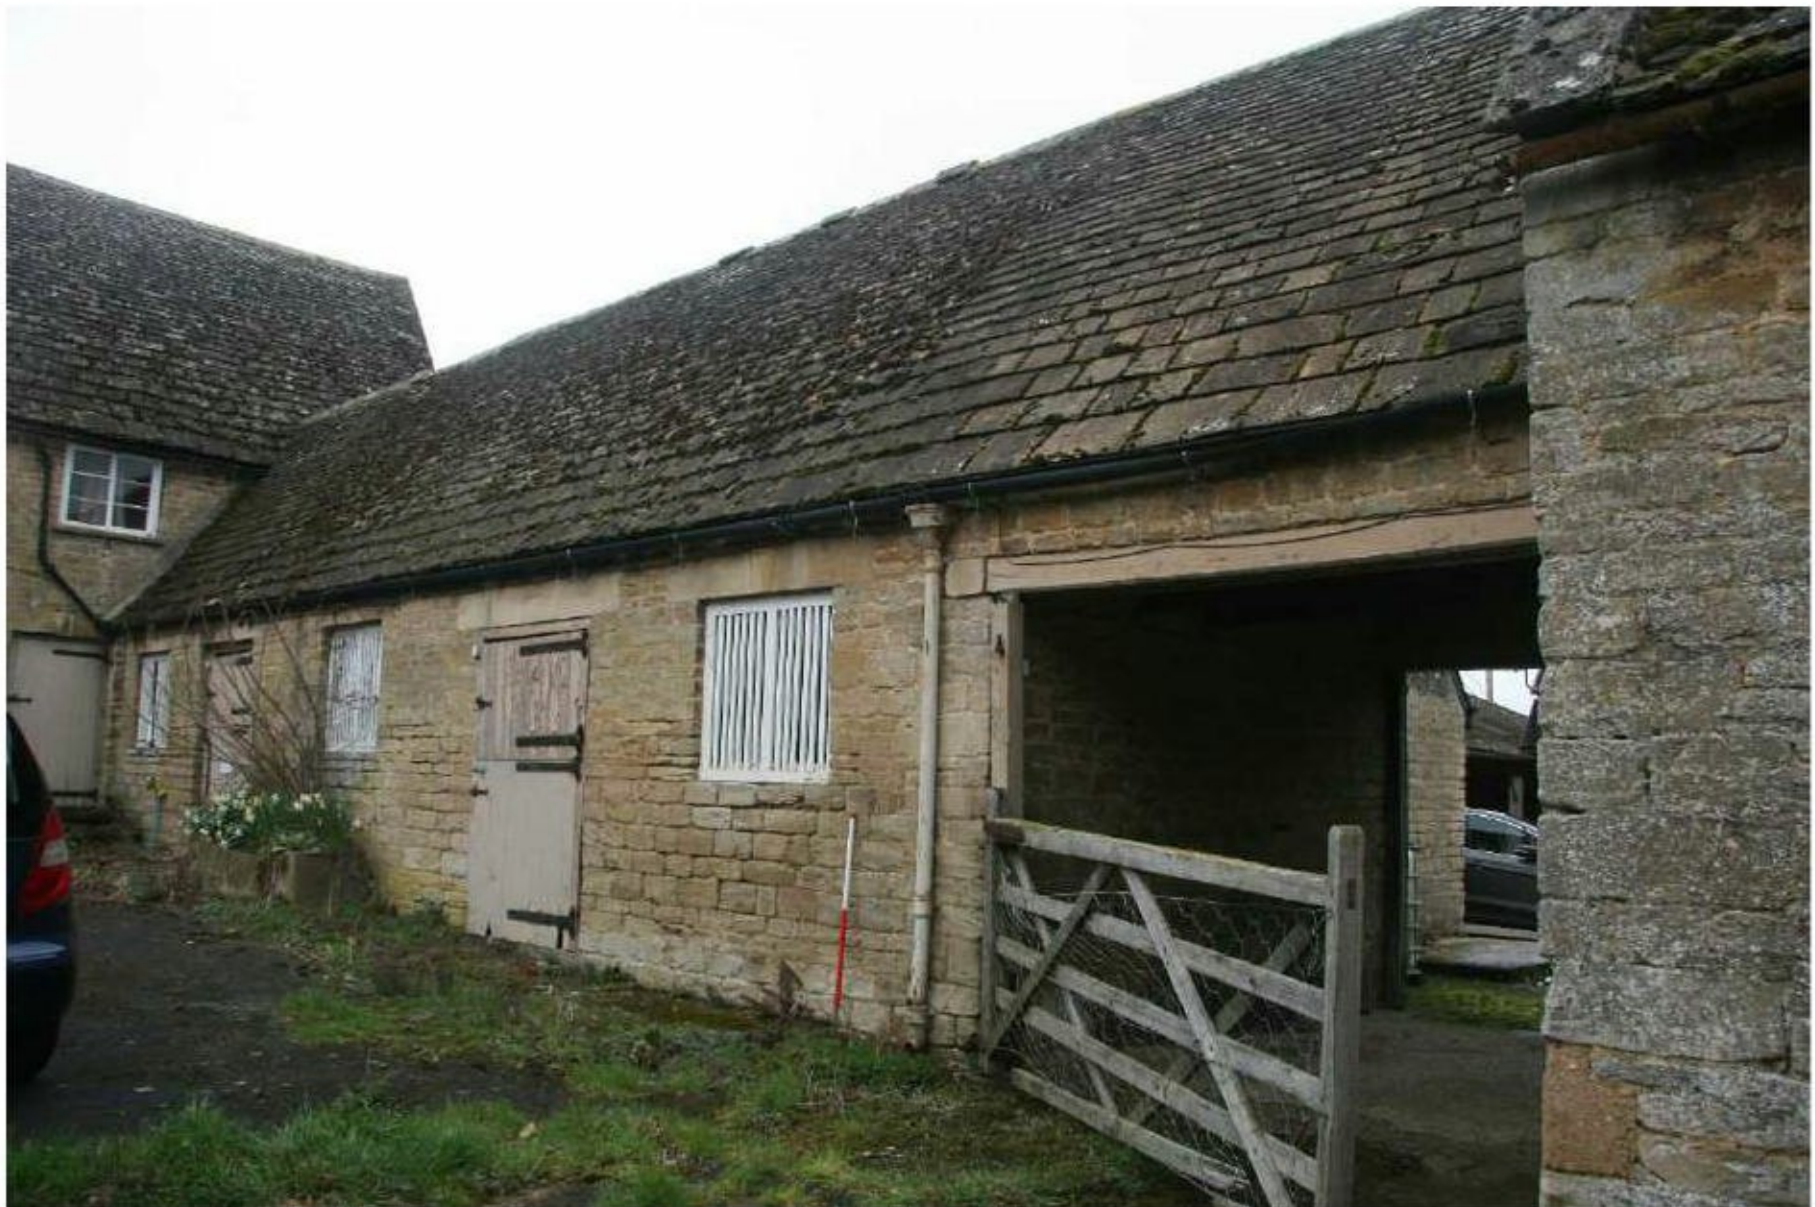
**Plate 22:** Building E, elevation 3, looking northwest.

Buildings E and F are connected on the northern side of building E and both are rectangular in shape. The northern wall is red brick (8.75" x 3") with lime mortar construction with 4 red brick (9" x 3") and concrete pillars. The brick in-filling appears to be of a later date and this wall would have originally been open with just the pillars supporting the roof. On the eastern end of the wall there is a large sliding door, 3.3m to the west of this a single wooden door can also be seen. The remaining three walls are of limestone and lime mortar construction. The western wall of building F contains a wooden door and a sliding metal door. The southern wall contains an open walkway, two stable doors and three wooden slatted windows. The roof is gabled and under Collyweston slate.

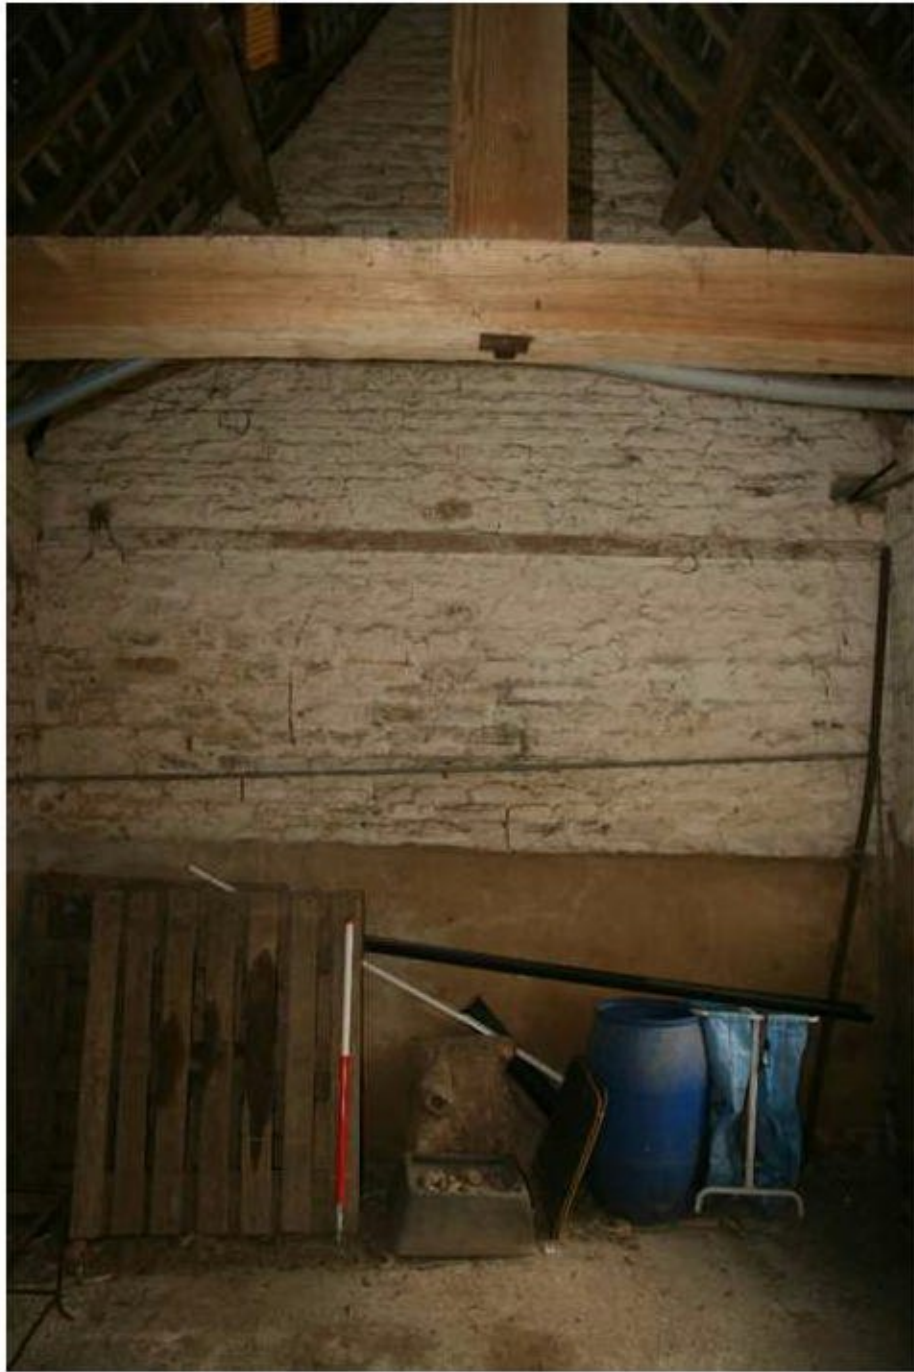
**Plate 23:** Building E, eastern room, looking northeast.

The eastern room is 19.00 sqm in area with a concrete floor and concrete slip (lower 1.5m) over the stone. The roof is constructed with rafters, collars and butt purlin supported on timber king post trusses. The southern wall contains a single stable door and window.
