RECTORY FARM BUILDINGS,  
MAIN STREET  
LOWER BENEFIELD

HISTORIC BUILDING SURVEY

Prepared for:  
Best Asset Ltd

By Neil Jefferson BSc (Hons) at  
Contour Archaeology  
Edited by Carol Duxbury

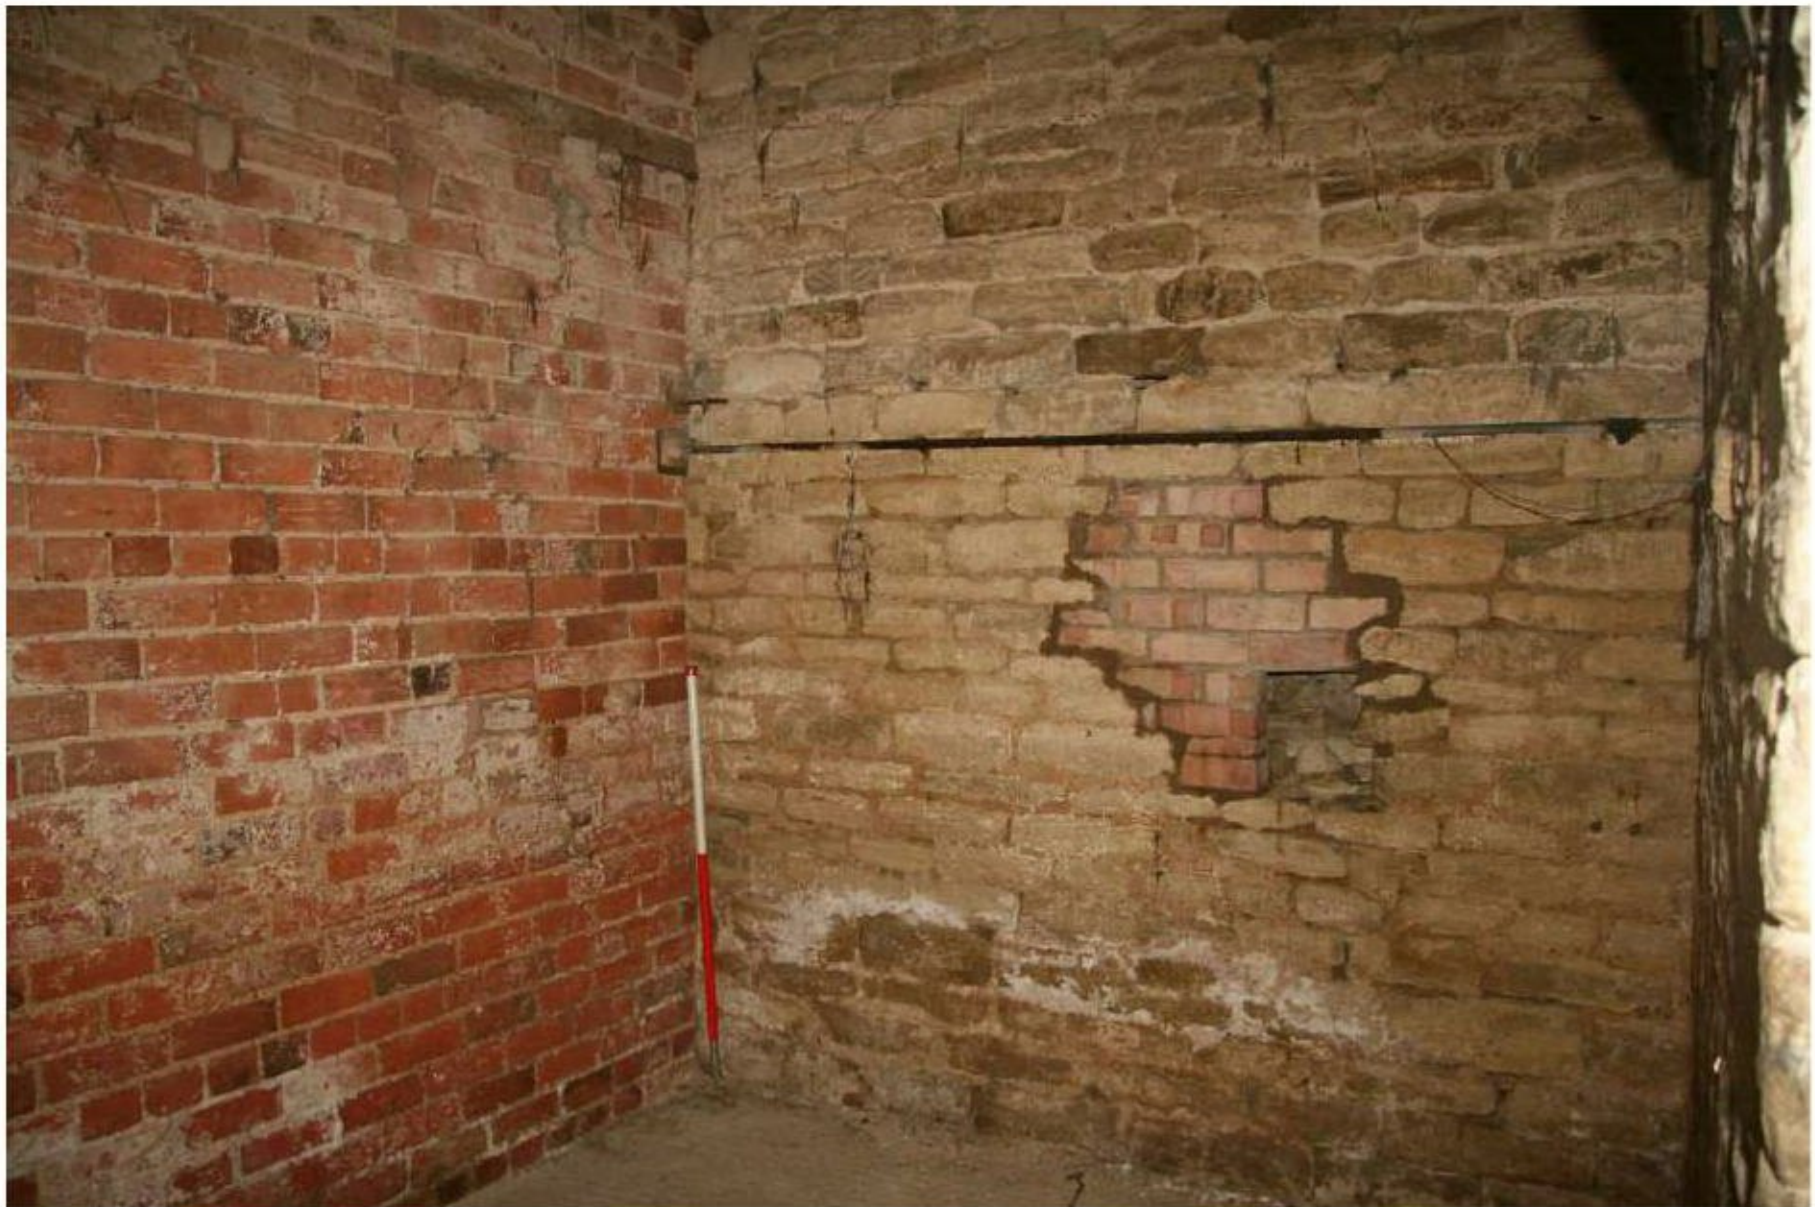
**Plate 24:** Building E, middle room, looking northwest.

The middle room is 9.40 sqm in area with a concrete floor. The western wall is constructed in a red brick (8.75" x 3") with lime mortar in Flemish bond and contains a stable door. This wall was a later addition to the building, splitting this room and the western room into two. In the middle of the northern wall a hole has been repaired in a red brick (8.75" x 3") with lime

mortar. the southern wall contained a single wooden slitted window. The roof construction is the same as above.

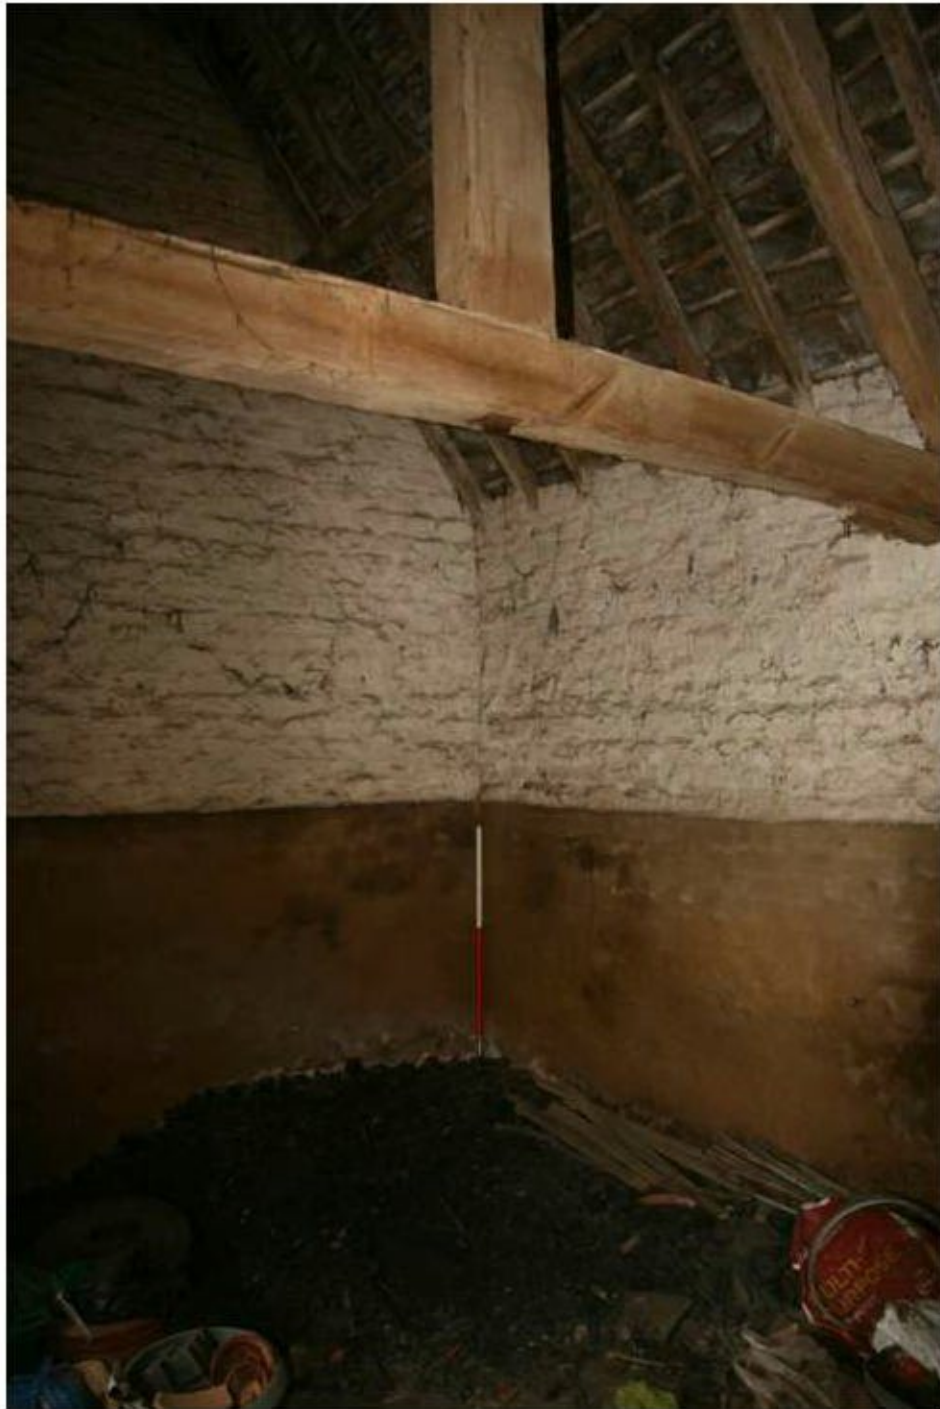
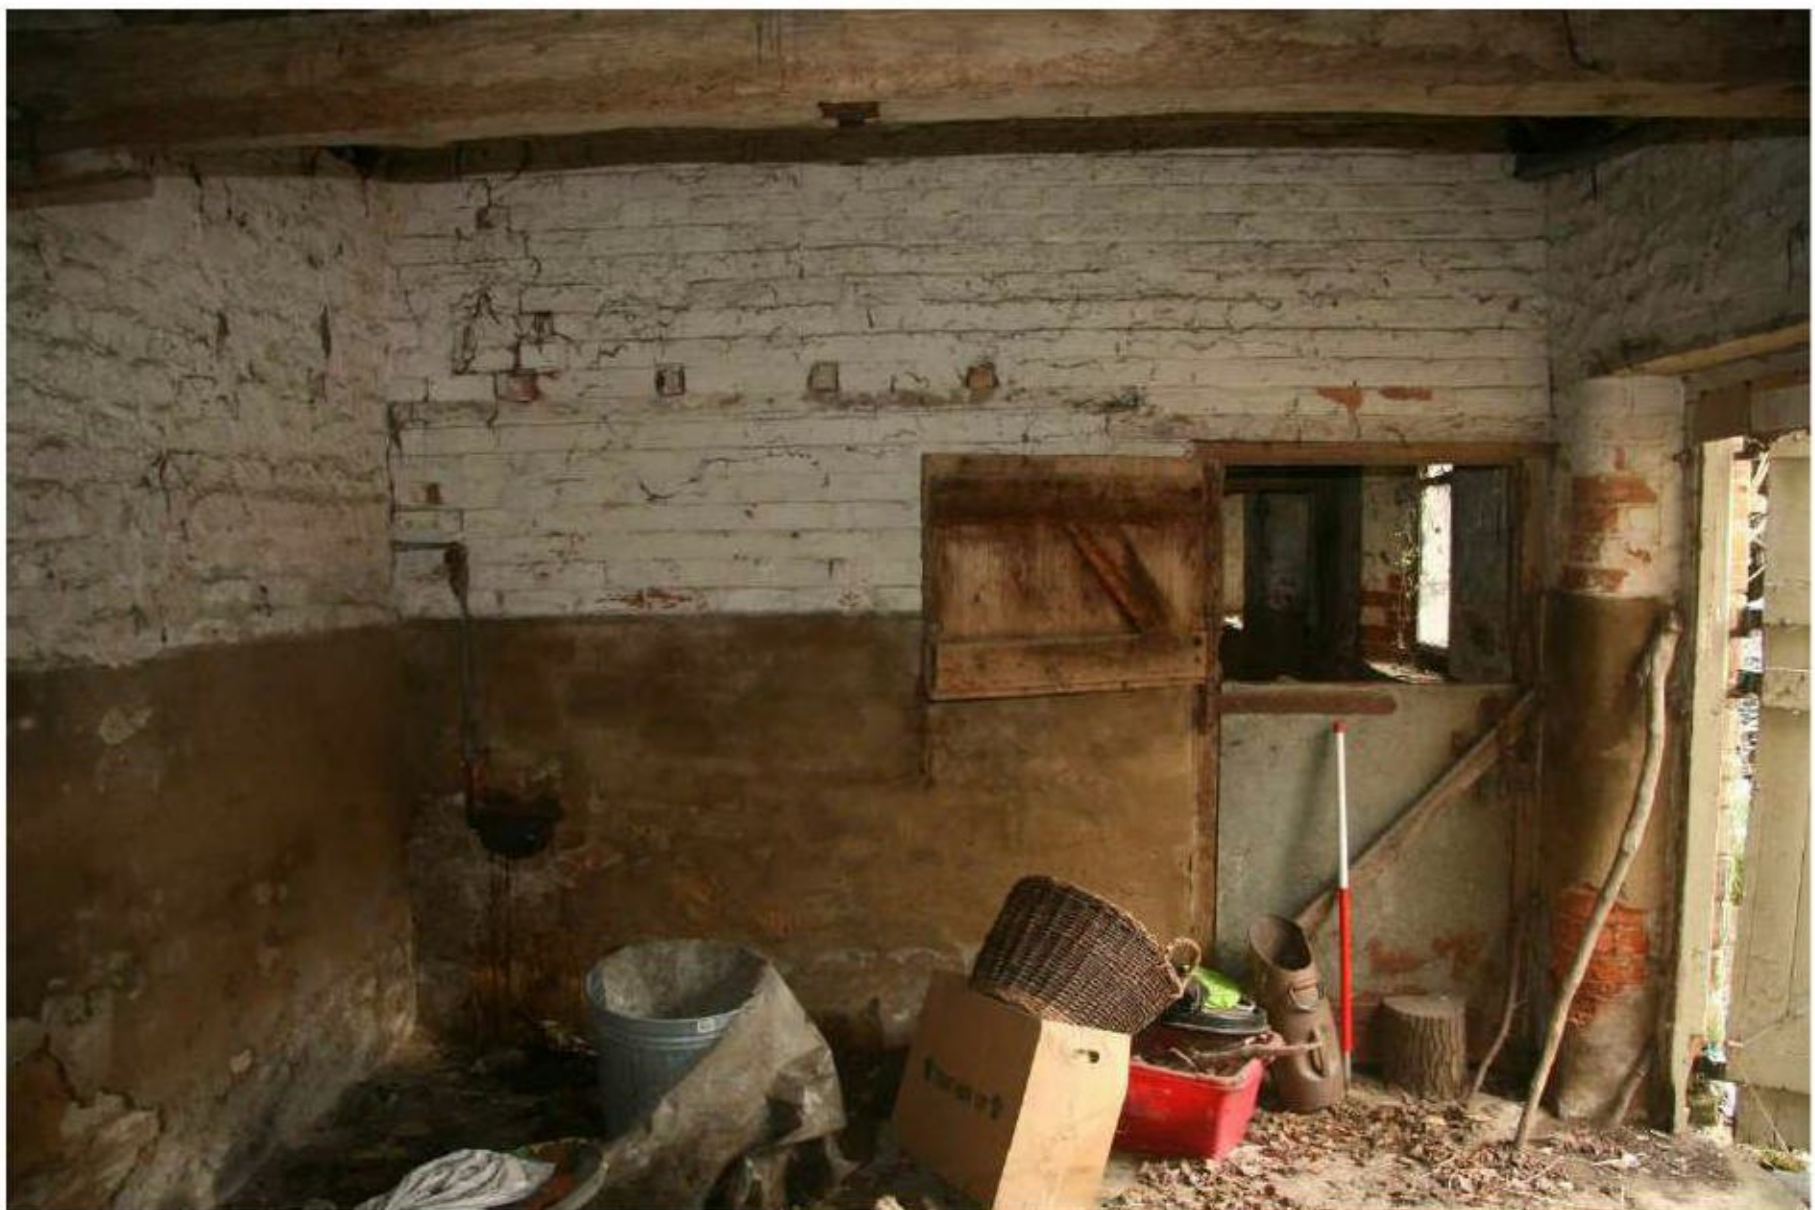
The western room is 17sqm in size with a concrete floor and concrete slip (lower 1.5m) over the stone and brick. The southern wall contained a wooden stable door and one wooden window. The roof construction is the same as above.

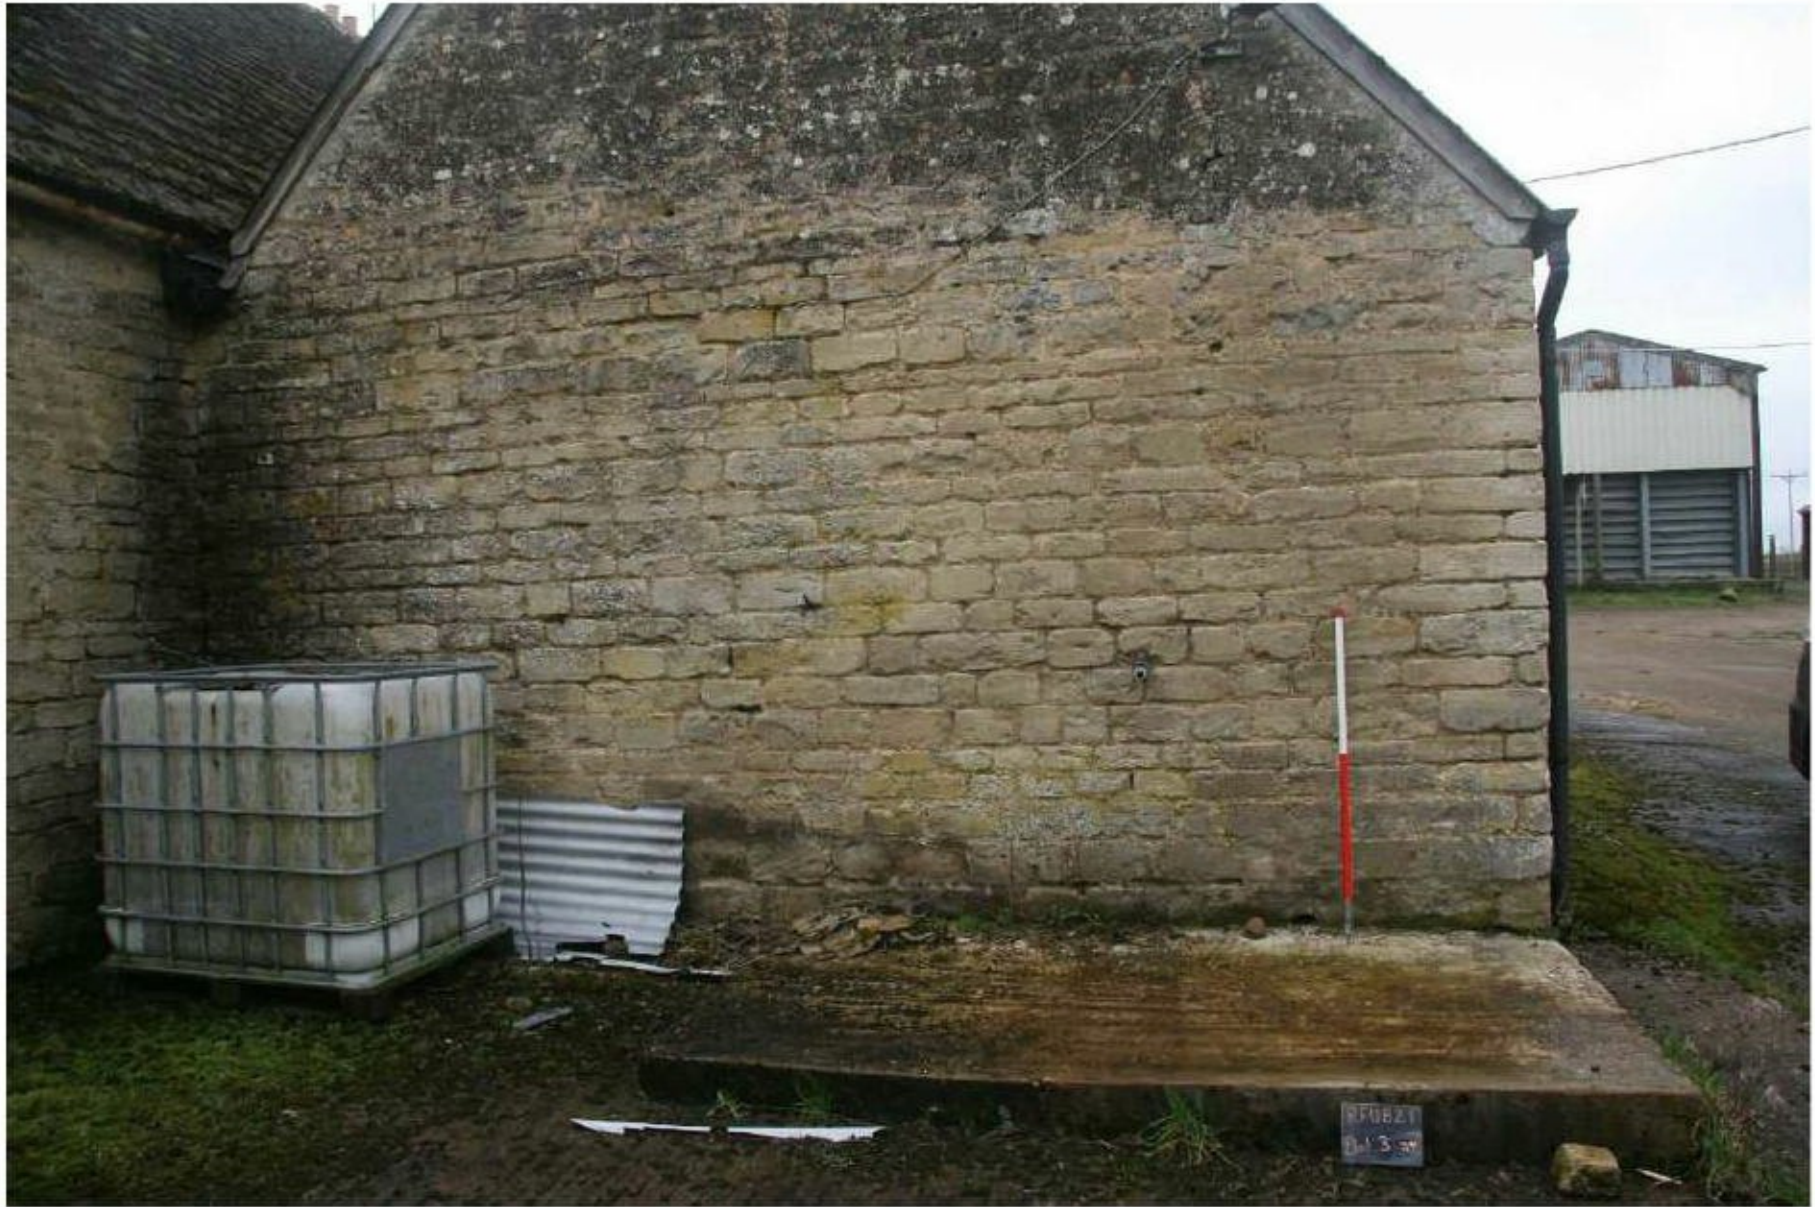
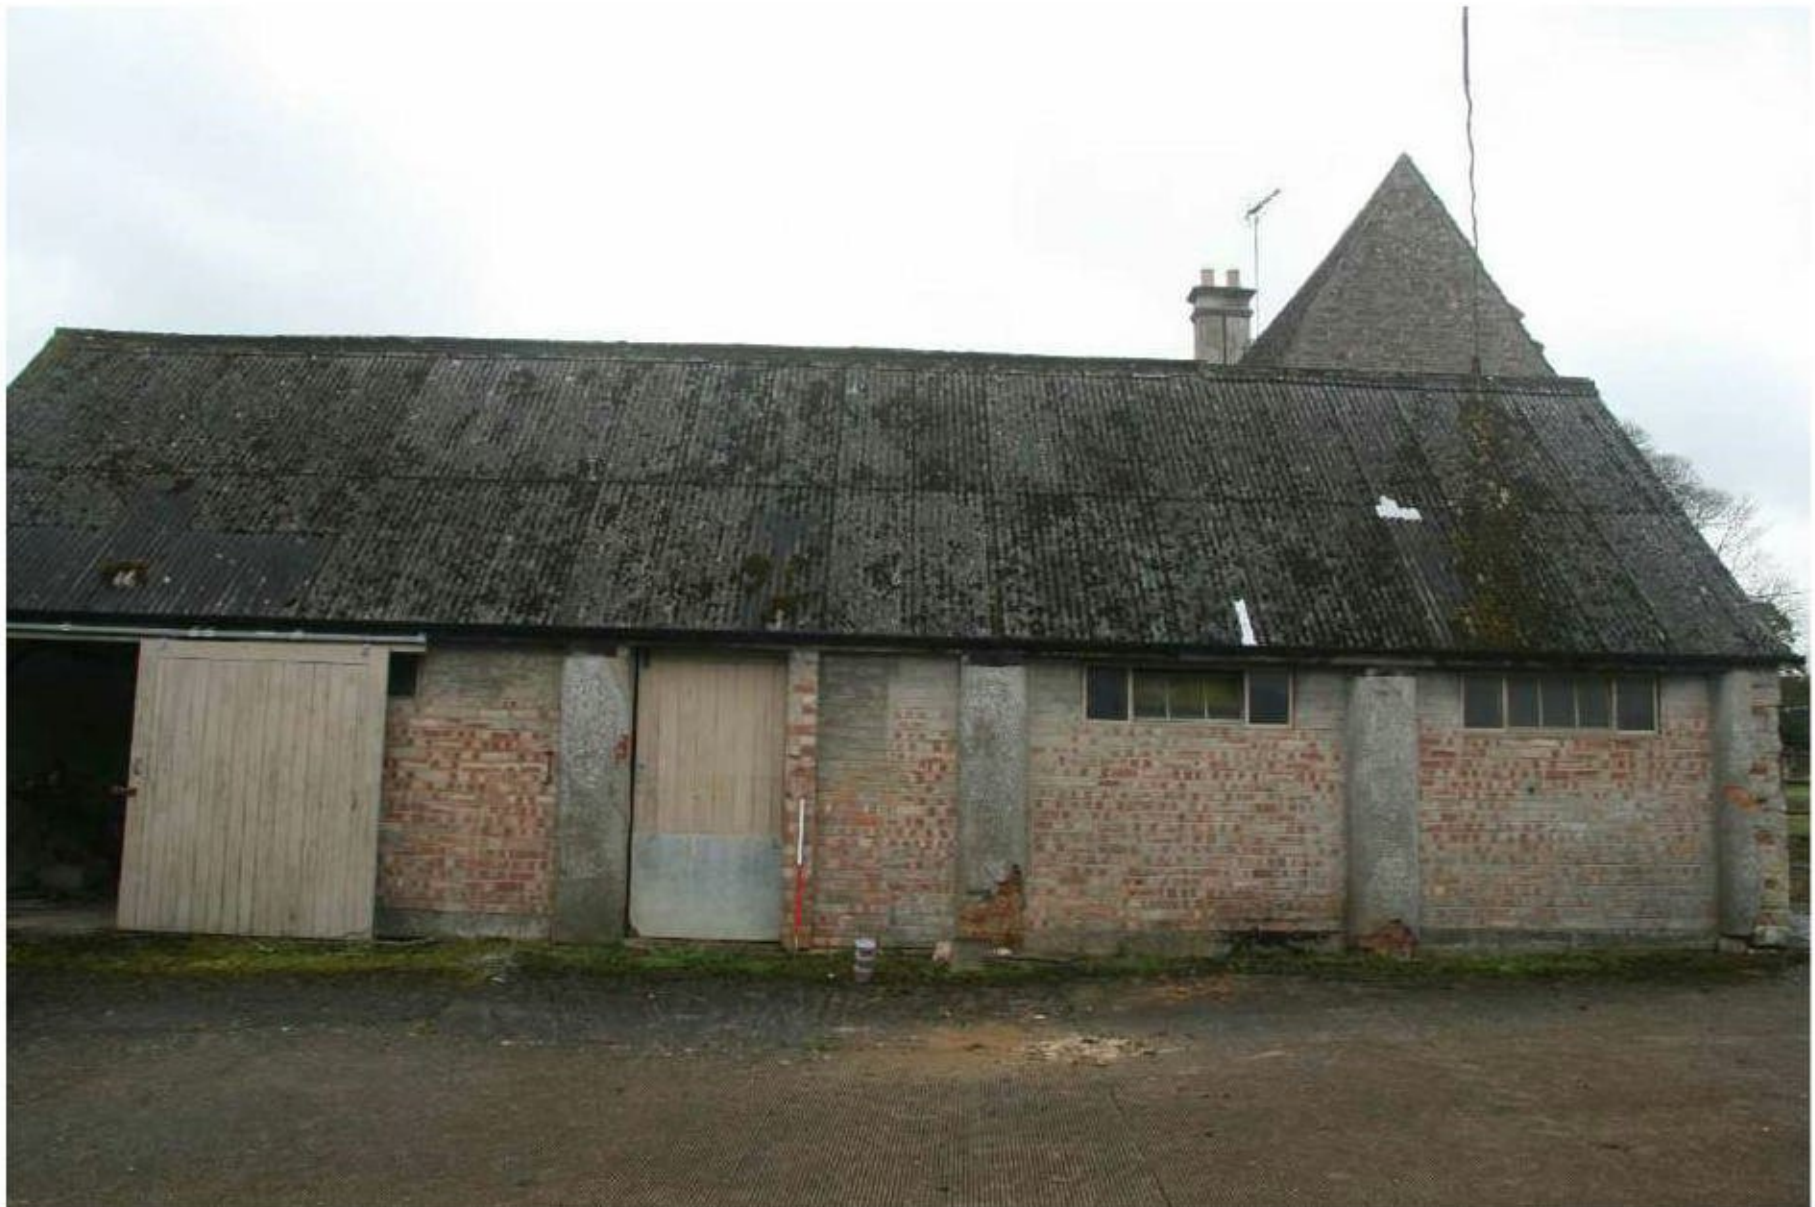
Buildings E and F are connected on the northern side of building E and both are rectangular in shape. The northern wall is red brick (8.75" x 3") with lime mortar construction with 4 red brick (9" x 3") and concrete pillars. The brick in-filling appears to be of a later date and this wall would have originally been open with just the pillars supporting the roof. On the eastern end of the wall there is a large sliding door, 3.3m to the west of this a single wooden door can also be seen. The remaining three walls are of limestone and lime mortar construction. The western wall of building F contains a wooden door and a sliding metal door. The southern wall contains an open walkway, two stable doors and three wooden slatted windows. The roof is gabled and under Collyweston slate.

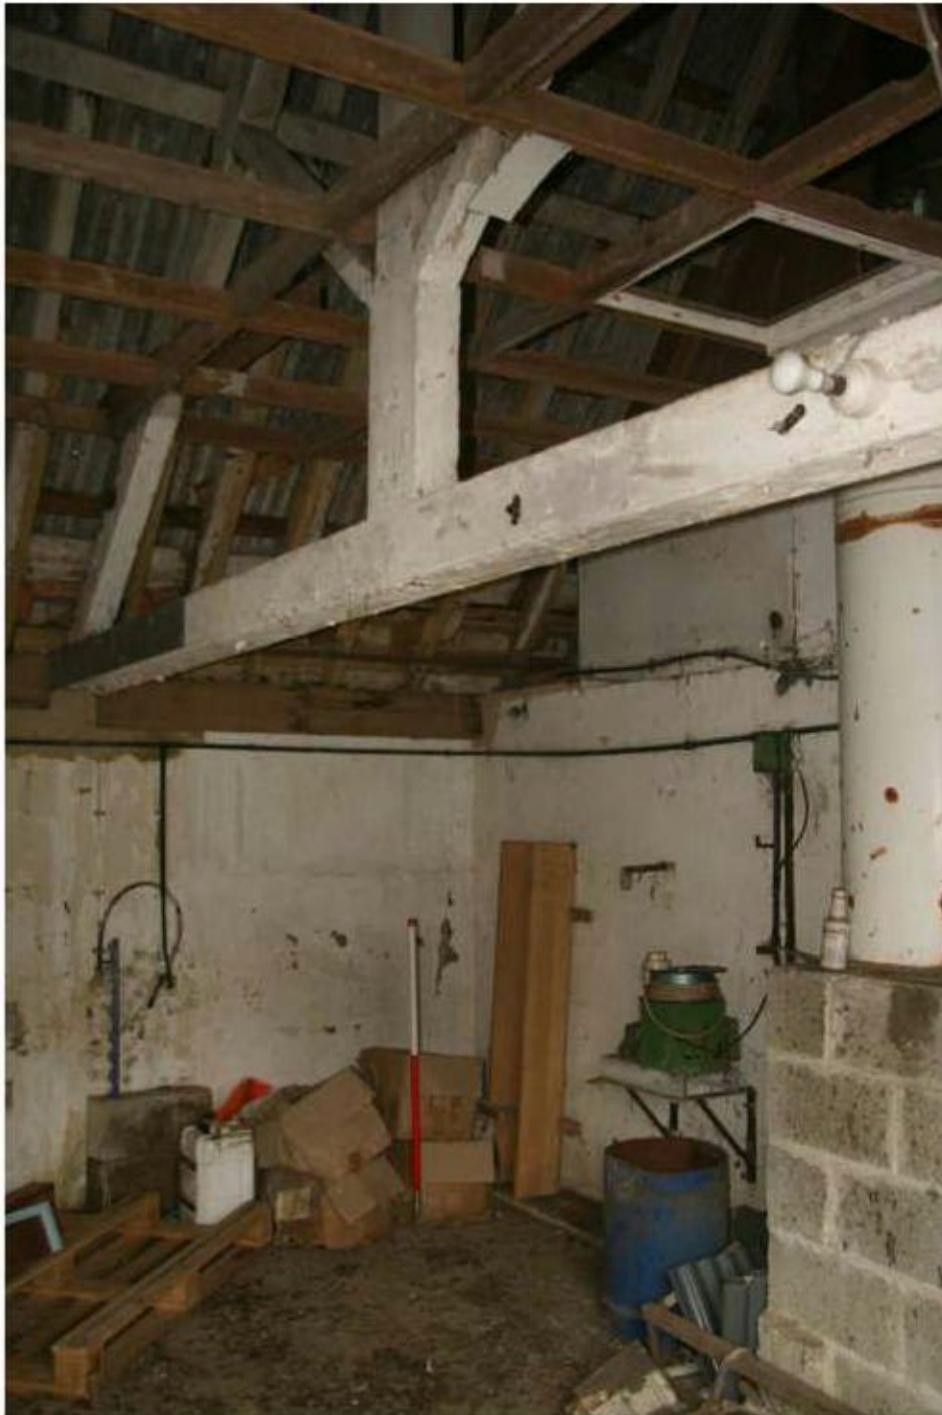
**Plate 29:** Building F, eastern room, looking southwest

The eastern room is 23.00 sqm in area with a concrete floor. The western wall is of a concrete block construction. The roof is constructed with rafters, collars and butt purlin supported on timber king post trusses. The room contained a modern boiler and sink.

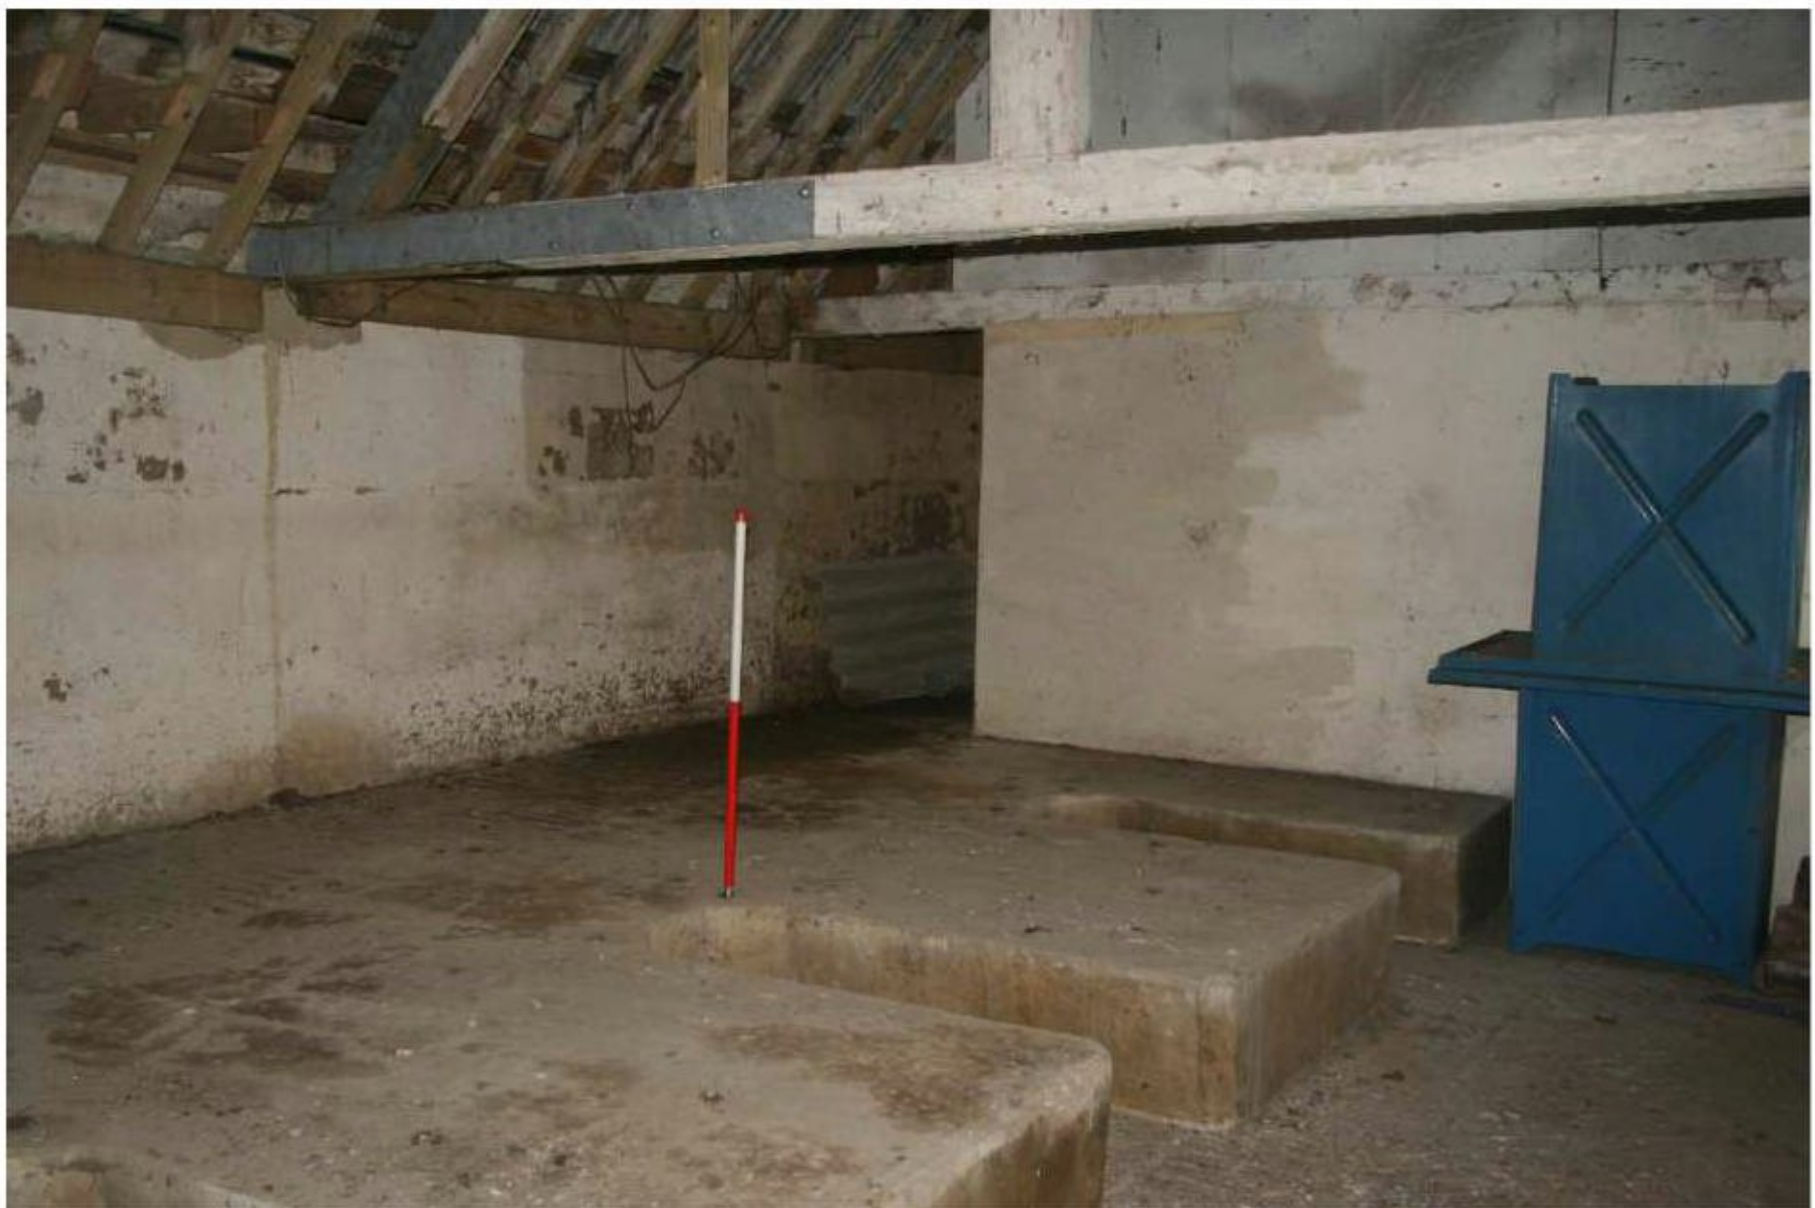
**Plate 30:** Building F, middle room, looking southwest.

The middle room is 36.00 sqm in area with a concrete floor. The western and eastern wall is of a concrete block construction. the floor had a raised modern concreted area with insets for milking of cattle. The roof construction is the same as above.

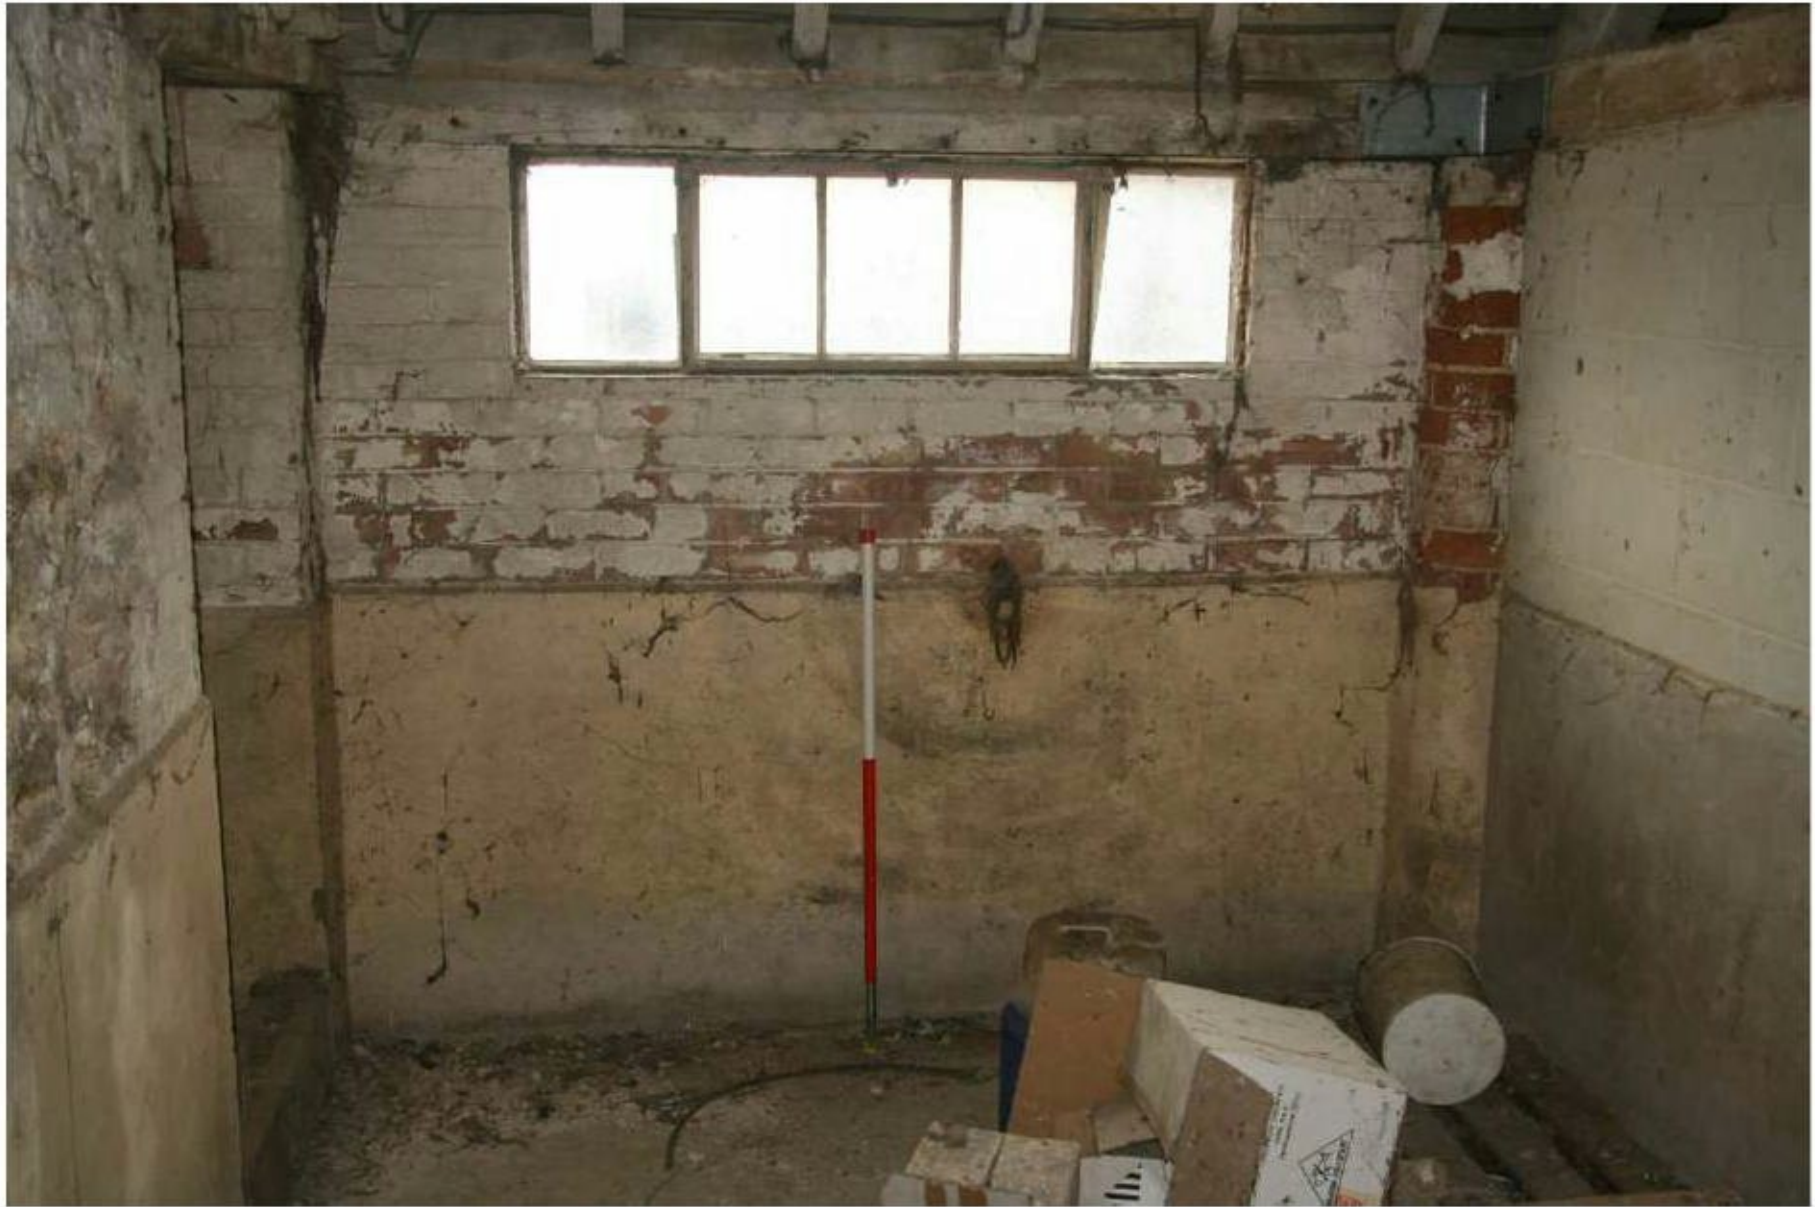
**Plate 31:** Building F, western room, looking northwest

The western room is 10.5 sqm in area with a concrete floor. The eastern wall is of a concrete block construction. The roof is the same as above.
