# Tanglewood, Beechwood Lane, Burley, BH24 4AS.

Vesper Conservation & Ecology Limited 21/12/2021

Phase 1 Bat Surveys:

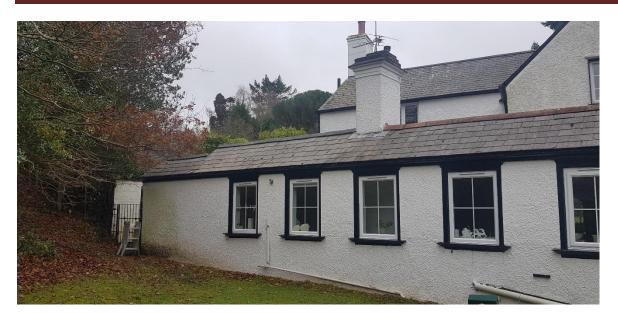
- 2.5 The main part of the house ridge has several gaps that would allowing ingress into the building, the single storey front extension has numerous gaps along the ridge on both the rear and front elevations.

**Picture 1:** Showing the northern elevation, the single storey extenstion

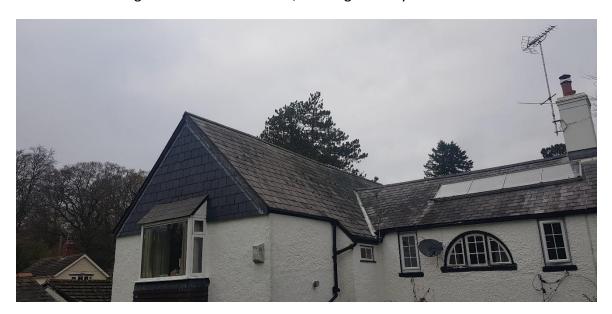
- 2.8 The southern rear gable has tight fitting slate hanging tiles with lead flashing around the edges up and under the barge boards, there are no obvious gaps that would allow ingress.

**Picture 2:** Showing the rear, southern elevation.

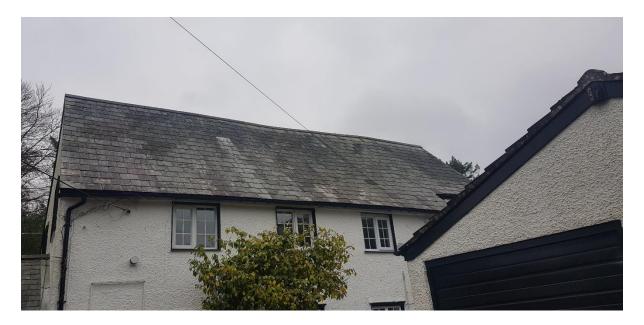
Picture 3: Showing the western elevation of the property

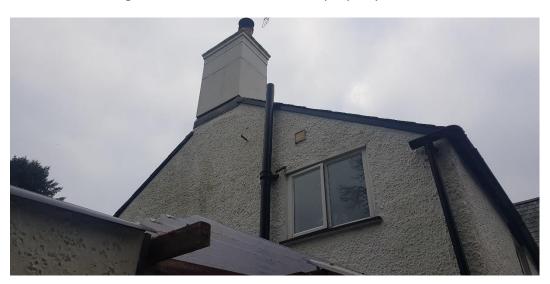
**Picture 4:** Showing the eastern elevation.

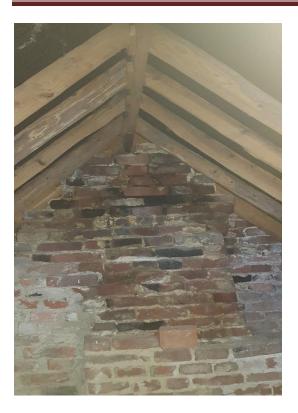
- 2.10 This property has a roof space that covers the whole of the main house; access was mostly throughout, there was an in accessible apart of the roof to the southern end of the building. The floor was boarded almost throughout the roof space. There is also a small access into the roof of the northern single storey extension, access was very tight so no access other than that around the hatch was done.

- 2.13 The roof is constructed as a truss frame there is a ridge beam that runs east to west, even into the newer extension.
- 2.14 The floor of the roof was covered with a thick layer of glass fibre insulation throughout. No light was seen coming in through the eaves.

Picture 5: Showing the internal roof space

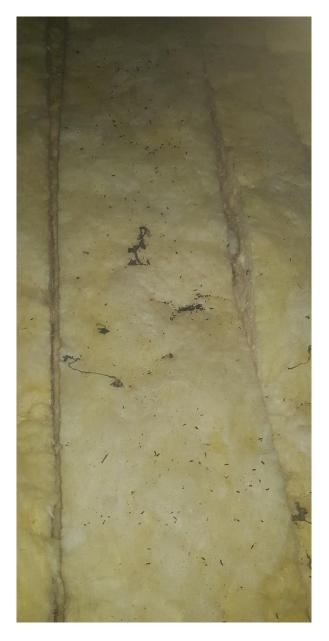
- 2.15 Bat droppings were seen in the larger of the two main roof areas, droppings C150 were seen under a ridge beam, these have the size and shape of Brown Long eared bats, a sample was taken for DNA analysis.

- 2.1 The preliminary survey carried out on 15th December 2021 by Vesper Conservation & Ecology Limited showed that this building is been used as a bat roost. There are also numerous gaps in the roof that could allow ingress into the building.

**Picture 6:** Showing the bat droppings on the insulation

- 3.1 It is recommended that 3 x bat activity survey will be needed with at least 3 surveyors to be used to cover all possible angles of the building.
- 3.2 The activity surveys will inform and be part of a mitigation strategy so that no loss of roosting opportunities will occur, the likelihood is that the proposed works will need a Protected Species License from Natural England. This can only be applied for once the planning permission has been granted.
