## Question 7. Identification Of Tree(s) And Description Of Works

Proposed work to be carried out is on a Salix alba

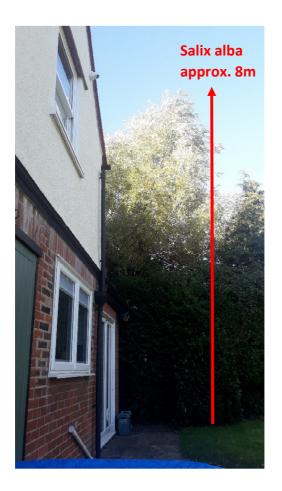
To the best of my knowledge, the tree has been identified as Salix alba (White Willow). The leaves are narrow and long, up to 12cm, finely toothed and white on the underside. Bark is deeply ridged with a large trunk girth. Tree height approx. 8 metres (see photo page fig 1).

Figure 1. Showing the height and position of the tree in relation to the house.

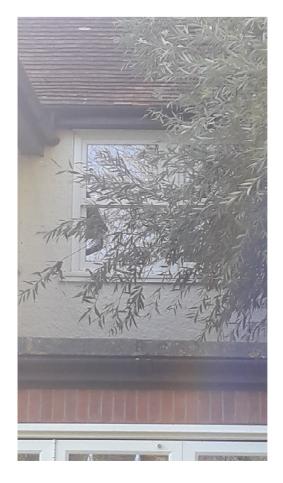
The Canopy is growing against the wall of the house and completely covers the bedroom window. It has also caused damage to the guttering. Canopy intrudes over the boundary line by approx. 4 metres.

Figure 2. The canopy blocking the bedroom window.

Proposed work is to perform a partial crown reduction to remove the branches covering the bedroom window, and those that are touching the wall and guttering. The amount that needs to be removed from the window is 2 meters. The amount proposed to be removed from wall and guttering is 1 metre.

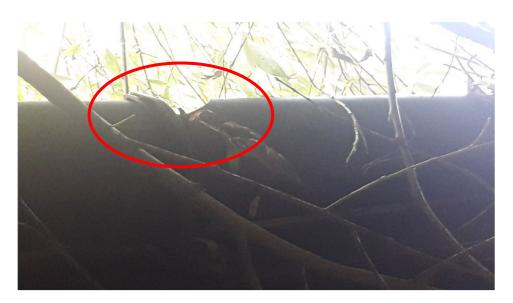
The tree has grown over the boundary line by approx. 4 meters and is touching the side wall of the house. It is pushing against the guttering which has caused some damage (see photo page fig. 3). The canopy has grown across the entire bedroom window (see photo page fig. 2).

Figure 3. Branches growing against guttering. Red circle highlights damage to gutter.
