**Preliminary Bat Roost Assessment and Bird
Survey for,
Smith Brothers Farms Limited.
Building at,
Southwood,
Canwell Drive,
Canwell,
Sutton Coldfield,
B75 5SG.**

**Map Ref SK 1440 0000
28th October 2021.**

**S. Christopher Smith MRICS MSc CEnv.
The Hayloft,
Farm Lane,
Grendon,
ATHERSTONE,
Warwickshire.
CV9 3DR
01827 713324**

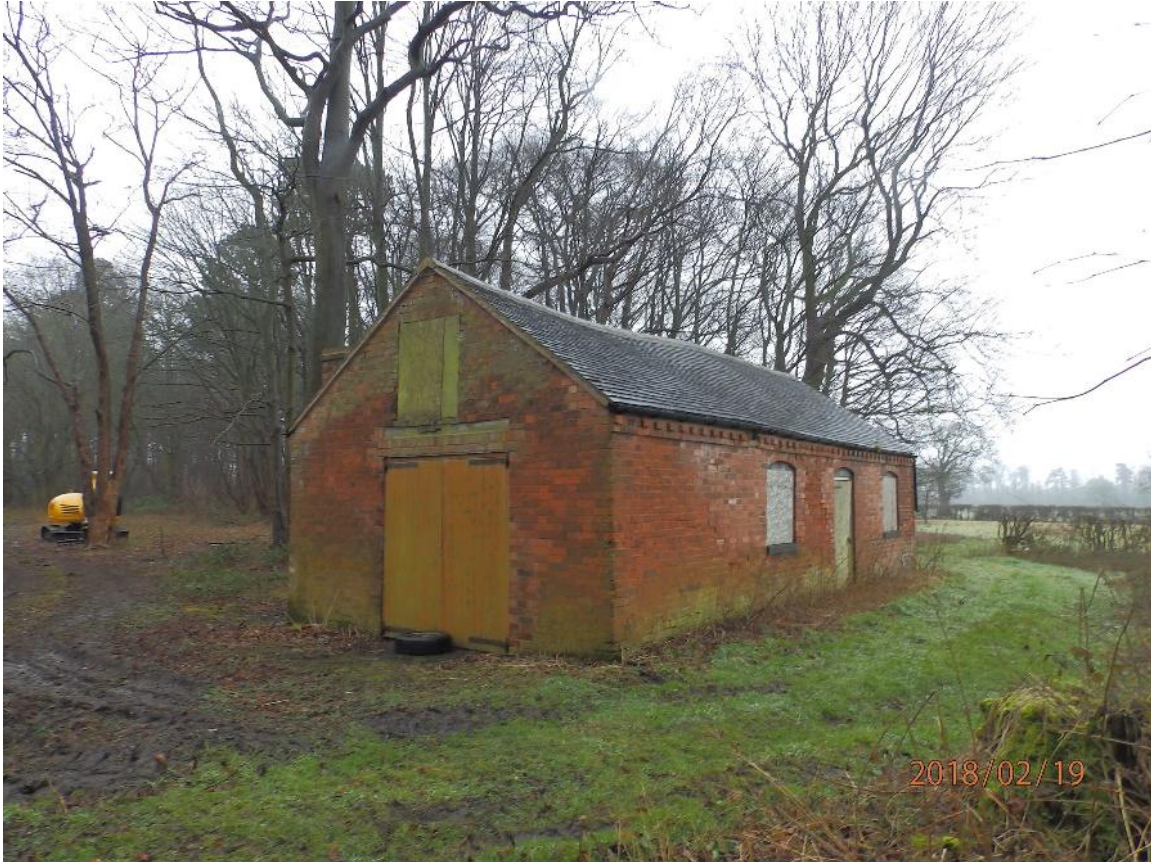
The buildings to be surveyed consisted of a single storey solid brick barn with a pitched roof. The roof is covered with a breathable roofing membrane and has plain tiles above.

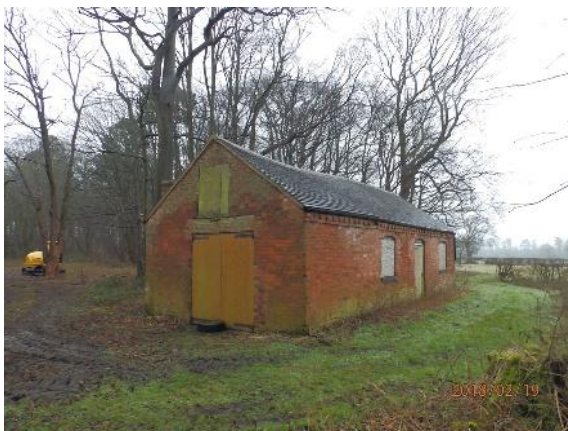
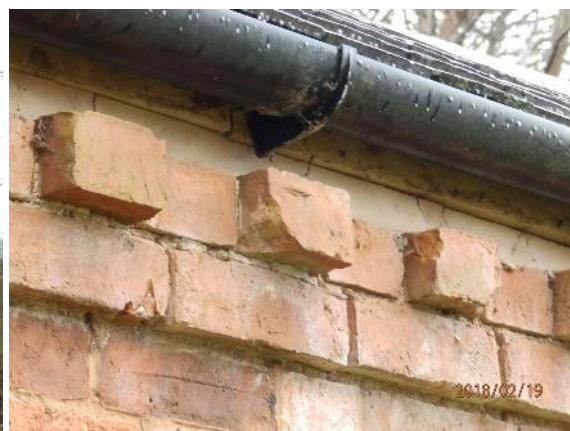
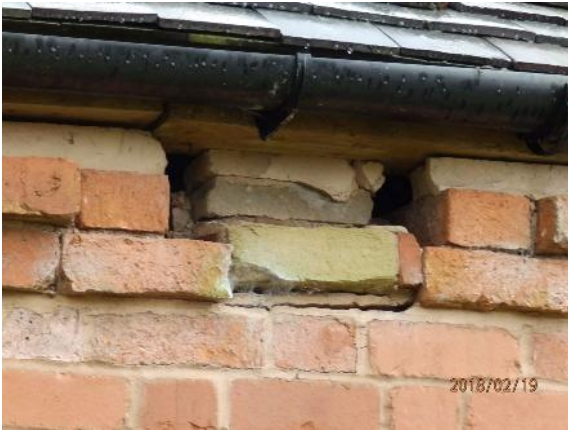
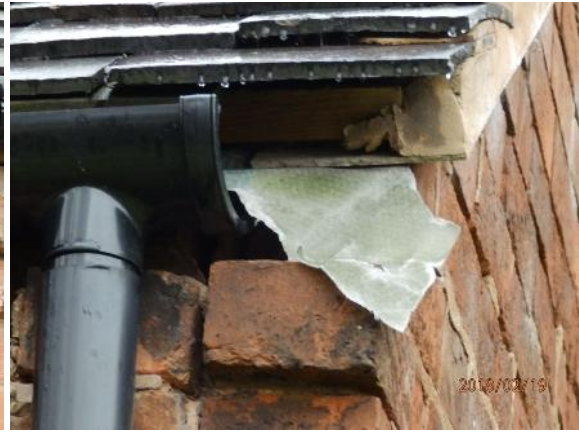
This is a solid brick walled building with a pitched roof. The eaves are corbel brickwork with two areas of damaged brick giving access to the inside of the building.

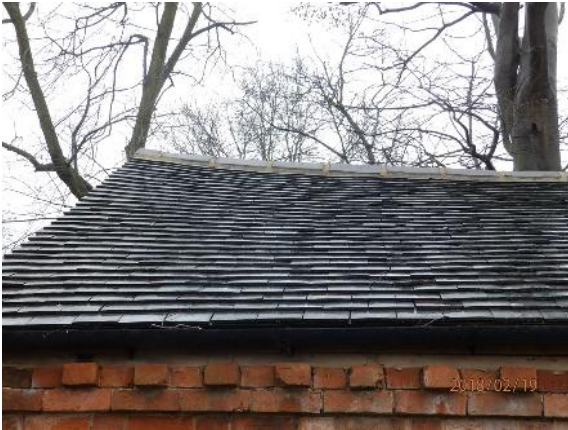
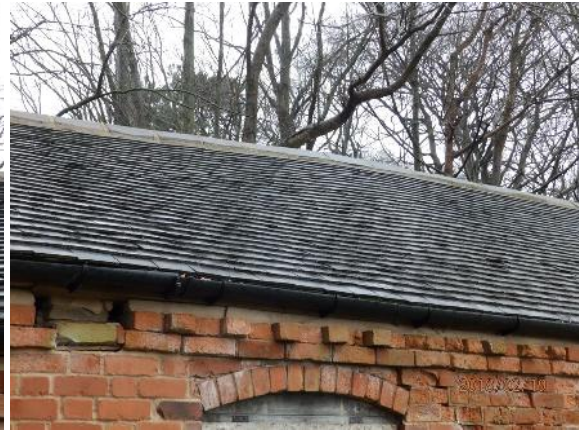
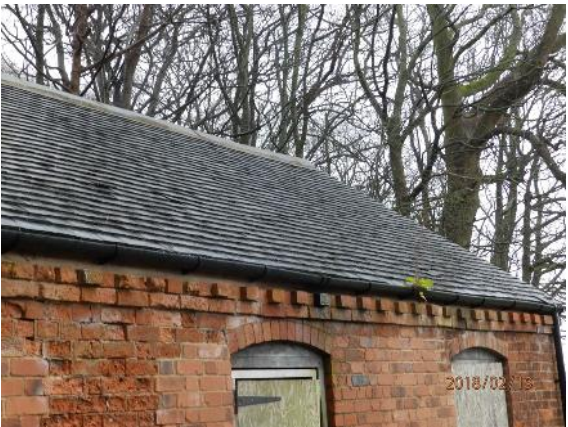
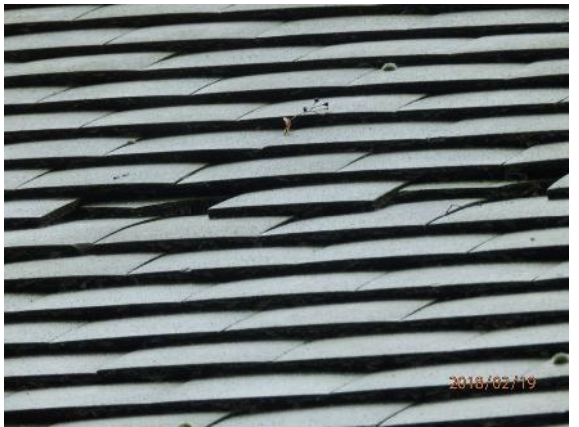
There are a number of broken plain tiles but there are no gaps giving access to the space between the rear of the plain tiles and the breathable roofing membrane.

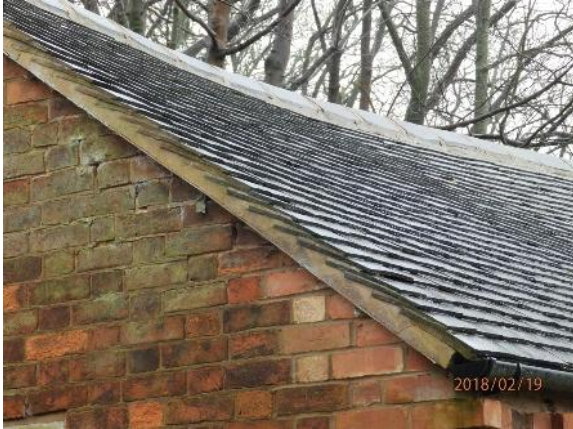
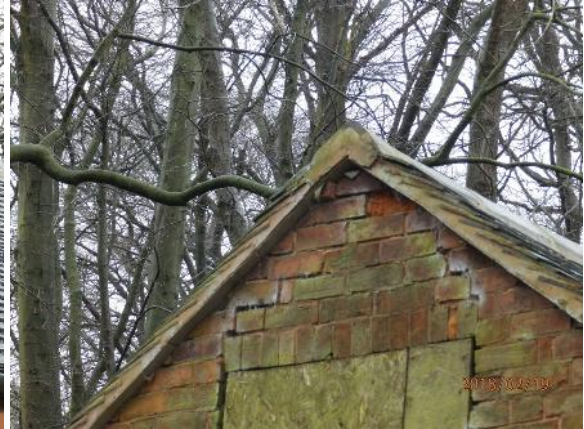
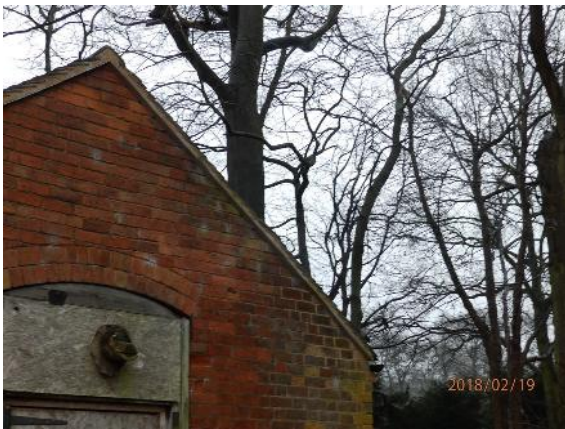
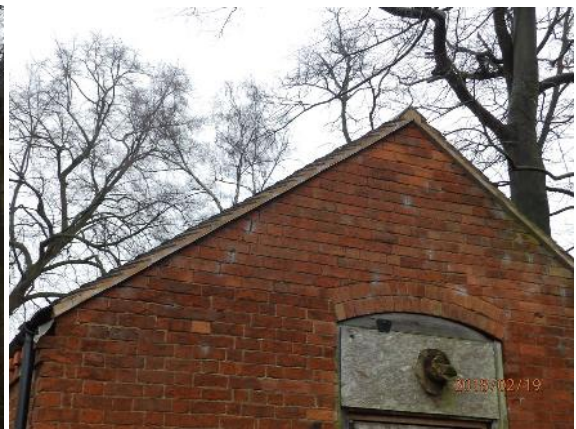
The northern verge is sealed and there is no access for bats but on the southern gable there is access beneath the verge where a brick is missing..

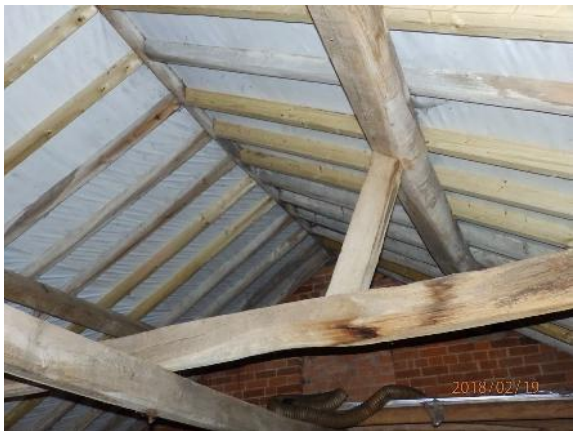
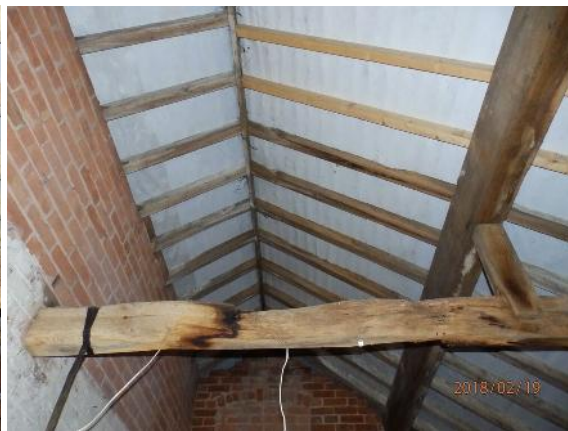
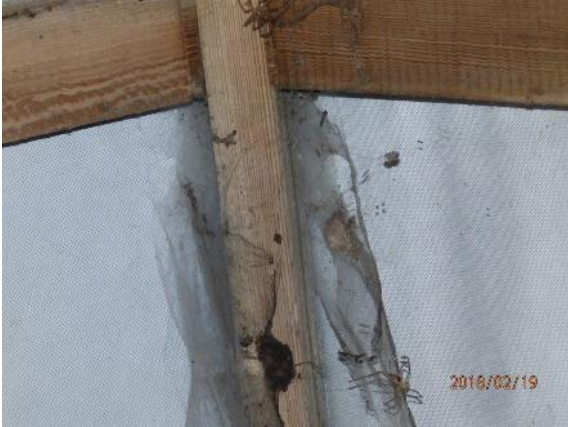
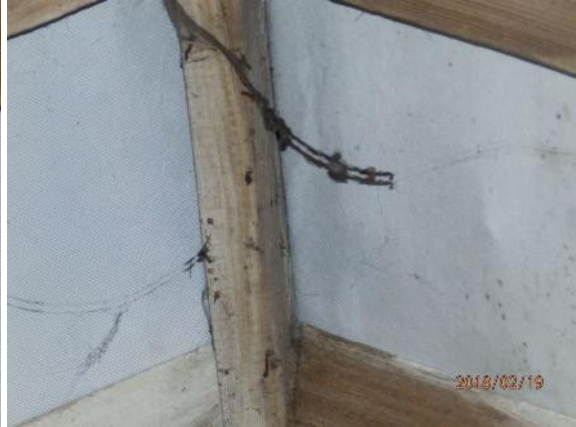
The roof is supported on timber purlins and rafters. There is a ridge board along the full length of the building.

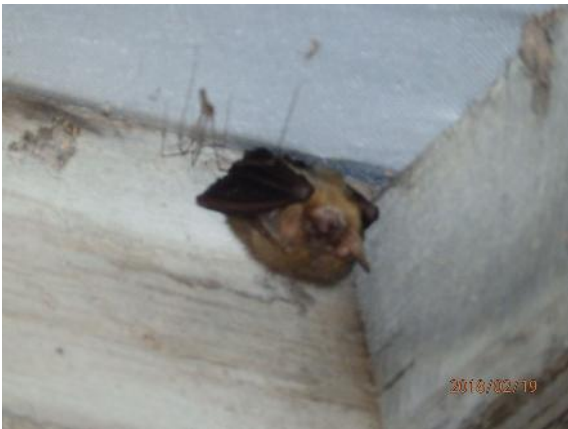
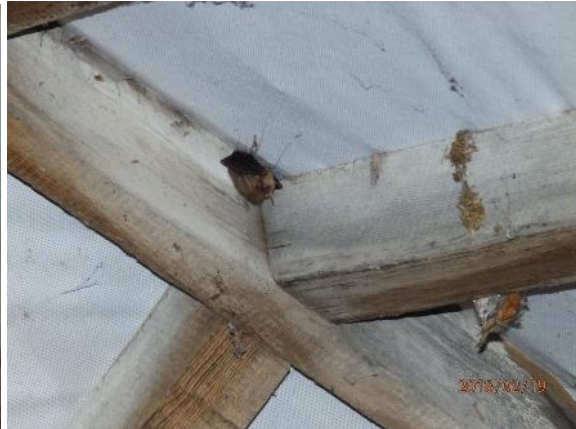
A single Brown long eared bat was seen roosting against the ridge board in the northern part of the building.

Bat roosting opportunities; Definite.

The bat consultant recommends that a new bat loft is created for both hibernation and day roosting.

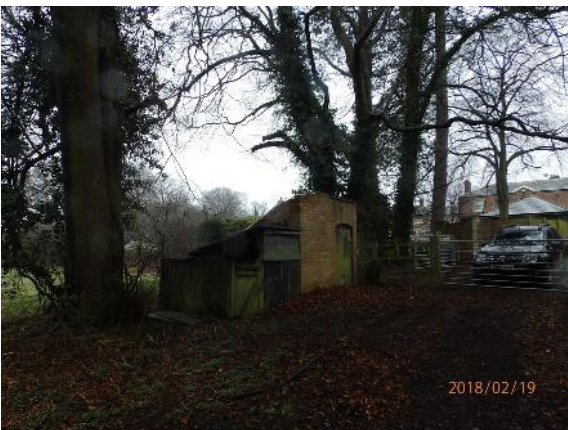
Animal pen and house.

This is a solid brick walled structure with a mono pitched roof. There are timber rafters with some degraded polycarbonate sheets or slates above.

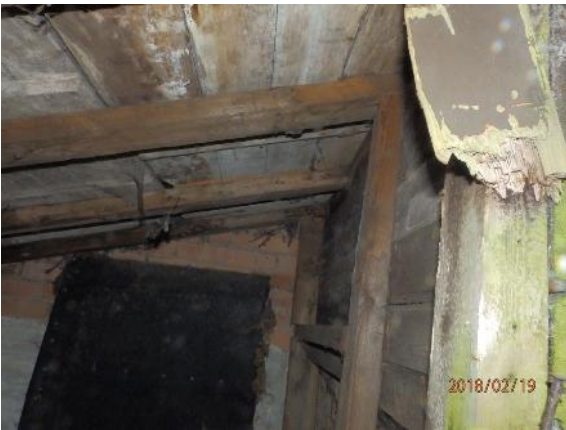
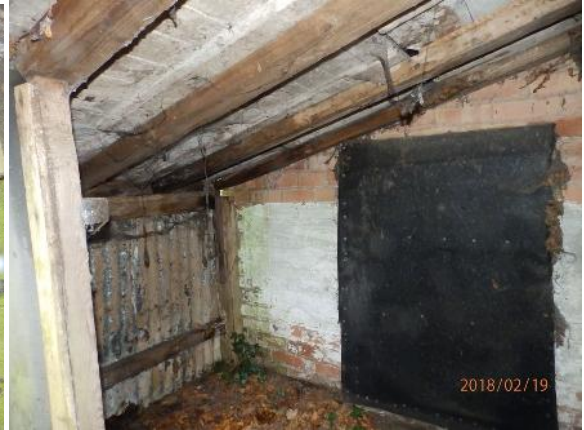
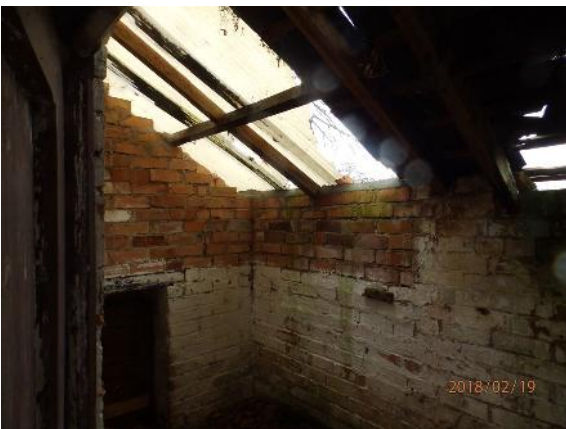
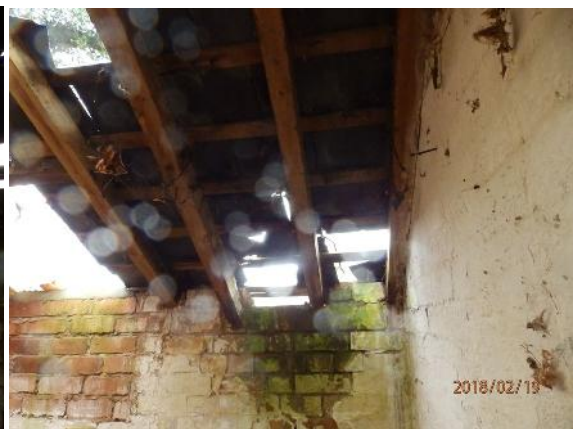
The building offers only very temporary places of shelter for bats which are exposed to weather penetration. The building could provide a temporary place of shelter for individual bats during periods of warm weather. This place of shelter is very poor and unlikely to be used.

Bat roosting opportunities; Very Poor/None.

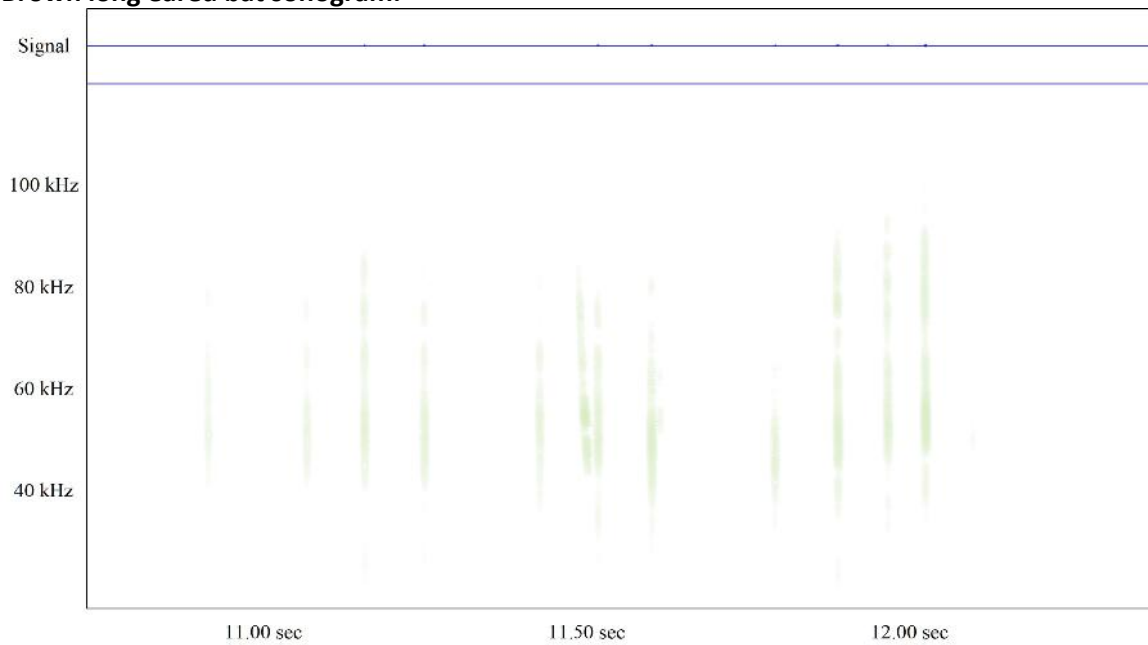
Brown long eared bat sonogram.

The presence of Brown long eared bats was confirmed by the bats being seen in flight. The calls are very quiet and show a faint frequency modulated call with a split in the call making it appear as a staggered downwards line.

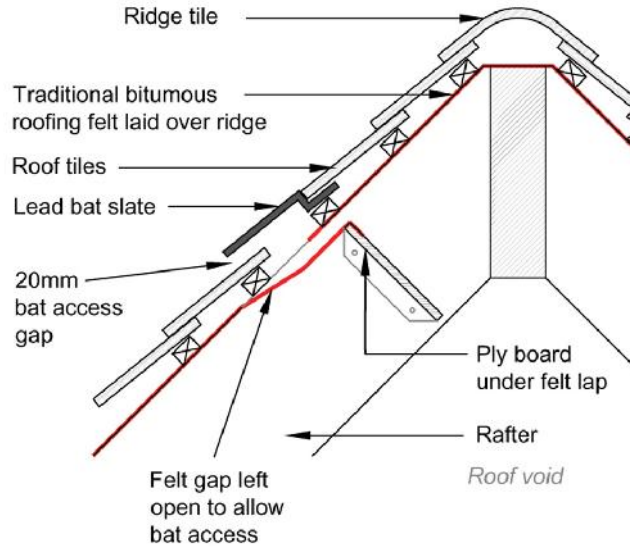
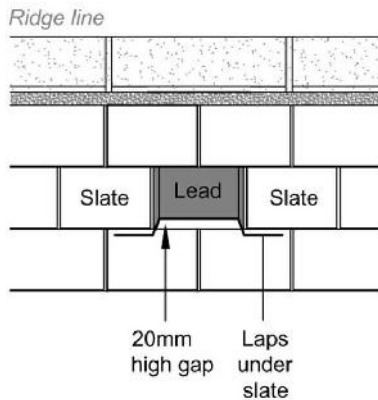
**BAT ACCESS 'SLATE'
DETAIL 1B - with access to
roof void**

SECTION: BAT ACCESS 'SLATE' 1B
Not to scale

Elevation: BAT ACCESS 'SLATE' DETAIL 1B
Not to scale

Bat slate built into slope

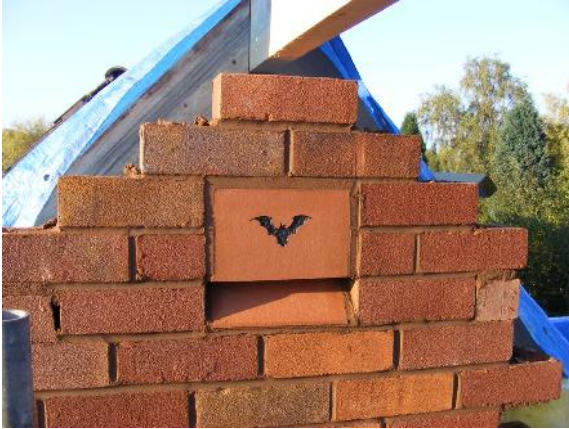
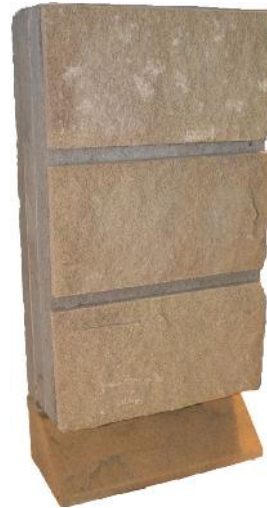
A brick built bat box can be installed at the gable apex of southern elevation of the new dwelling, should planning permission be granted. These are constructed from brick or concrete blocks and are built into the outer leaf of brickwork. They can have facing bricks or be rendered. They provide no access to the cavity wall.
