Arboricultural Constraints Appraisal

in Relation to Proposed Construction of Food Store at

**Pennylands House, High Street,
Skelmersdale, Lancashire, WN8 8AZ**

November 2021

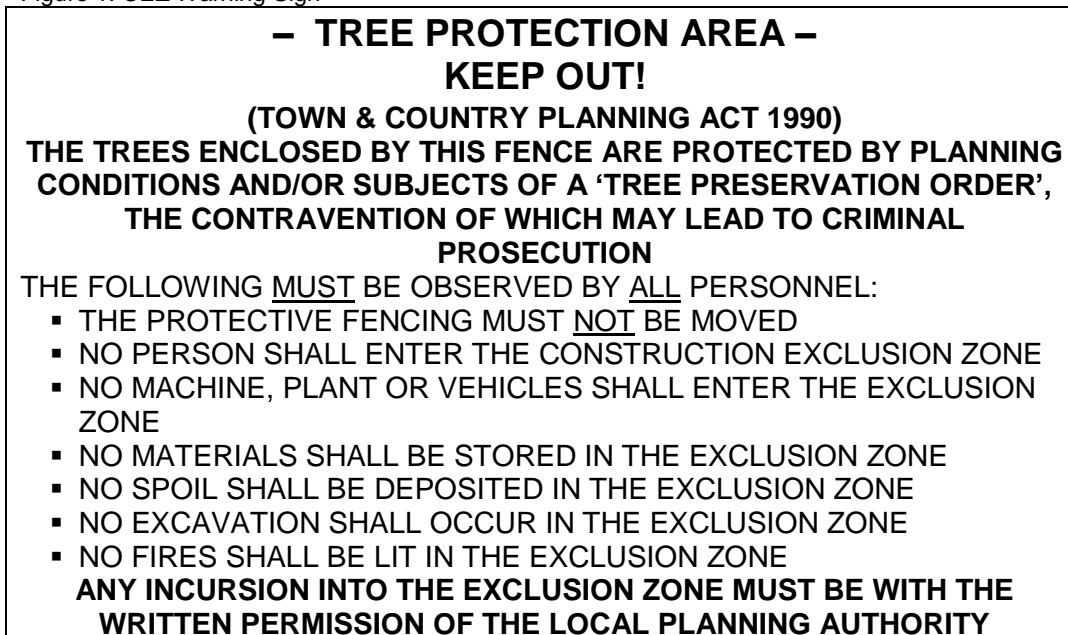
Figure 1: CEZ Warning Sign

8. be affixed with a 600mm x 300mm warning sign reading "TREE PROTECTION AREA KEEP OUT" (see Figure 1, below), at every 10.0 metre length of protective fencing.
