# The Old School.

The Pottery, Culmington, Ludlow, Shropshire. SY82DF. September 2021

# Flood Risk Assessment / Drainage.

Appendix D : Percolation test.

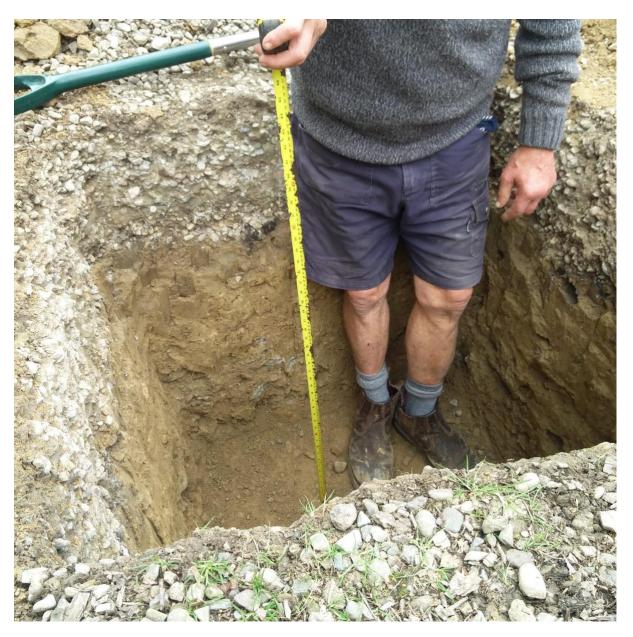
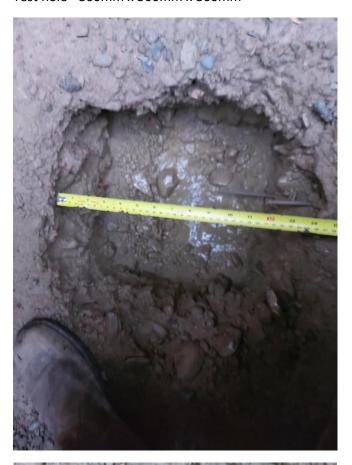
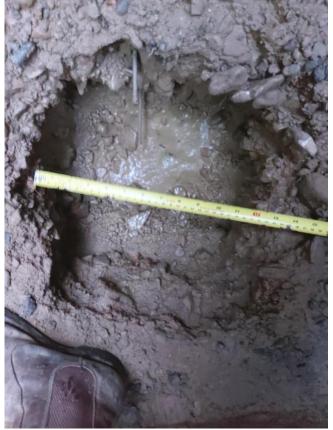
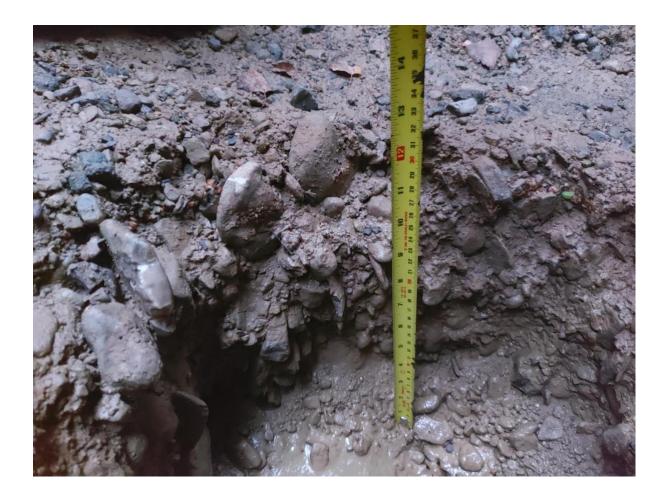
#### 1. Hole dimensions

First hole before test hole taken out of the centre 1000mm x 1000mm x 1000mm

Test hole - 300mm x 300mm x 300mm

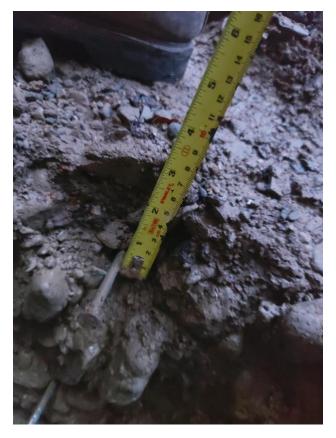
Nail 1 : 75 mm from test hole 'top'

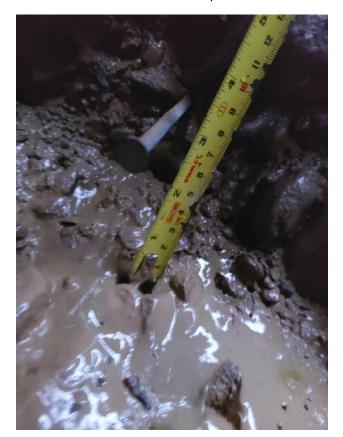
Nail 2: 75mm from test hole 'bottom'

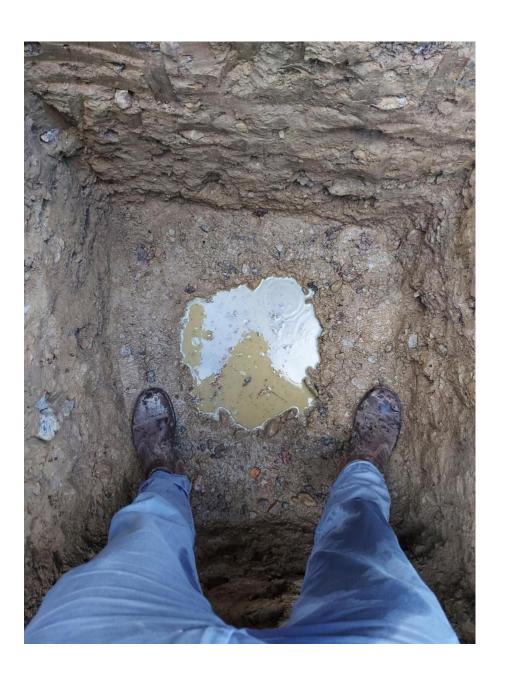
## 3. Test hole first fill at 18.17pm 17/09/2021 (left to drain for 12 hours)

Hole first filled and left for 12hours at 18.17pm 17/09/2021

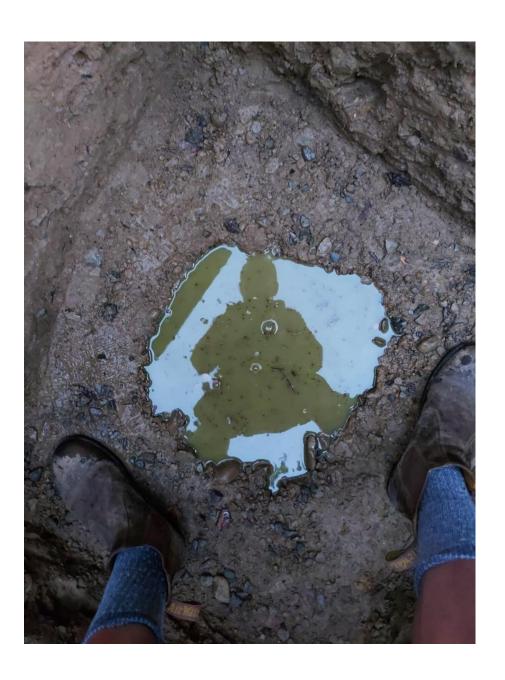
# 4. Typical test : Full.

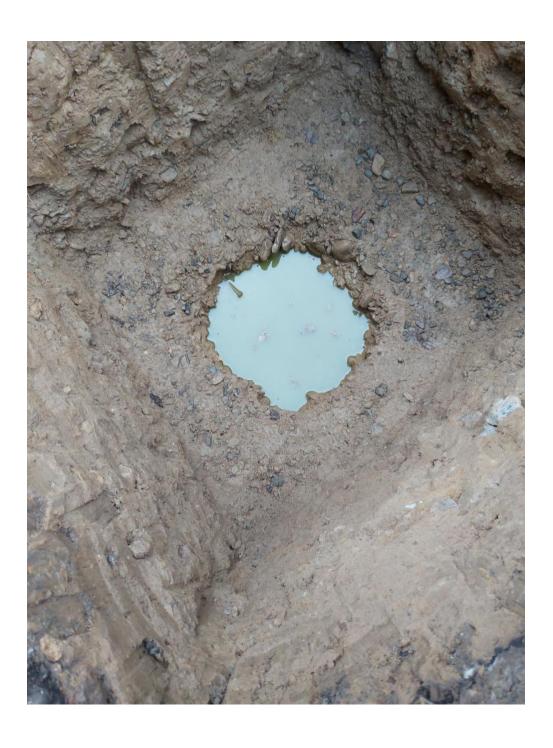
## Draining to nail 1

Test	Date	Fill time	Nail 1	Nail 2	Stopwatch	Total seconds	Sec/150
1	18/09/2021	6.50am	7.52am	11.54am	4h1m39s	14499	96.66
2	18/09/2021	12pm	13.25pm	17.28pm	4h2m52s	14572	97.14
3	19/09/2021	9.01am	9.59am	14.00pm	3h59m08s	14348	95.65
							96.48333

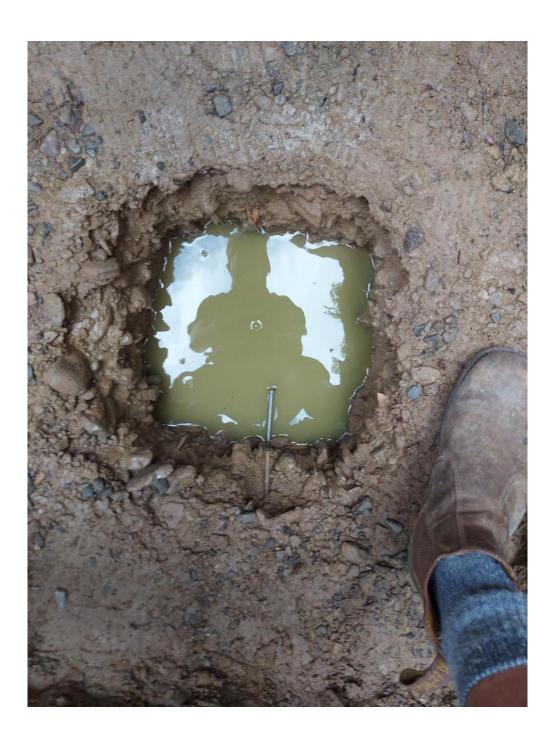
## Draining to nail 2.
