Watering Farm

Existing typical wall buildup
 174_WF1_HAT_PL_035

Status: Planning
 Revision: PL2
 Date: 22/12/2021
 Scale: 1:100 & 1:10@A3

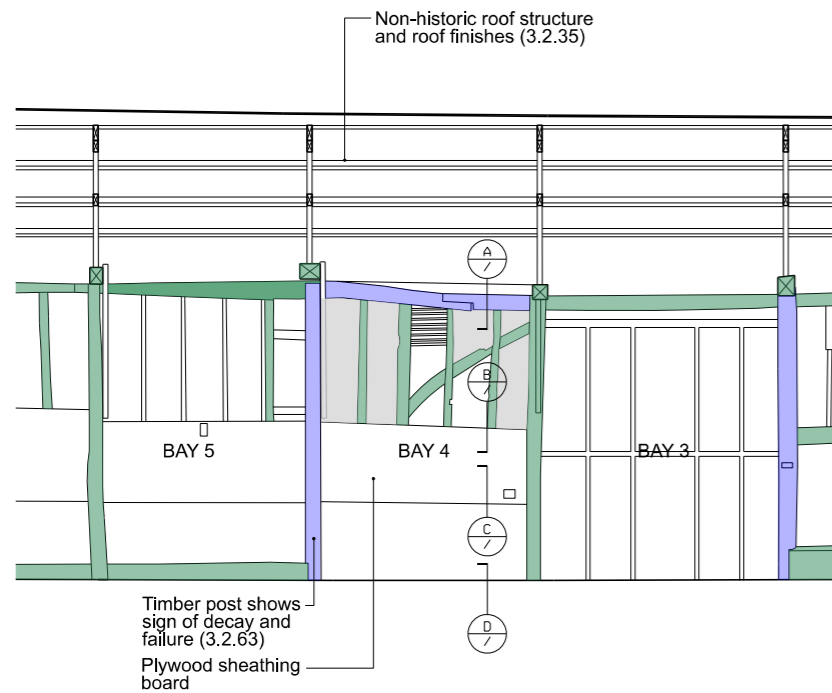
Internal Wall elevation (from Section DD)
 All wattle and daub infill on this wall in poor condition (3.2.62)

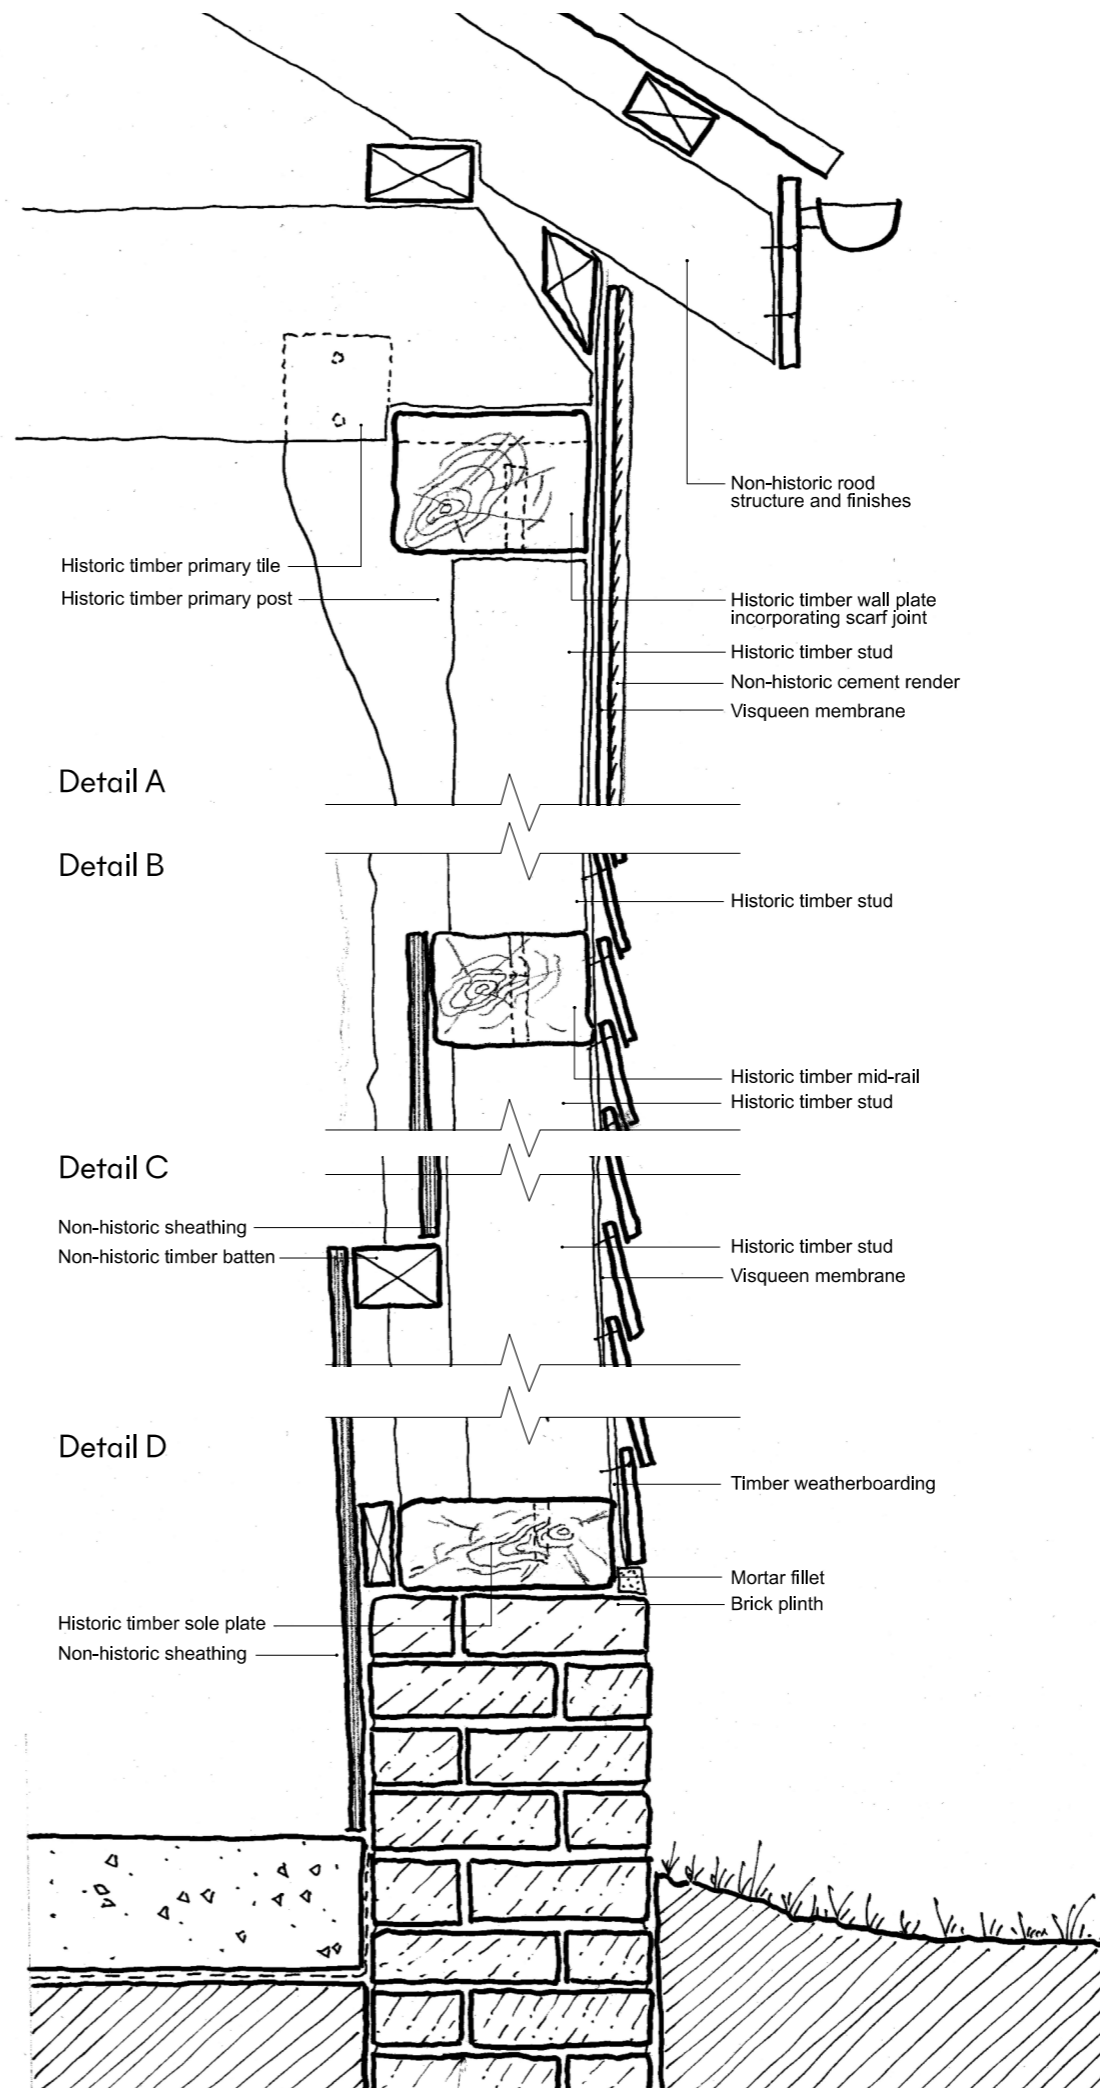
- Areas of historic wattle and daub
- Visible historic timber elements
- Historic frame elements identified in structural survey as in need of replacement or repair
