## Watering Farm, Nettlestead

## Bat Activity Survey

July 2020

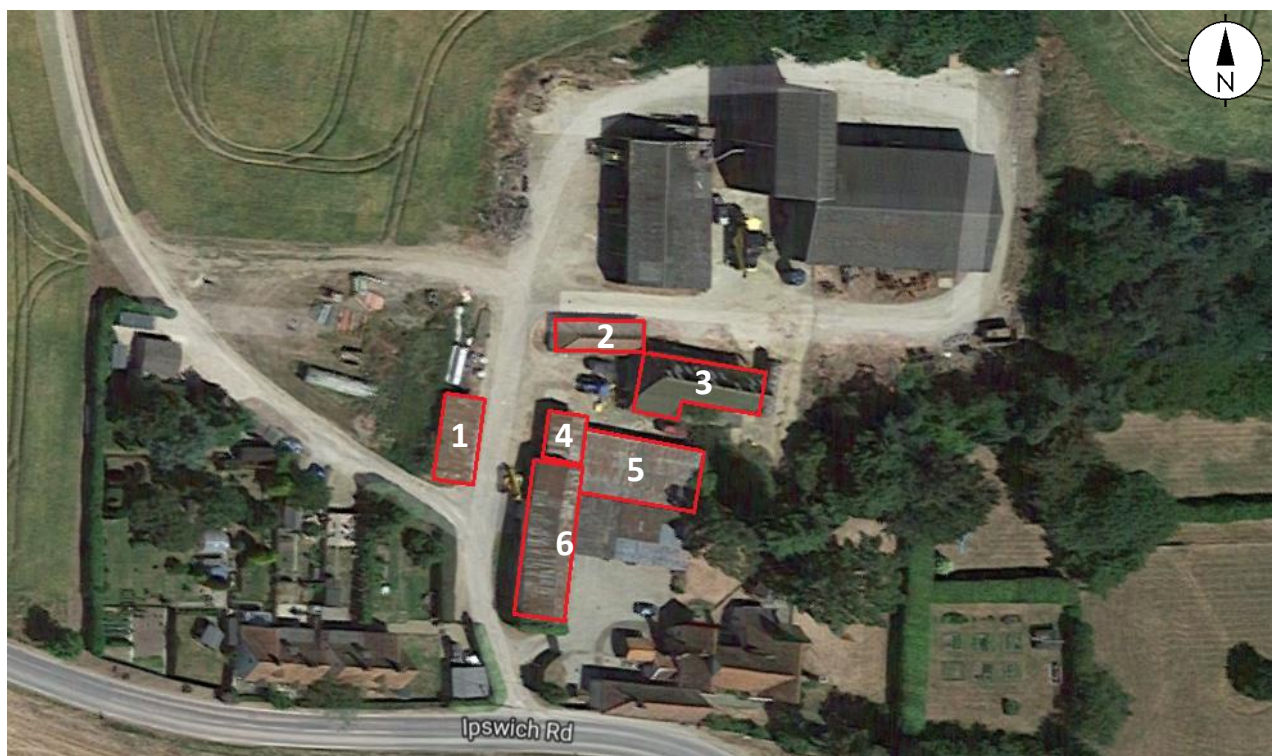
**Figure 1:** An aerial photograph of the surveyed structures (numbered) at Watering Farm, Nettlestead (as shown by the red outline). The arbitrary numbers for each building referred to throughout this report are also illustrated.

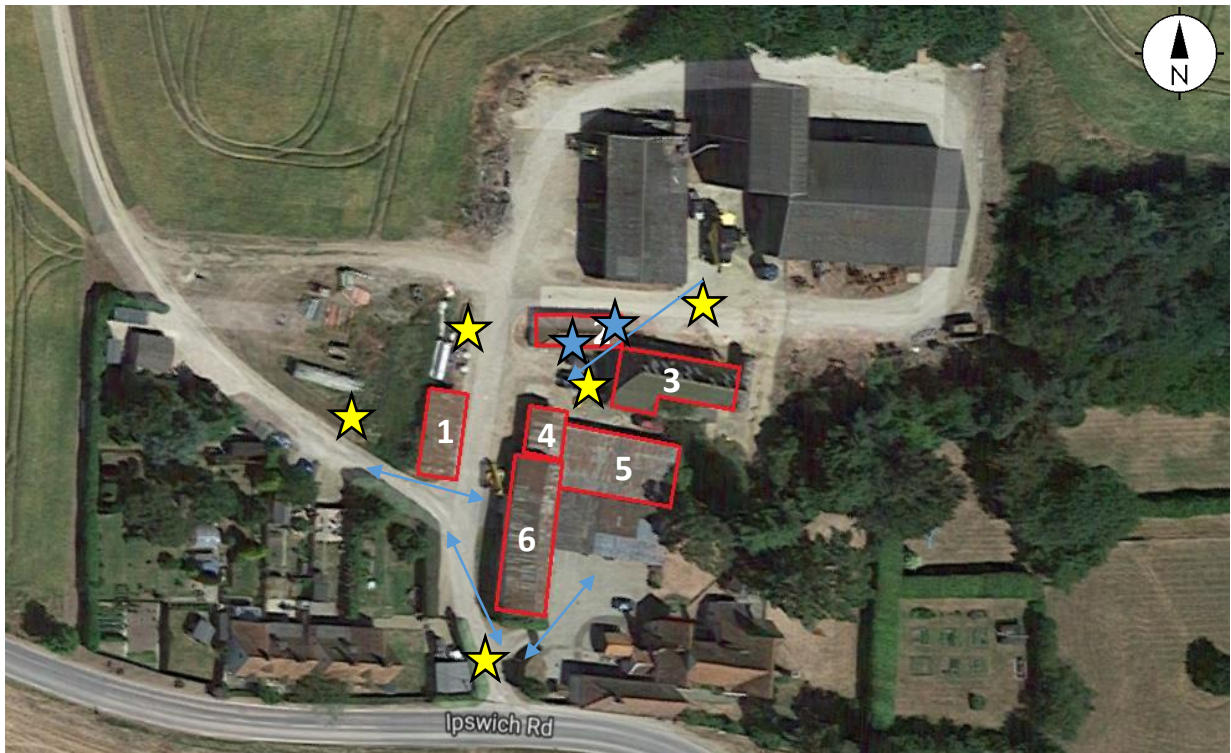
This survey was undertaken at dusk, with sunset being recorded at 20:15. During this survey, common pipistrelle (*Pipistrellus pipistrellus*) and myotis (*Myotis sp.*) bats were recorded commuting and foraging around the survey site. In addition, two common pipistrelle bats were observed emerging from building 2 (B2). The egress points were identified underneath a roof tile on the southern elevation and from the eastern elevations.

The activity surveys provided evidence that building 2 (B2) at Watering Farm is in use as **day roosts** for common pipistrelle (*Pipistrellus pipistrellus*) bats, with a peak count of two roosting individuals. In addition, the surveys provided evidence of common pipistrelle (*Pipistrellus pipistrellus*) and myotis (*Myotis sp.*) bat activity around the survey site.

**Figure 3:** An aerial photograph of the surveyed structure (red outline), the surveyor locations (yellow stars) and the identified bat flight paths (blue arrows). The common pipistrelle day roosts are indicated by a blue star.

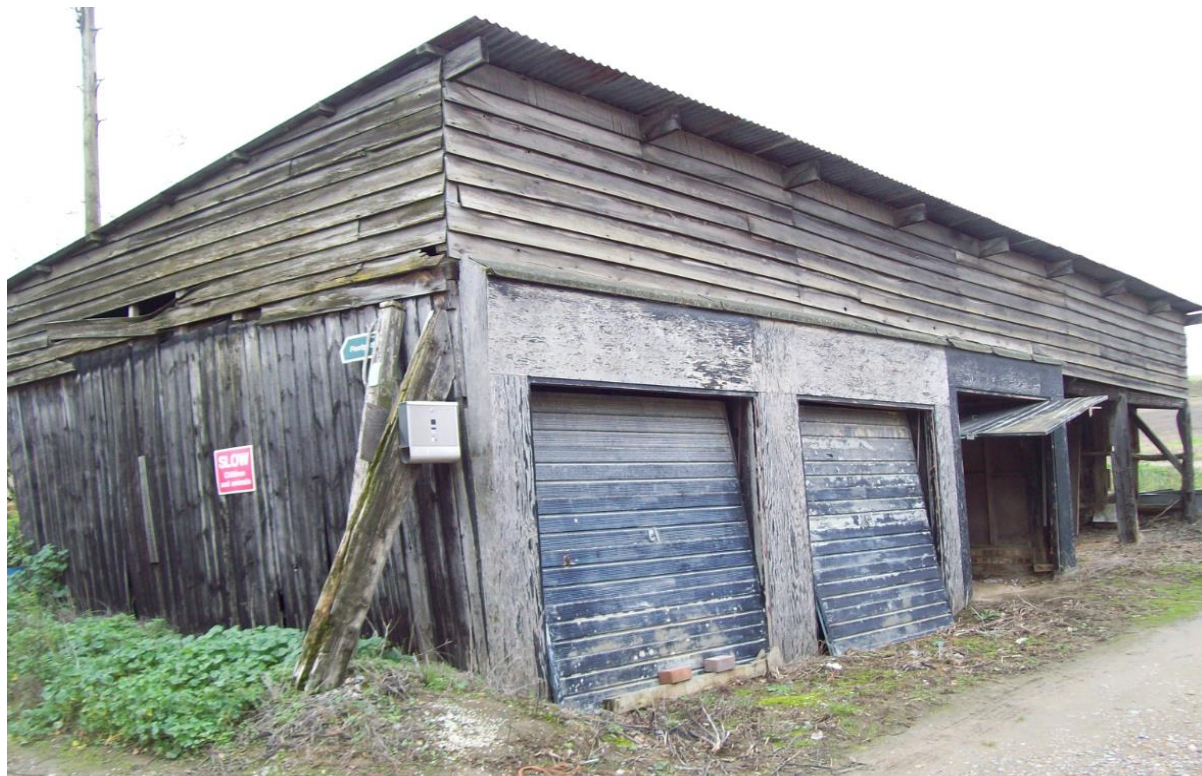
This structure is an old garage and shed. It has a shed-style, corrugated metal roof. The external walls are constructed out of horizontal and vertical timber cladding which is damaged in multiple areas. Three garage doors to the south are also damaged or left open to facilitate access to the interior. The northern section of the building consists of an open shed. No bird nests were identified on the exterior of this building.

**Plate 1:** A photograph of the eastern and southern elevations of B1.

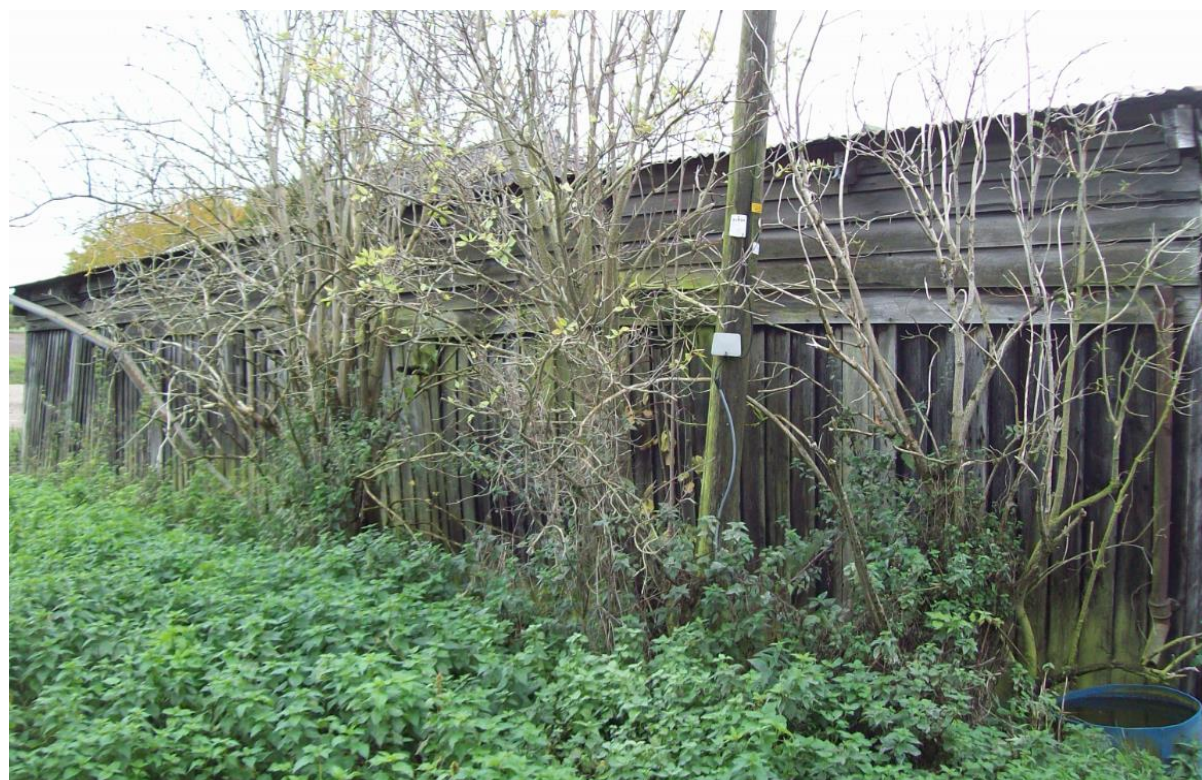
**Plate 2:** An image of the western elevation of B1.

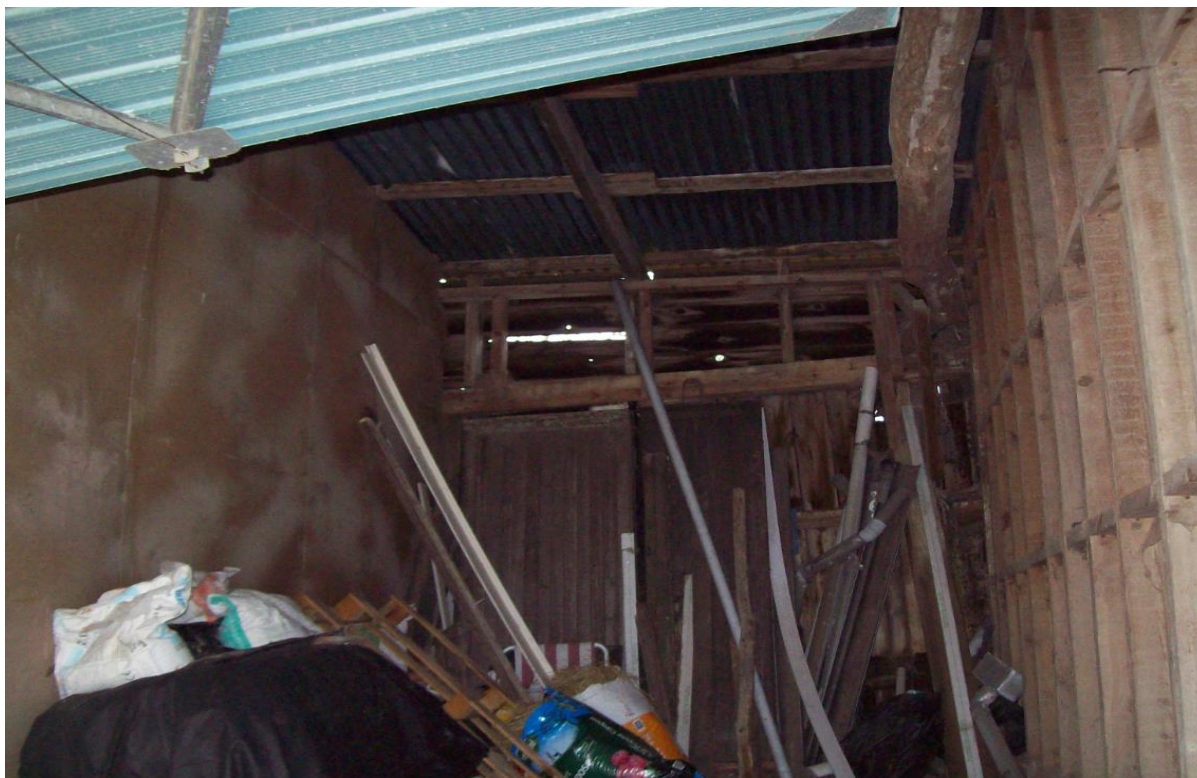
Internally, the structure is used for storage purposes, with the roof being directly supported by timber rafters. Gaps in the external walls are also apparent from the inside. Due to the damaged garage doors, it is impossible to enter the building for internal inspection. No evidence of bats or birds' nests were observed in the internal areas that were visible from the outside.

**Plate 3:** An internal view of B1.

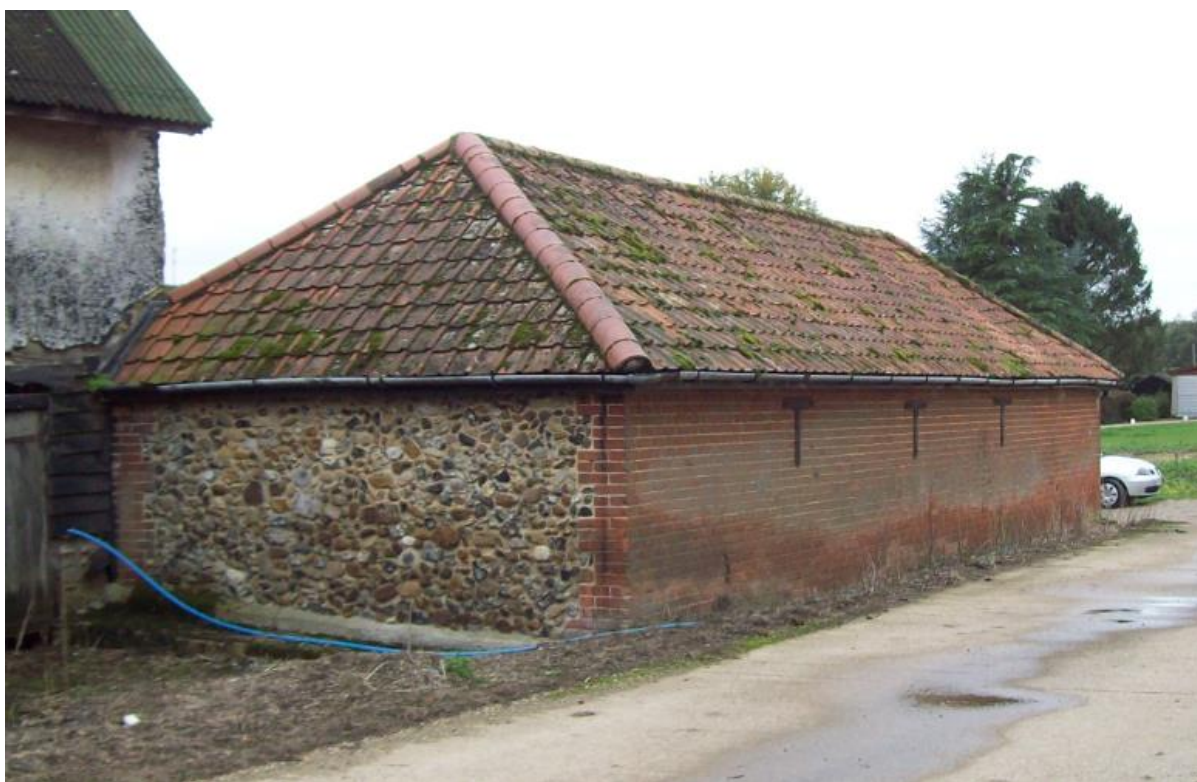
This building is a single-storey dwelling. The external walls are of a brick construction on the northern elevation, a stone construction on the eastern elevation and rendered on the southern and western elevations. The roof is hipped and has clay tiles. No roof tiles are missing or dislodged and no substantial gaps are apparent. There are slight gaps between the wooden soffits and external walls, with one of the soffit boards missing leaving a large gap for bats and birds to use. A window on the southern elevation is partially open. No evidence of nesting birds or bat presence was identified externally.

**Plate 4:** The northern and western elevations of B2.

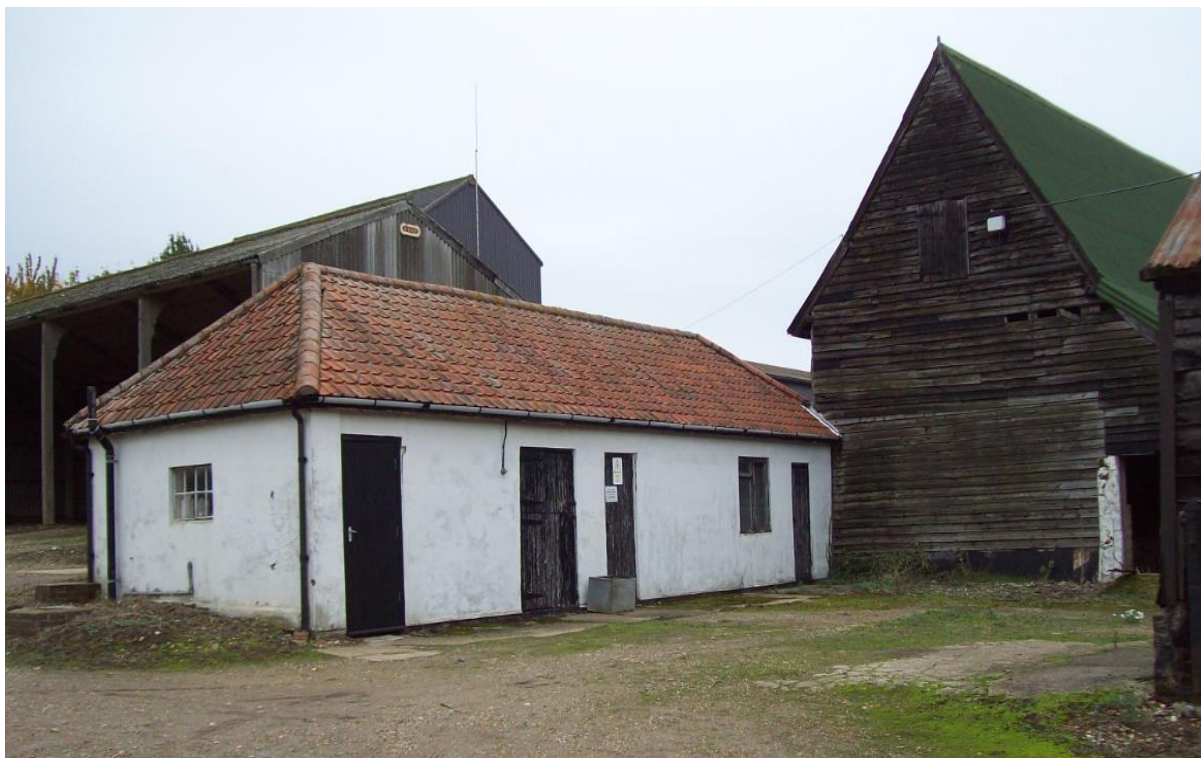
**Plate 5:** An image of the southern and western elevations of B2.

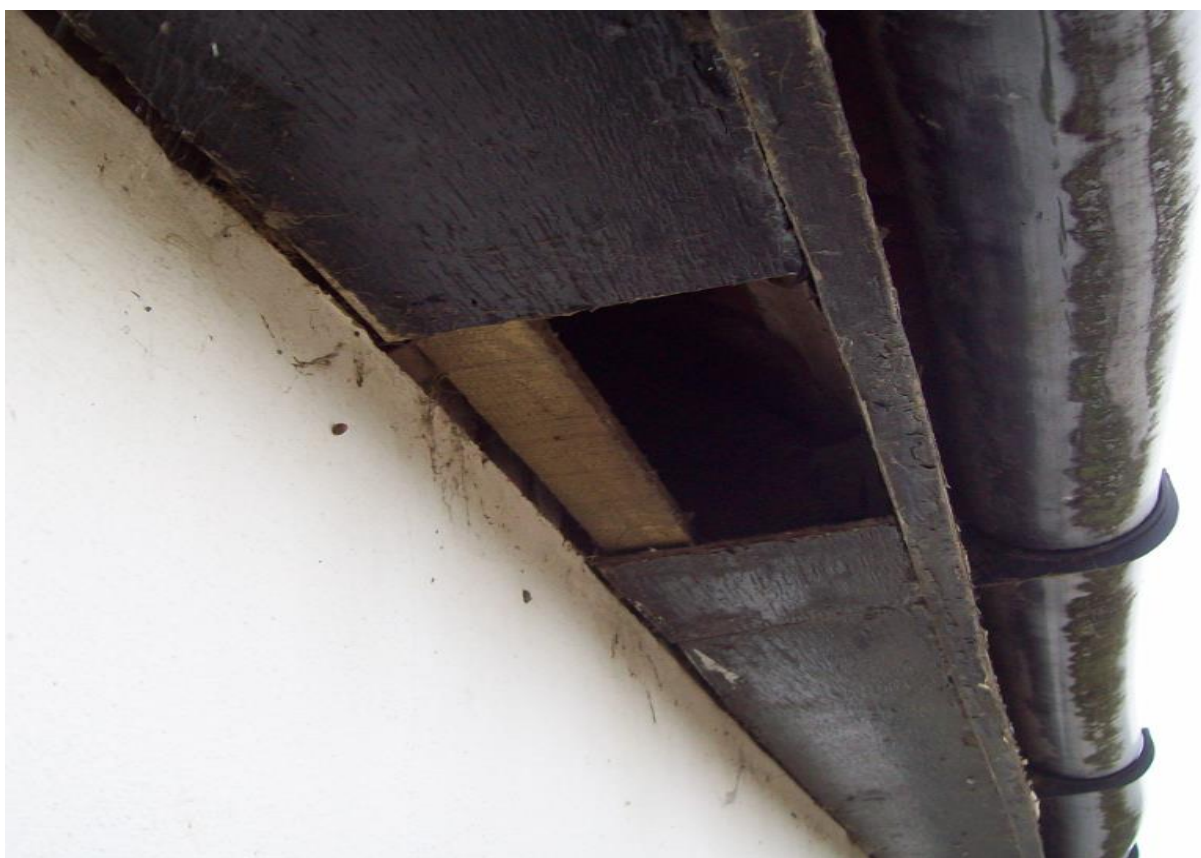
**Plate 6:** Detail of missing soffit board in B2.

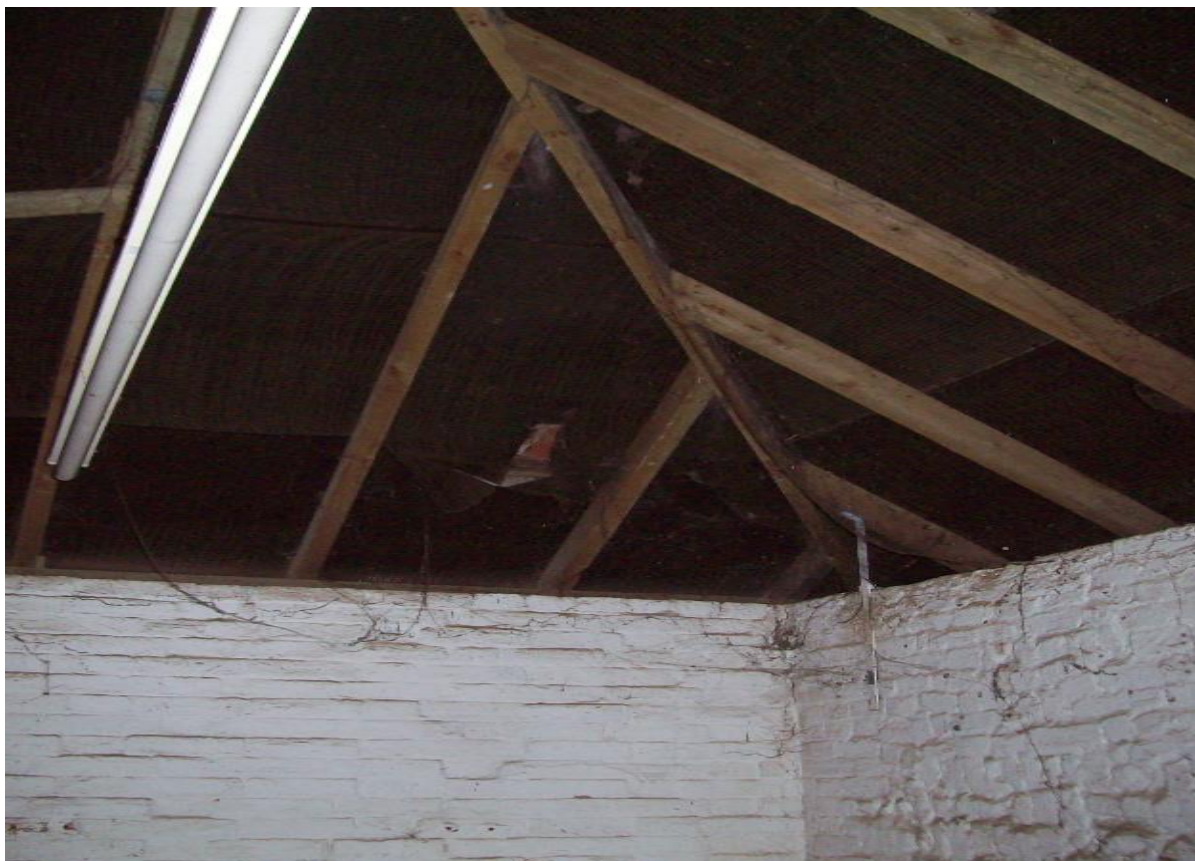
Internally, the building is used as an office block. The roof is supported by timber rafters and lined with felt, which is torn in a few areas. There is evidence of rat or mouse presence in the loft due to the identification of rodent droppings. No evidence of birds' nests or bats was found.

**Plate 7:** The interior of B2.

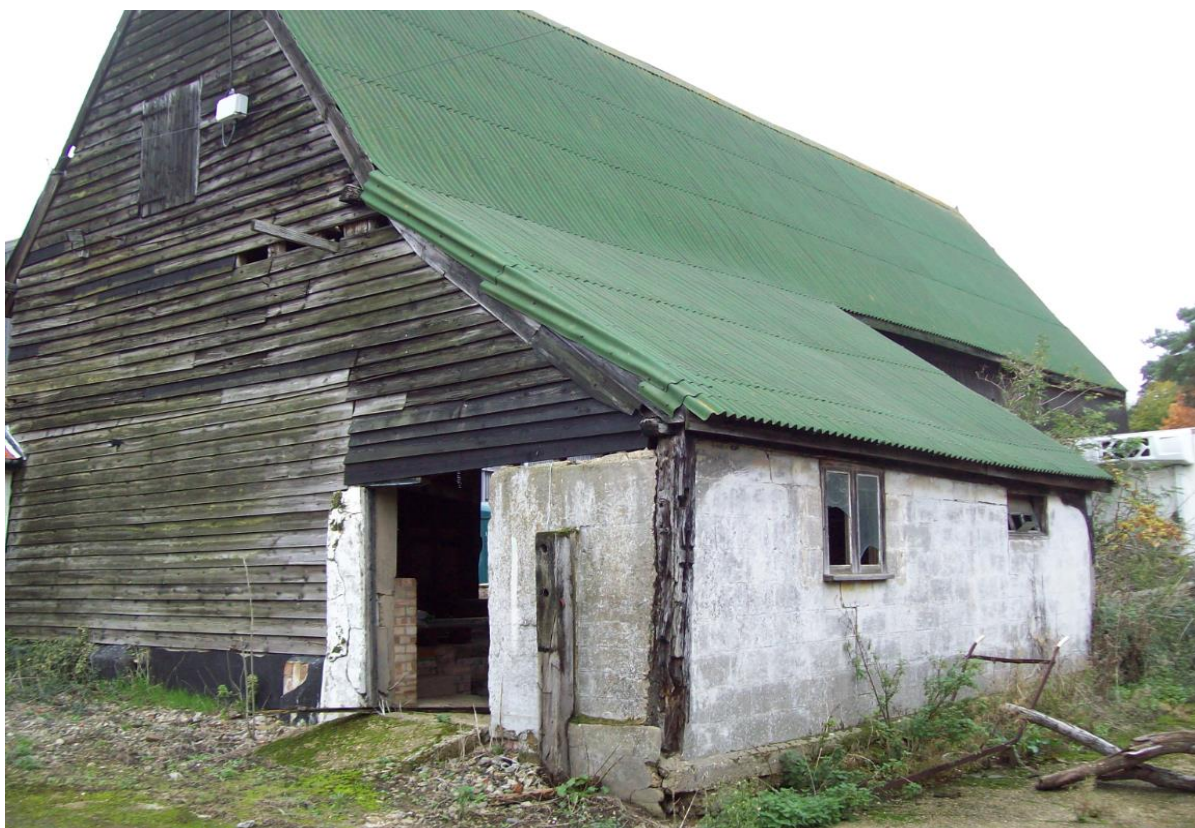
This structure is a high, single-storey building. The external walls are primarily constructed out of timber cladding, with a concrete block extension to the south. The structure has a pitched, corrugated metal roof. The cladding is damaged in multiple areas and doors are missing on the northern and western elevations, thus providing large entry points for wildlife. No evidence of nesting birds' were found externally.

**Plate 8:** The southern and western elevations of B3.

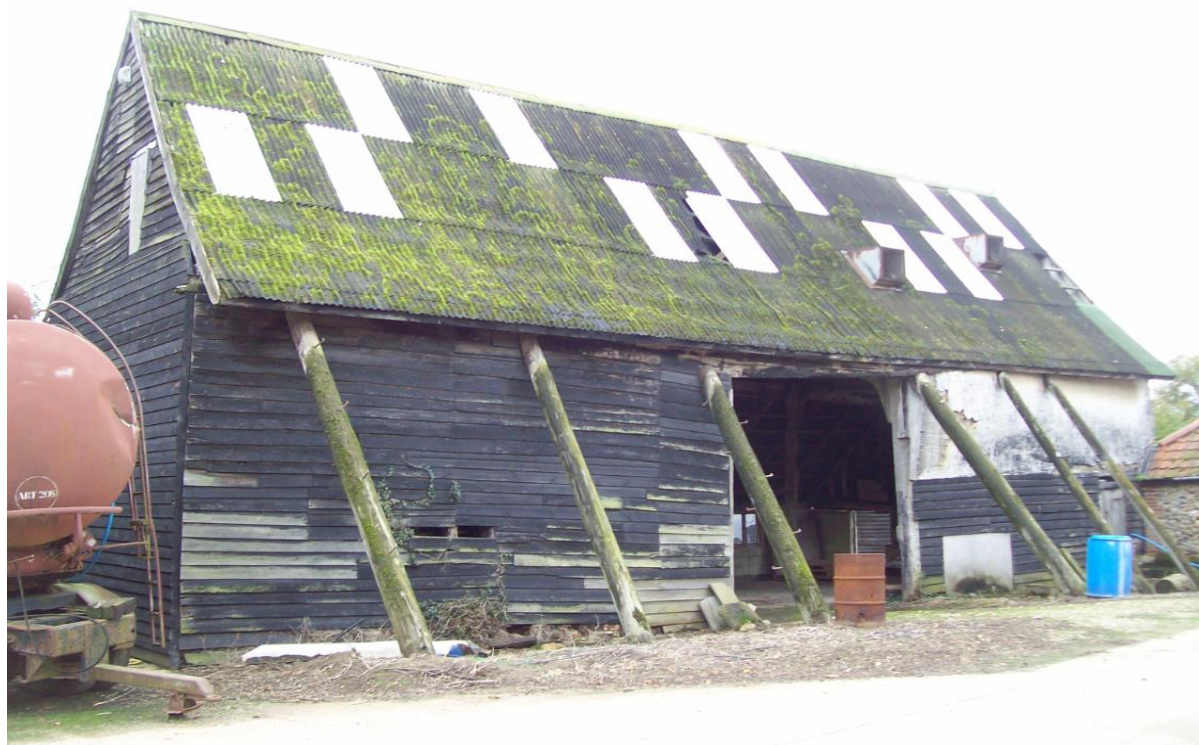
**Plate 9:** The northern elevation of B3.

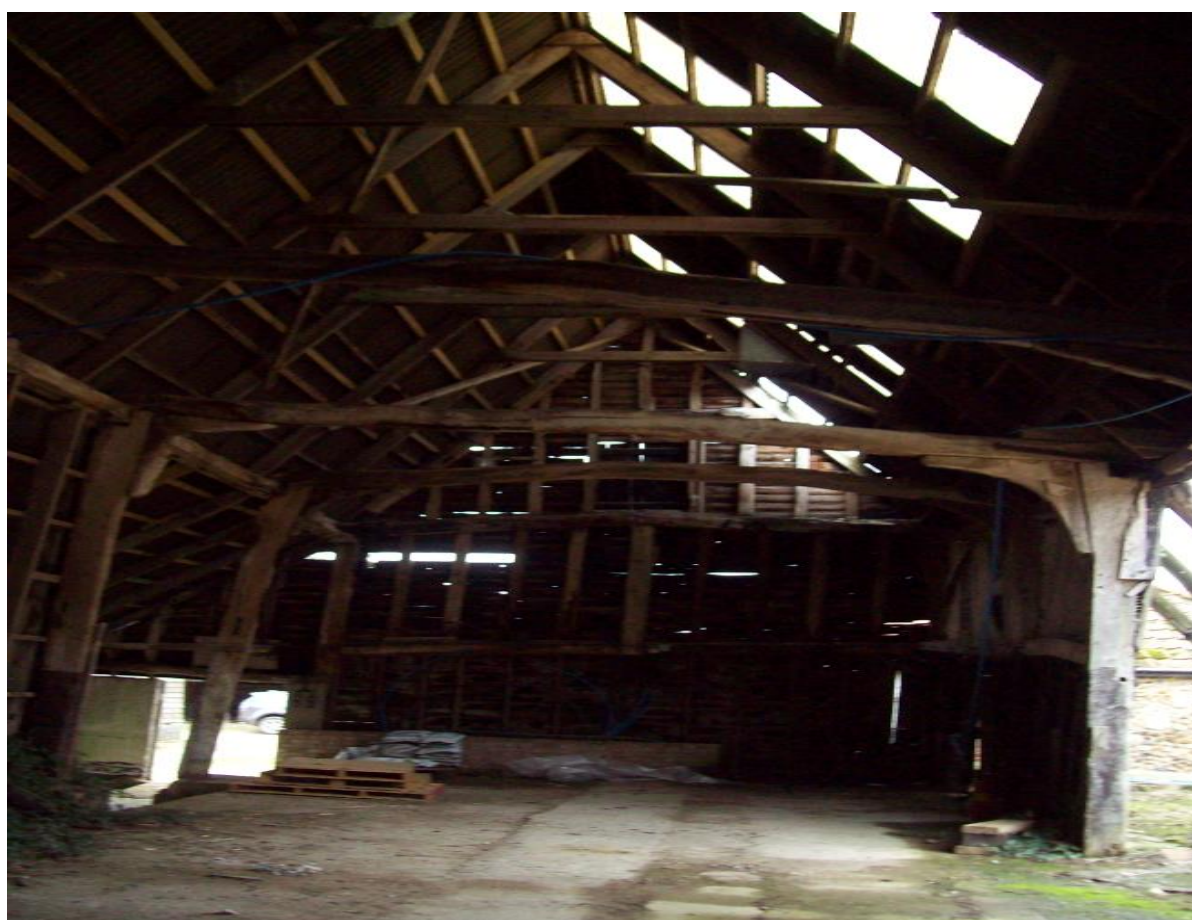
The building is empty inside and well-lit by daylight due to the missing doors. The roof is supported by timber beams and no roof lining is present. Bird droppings were found on the floor inside the building, although no evidence of bats or bird nests were identified.

**Plate 10:** An internal view of B3.

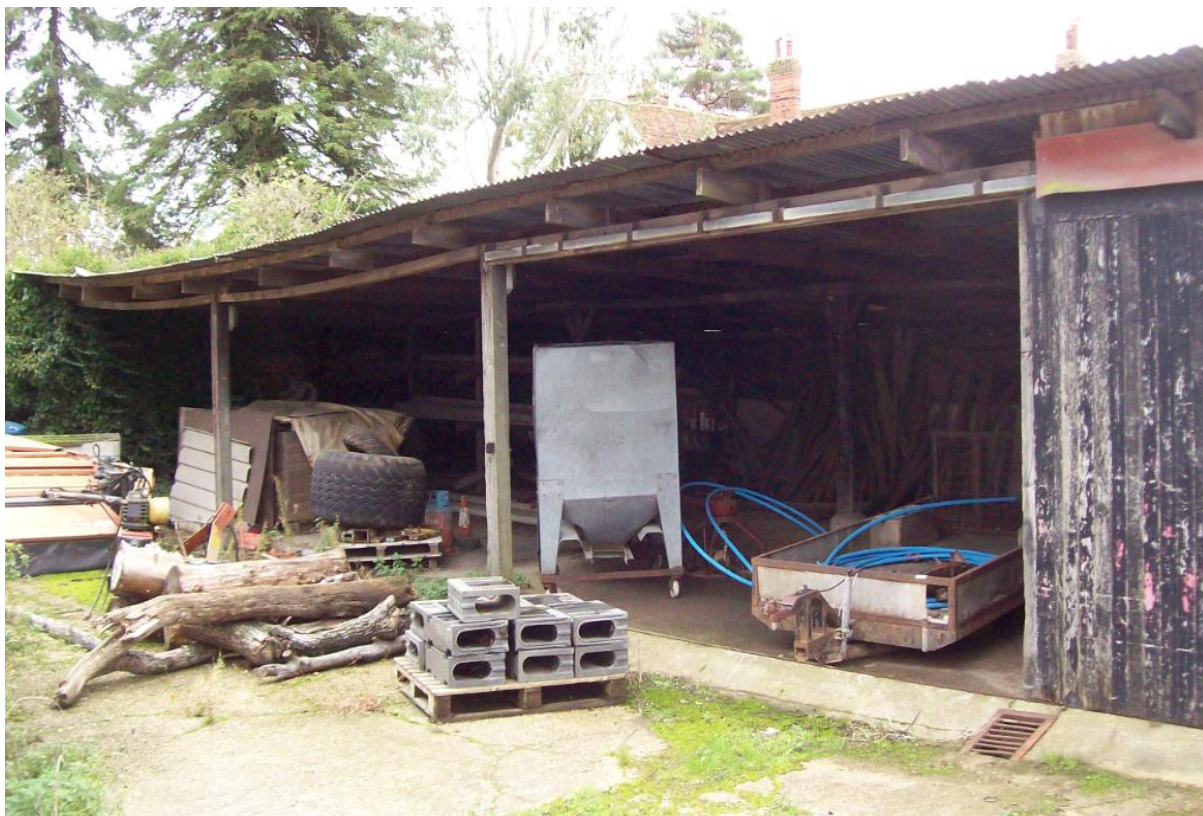
This structure is a largely open shed with an enclosed section to the west. It is a wooden construction with a flat, corrugated metal roof. There is lead flashing above the door to the enclosed area, underneath which there is a slight gap. No evidence of nesting birds were found externally.

**Plate 11:** A photograph of the northern elevation of B4.

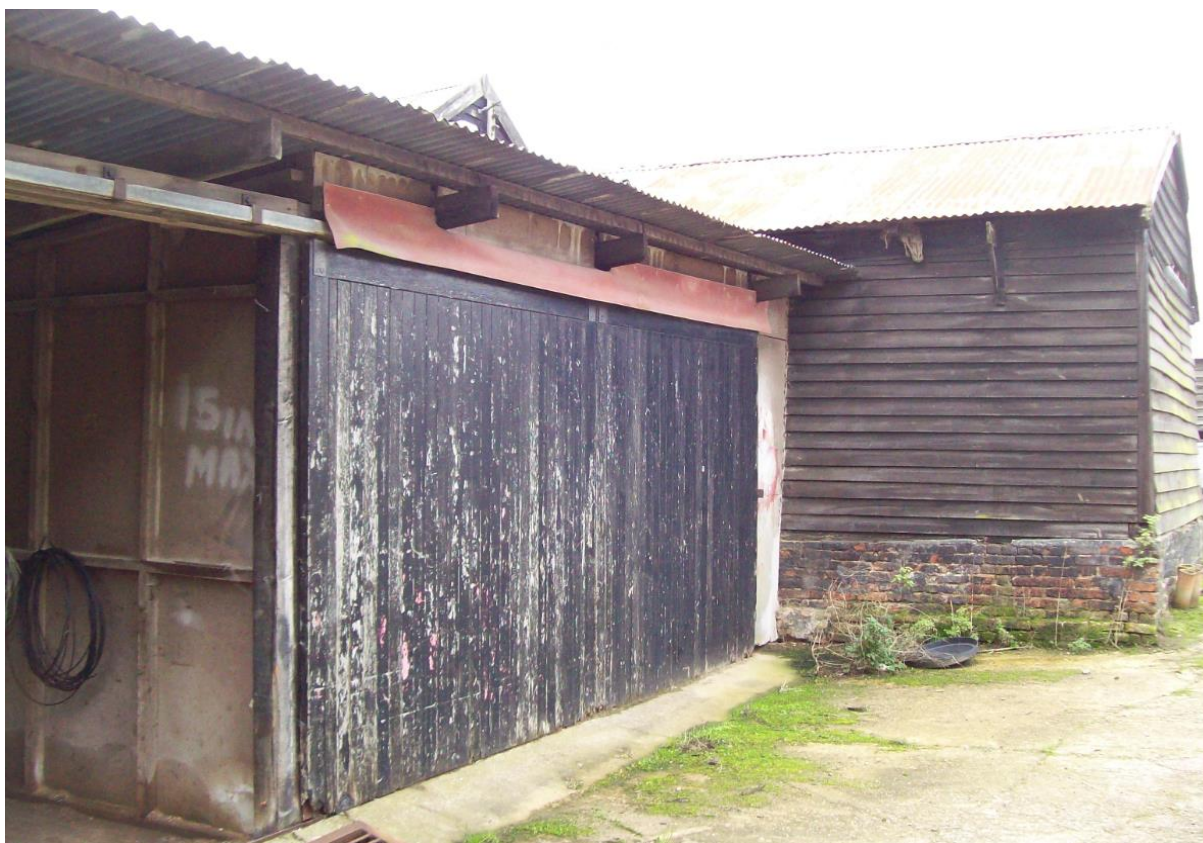
**Plate 12:** The northern elevation of B4 within the eastern portion.

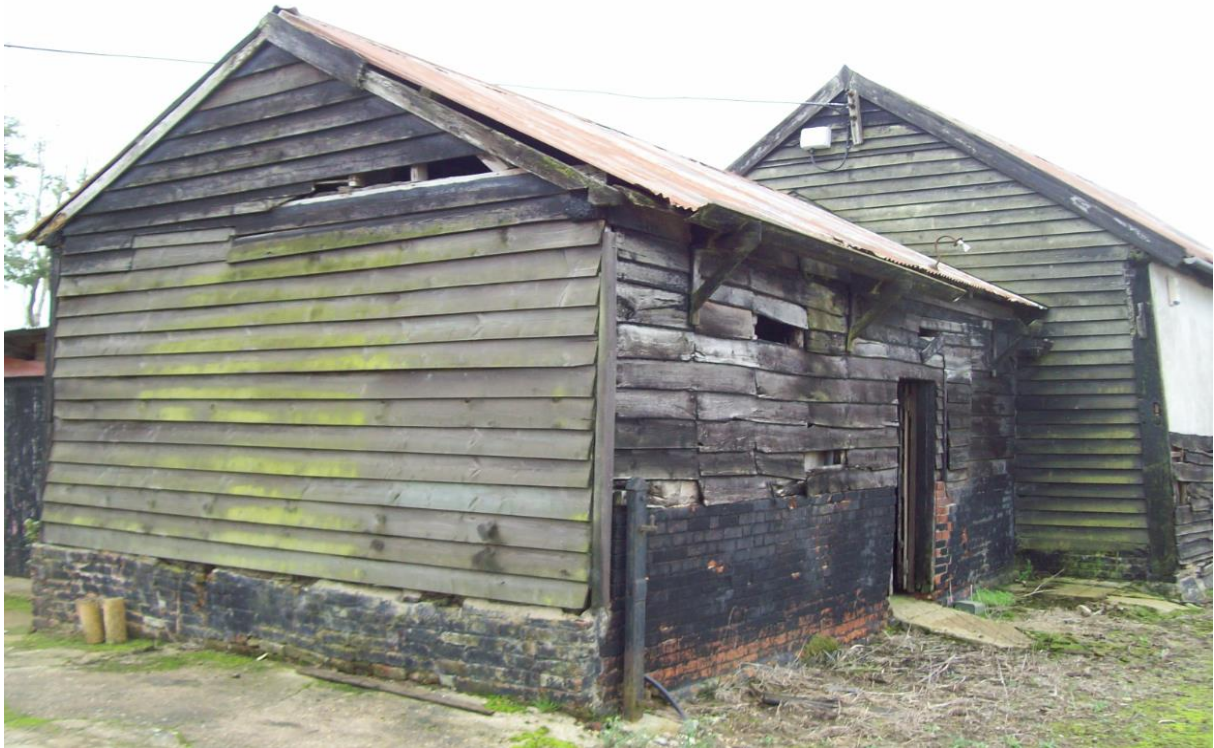
This barn is a brick and timber construction, with a pitched corrugated metal roof. The horizontal timber cladding is damaged or missing in multiple areas, providing large entry points for bats. No evidence of nesting birds were found externally.

**Plate 13:** The northern and eastern elevations of B5.

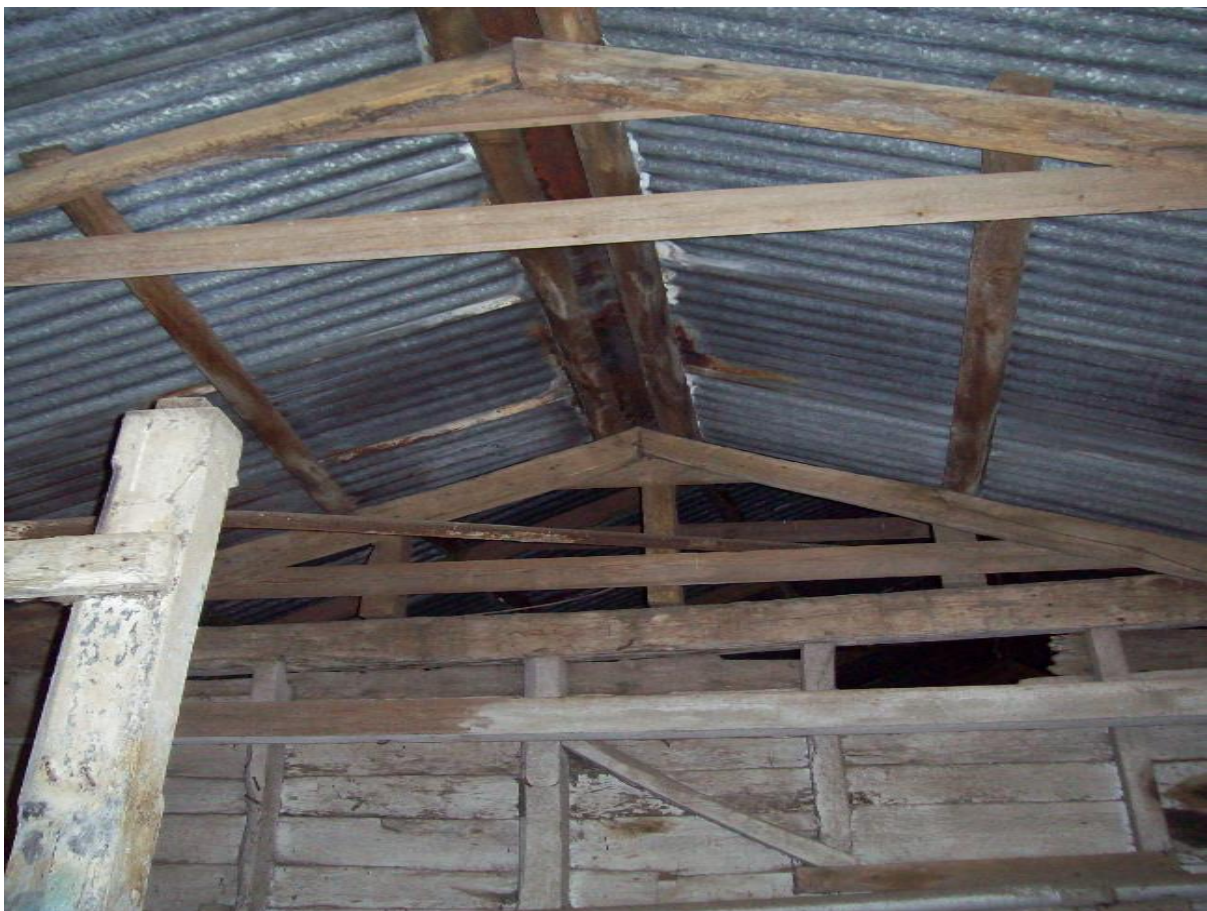
Internally, the structure is used for storage purposes, with the corrugated metal roof being supported by timber rafters. The gaps in the external walls of the structure are also apparent from the inside. No signs of bats or birds' nests were found internally.

**Plate 14:** An internal view of B5.

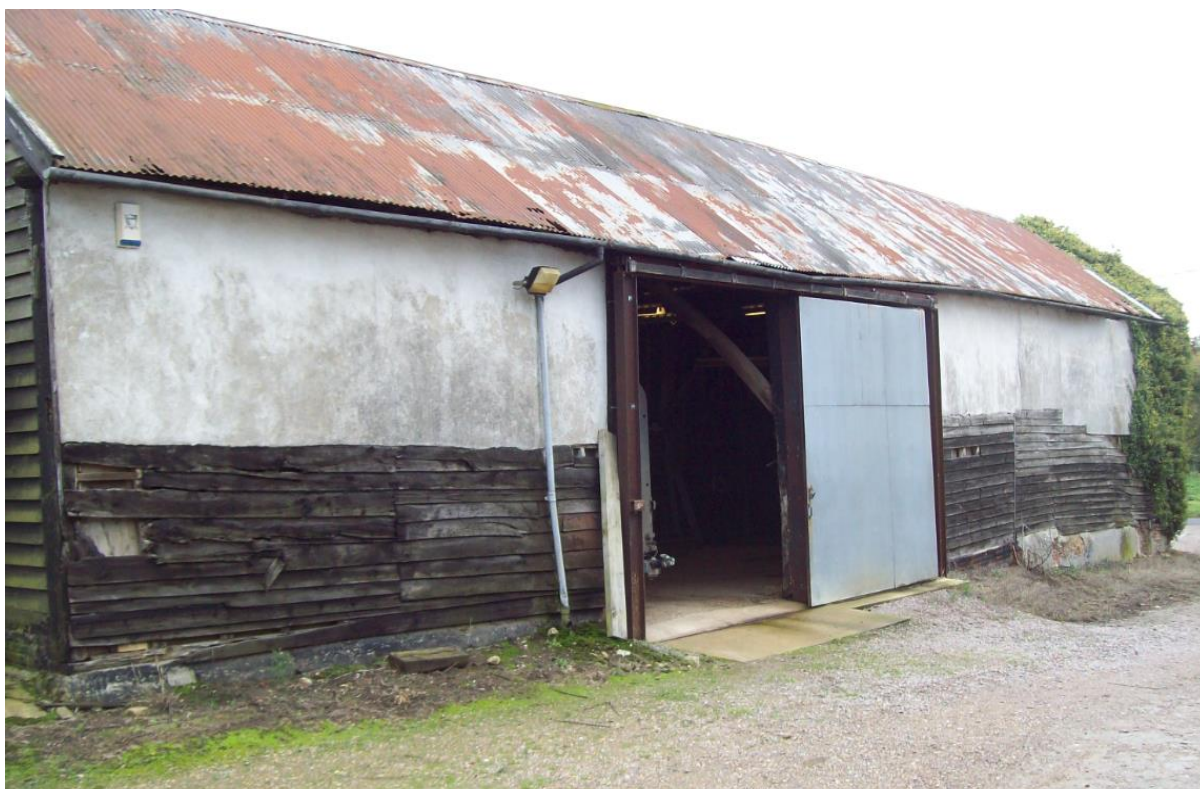
This structure is a large, two-storey barn. The external walls are partially rendered and partially constructed out of horizontal timber cladding. The southern gable end is overgrown with dense common ivy (*Hedera helix*). The structure has a pitched corrugated metal roof. Finally, there are gaps between the timber cladding and underneath the eaves, thus providing potential entry points into the structure. No evidence of nesting birds were found externally.

**Plate 15:** The eastern elevation of B6.

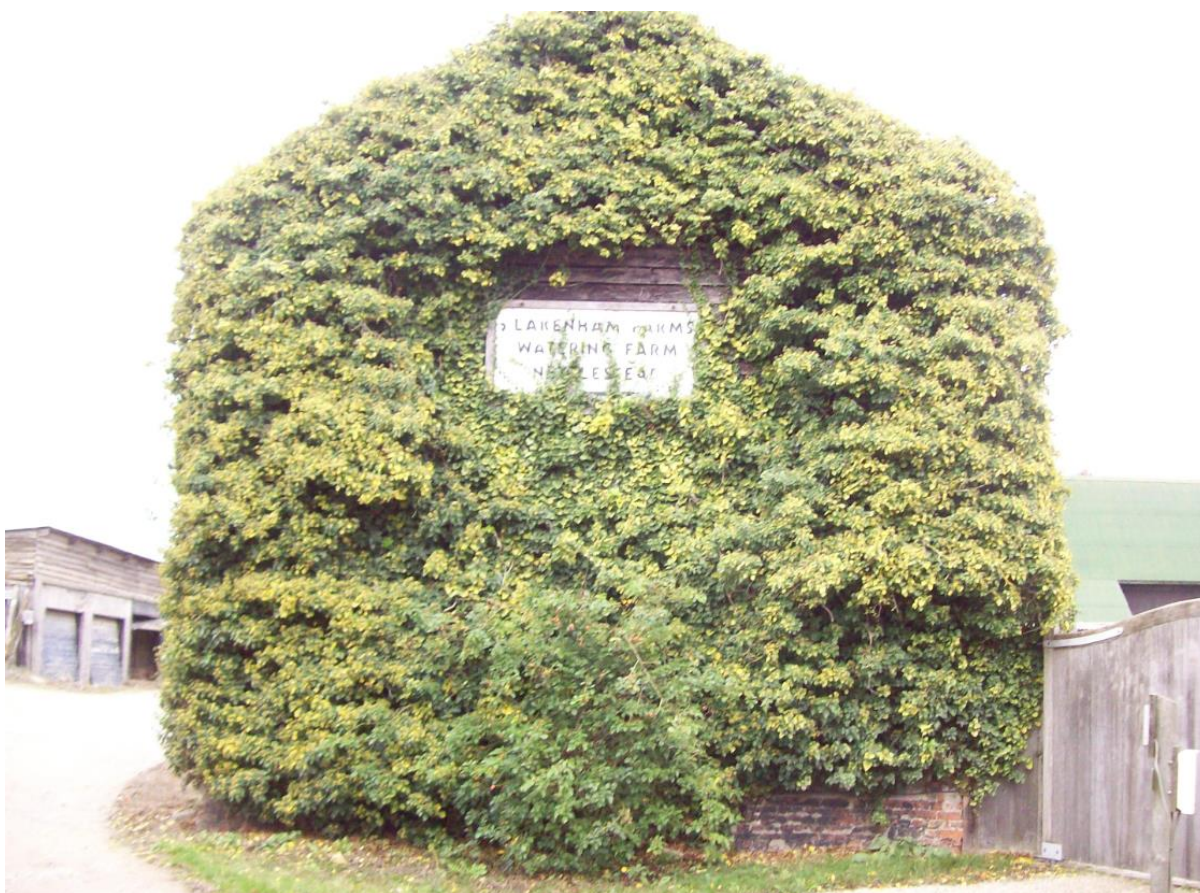
**Plate 16:** The southern elevation of B6.

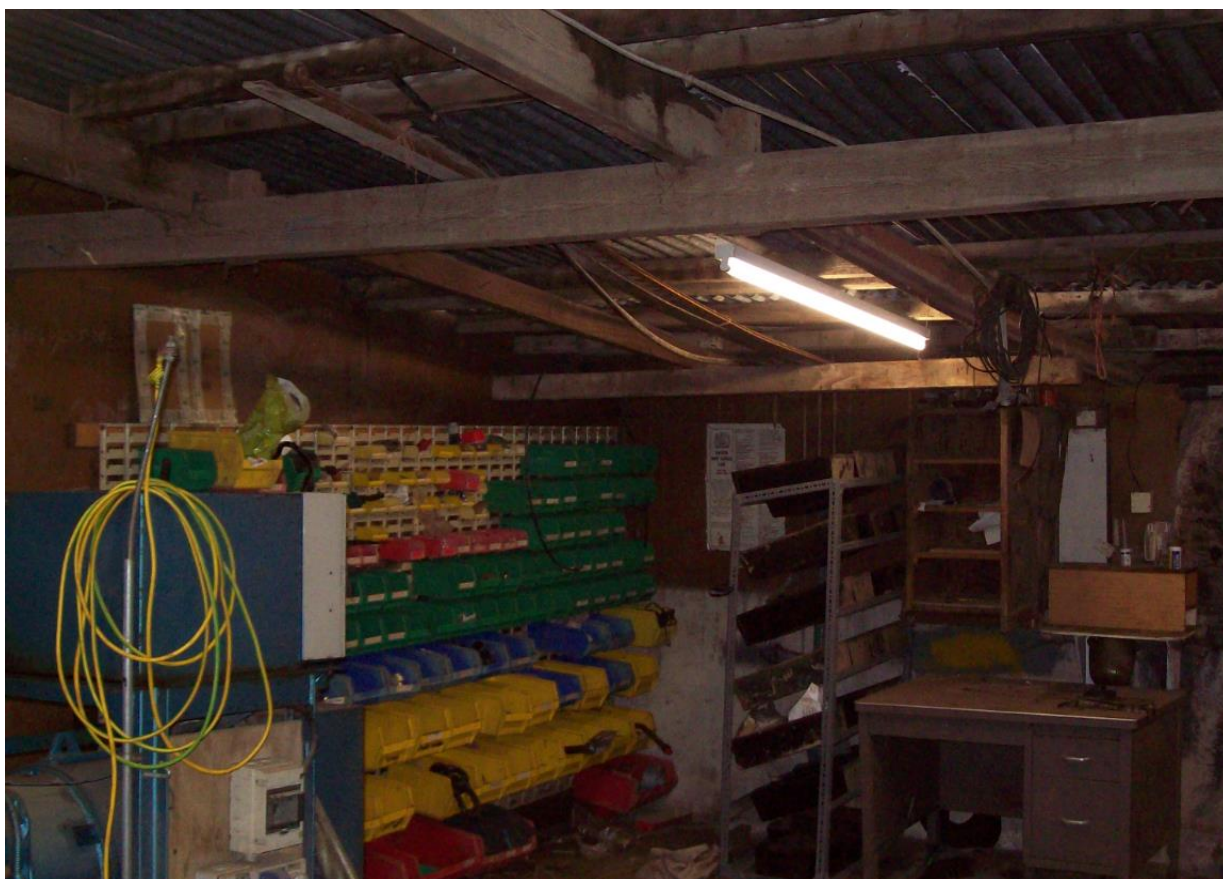
Within the barn there are multiple rooms present, some of which are used for storage purposes. The structure is supported by timber beams, with some roof lining material hanging loosely below the ceiling. In the southern portion of the building, the ceiling is constructed out of reused 5<sup>th</sup> Century timber. The first floor was not accessible for inspection at the time of the survey. No evidence of bats or birds' nests were found in the structure.

**Plate 17:** An internal view of B6, showing the room in northern section.

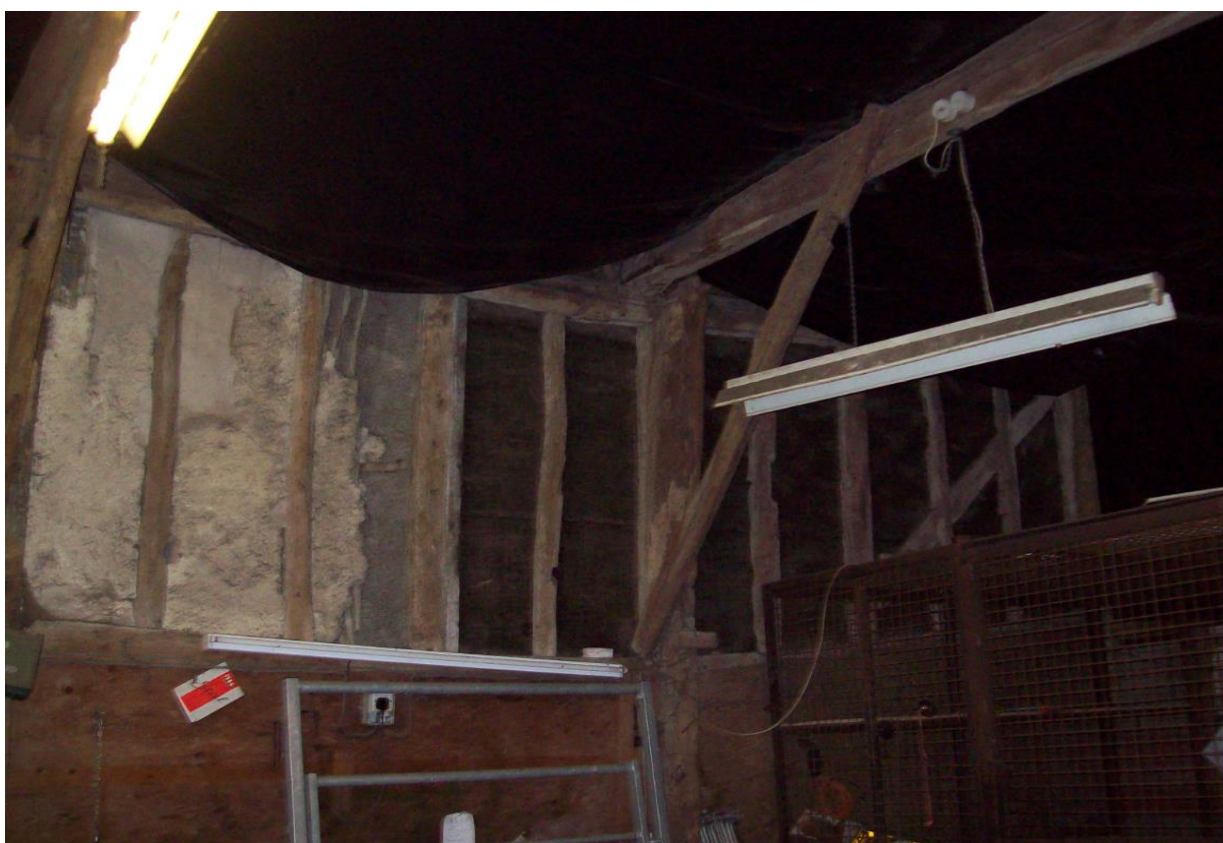
**Plate 18:** Another internal view of B6. This image illustrates the room in western section.

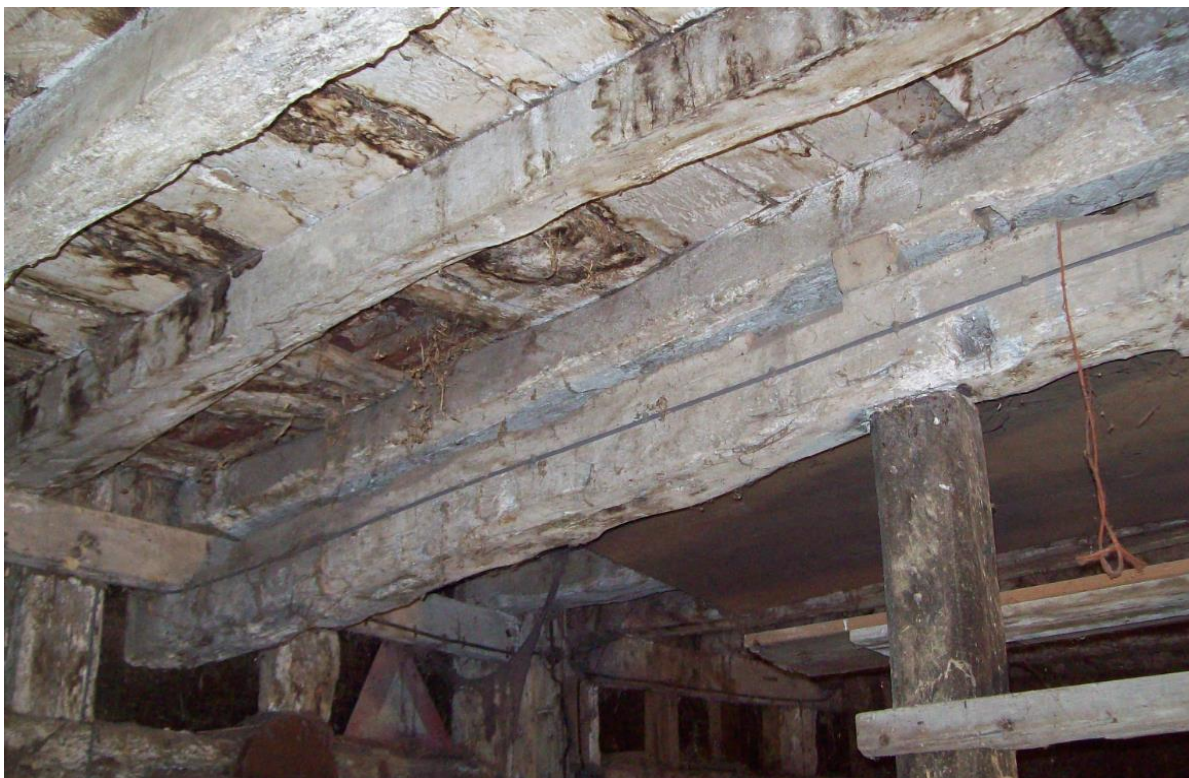
**Plate 19:** Another internal view of B6, showing the room in southern section.
