Report on a  
**PHASE 2 GEOENVIRONMENTAL  
GROUND INVESTIGATION**

Ref: 21/34496 | Date: December 2021

**64 Hamilton Terrace  
London  
NW8 9UJ**

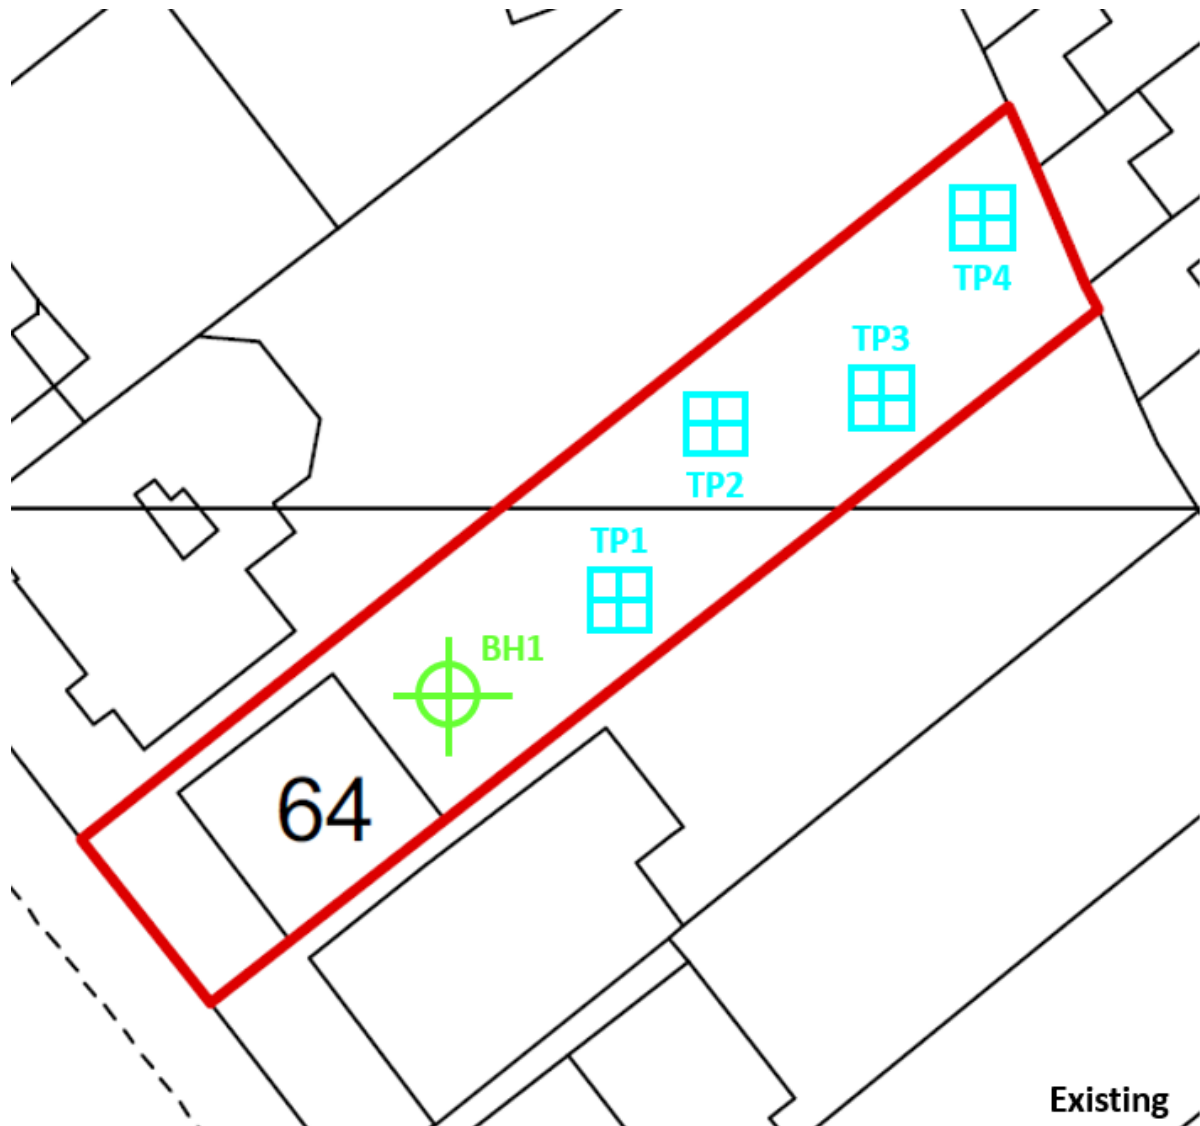
*Figure 4 – Site Sketch Plan*

A total of five sampling locations have been excavated at the site providing a density ranging from circa 5m to 10m grid.

Samples for a full contamination analysis were obtained from 0.25m in BH1, TP2 and TP4, and from 0.50m in TP1 and TP3 – all made at the locations indicated on the site sketch plan below (Figure 4).
