# **Bat & Owl Survey of White House Farm Barn Henley**

**Hollins Architects  
4a Market Hill  
Framlingham  
Suffolk  
IP13 9BA**

**John Dobson B.Sc  
Essex Mammal Surveys**

**December 2021**

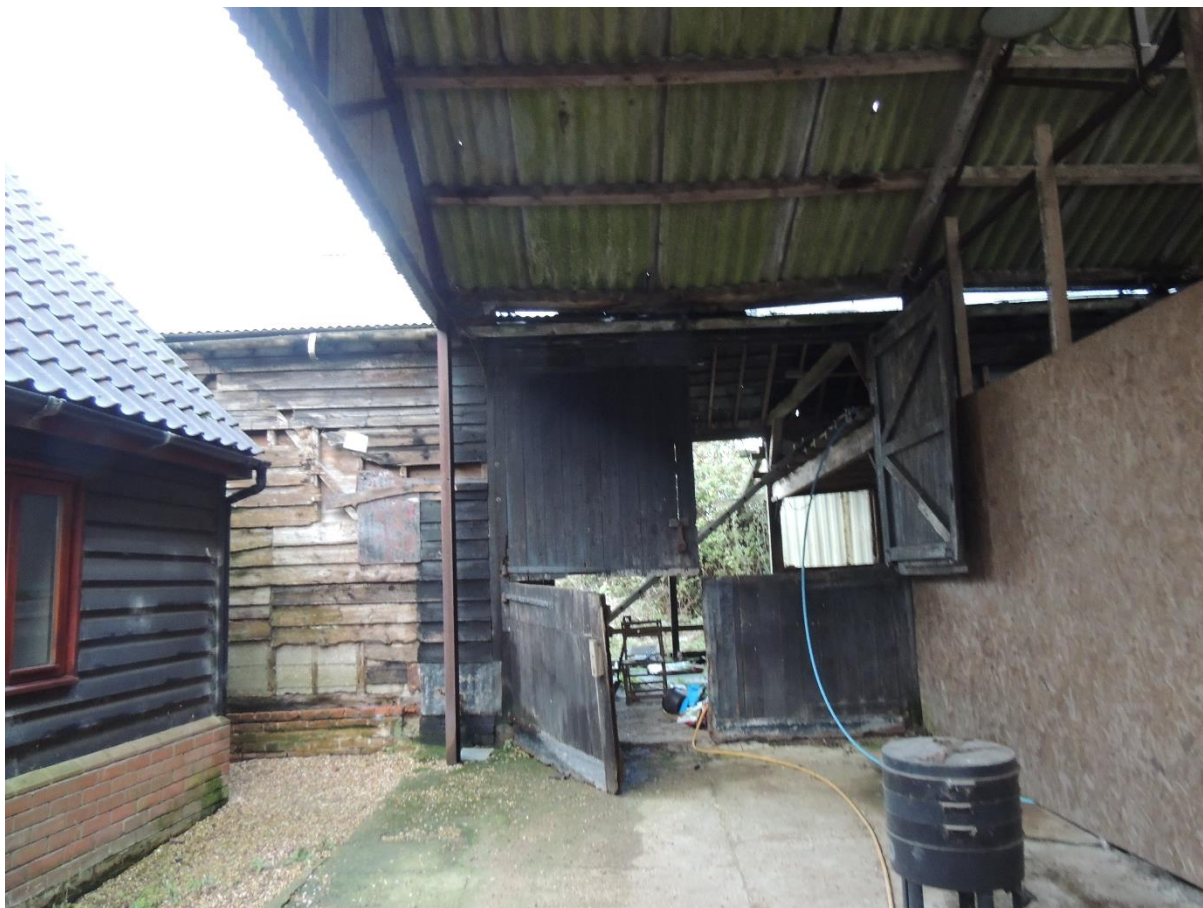
**Photo 1:** Looking towards the eastern elevation of the barn

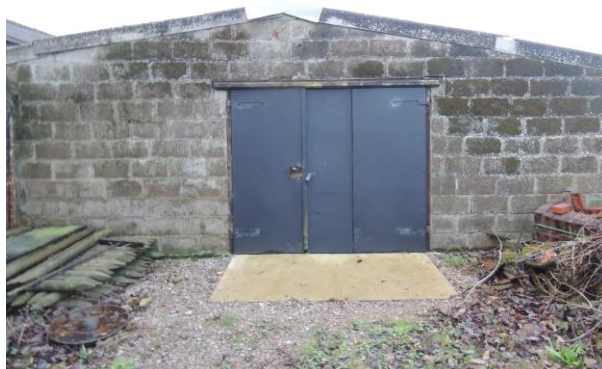
**Photo 2:** North-eastern end of former farrowing shed

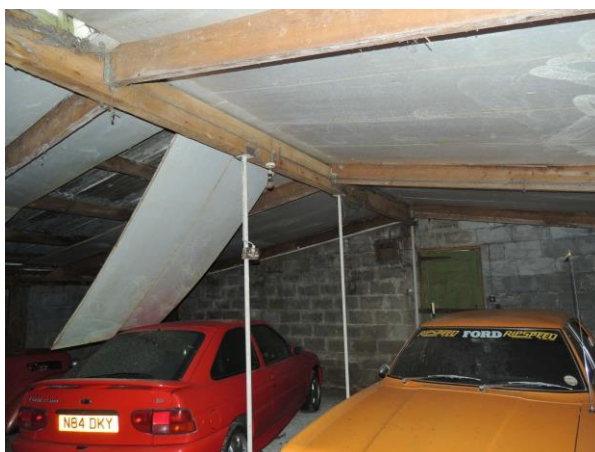
The survey building is a 5-bay barn with an unlined slate and part corrugated tin roof, with a block-built, single-storey former farrowing shed with a corrugated asbestos roof abutting it on the north-eastern side. The buildings are aligned approximately NE-SW. The survey found that the interior of the farrowing shed was used for storage, with a shallow-pitched, corrugated asbestos roof lined with plasterboard. The interior had no cavities that might be occupied by roosting bats and this building was considered to have **negligible** potential as a roosting place for bats.

**Photo 3:** Interior of former farrowing shed

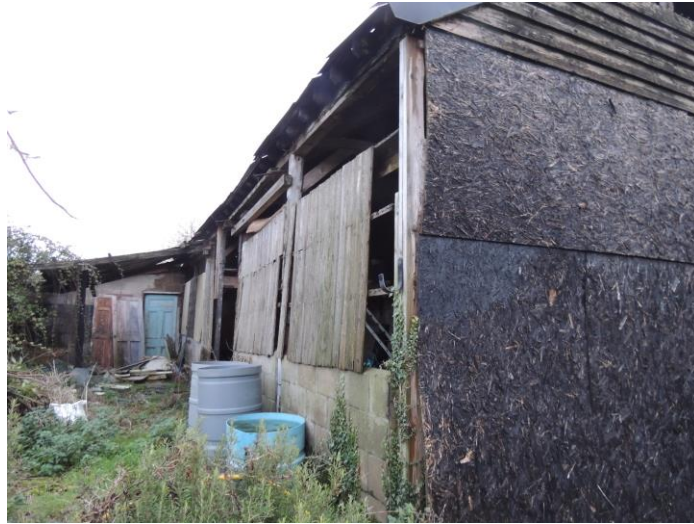
**Photo 4:** South-western end elevation of barn, north-western side (note gaps in walls) and, at far end, south-western end of farrowing shed

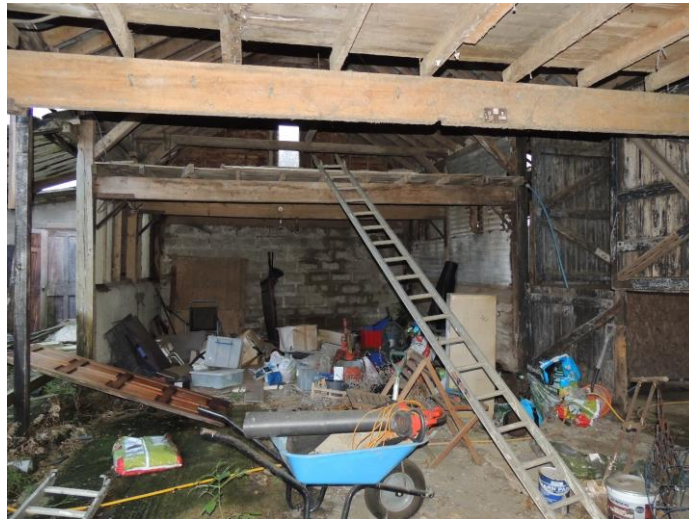
The interior of the barn received daylight illumination (and draughts and rain) via an open door on the south-eastern side, a missing section to the north-western elevation, windows in both gable walls and gaps in the wall cladding. At each end of the barn is a mezzanine floor that takes up two bays. These floors were inspected from a ladder and found to have no evidence of bats. With machine cut beams to the roof and walls, there was a lack of crevices around the mortise joints in the wall plates and tie beams and no cavities that might offer potential roosting places for bats. No evidence of their presence was found in this building, which was considered to have **negligible** potential as a roosting place for bats.

**Photo 5:** Looking north-eastwards in barn

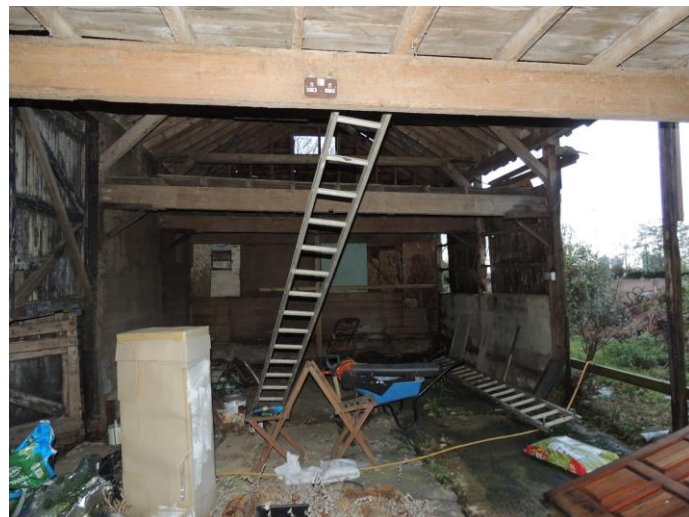
**Photo 6:** Looking south-westwards in barn. Note gaps in wall

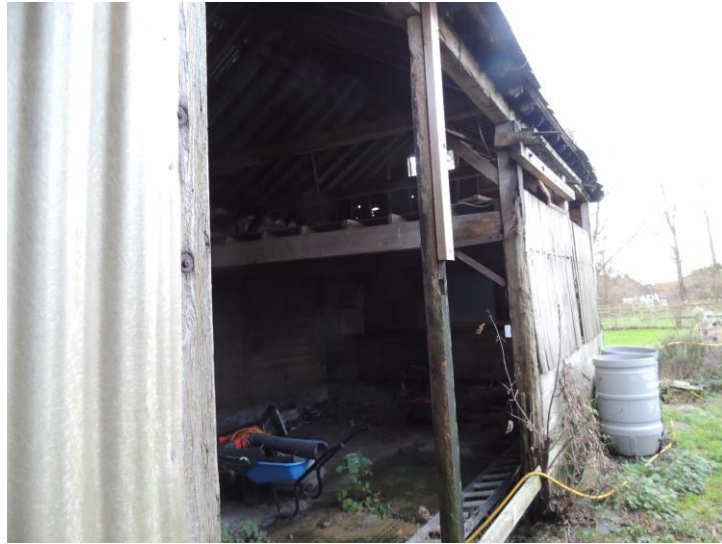
**Photo 7:** North-western side

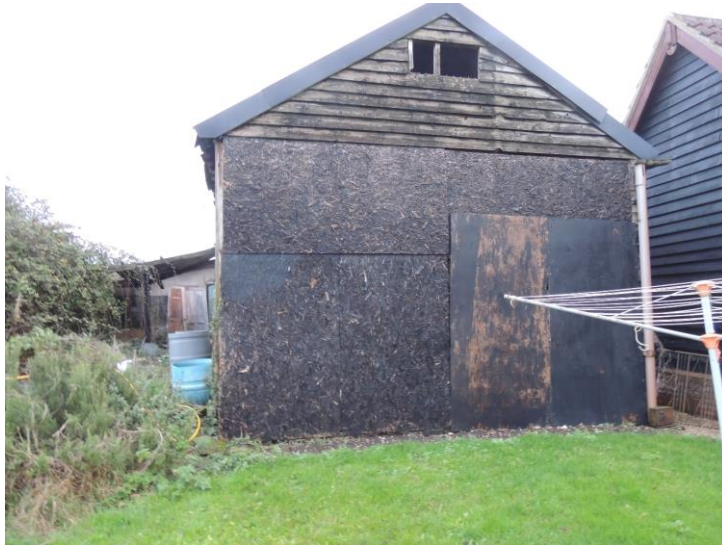
**Photo 8:** South-western elevation

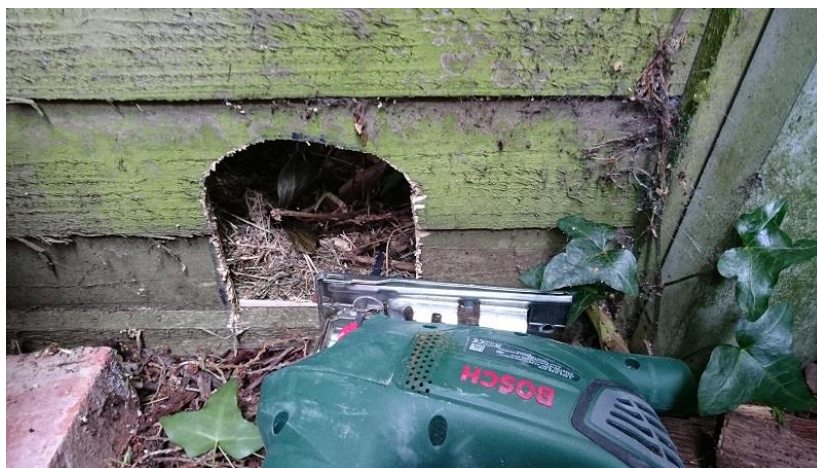
**Photo 14:** Hedgehog pathway at base of fence

**1:** It is recommended that the existing gaps along the site boundaries are retained to allow hedgehogs and common toads to forage across the site as, potentially, at present. However if boundary fences are to be introduced, see below:

**A gap 13cm by 13cm is sufficient for any hedgehog to pass through. This will be too small for nearly all pets.**

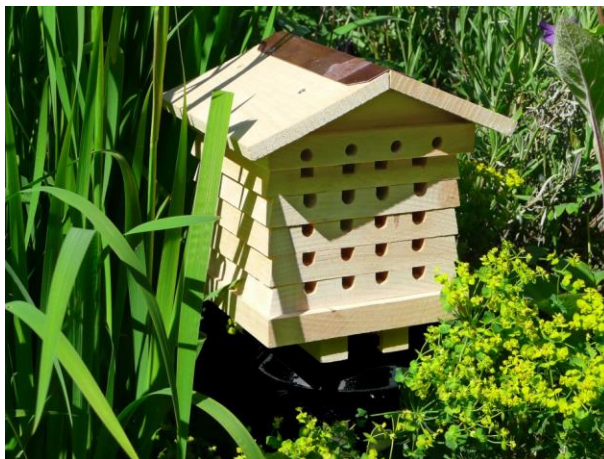
**Photo 15:** Solitary bee hive

This solitary beehive is manufactured from durable FSC timber (other designs are available) and provides valuable habitat for bees in modern gardens. It is designed specifically to attract non-swarming bees like the Red Mason Bee, Leafcutter Bee and other solitary bees which are naturally attracted to holes in wood.

**4:** Two solitary bee hives to be erected at the site.

**Siting:** Site in a visible warm place ideally oriented to face between southeast and south and to catch some sun. It is helpful to have soil nearby, and food sources such as flowers, orchards and fruit.
