Heritage Statement & Impact Assessment

Proposed Alteration:
Trendeal Vean Farmhouse
Ladock
Truro
TR2 4NW

Silverlake Design Ref: 3468HIA

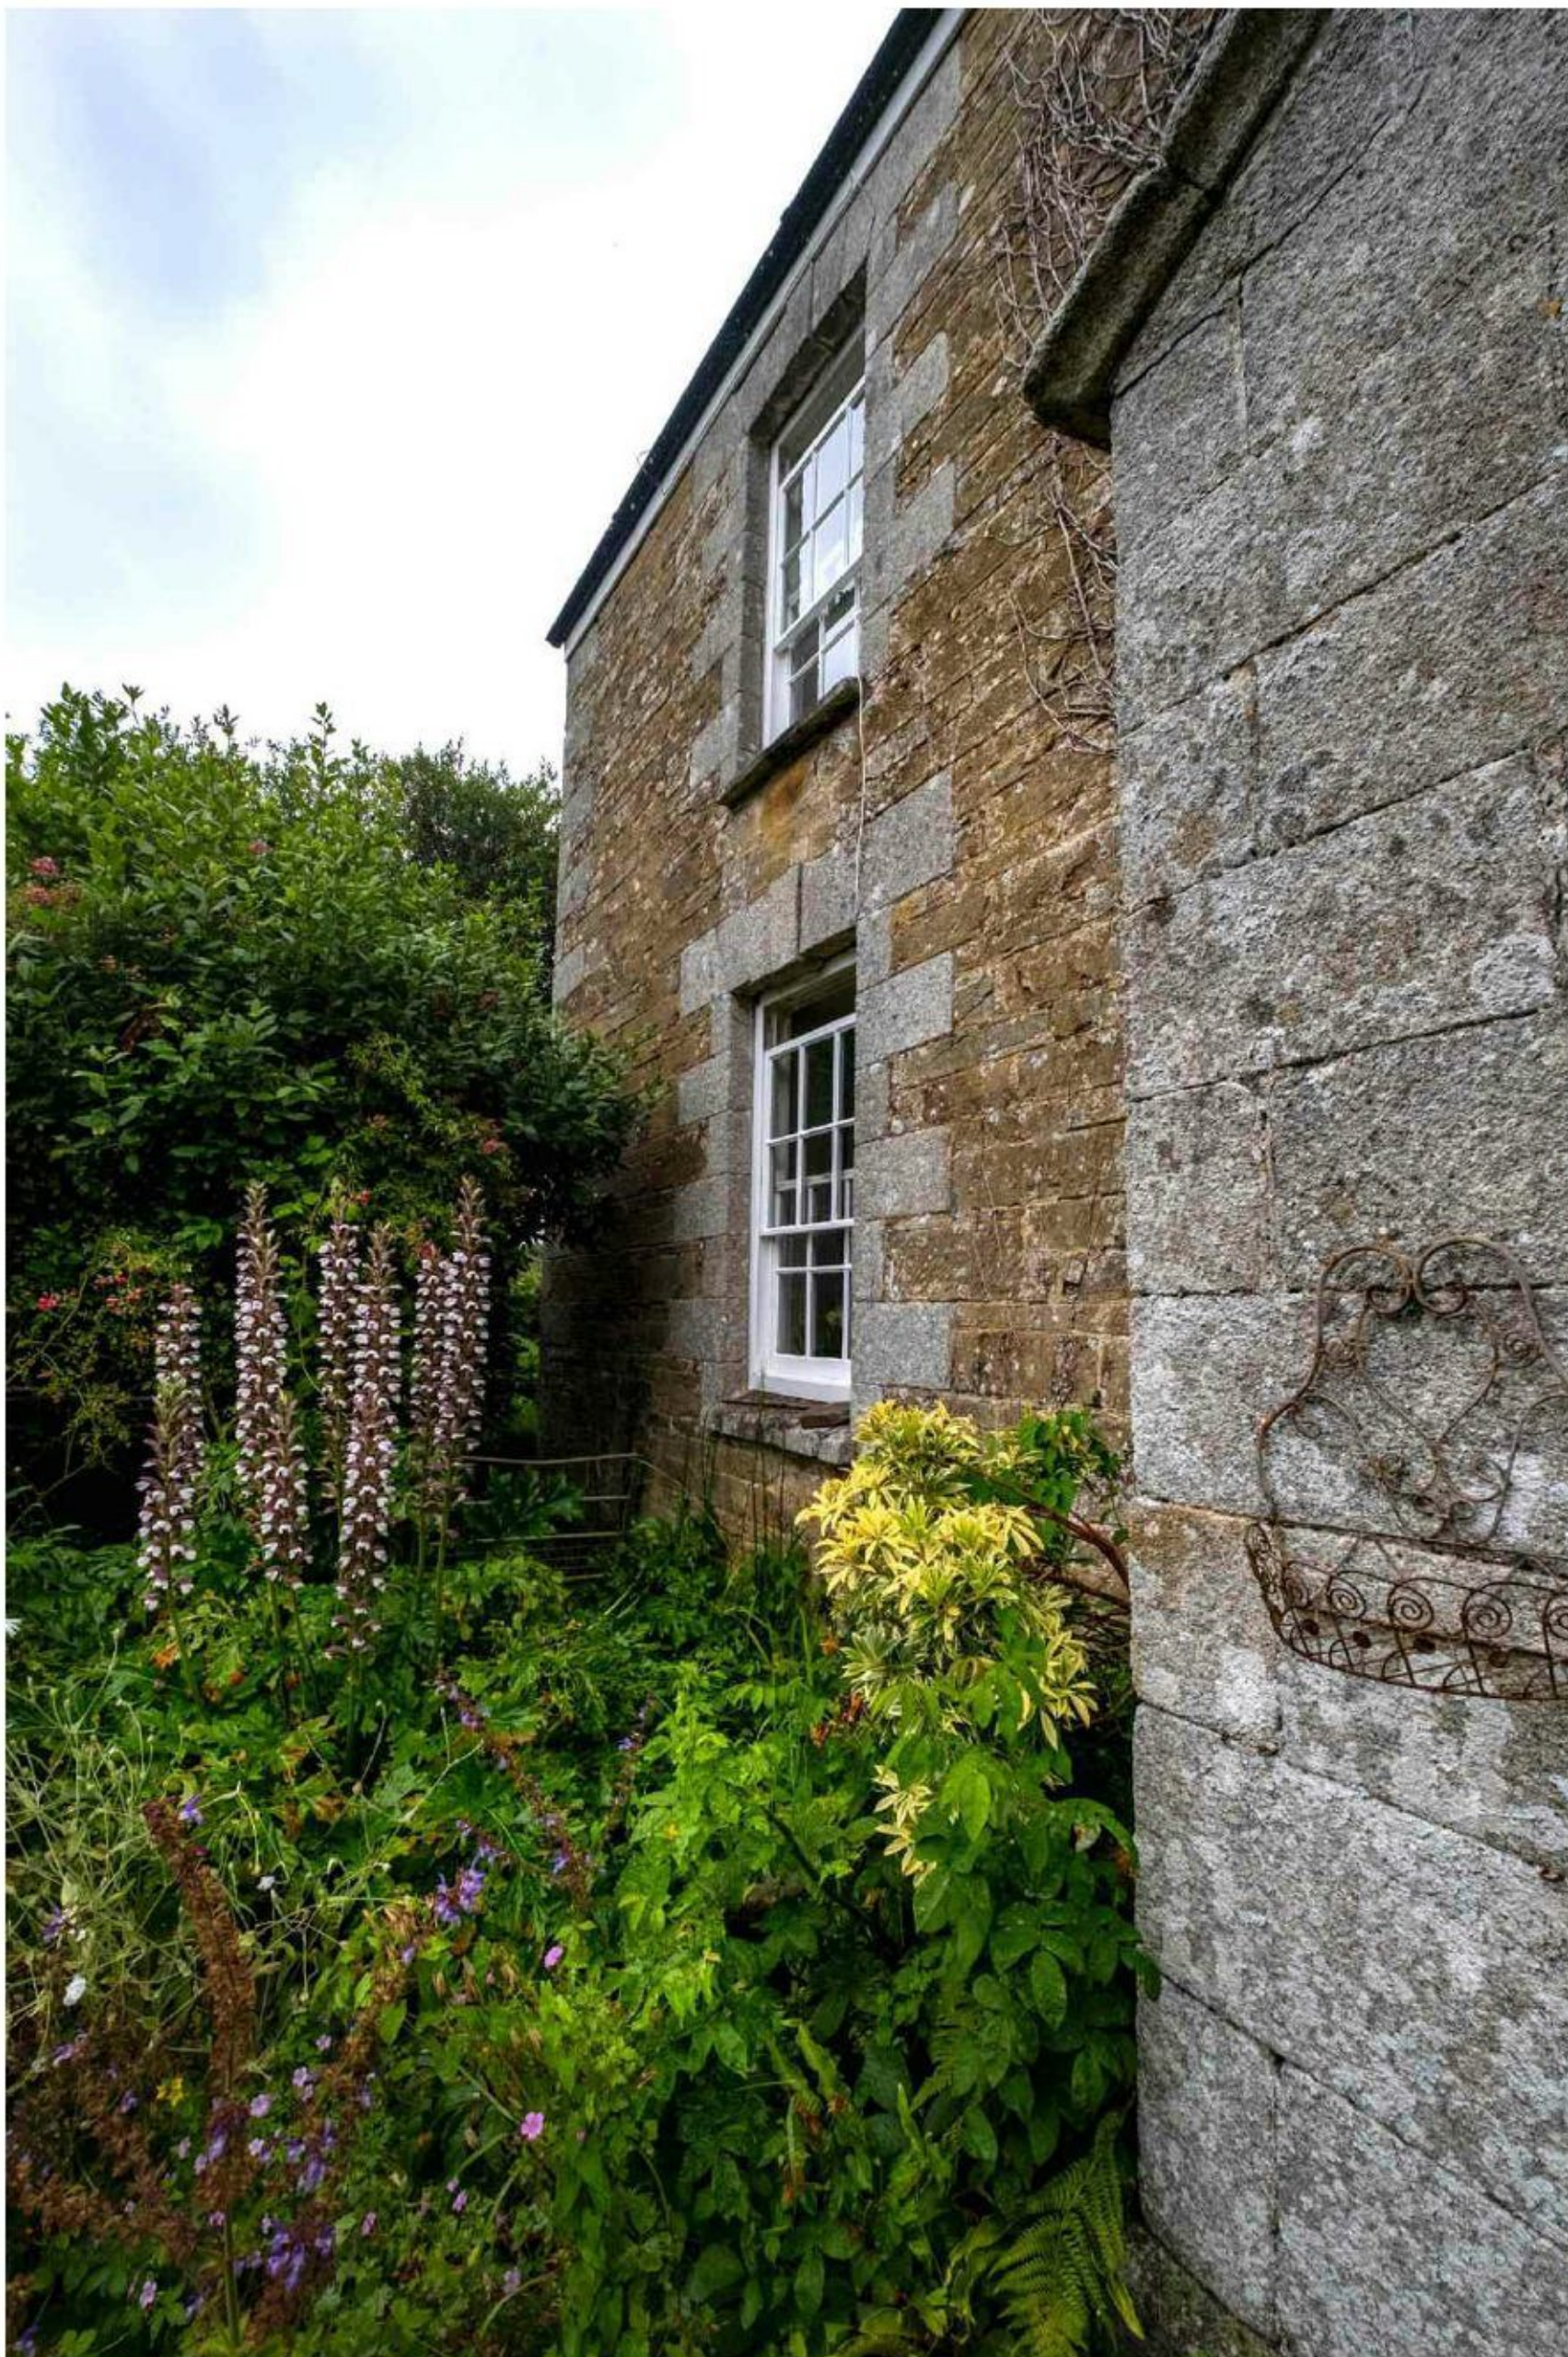
Detail showing the stone on the 'show', south elevation. The cavetto moulded copings to the granite ashlar porch are seen

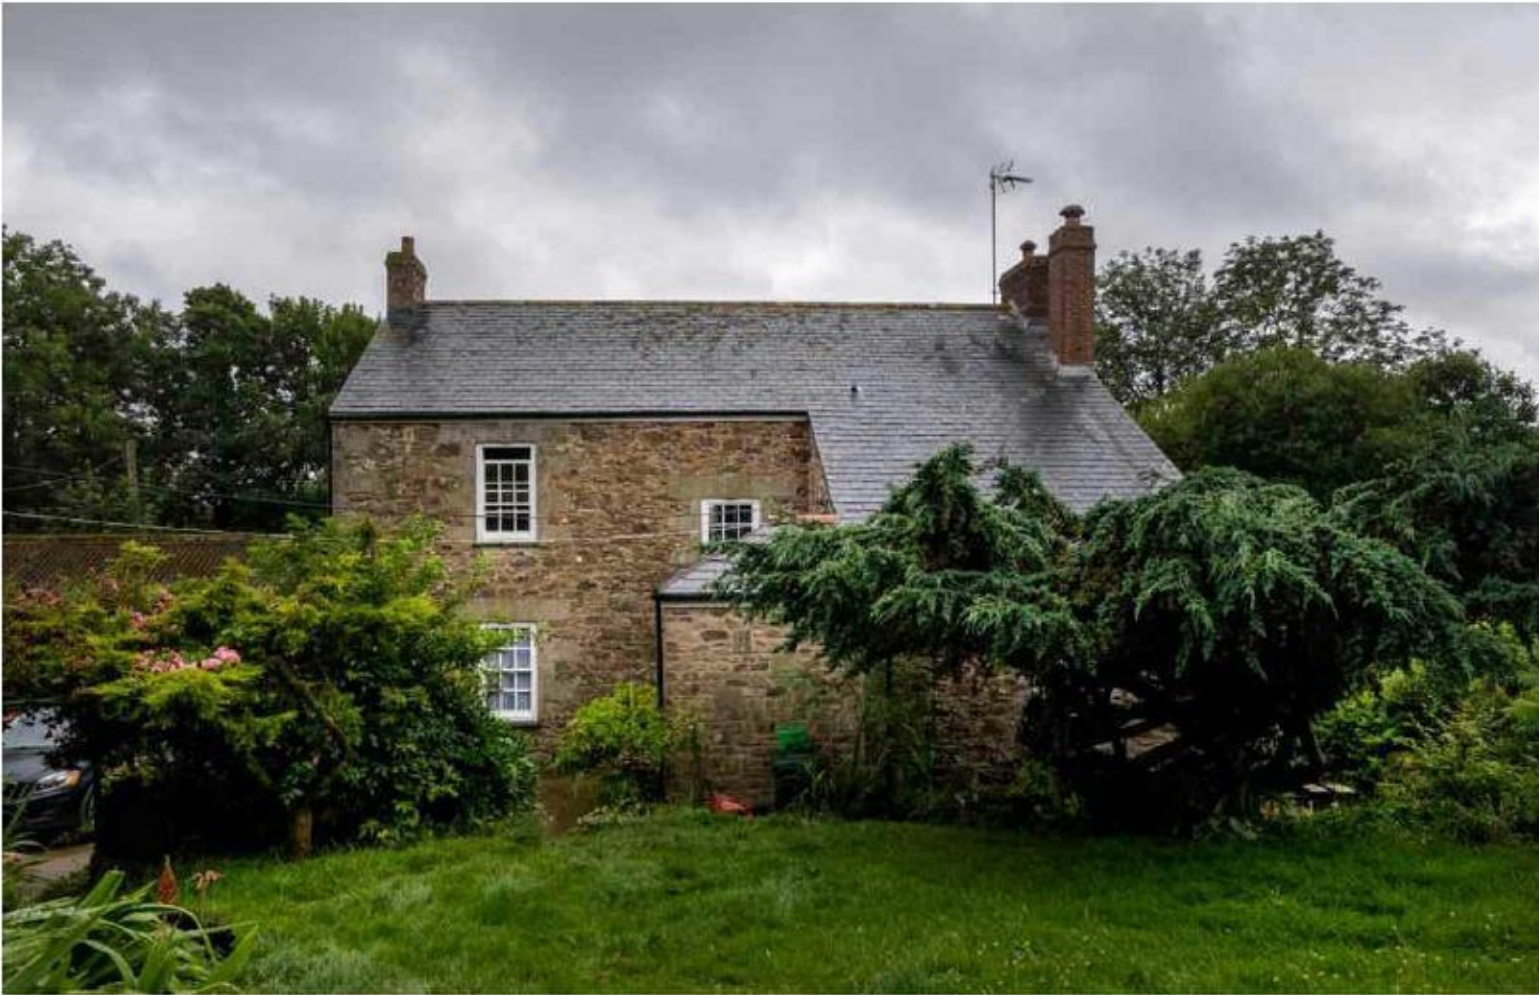
West elevation. Slate cladding is proposed to this elevation to address damp

During recent years there has been an increasing problem with damp penetrating the west wall. This has caused the internal wall to be wet, consequently affecting the thermal regulation of the building. The west wall bears the brunt of the prevailing weather. It is noted that some of the shalestone exterior appears porous and friable, and some hairline cracking of the masonry has been observed. The stone itself is therefore likely to be facilitating moisture ingress. Although this elevation mostly appears to have a lime mortar, there are some distinct areas, such as to the granite quoins, where a hard cement mortar has been applied. Whilst the vermiculite liner to the sitting room flue is cracked, it is unlikely that this

alone would account for the pervasive damp noted. It is feasible that continued movement of the walls, although appraised as minimal, may also allow conditions for moisture ingress. Interventions applied to the internal face of the west wall, in an attempt to counter the damp include bitumen paint to the wall and a hard cement render. Unfortunately, these well-intentioned interventions have probably served to exacerbate the problem by trapping moisture within the wall.

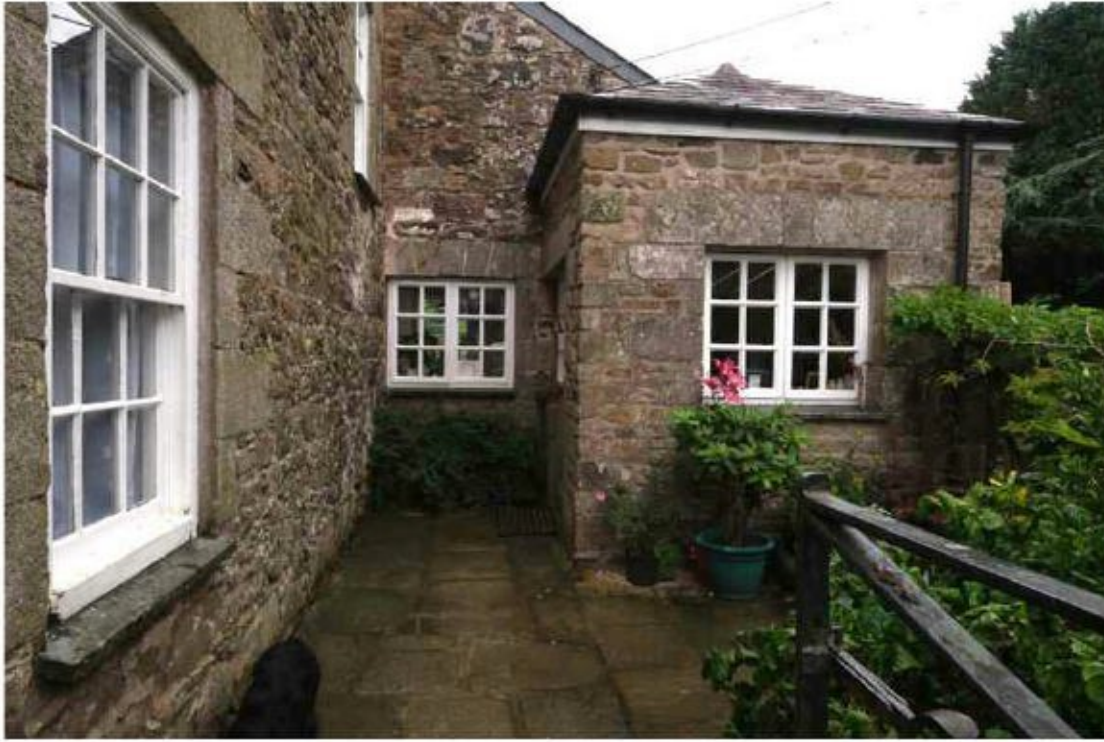
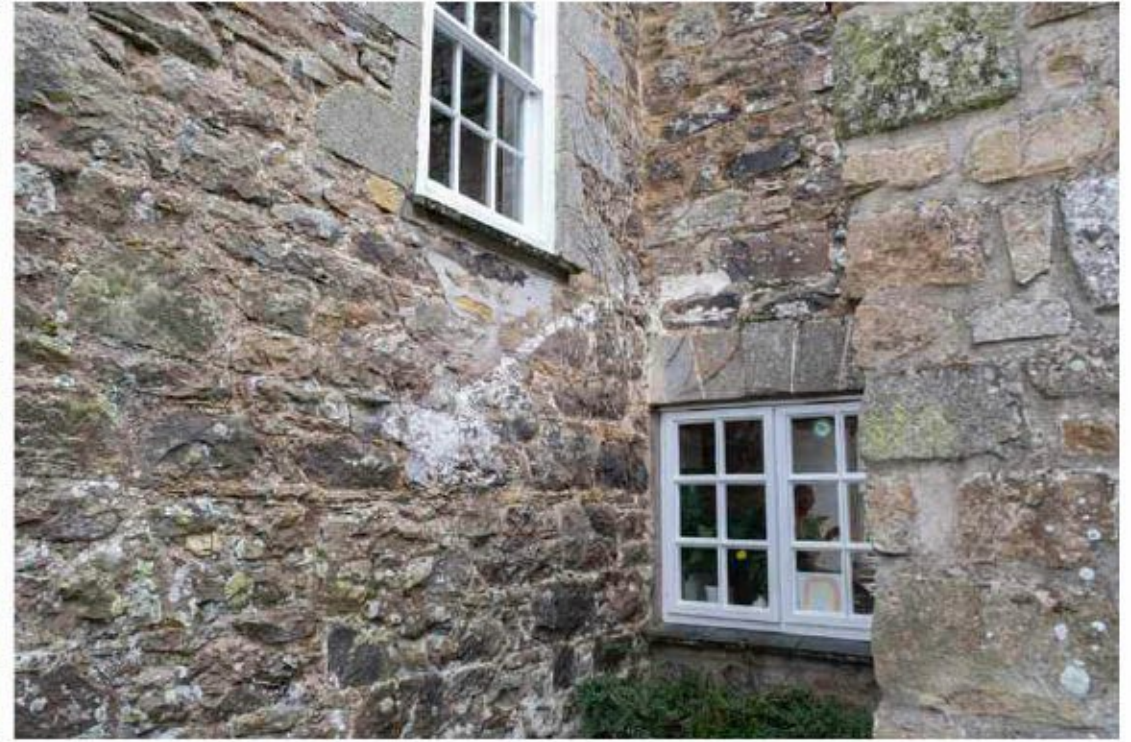
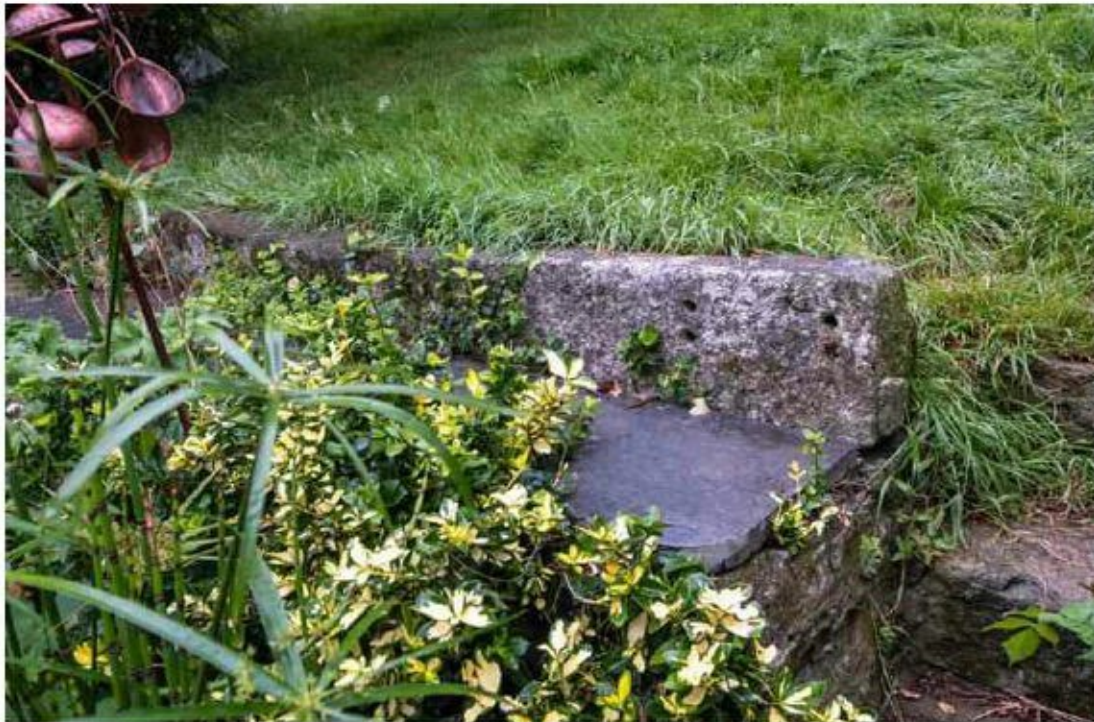
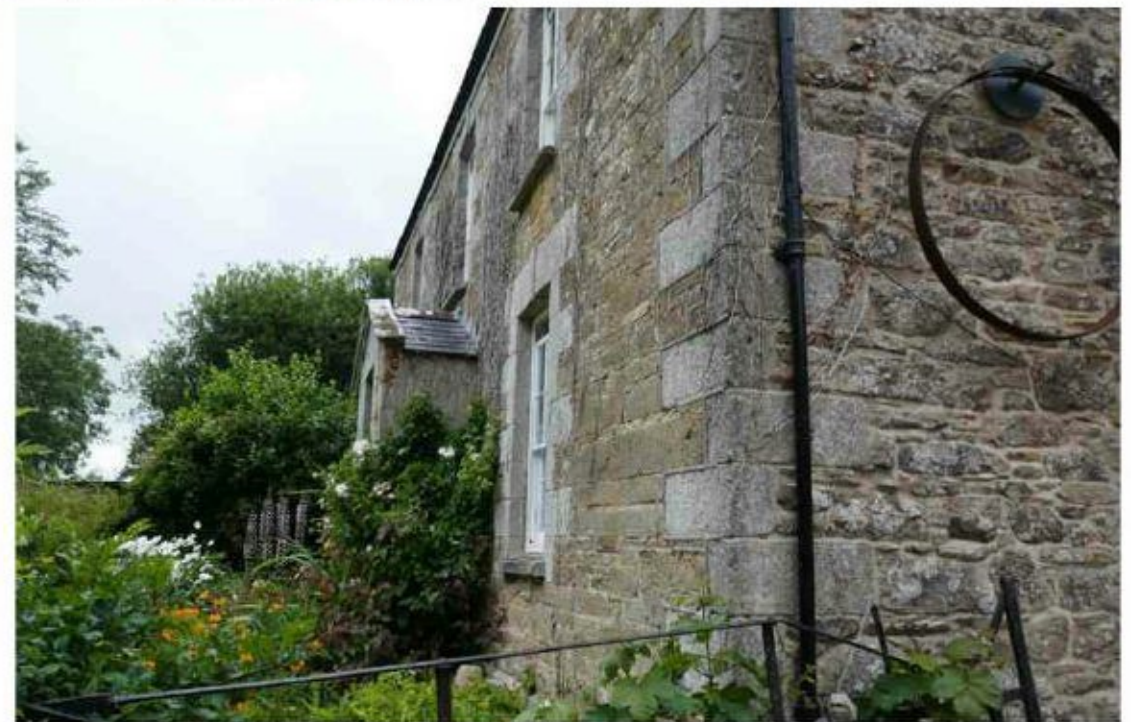
Top: East elevation showing C20 porch and palimpsest of former porch to original opening

Below left: Removed slate counters from dairy relocated within the garden

Below right: the south east corner of the house

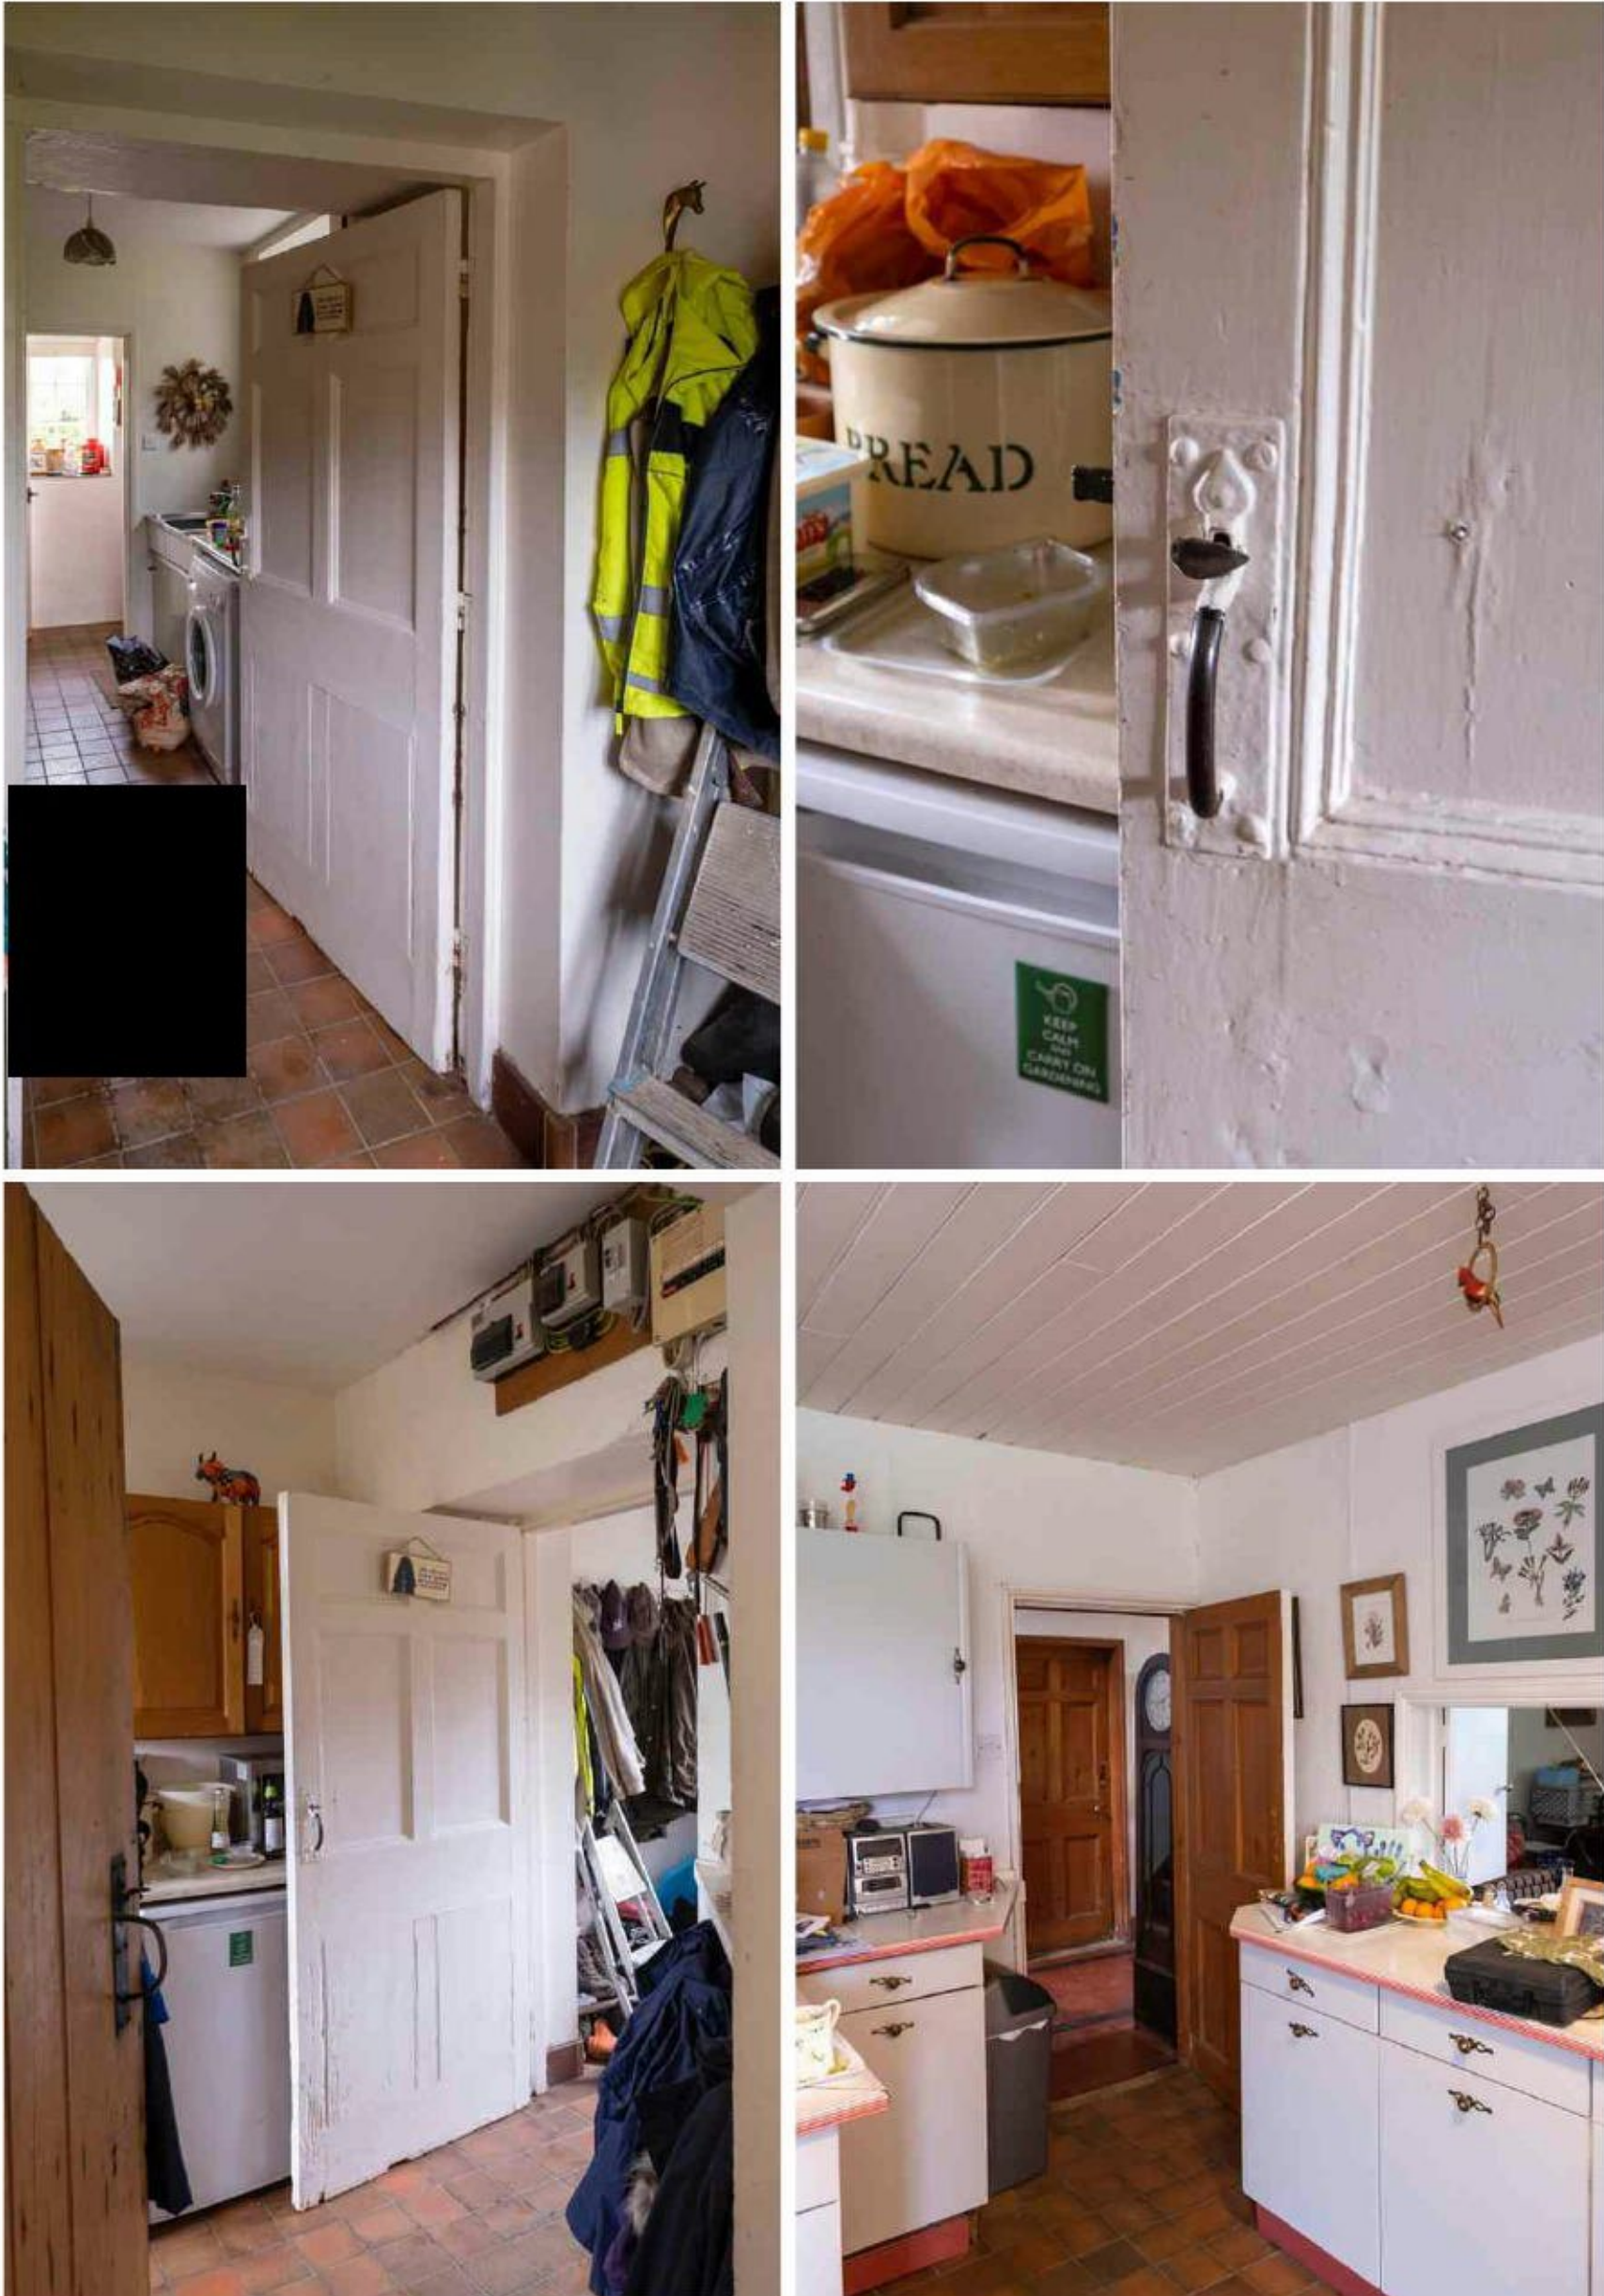
Top : The view from the C20 porch into the existing utility room

Below left: door between porch and utility room bears the scratches of dogs which help tell the story of the house.

Below right: view from the kitchen to the hall

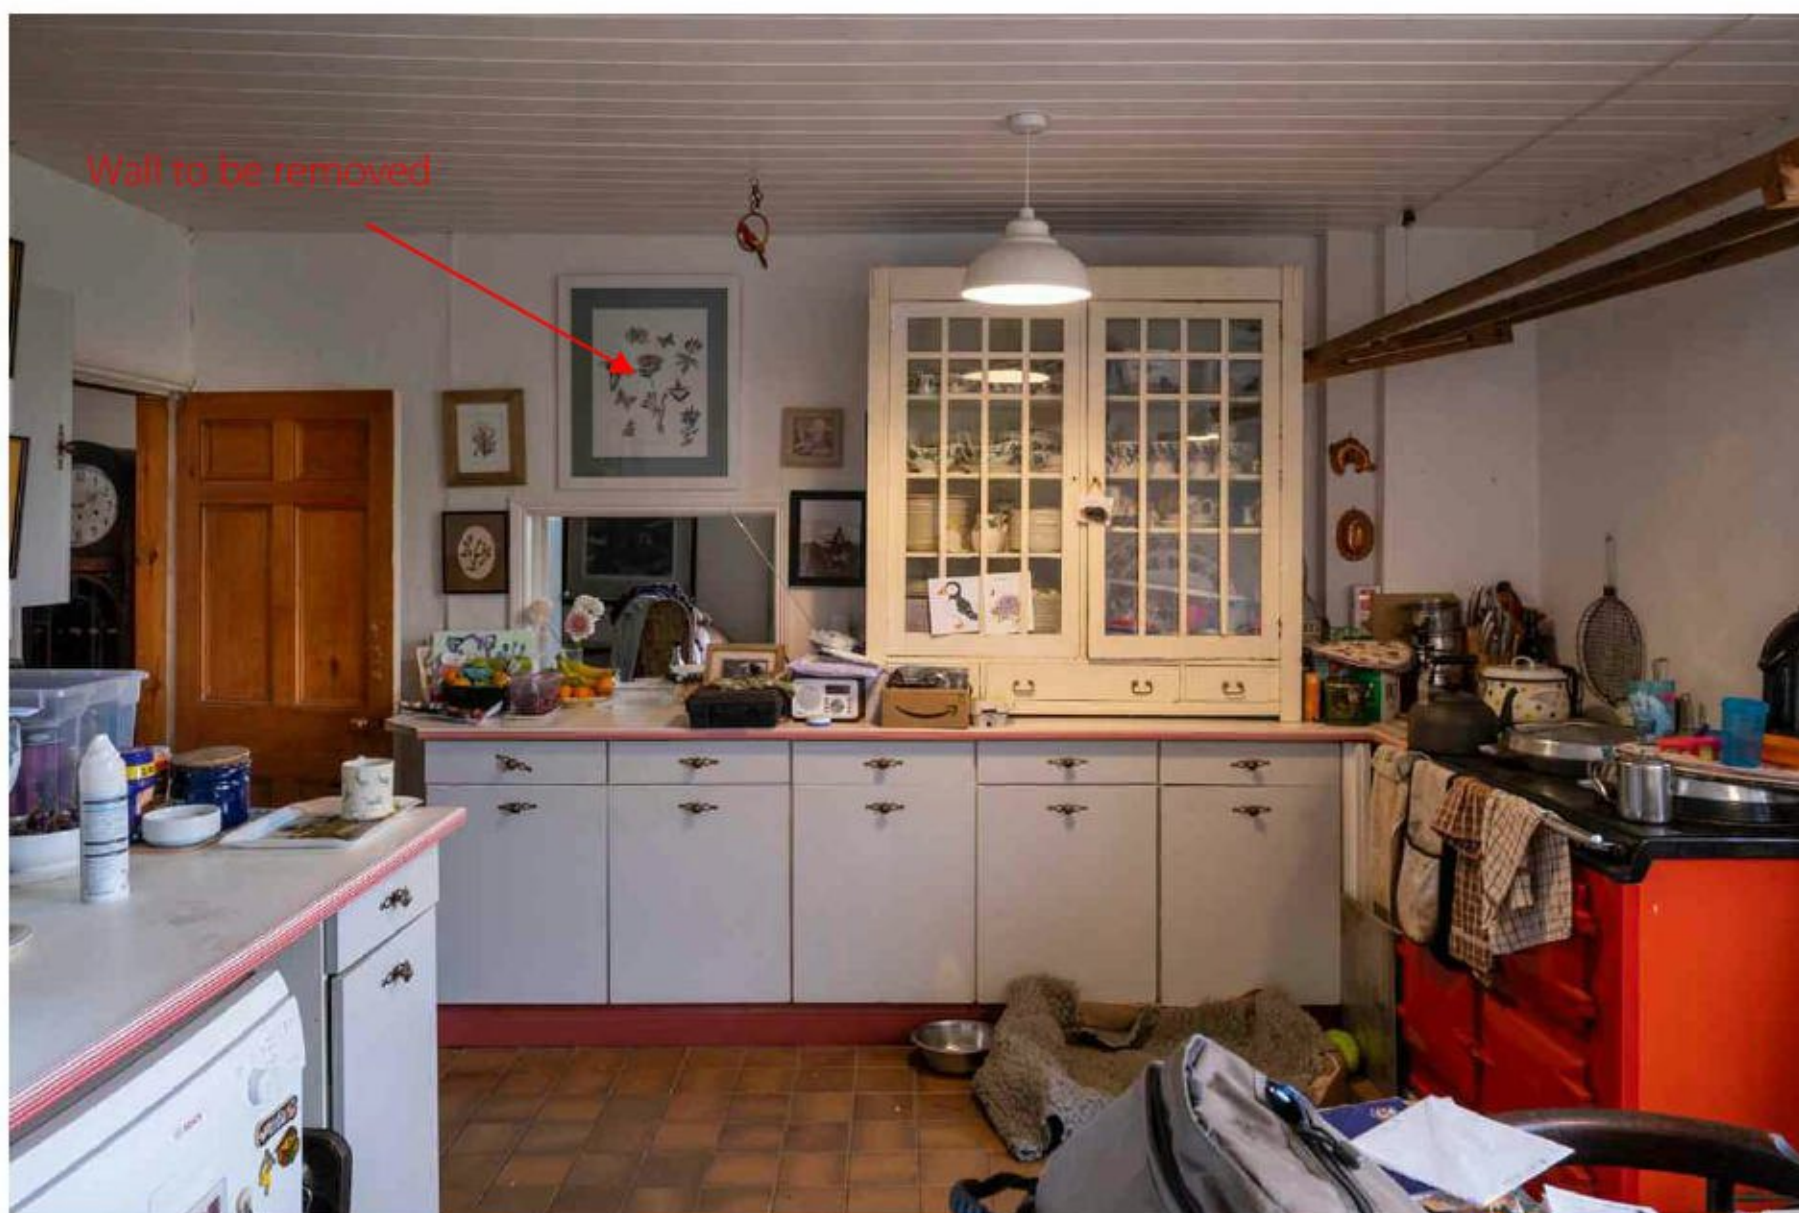
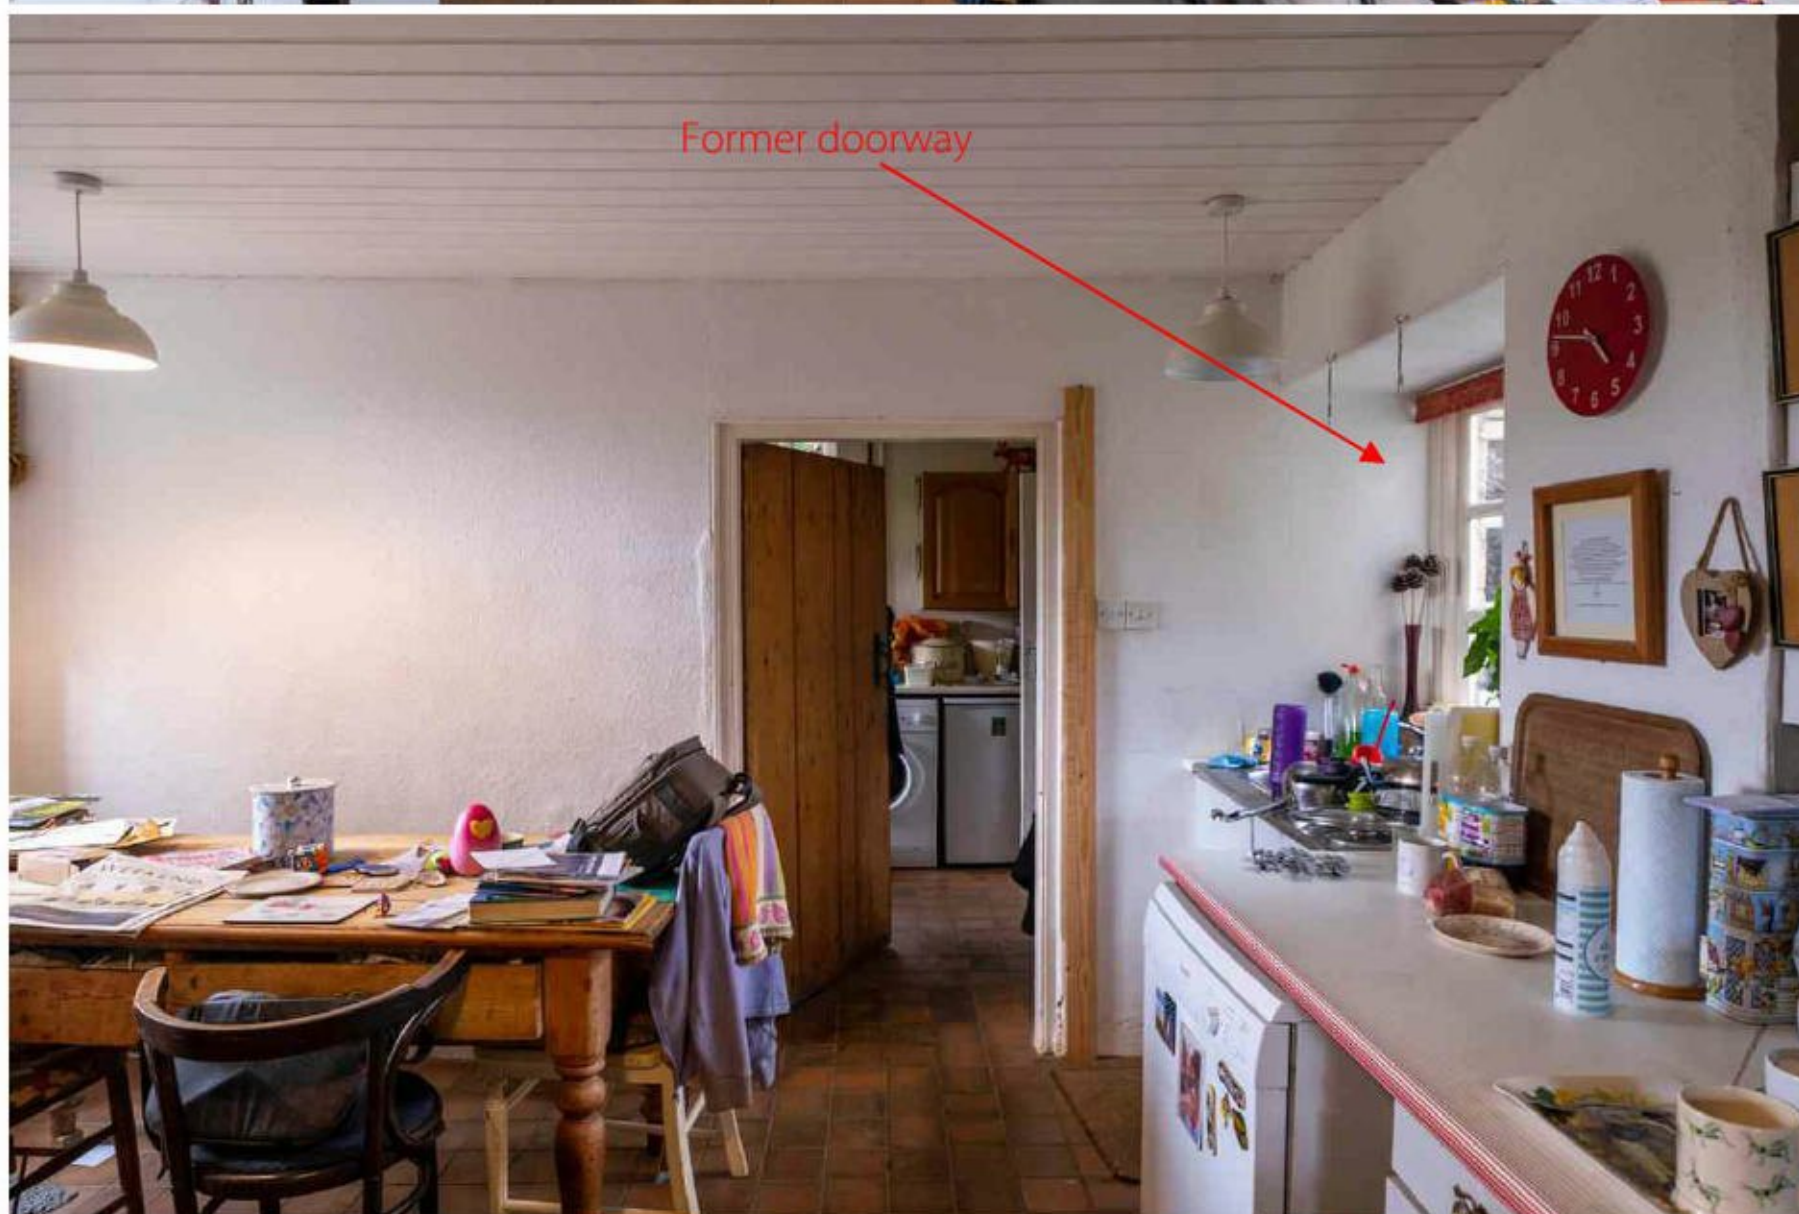
Top: The kitchen looking toward the sitting room. It is proposed to remove the dividing wall
Below: View from kitchen to the utility room

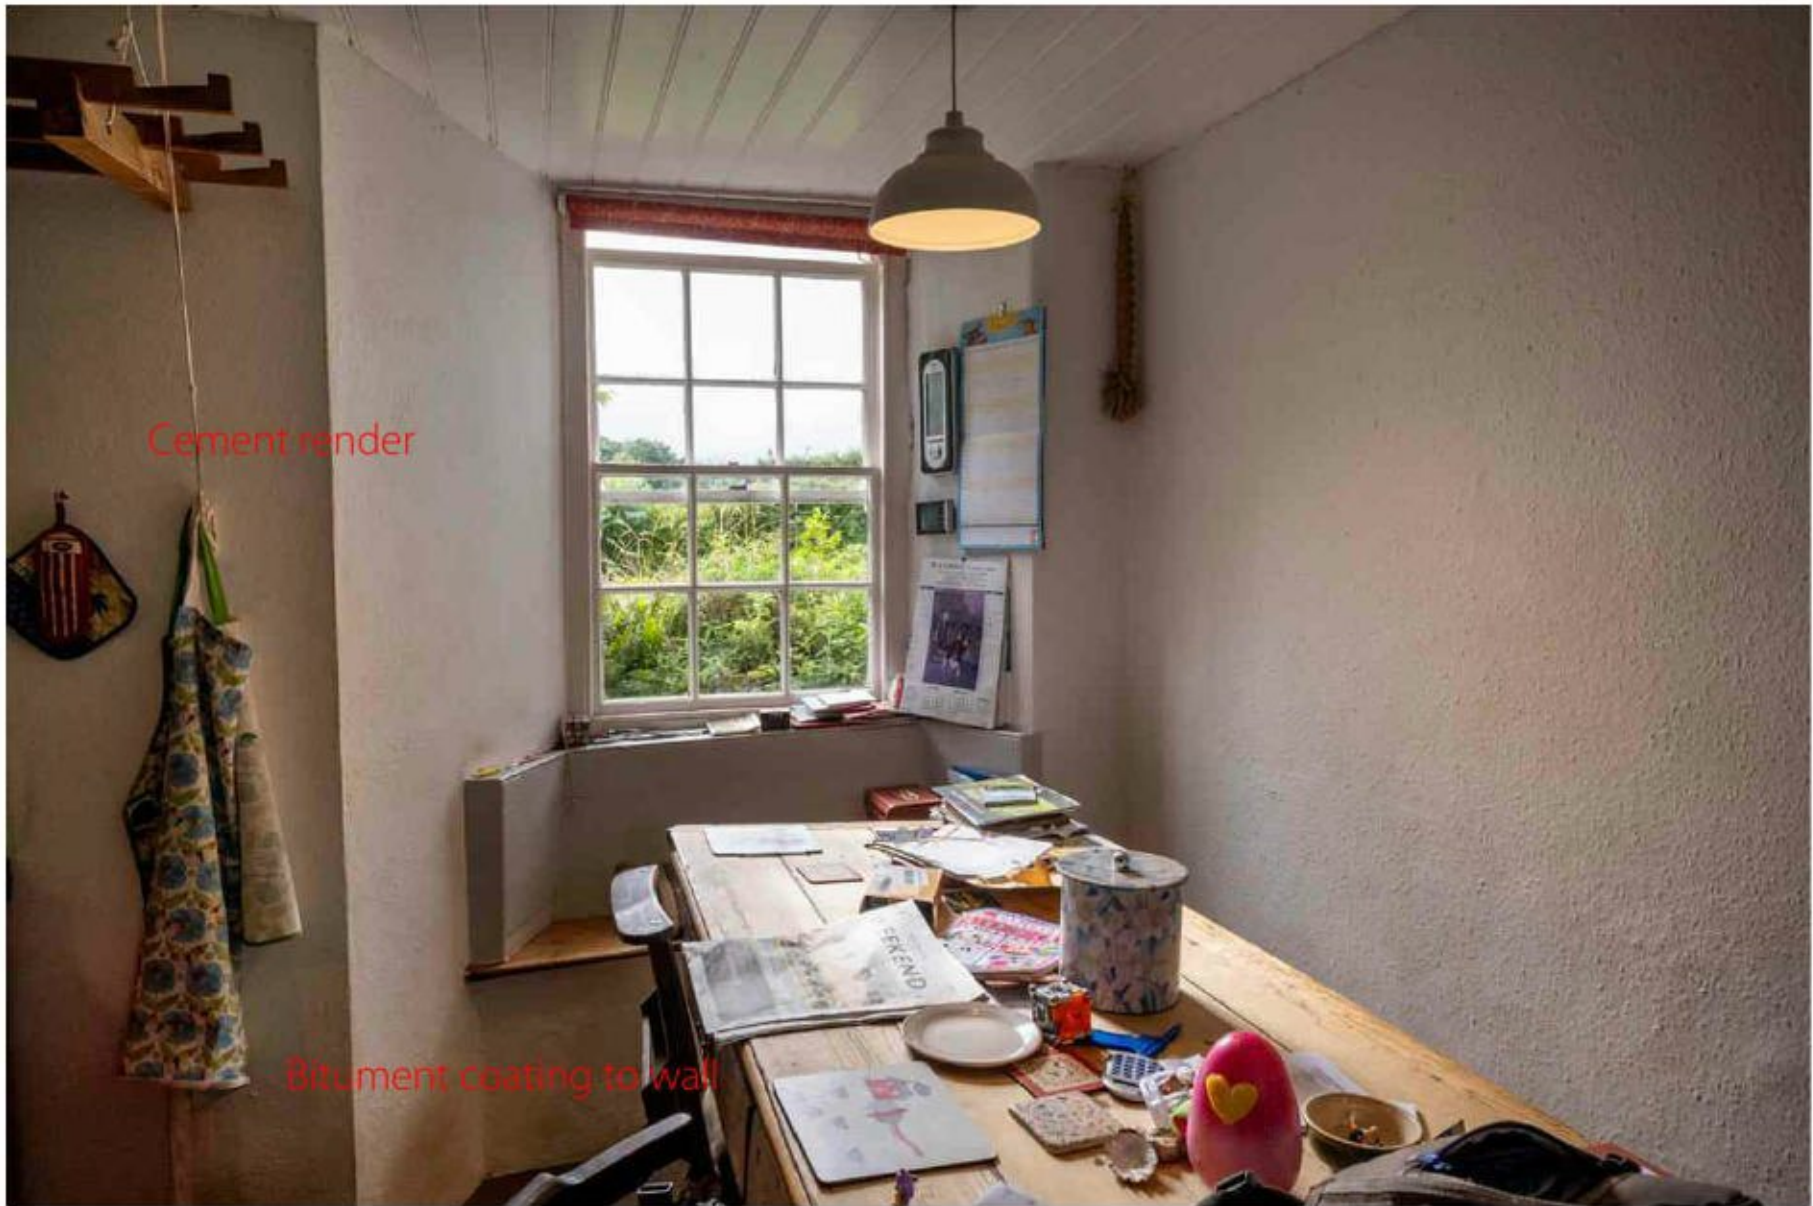
Cement render

Bitument coating to wall

Similarly, the west wall of the kitchen has received a bitumen coating (extent unclear) and a hard cement render, with the expressed intention²⁰ of providing a more rustic aesthetic than smooth plaster. As mentioned, this can compromise the moisture buffering properties of the wall, exacerbating problems with damp. This existing kitchen formerly had a cloam oven, which it is understood was removed when the room was refurbished in the late C20.
