Heritage Statement & Impact Assessment

Proposed Alteration:
Trendeal Vean Farmhouse
Ladock
Truro
TR2 4NW

Silverlake Design Ref: 3468HIA

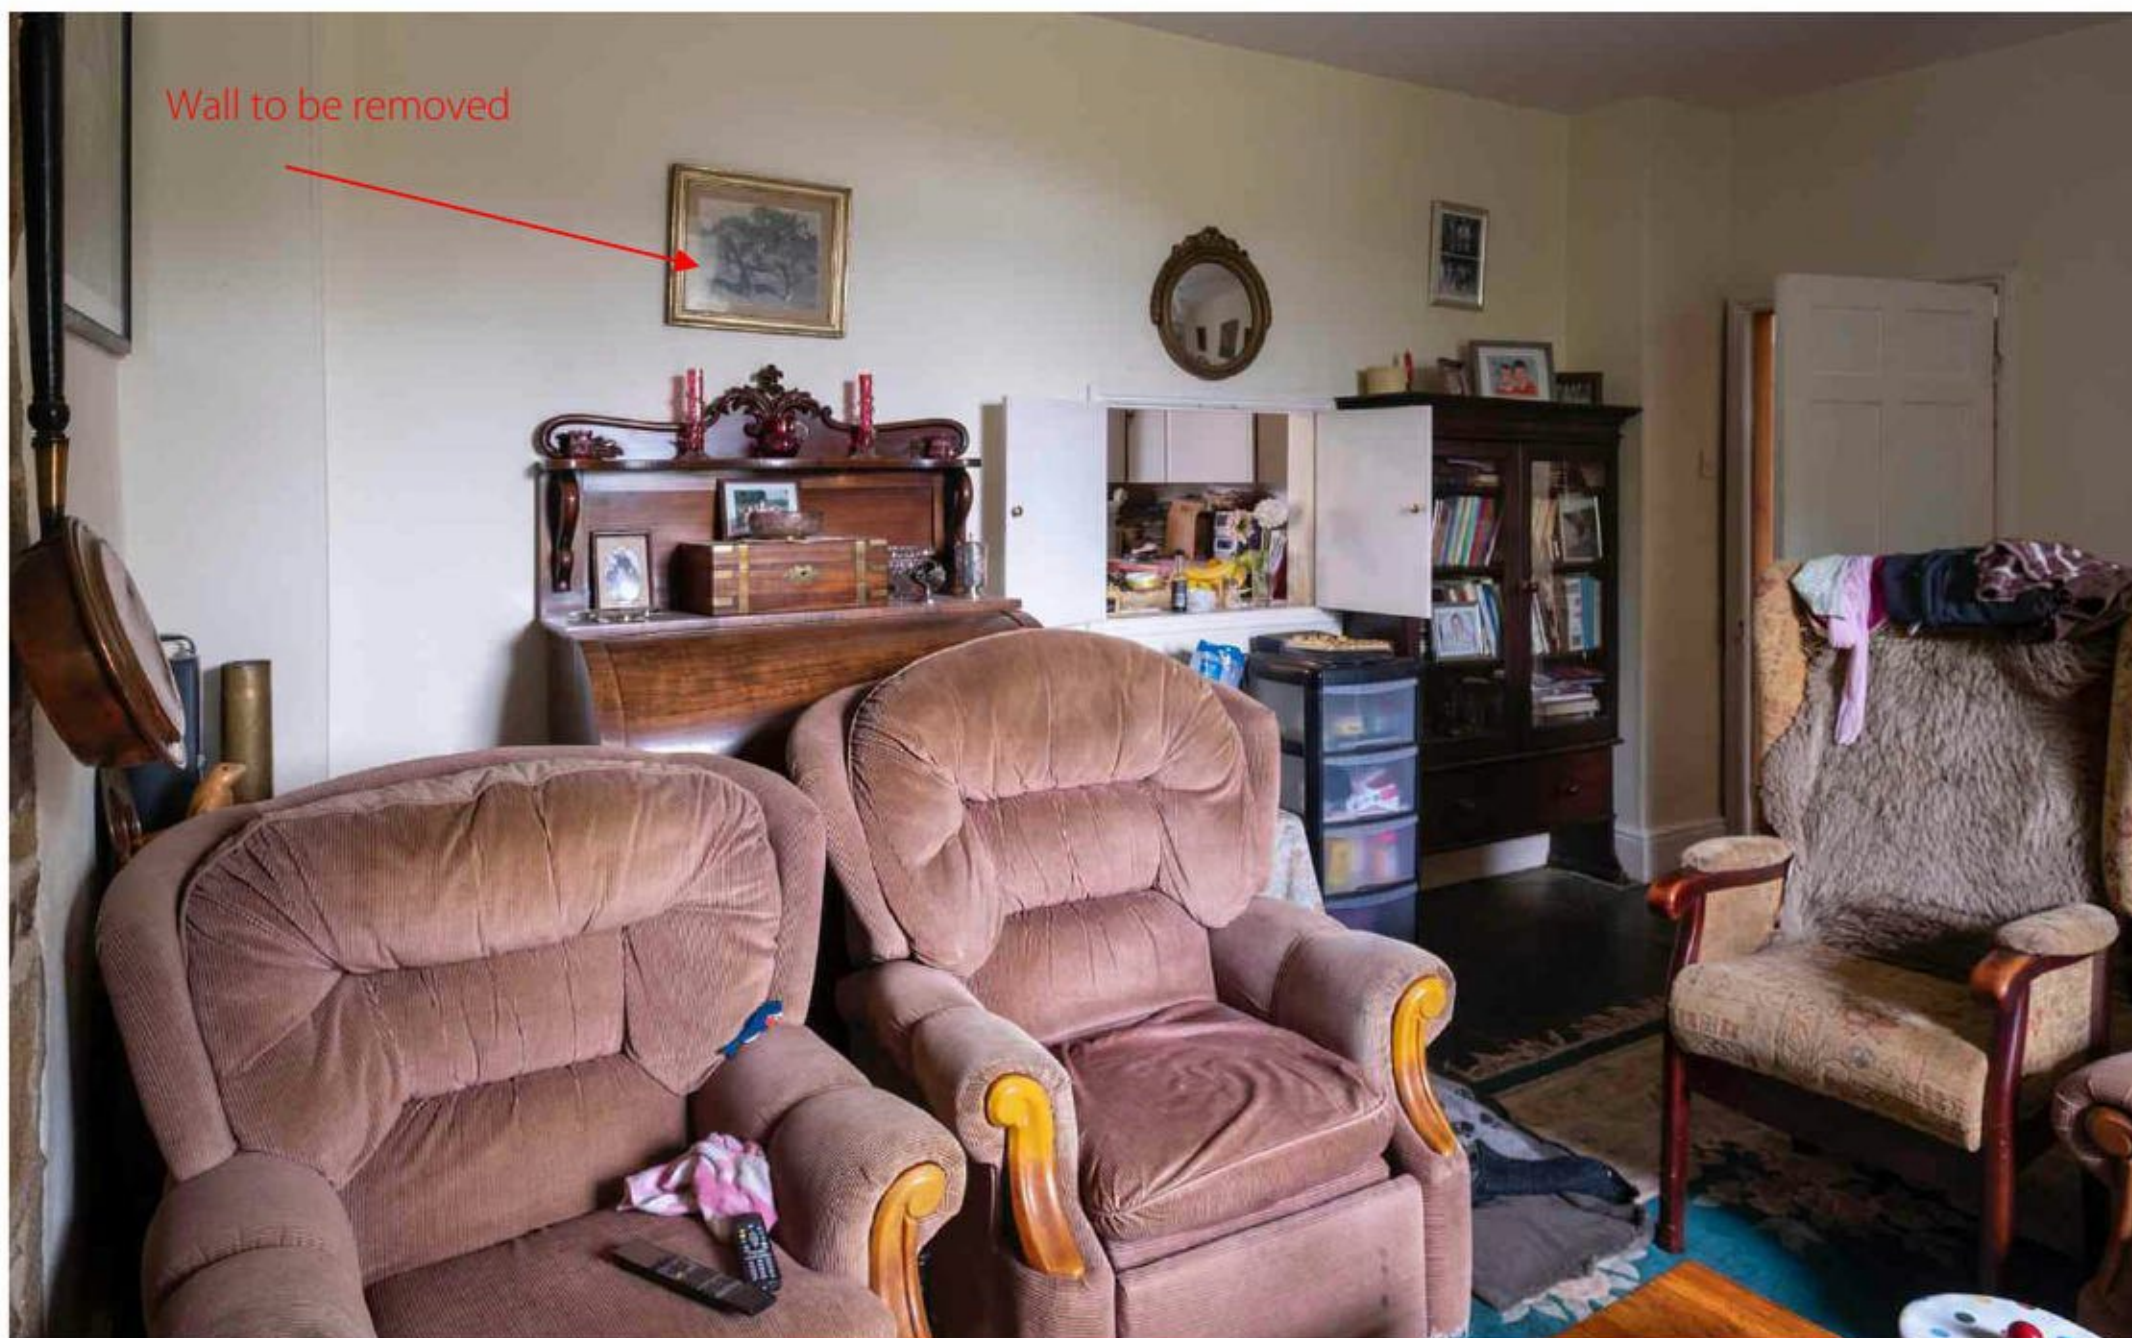
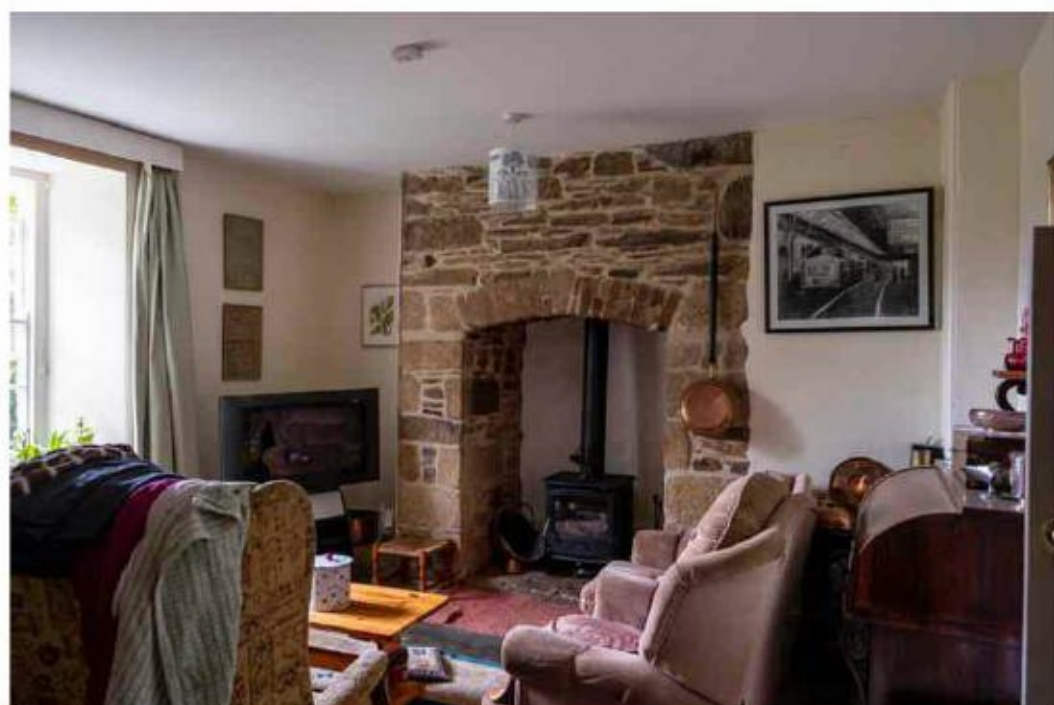
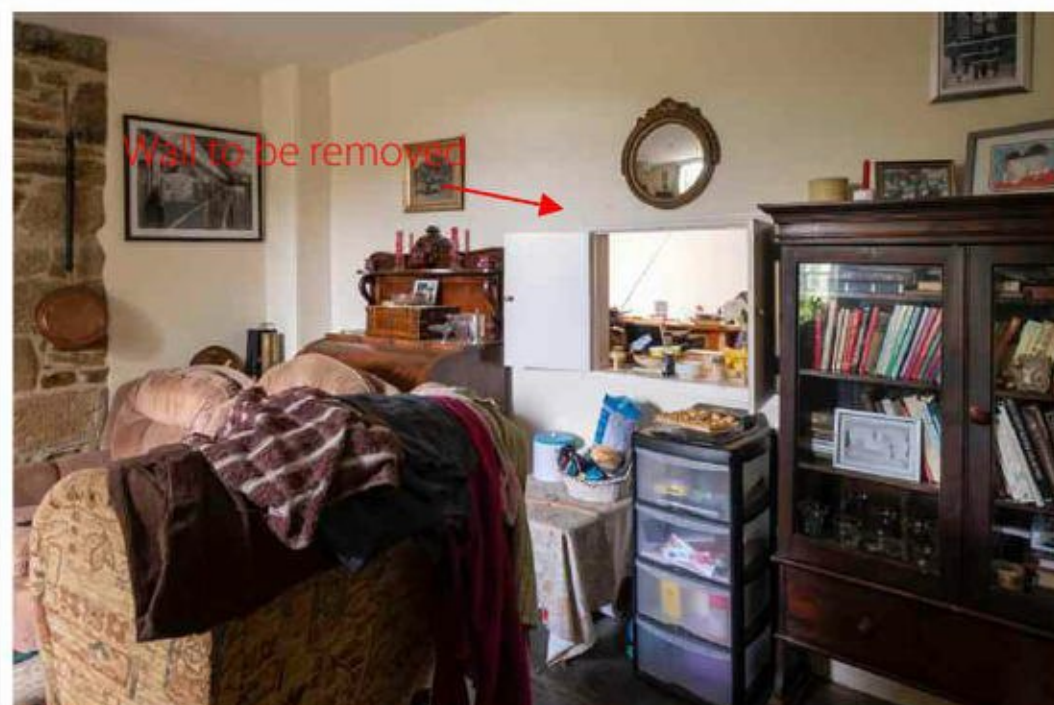
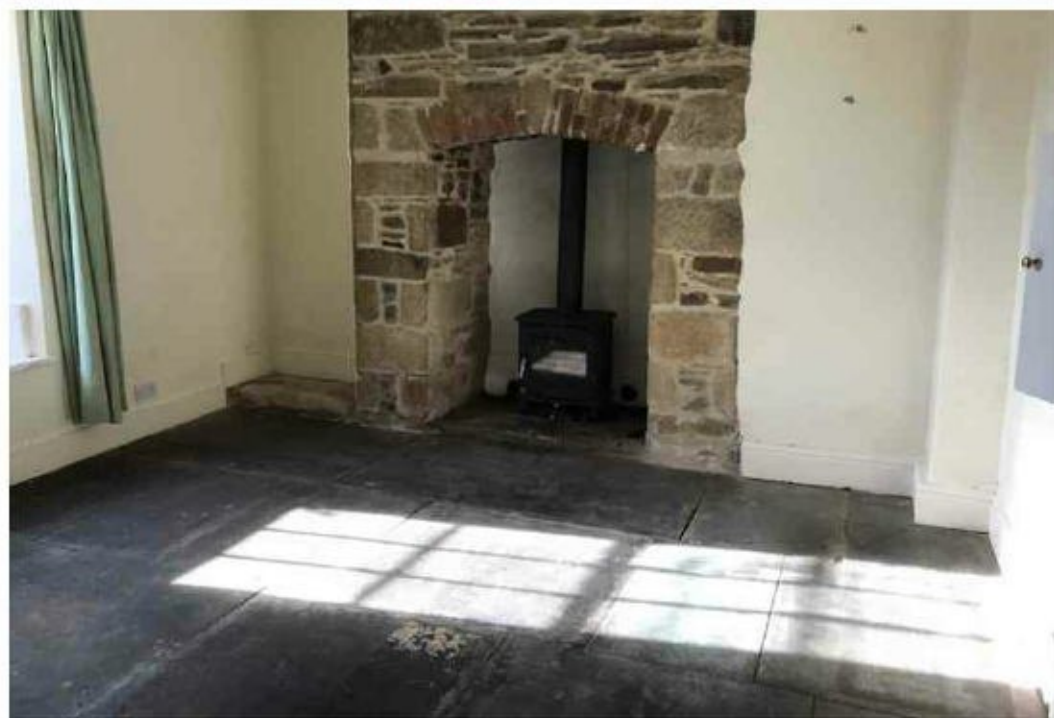
Sitting Room

Photo below-left supplied by the Duchy of Cornwall. This shows the room and slate floor following clearance

With the exception of the sitting room (former kitchen), which retains good slate flags, all downstairs floors have been replaced, with concrete, modern ceramic tiles and, in the dining room (proposed living room 2) timber floorboards. No floors are insulated. The tenants reported that cupboard under the stairs retained some earth floor and there has been a problem with rats tunnelling through. Historically, rats also chewed away part of the bottom rail of the former dairy door to access food.
