**DESIGN, ACCESS STATEMENT**  
**and**  
**HERITAGE IMPACT ASSESSMENT**

**Proposed Minor Repairs and Alterations at Trelonk Farmhouse [Grade II]**

**Trelonk Ruan High Lanes Truro Cornwall TR2 5PA**

Project reference : TBP 21-034

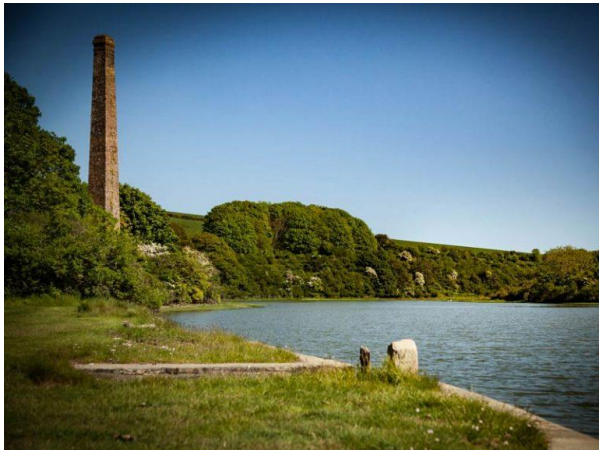
Copyright Parnall Engineering. The surviving Stack to the Kilns

The Brickworks operated from 1891 until 1907 taking advantage of the clay washing down the river and silting up the creek. The bricks produced were used to build many of the grand houses of Falmouth and Truro but all that remains of this industry now is the tall chimney once used to draw air through the kilns. See OS Map 1906 – north side of the creek

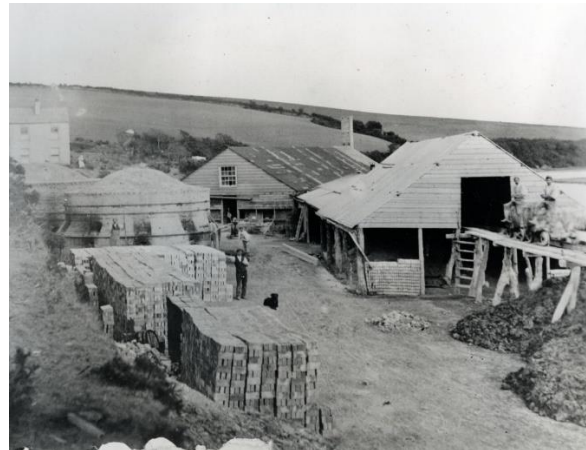
Copyright Cornish Memory.Com. Brickworks circa 1870

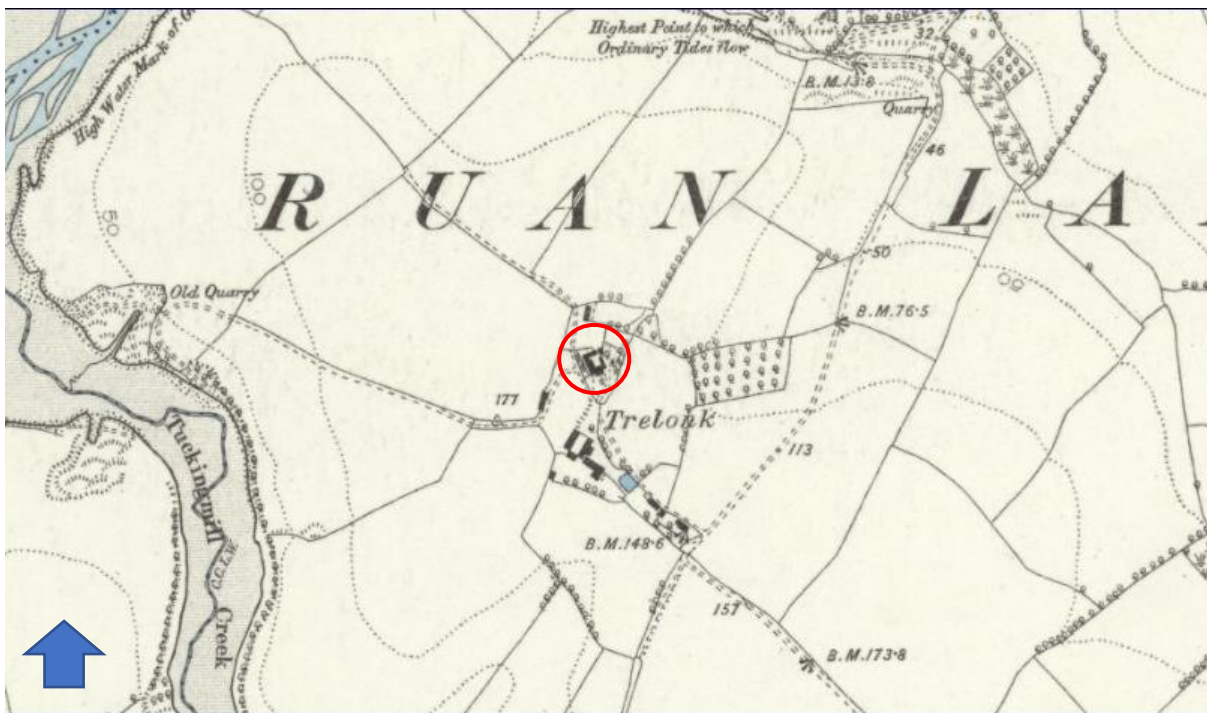
OS Extract 1880

In order to supplement the HER data summarised above historic Ordnance Survey maps dating to 1880 and 1906 were accessed in order to gain an understanding of changes made in the late 19th and early 20th centuries.

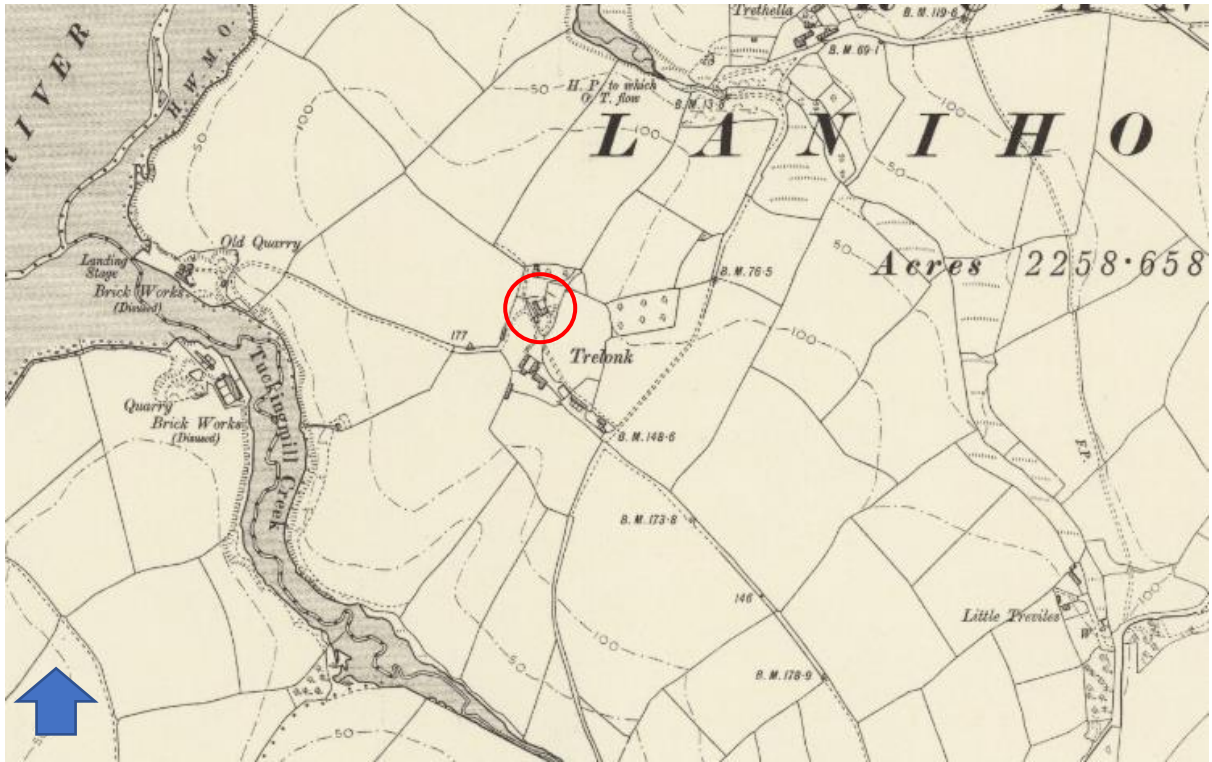
OS 1906 [published 1908]

The Site was largely unchanged by the time of the Ordnance Survey map of 1906 although there had been extensions or rebuilding of some of the outbuildings to the northern range. Recent planning applications also document rebuilding of the rear courtyard walls and garage.

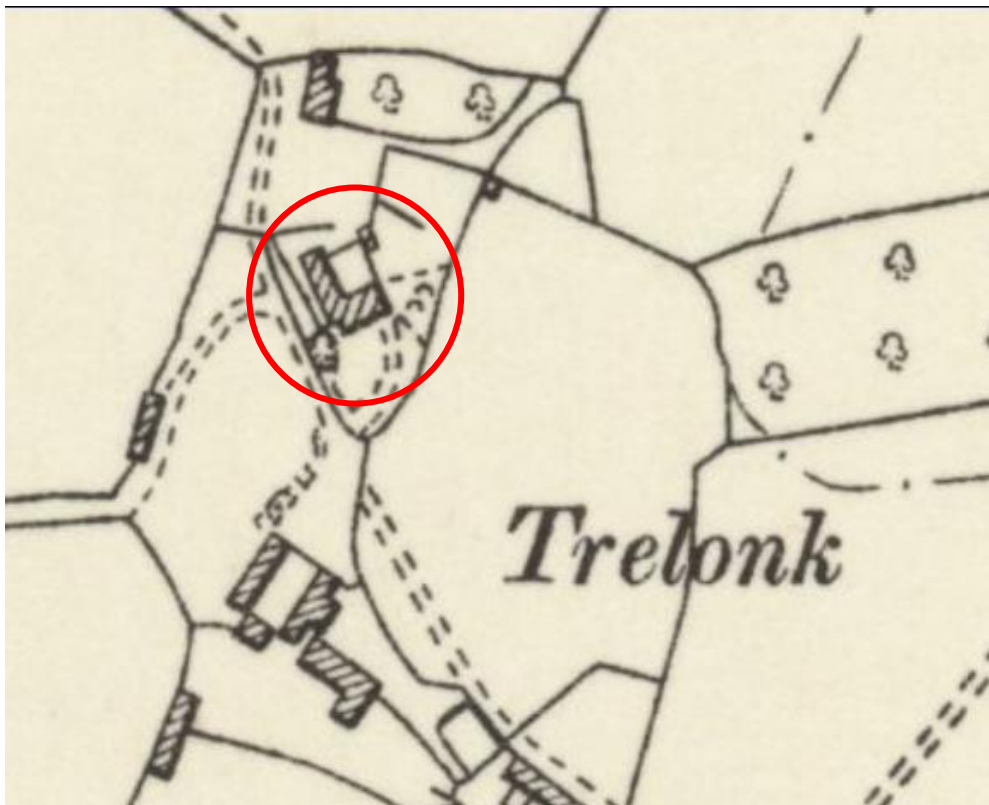
OS 1906 [published 1908] - zoomed in [northern range of outbuildings missing]

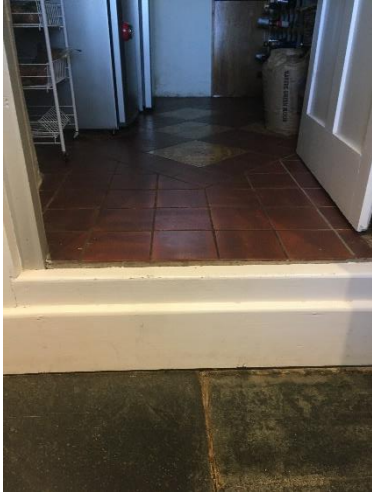
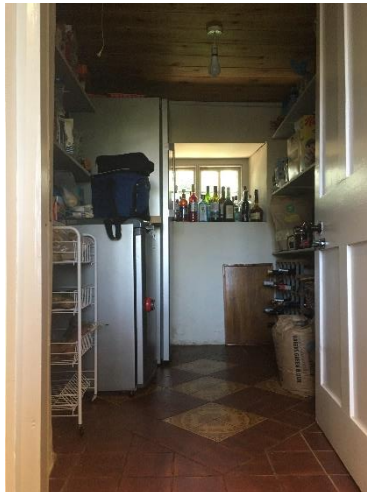
#### A - Removal of Internal Pantry

The existing pantry, which is located at the northern end of the kitchen is to be removed. The walls have been clad in a modern painted timber board. It takes up valuable space within the kitchen plan and reduces the width of useable space. Its floor level is raised above the main kitchen floor by one step and has a modern ceramic tile covering.

The disturbed surfaces of the external wall will be made good, and lime plastered. The modern plasterboard ceiling and skin will be made good to match.

It is possible that a slate flag floor has been left in-situ under the pantry floor. If this is found, then the flags will be carefully cleaned and retained. If not, then salvaged second hand local flags will be laid to blend with the existing slate flag floor.

The rather oddly located and probably later 'pantry' space is to be removed to improve the layout and connectivity of the 'new' kitchen. The floor to the pantry is covered in a modern ceramic tile and the walls are clad in a painted timber boarding. Modern plasterboard internal wall facing and ceiling.

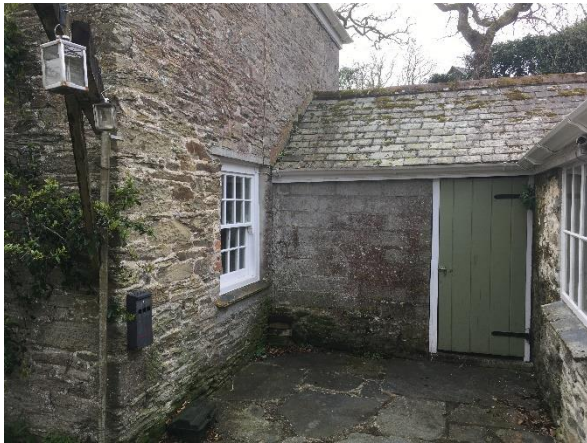
It is proposed to remove the existing block external wall and door on the courtyard side. This is a modern concrete block wall which has been used in a rebuilding of the original slate stone wall some time ago, a small amount of which survives at ground level. See photograph.

The external ground slate will be salvaged and used elsewhere within the garden curtilage.

In order to make better use of the external recess created by the narrower section of out-building, it is proposed to take down the later concrete block skin and expand the 'link' space by constructing a new external wall using the Trelonk brick. The existing pitched roof form will remain, but a new traditional lead rolled roof will be constructed over the increased area. This will preserve the form and scale of the existing out-building roofs. The expanded space again contributes to the visual connectivity from the kitchen through to the dining space, with a view also, out to the smaller courtyard and garden areas immediately north of the dining space.

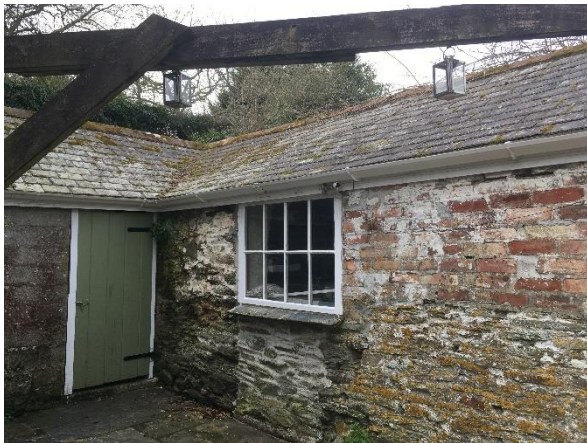
A further section of walling forming the separating flank wall between the small store and the northern out-building wing including the window and later door infill. See photograph.

Additional Oak and Oak clad steel beams will pick up the existing roof structure.

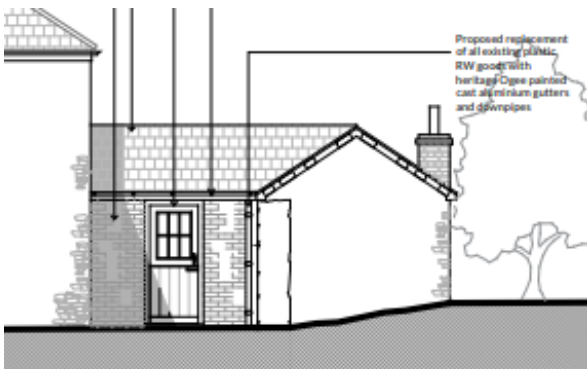
Proposed infilling of 'Link' space to create Dining function. Lead rolled flat roof over new external wall constructed using salvaged 'Trelonk' brick laid in matching bond and a lime mortar.

Painted timber fascia to match. Painted cast aluminium Ogee gutters and circular downpipes.

Traditionally detailed semi-glazed and boarded stable type door – painted to match existing.

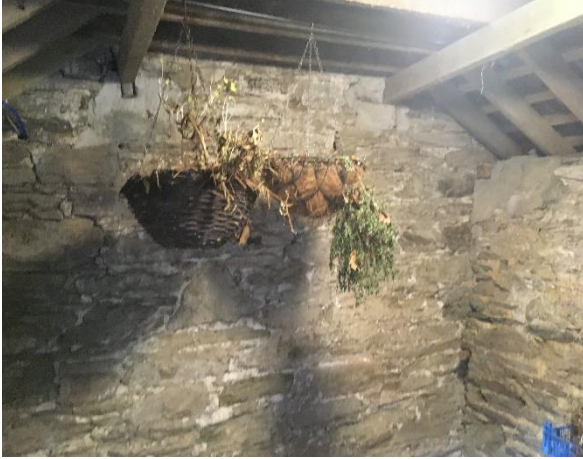
Photograph showing internal separating wall to small store – to be removed. A cranked timber beam will pick up the existing purlins.

Interior of small store. The roof structure is in good condition. A new PavaTherm by PavaTex Woodfibre insulation / ceiling board with a lime plaster skim finish will be fixed to the underside of the rafters.

The interior face of the external walls will be lined out with a sw timber frame offset from the wall and fixed independently, insulated between studs with ThermaFleece [sheep’s wool] insulation. The

frame will be clad with PavaTherm wood fibre insulation with a lime plaster skim finish. Lose stones and mortar to top of walling will be re-bedded and made good. See detailed drawing.

The existing modern floor screed will be retained. New slate flooring will be overlaid. No skirting.

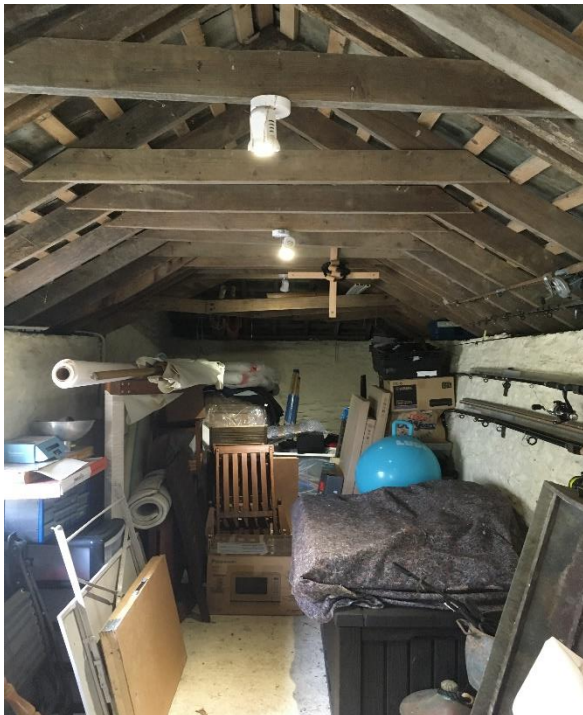
Interior of northern out-building. The roof structure is in good condition. A new PavaTherm by PavaTex Woodfibre insulation / ceiling board with a lime plaster skim finish will be fixed to the underside of the rafters.

The interior face of the external walls will be lined out with a sw timber frame insulated between studs with ThermaFleece [sheep’s wool] insulation. The frame will be clad with PavaTherm wood fibre insulation with a lime plaster skim finish. See detailed drawing.

The existing modern floor screed will be retained. New slate flooring will be overlaid. No skirting

Lose stones and mortar to top of walling will be re-bedded and made good.

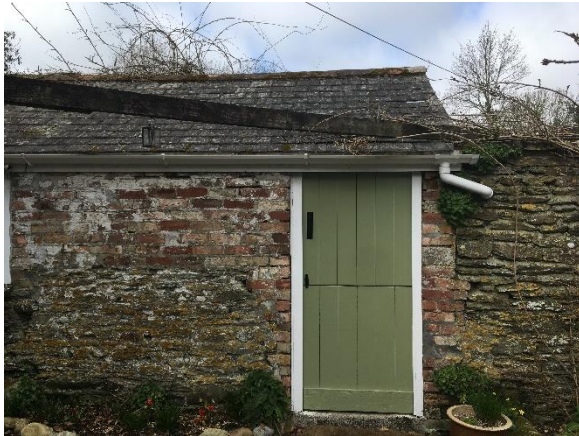
Existing door to Boot Room and Store to remain unaltered

The new separating partition between the Boot Room and the Dining space will be constructed from sw timber stud framing and clad with ThermaFleece [sheep’s wool] insulation inserted between the frames. The frame will be clad with PavaTherm wood fibre insulation with a lime plaster skim finish. No skirtings. See proposed Plan.

The sliding ‘pocket’ door will be salvaged and re-used from the pantry.

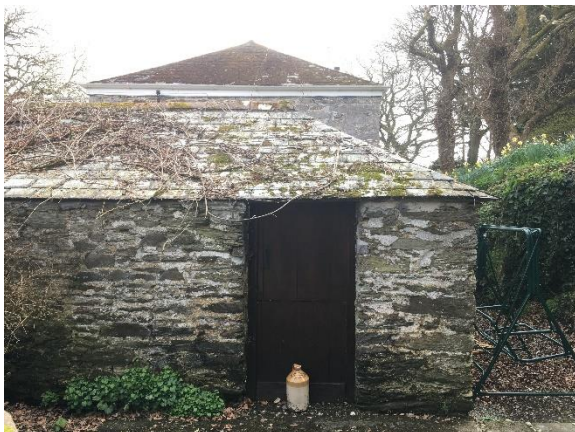
Northern end of Out-Building / Store [proposed Dining space]

Slipped and broken slates to be repaired with matching salvaged slate.

Defective pointing to be removed and joints re-pointed using a suitable matching lime mortar

New cast aluminium Ogee gutter and down pipes to be fitted.

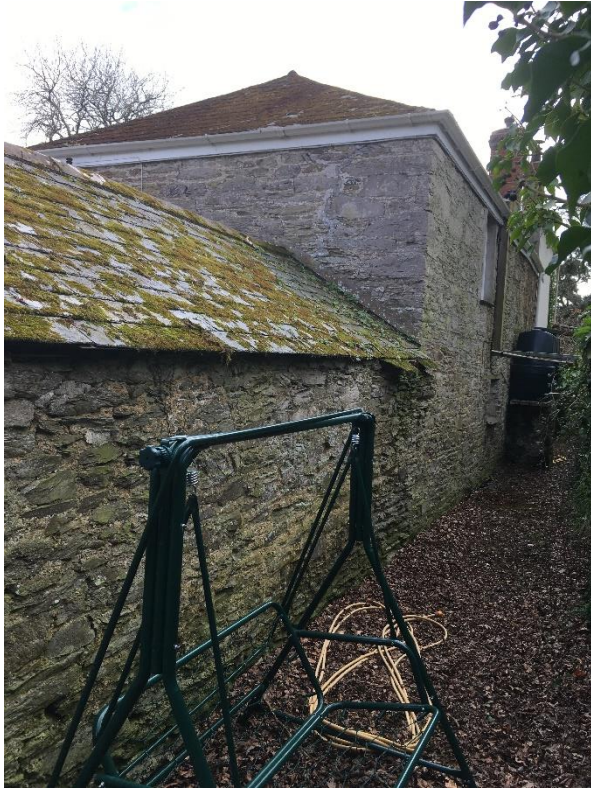
Western flank wall of Out-Building range and House

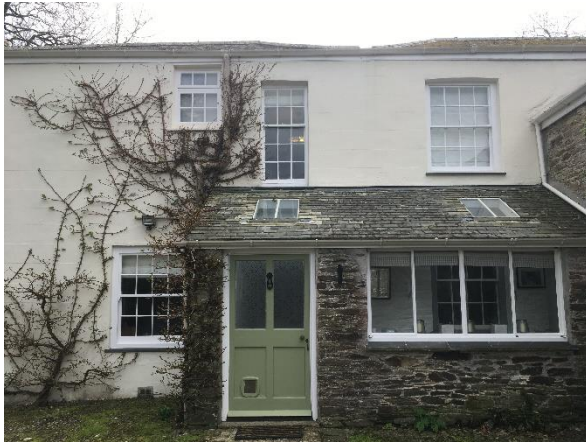
The existing porch is a later addition.

It is proposed to replace the existing metal framed window and insert a new plain chamfered granite mullioned stone surround.

It is proposed to build up projecting matching stone jambs either side of the existing door to form a small 'porch' roof overhang.

The rear 'lean-to' porch is a later addition. The small amount of 'porch roof' extension to the entrance door will provide additional weathering and improved visual reference.

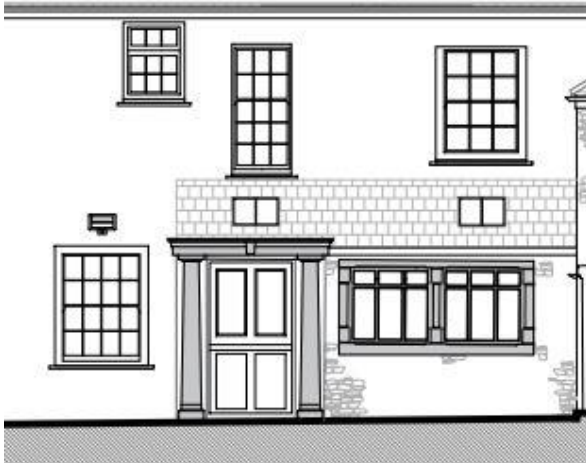
Two half round plain, slightly tapered granite columns with simple chamfered and square edged capital and base planted on face of new stone jambs. A simple plain granite entablature set above the columns and across the width of the door with plain simple entablature.

A shallow lead flat roof behind the entablature will be constructed and drained to discharge on to the adjacent slate roof.

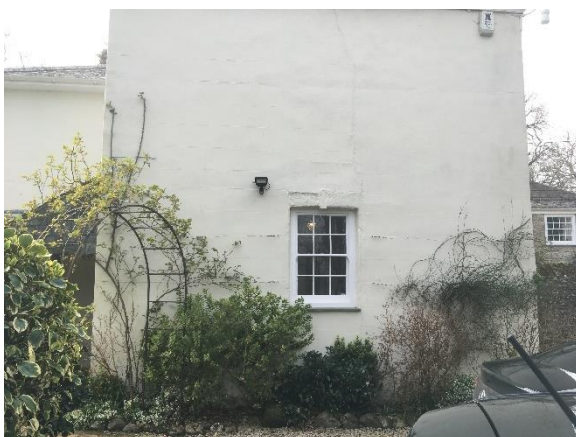
It is proposed to form and insert a new matching painted timber sliding sash window of the same size and pattern as the existing window shown at ground floor, to serve the bedroom above

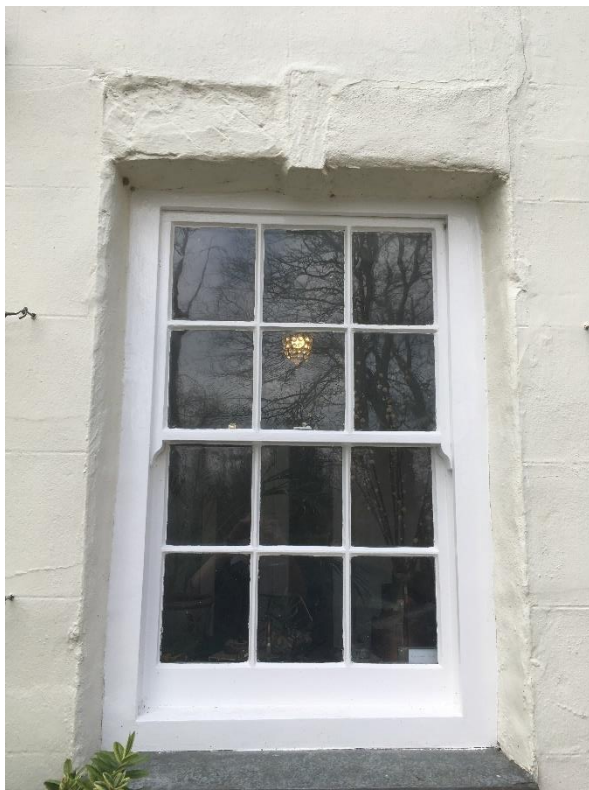
The render across the window head is to be repaired. Carefully cut back defective render to the stone face. Lightly repair any defecting pointing in a suitable lime mortar. Prepare face of stonework and build up in layers [subject to the thickness of the existing stucco] to marry with the existing surface. Form matching keystone in layers to same size and projection as existing.

The specification for the repair will be determined once the existing stucco make up has been determined from site and or laboratory analysis.

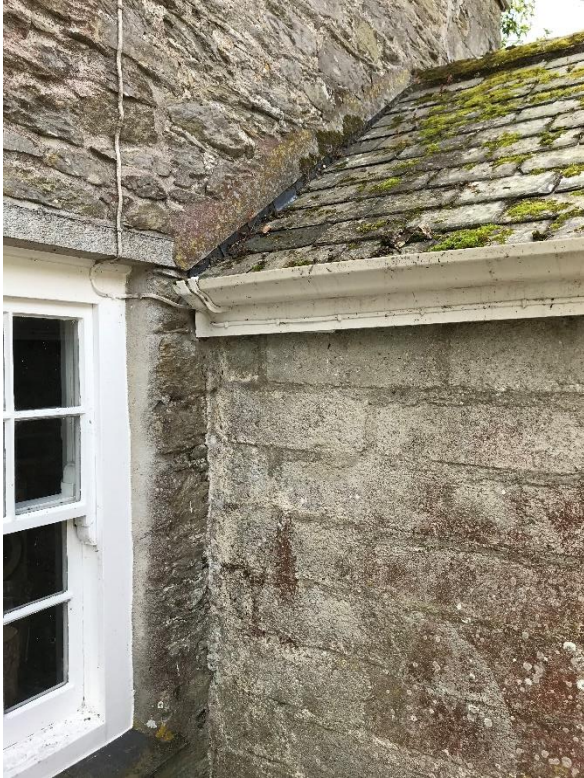
Example cast aluminium rainwater goods

Almost all of the rainwater goods around the house are of a white pvc-u plastic! It is proposed to replace all of the gutters and downs pipes with a Heritage painted cast aluminium Ogee gutter and circular downpipe with moulded collars, outlets, end and shoes

The existing RWGs are mostly white pvc-u. It is proposed to replace all goods with a painted cast aluminium 'heritage' Ogee profile gutter and circular downpipes. E.g.
