Re: Update site walkover to assess status-quo of structures against the findings of 2019

Site: Whitegate Nurseries, 66 Chapel Road, Hesketh Bank, PR4 6RT/ National Grid Ref: SD 44385 23381

Update site walkover

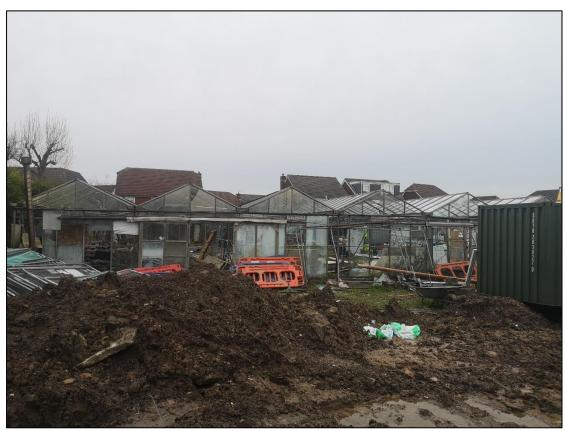
The remaining building on site is a single storey greenhouse previously denoted as B1 in the 2019 Preliminary Ecological Appraisal; The building is open to the ridge, with no roof void and is highly illuminated, draughty and cold due to broken glass panes in the roof and sides; This survey The building provides no viable ingress/egress opportunities / crevice opportunity to support crevice dwelling bats and is there fir classified as 'Negligible' in regard to bats. These findings are consistent with those in the previous PEA.

Plate 1 – Glass green house to be demolished

Based on the site-specific guidance assessment as described, risks of impacts to bats can be considered highly unlikely and the barn is duly categorised as offering '**Negligible**' bat roost potential in accordance with Bat Conservation Trust 'Bat Surveys: Good Practice Guidelines' (2016) (see Figure 8.1); no further surveys are required in relation to bats. Enhancement is recommended for bats in Appendix III.

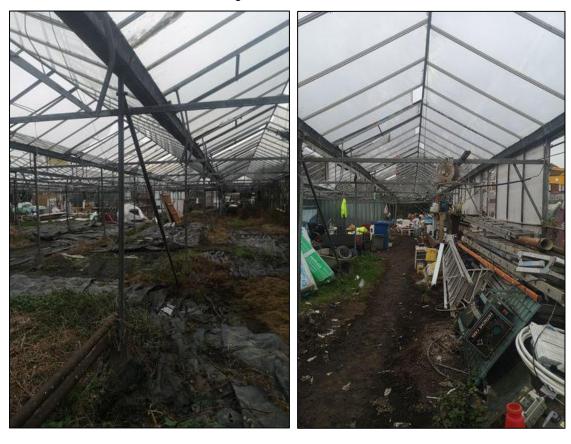
Plate 2-Interior of green house

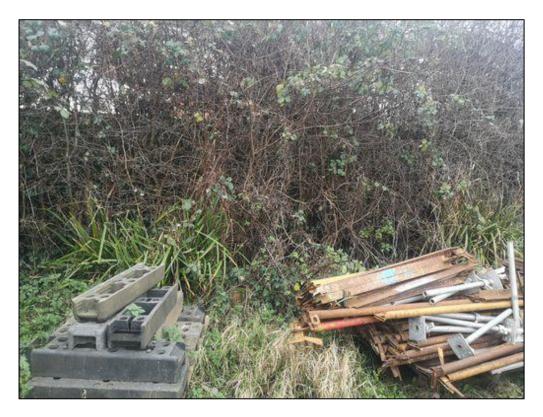
Plate 3 – Scrub at base of northern hedge

As the site still offers suitable nesting platforms for rural and garden birds particular in the north of the site, though no historic/active nests were identified at the time of the survey. It is therefore recommended that works commence outside the breeding season for birds (broadly March-August inclusive), unless it can conclusively be demonstrated by a suitably qualified ecologist that nesting birds are absent 48 hours before hand.

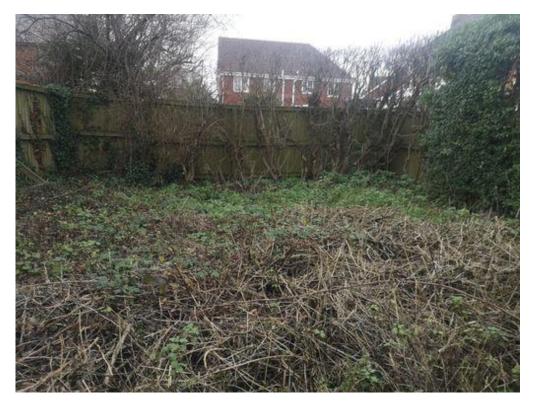
The site may support common bird species such as house sparrow, which were observed utilising the western hedgerow during the site visit. The northwest corner of the site where the garden of plot 2.1 is to be situated was previously denoted as scattered trees, it appears this area has been cleared of trees however scrub encroachment and the remaining hedge row in conjunction with the northern hedgerow and associated scrub would also provide suitable nesting platforms for birds associated with garden and rural habitats

Plate 4 – Scrub encroachment in the northwest corner

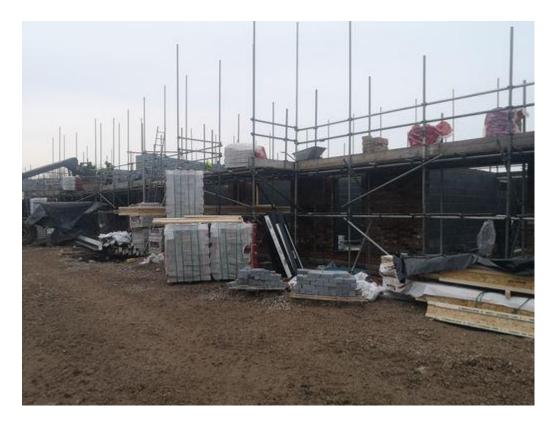
During the survey it was immediately noted that the majority of the south of the site has been cleared and is ready for development; or is currently under development.

Plate 5 – General character of the rest of the site.

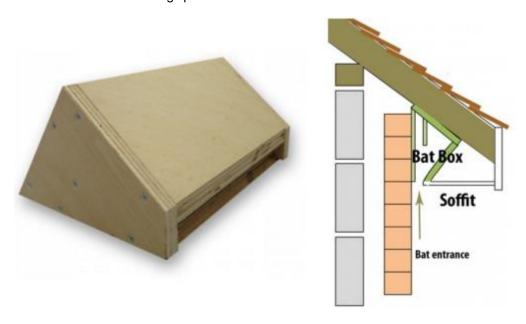
Where soffits are instated at gable elevations, roost provision may be instated in the form of a soffit bat box with internal roosting space.

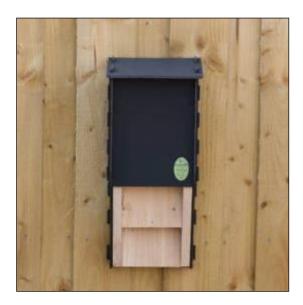
A large number of externally fitted box models for bats exist for buildings and trees. Suitable models for both buildings and trees may include the Eco Kent Bat Box.
