THE BREAD OVEN ROOM WARRENS

Architectural Paint Research Report

December 2021

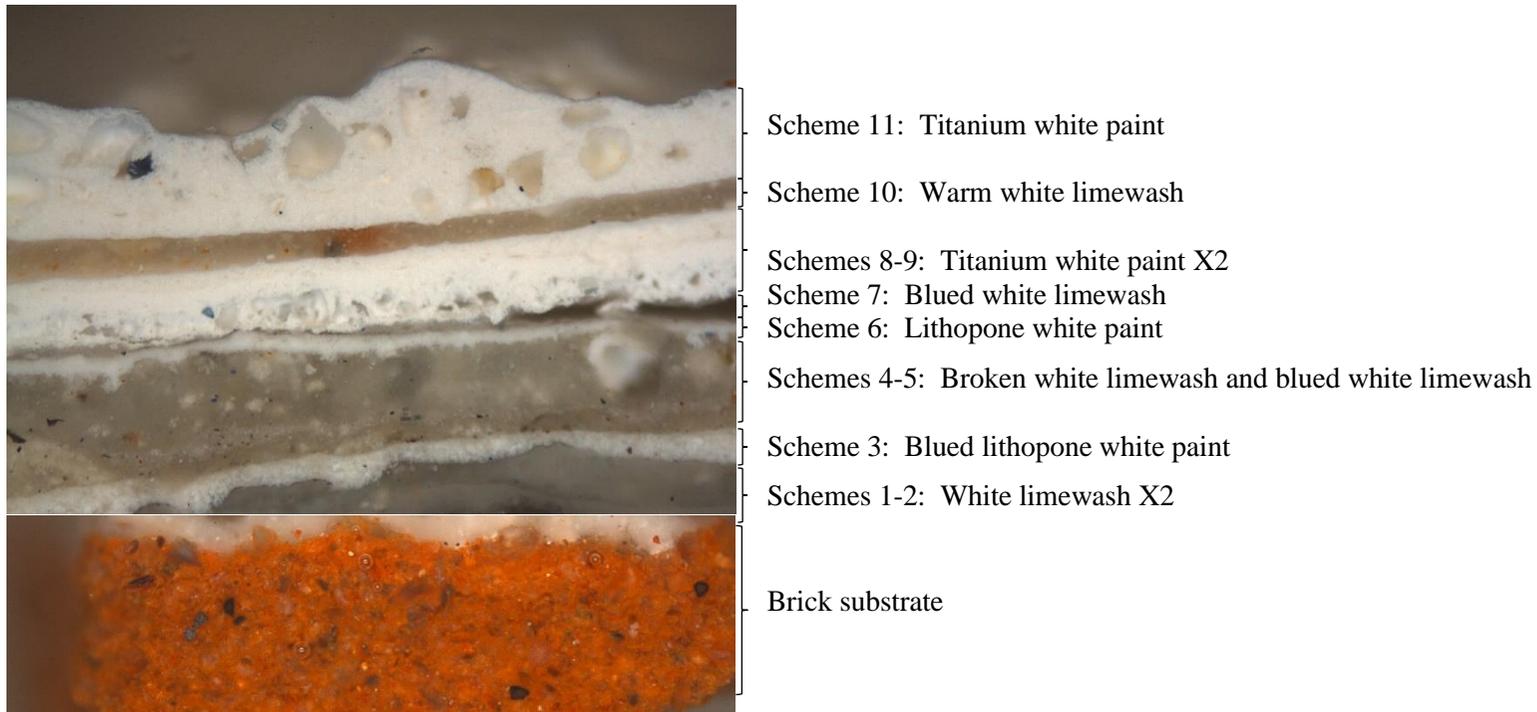
Bread Oven Room Wall Surfaces

The south elevation wall retained the most extensive paint history, a total of 11 separate phases of decoration over a red brick substrate. This is considered a sufficient number of decoration schemes to date back to the construction of the Bread Oven Room in the last decade of the 19th century and indicates that the walls were painted in decorative cycles of every 10-15 years.

In the initial two phases the wall was plainly limewashed white. In Scheme 3 the wall was redecorated with a white painted mixture blued a more brilliant shade of white with particles of French ultramarine. Micro-chemical tests and examination of this mixture under incident and ultra-violet light suggests that it was composed of a lithopone-based oil paint.

Photomicrograph illustrating sample 10 taken from the south elevation wall, showing its painted history. Photographed in cross-section in incident light using a 10X lens. Printed magnification not calculated.

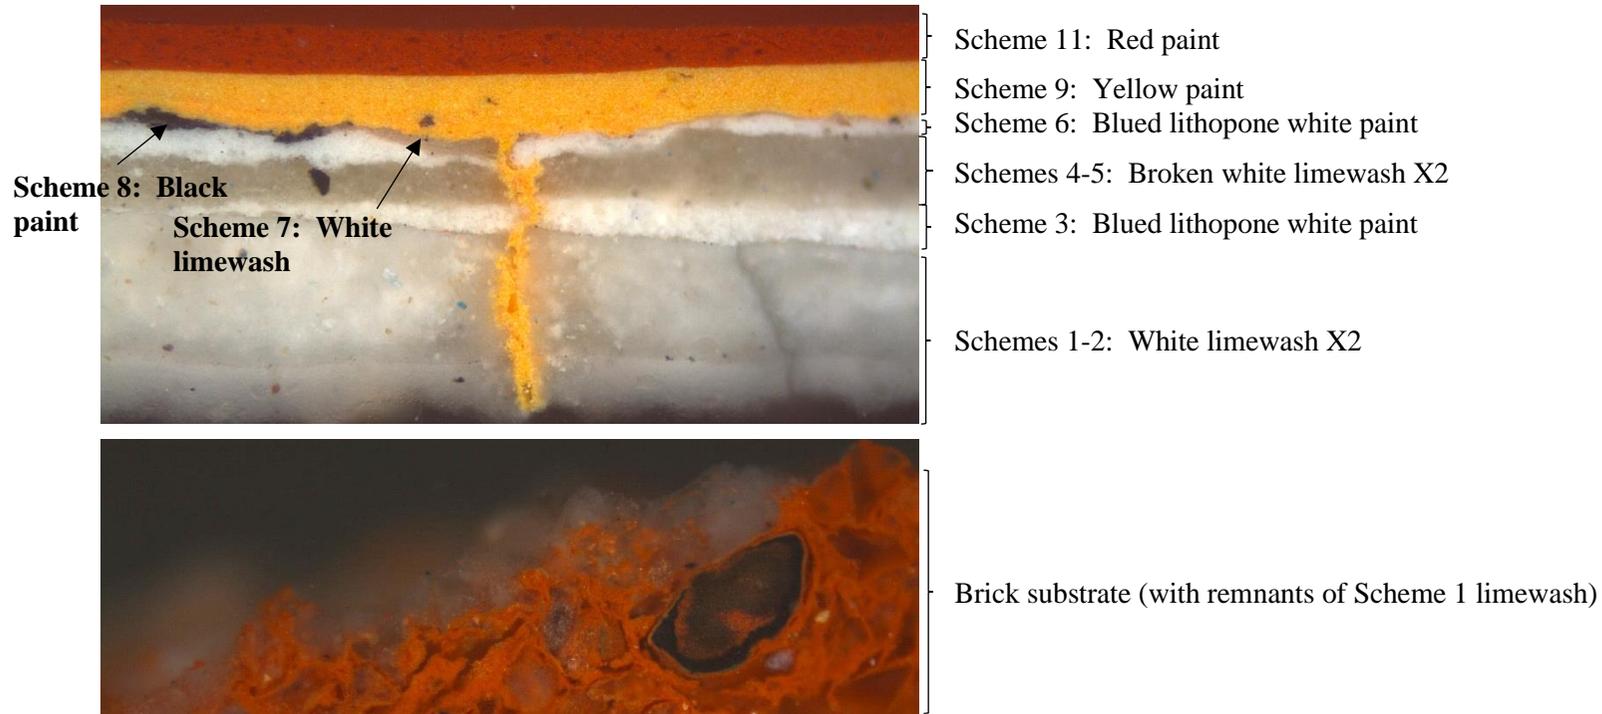
Bread Oven

The red painted lintel retained ten separate phases of decoration over a red brick substrate. Commencing from Scheme 1, it was initially limewashed white twice. A blued lithopone white paint with French ultramarine inclusions and two white limewash coatings followed.

In Scheme 6, the lintel was repainted lithopone white, blued a more brilliant shade once more with French ultramarine particles. The fragmented remains of a white limewash decoration can then be seen.

In Scheme 8 the lintel was repainted black followed by a yellow and then the existing red paint mixture. Whilst the finely ground nature of these coatings makes the identification of individual pigment particles difficult to discern, it does strongly suggest that titanium-based paints were employed during this final period.

Analysis indicated that the bread oven lintel was either painted or limewashed white in tandem with the surrounding oven and walls for most of its decorative history, only being differentiated through a use of contrasting colour from Scheme 8, executed at some point after c. 1960.

Photomicrograph illustrating sample 3 taken from the red painted oven lintel, showing its painted history. Photographed in cross-section in incident light using a 20X lens. Printed magnification not calculated.

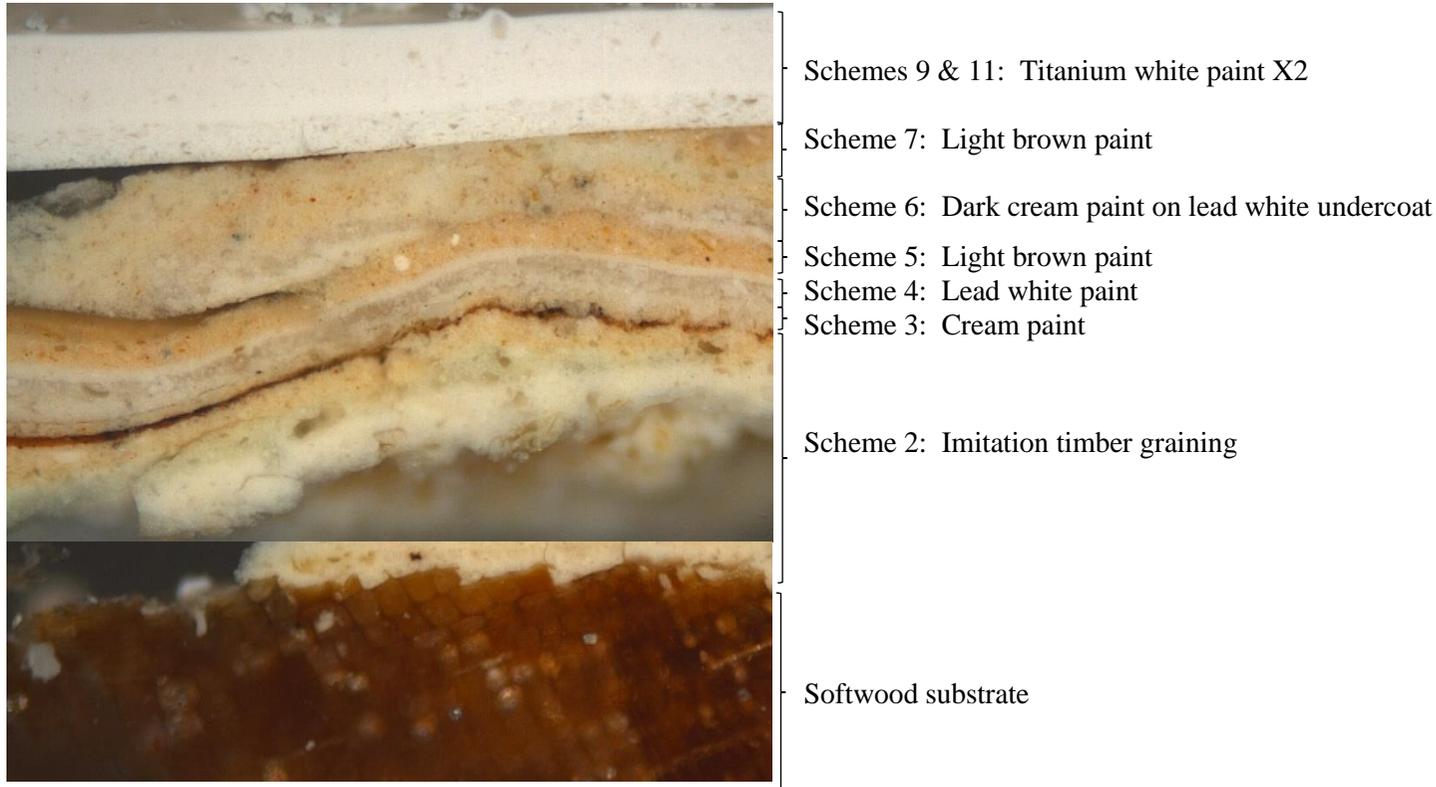
Bread Oven Room Entrance Door

Commencing from Scheme 2, eight separate phases of decoration were recorded over a softwood timber substrate. Initially the door was grained in imitation of timber using a series of lead-based light brown, cream and white oil paint mixtures, a brown meglip glaze and a finishing coat of varnish. It would be necessary to uncover later layers of paint to assess the pattern of the graining and the type of timber it intended to emulate.

The door was painted a cream colour and then white in the following two phases using lead-based paints. Flecks of iron oxide earth and carbon black can be seen in the cream coating.

In Scheme 5 a similarly pigmented light brown zinc-based oil paint mixture was applied. A light brown zinc-based paint relating to this phase was previously noted on the west elevation inner door lintel.

Next, a dark cream coloured decoration formulated from a lead-based oil paint pigmented with chunks of iron oxide earth and carbon black can be seen resting over a lead white undercoat. This was followed by another application of light brown zinc-based paint.

In the final two schemes the door was plainly decorated white with modern titanium-based paints.

Photomicrograph illustrating sample 15 taken from the upper rail of the Bread Oven Room entrance door, showing its painted history. Photographed in cross-section in incident light using a 10X lens. Printed magnification not calculated.
