Design, Access and Heritage Statement

The Old House, Cranham, Gloucestershire, GL4 8HP

Proposed Restoration To Original Features By:

- Removal Of Concrete Render To Reveal Original Cotswold Stone Underneath; and
- Repointing With Lime Mortar

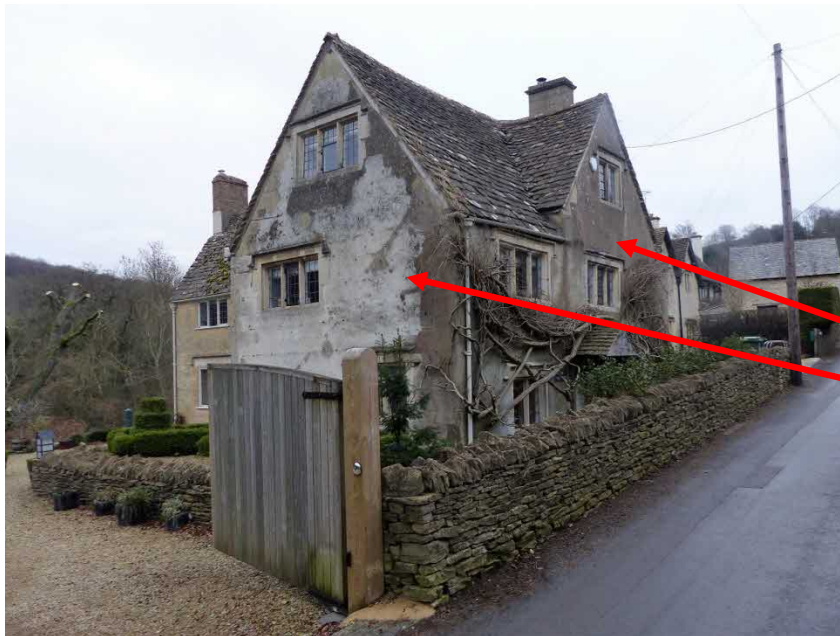
Figure 2 View of the property from the south-west

Remove render on the arrowed walls and return to original features of the Cotswold stone underneath. Repoint with lime mortar once render removed. The render is preventing the Cotswold stone from breathing and causing damp inside the property.

- The removal of the concrete render to the walls arrowed in the figures 2, 3, 4 and 5 that follow, thereby revealing the original Cotswold stone underneath; and
- repointing those same walls with lime mortar following the removal of the render, as arrowed in the figures 2, 3, 4 and 5 that follow.

The concrete render is unsympathetic to the original features and character of the property.

It is preventing the Cotswold Stone underneath from breathing, leading to damp issues (some significant in places) inside the property.

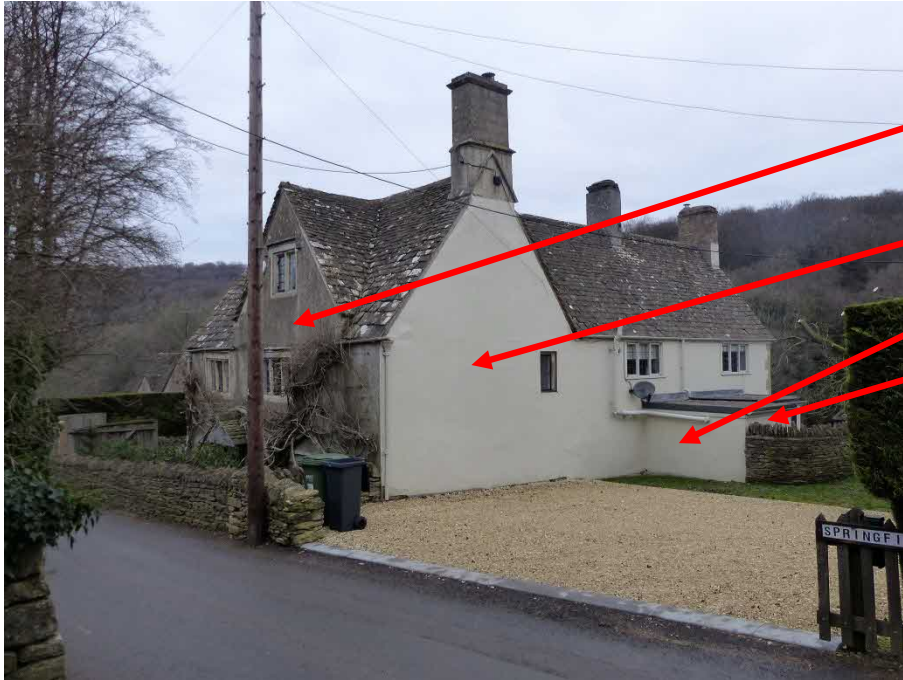
Figure 3 View of the property from the south-east

Remove render on the arrowed walls and return to original features of the Cotswold stone underneath. Repoint with lime mortar once render removed. The render is preventing the Cotswold stone from breathing and causing damp inside the property.

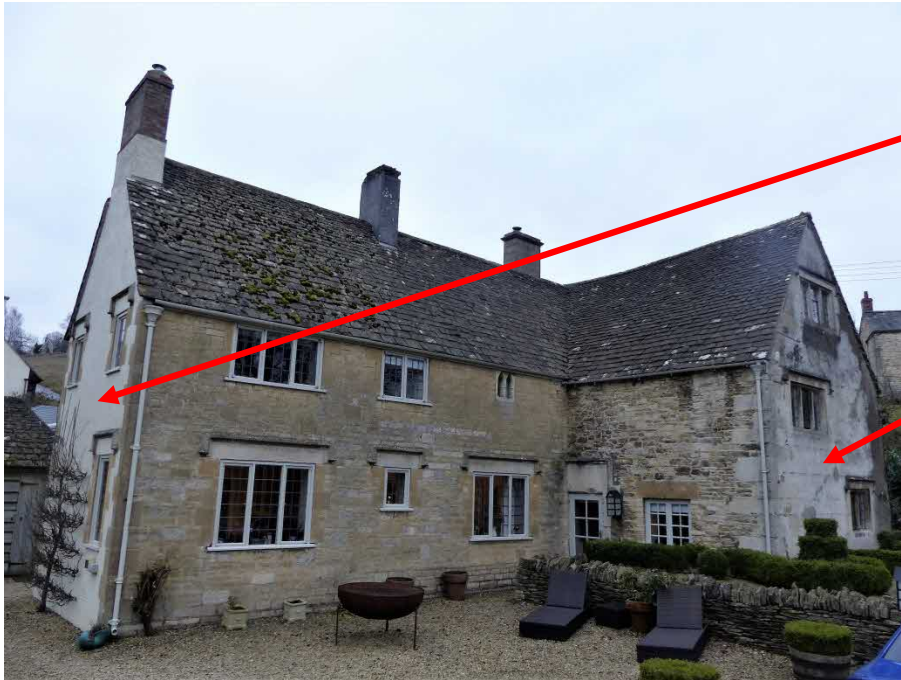
Figure 4 View of the property from the north-west

Remove render on the arrowed walls and return to original features of the Cotswold stone underneath. Repoint with lime mortar once render removed. The render is preventing the Cotswold stone from breathing and causing damp inside the property.

The render is in poor contrast to the two non-rendered walls which can be seen in figure 4 which show traditional Cotswold stone.
