28 June 2021

**Report of Preliminary Bat Roost Assessment at Great Birchwood Country Park Lytham Road,
Lytham, Lancashire, PR4 1TE**

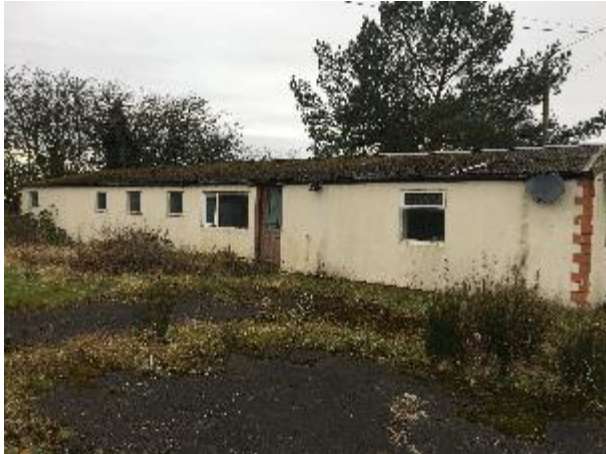
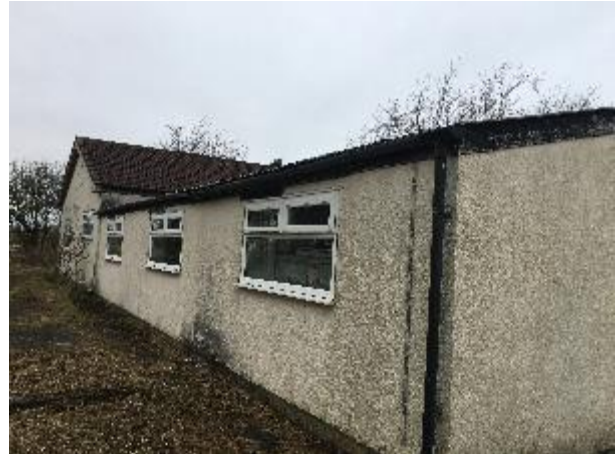
B1 is a single-storey breeze block-built residential property with dual pitch roof of corrugated metal sheets. The previous survey found the building to have negligible habitat for roosting bats. The updated 2021 site visit found the building to still have negligible habitat for bats.

B2 is a single-storey L-shaped, brick-built house with dual pitched roof of clay tiles and corrugated metal sheeting. The previous survey found B2 to have low potential for supporting roosting bats. A subsequent bat emergence survey was carried out on 2017 which found no bats to be found roosting within the building. There have been no material changes in the condition of the building and as such it is determined that bats are unlikely to have started to utilise the building.

Figures 1 & 2: B1 and B2

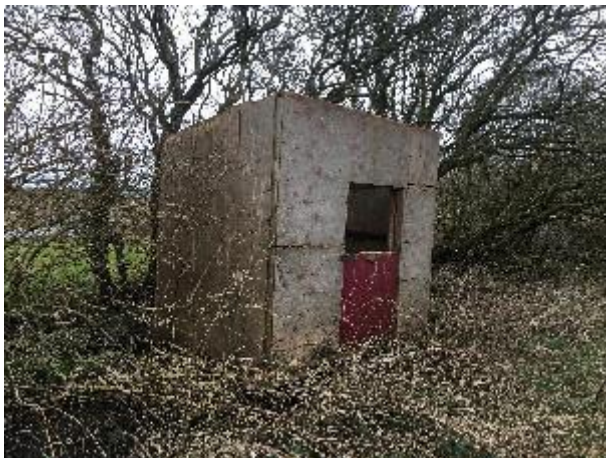
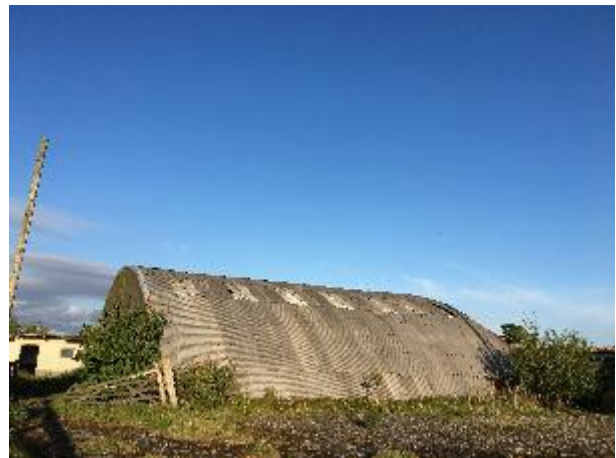
B3 is a single-storey wood-built shed with mono-pitched roof of wood. The structure appears to be in need of repair. The previous survey found the building to have negligible habitat for roosting bats. The updated 2021 site visit found the building to still have negligible habitat for bats.

B5 is a large domed barn comprising steel frame and corrugated metal and plastic sheeting. The previous survey found the building to have negligible habitat for roosting bats. The updated 2021 site visit found the building to still have negligible habitat for bats.

Figures 3 & 4: B3 and B5

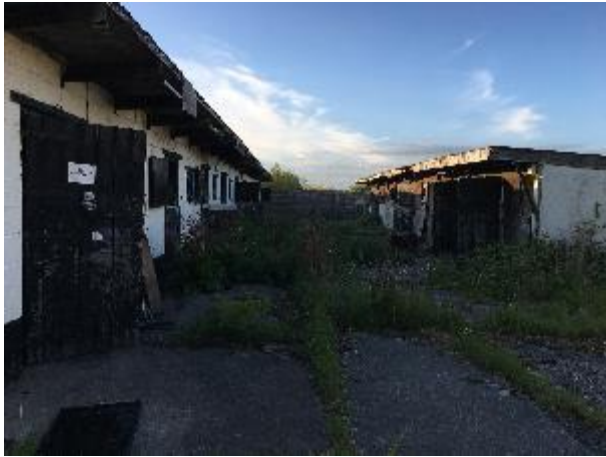
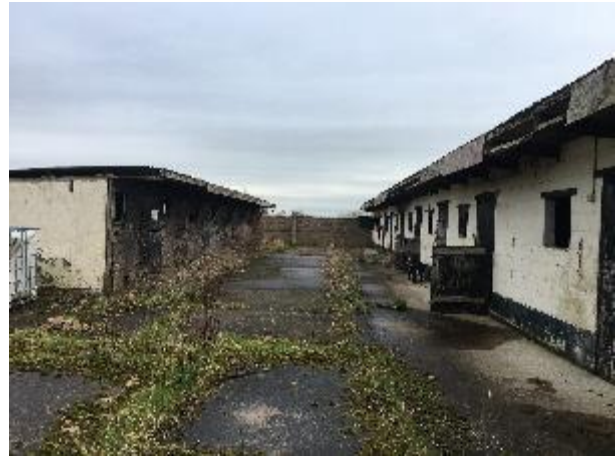
B6 is a single-storey breeze block-built stable block with mono-pitched roof of corrugated metal sheeting. The previous survey found the building to have negligible habitat for roosting bats. The updated 2021 site visit found the building to still have negligible habitat for bats.

B7 is a two single-storey breeze block-built stable blocks with dual-pitched roof of corrugated metal sheeting. The previous survey found the building to have negligible habitat for roosting bats. The updated 2021 site visit found the building to still have negligible habitat for bats.

B8 is a single-storey breeze block-built stable block with mono-pitched roof of corrugated metal sheeting. The previous survey found the building to have negligible habitat for roosting bats. The updated 2021 site visit found the building to still have negligible habitat for bats.

Figures 5 & 6: B6, B7 and B8

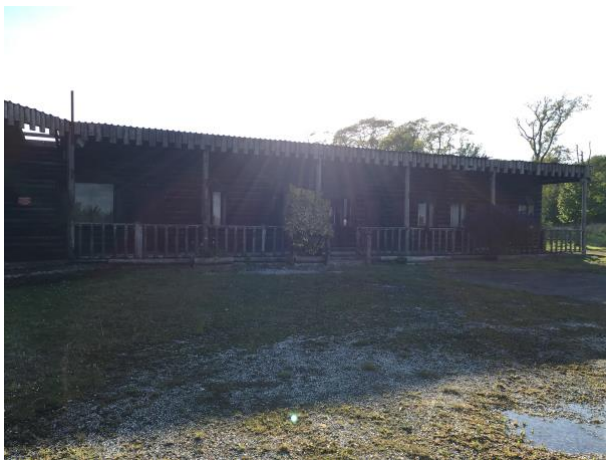
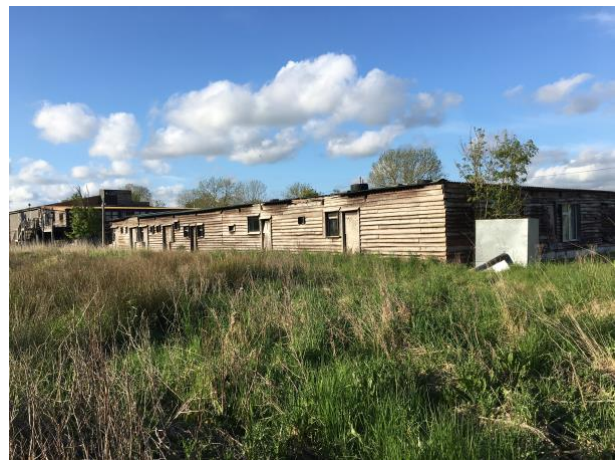
B10 is a single-storey L-shaped, wooden-built structure with mono-pitched roof of corrugated metal sheeting. The previous survey found B10 to have low potential for supporting roosting bats. During the subsequent bat emergence survey bats were found to be roosting within the building. A full suite of three surveys was subsequently carried out which found the building to contain a maternity roost of common pipistrelle bats. During the updated 2021 site visit an inspection of the previously known roosting locations were carried out and pipistrelle bats were found to the roosting behind the weatherboarding on the southern and western elevations of the building. A follow up bat emergence survey confirmed the presence of a common pipistrelle maternity being present within B10.

Figures 7 & 8: Eastern and western elevations of B10

Buildings B1 – B9, and B12 have negligible habitat value for supporting roosting and as such there is not expected to be any impact on roosting bats as a result of the demolition of these buildings. Buildings B10 and B11 will require an European Protected Species Mitigation Licence (EPSML) once planning permission has been granted. The mitigation provided within the 2017 Bat Emergence/Re-entry Survey report is still valid as similar findings were found on both surveys, and therefore the same mitigation will be required. For full details of the mitigation and compensation that will be required as part of the licence application please refer to this report.

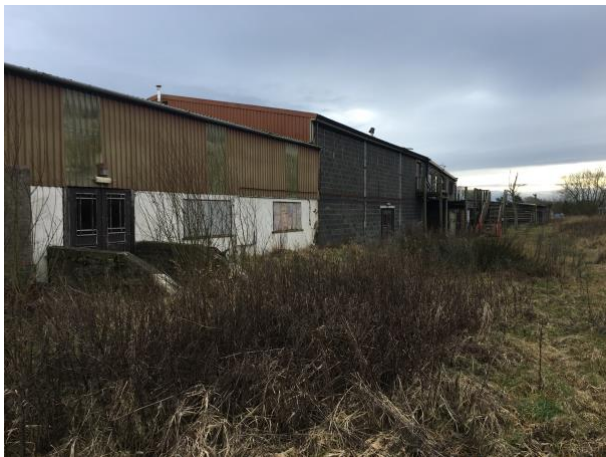
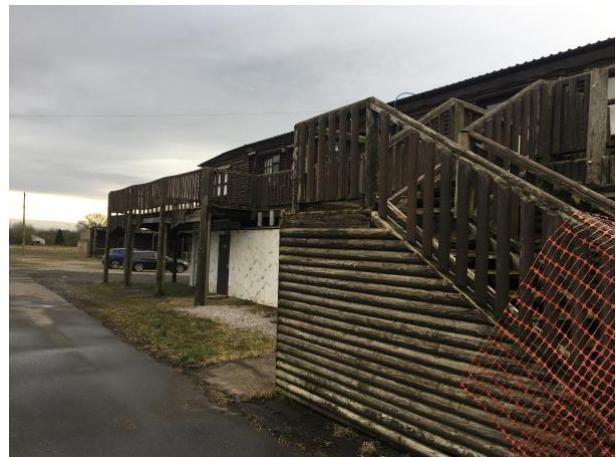
B11 consists of three sections; the cabin (which is an L-shaped, wooden-built structure with mono-pitched roof of corrugated metal sheeting surrounding the eastern and southern elevations of the central section of the structure), the bar (which comprises steel frames with corrugated metal sheeting walls and dual pitched roof of corrugated metal sheeting) and the cellar (which is a single storey brick-built cellar with flat roof of concrete). The previous survey found B11 to have low potential for supporting roosting bats. During the subsequent bat emergence survey bats were found to be roosting within the building. A full suite of three surveys was subsequently carried out which found the building to contain a day roost of common pipistrelle bats. The building appeared to be in a materially similar condition to the 2017 site visit. A follow up bat emergence survey confirmed the present of a common pipistrelle day roost still being present within the building.

Figures 9 & 10: Western and eastern elevations of B11

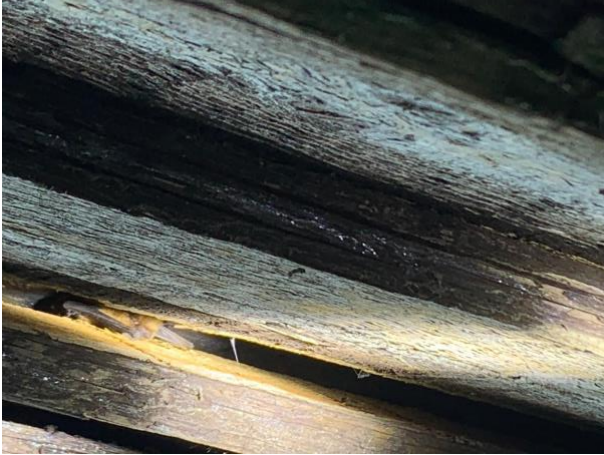
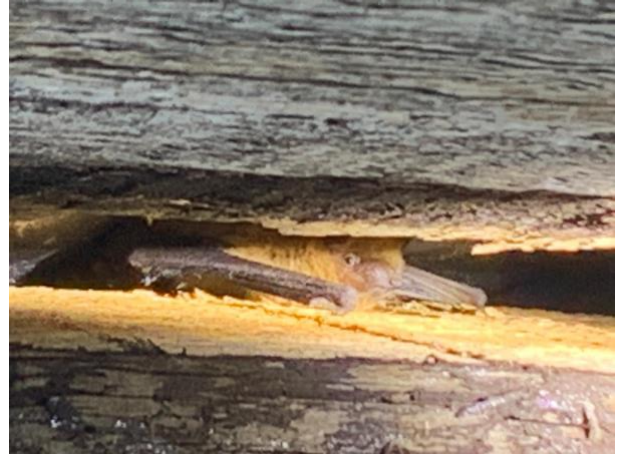
Figures 10 & 11: pipistrelle bat behind weather boarding on western elevation of B10
