HOLLYCOMBE HOUSE AND ESTATE  
DESIGN, ACCESS AND HERITAGE IMPACT ASSESSMENT:  
PROPOSED INTERNAL REDECORATION AND INVESTIGATIVE WORKS  
ISSUE 01 : DECEMBER 2021

# HOLLYCOMBE HOUSE AND ESTATE: DESIGN, ACCESS AND HERITAGE STATEMENT

This Design, Access and Heritage Impact Assessment supports the Listed Building Consent application for building fabric investigation works, a scheme of interior redecoration which includes the re-finishing of existing hardwood flooring.

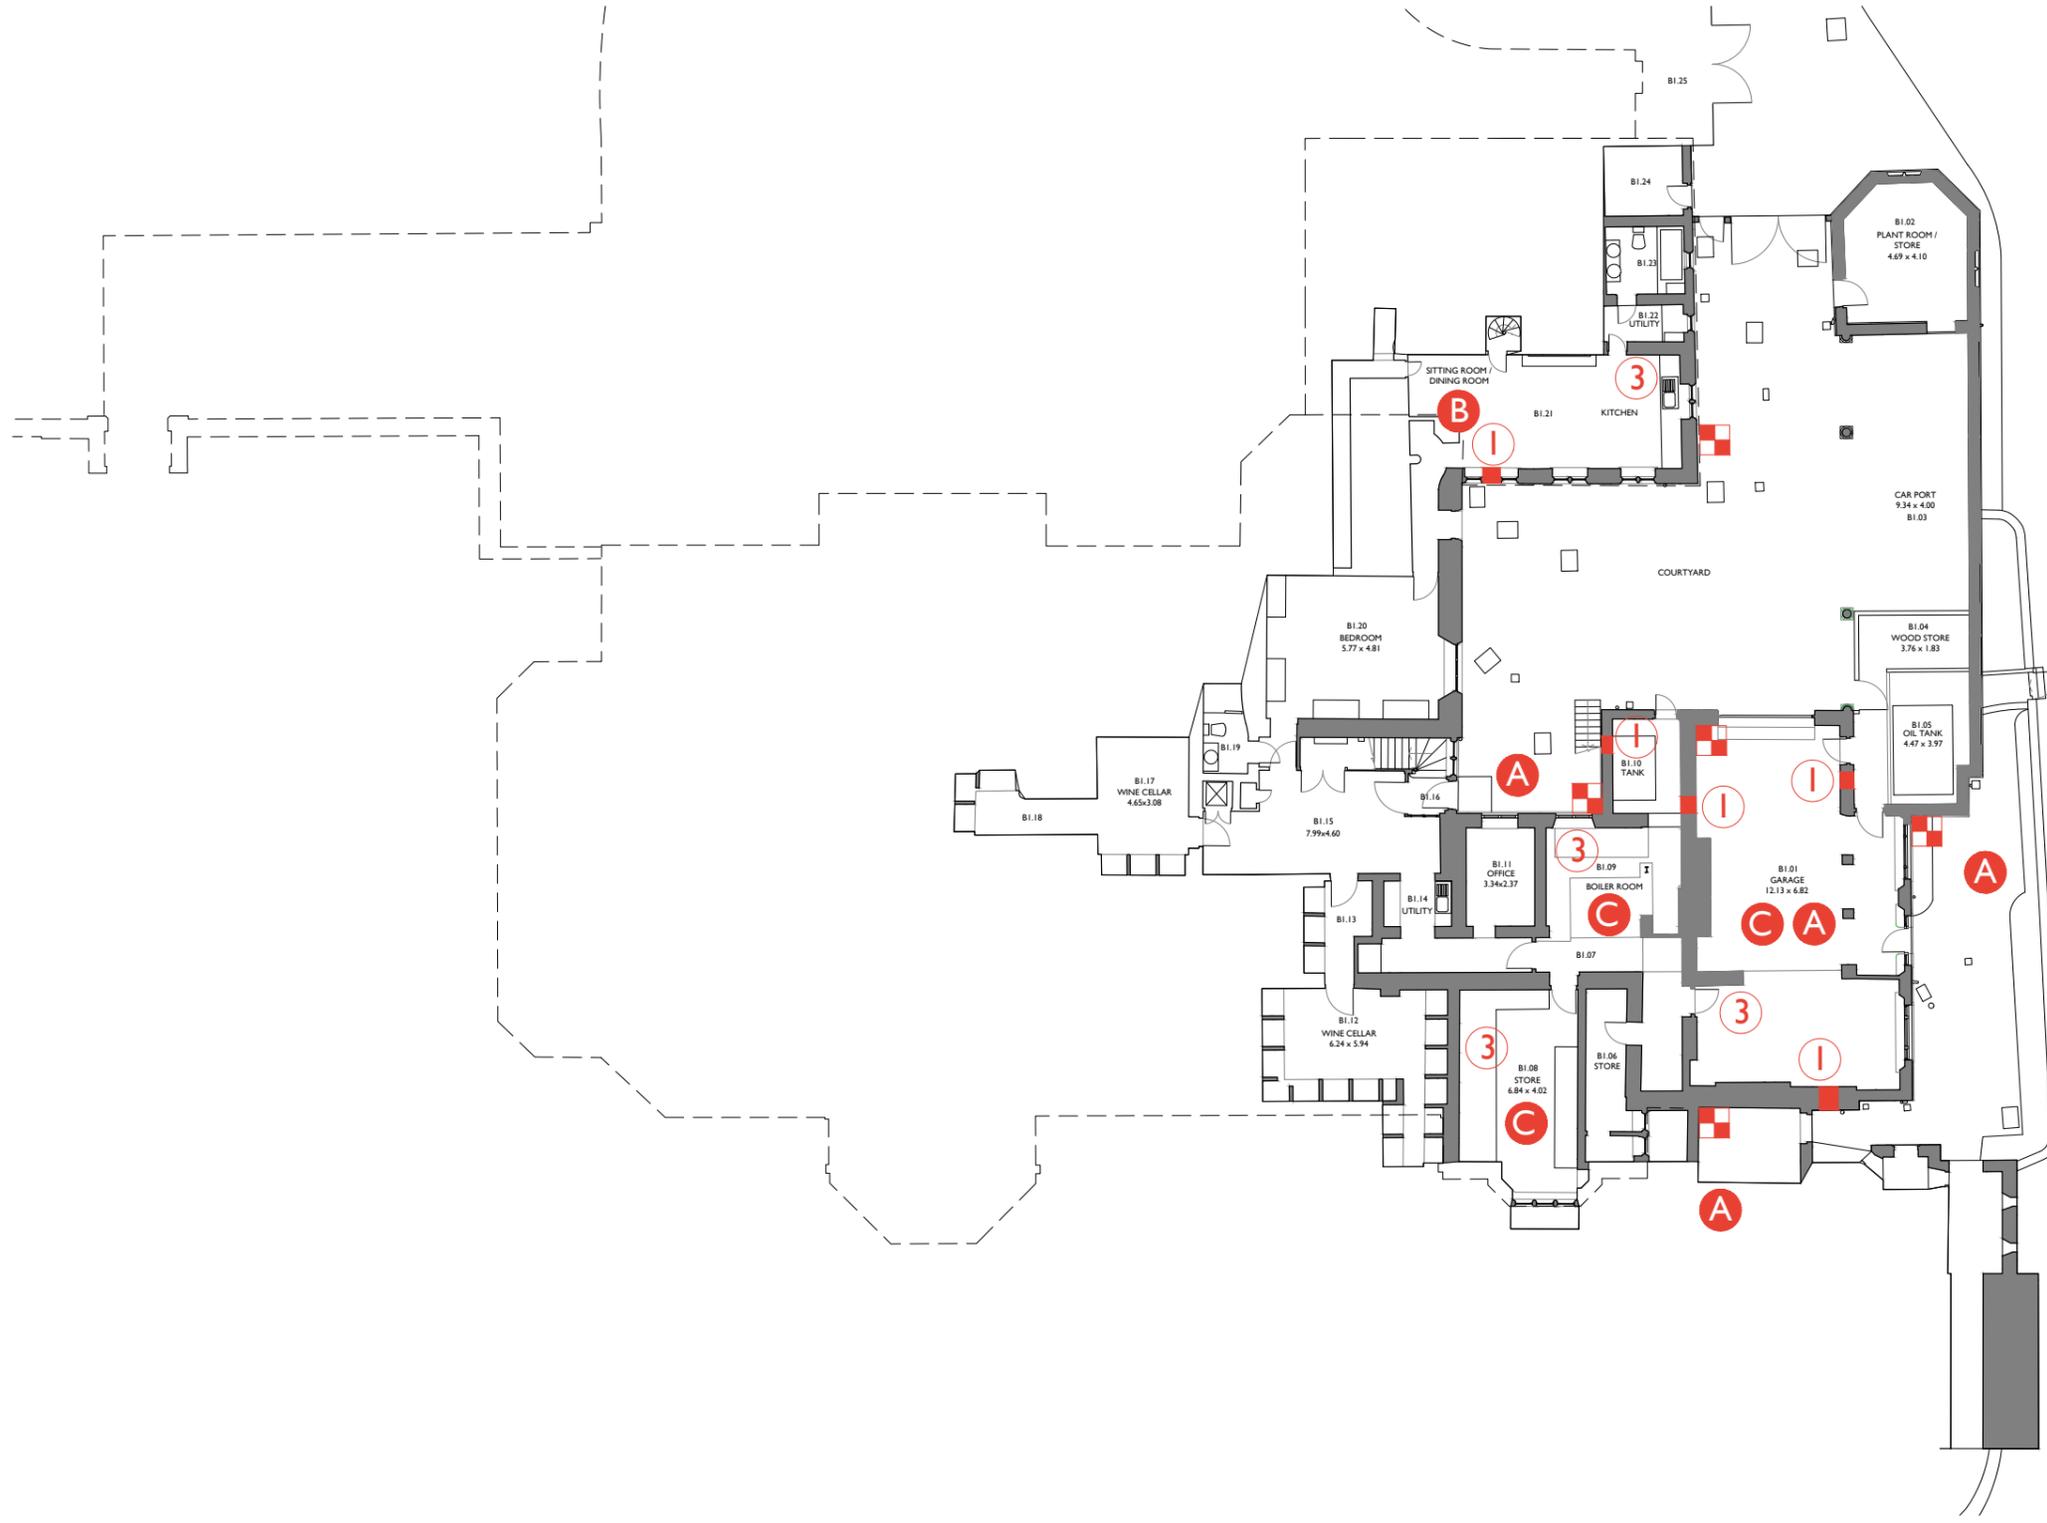
- A** - To determine extension of west wing from early to mid 19th century, demolished in the 1930's.
- B** - To determine extent of early to mid 19th century construction fabric vs 1890's stone over-clad addition.
- C** - To determine remaining fabric from original Nash Service wing following upward extension and subsequent demolition in the 1930's.
- D** - To determine roof structure above corrugated sheets.
- E** - To determine structural foundation and/or wall build up within existing footprint (non original Nash footprint).

- 1.0x1.0m (plan size) trial pit to establish depth and profile of the existing foundation. Depth of foundation unknown. Trial pit to be dug to a depth 100mm lower than the existing foundation. Where digging pits next to existing brick footings care is to be taken to ensure that the brick corbels are not damaged during excavation. External finishes to be carefully set aside for reinstatement on completion of the investigation.

- 0.5x2.0m (plan size) trial pit to establish depth and profile of historic foundation to previously demolished west wing. Depth of foundation unknown. Trial pit to be dug to a depth 100mm lower than the existing foundation. Where digging pits next to existing brick footings care is to be taken to ensure that the brick corbels are not damaged during excavation. Allow for reinstating the turf on completion of the investigation.

- Carefully remove floor finish and set aside. Lift floor boards to expose a minimum of 3No. timber floor joists. There must be sufficient access to measure the width, depth and spacing of the joists. Replace boards and finishes on completion of the investigation.

- Carefully remove 0.5x0.5m of the ceiling to determine construction of floor over; allow for drilling through slab to confirm thickness - removing floor finishes as required to prevent any damage. Ceiling and floor finishes to be reinstated on completion of investigation.

- Carefully remove floor finish and set aside. If timber floor - Lift floor boards to expose a minimum of 3No. timber floor joists. If concrete floor - allow for drilling through slab to confirm thickness and if there is a void below. Replace boards and finishes on completion of the investigation.

- Existing hardwood flooring to be re-polished and/or stained to a darker tone. Refer to proposals set out in the Schedule of Interior Finishes and photographs of the sample in the DASHIA report.

1.0x1.0m (plan size) trial pit to establish depth and profile of the existing foundation. Depth of foundation unknown.

Trial pit to be dug to a depth 100mm lower than the existing foundation. Where digging pits next to existing brick footings care is to be taken to ensure that the brick corbels are not damaged during excavation.

0.5x2.0m (plan size) trial pit to establish depth and profile of historic foundation to previously demolished 'west wing'. Depth of foundation unknown.

03 Carefully remove 0.5x0.5m of the ceiling to determine construction of floor over. Allow for drilling through slab to confirm thickness of concrete - removing floor finishes as required to prevent any damage.

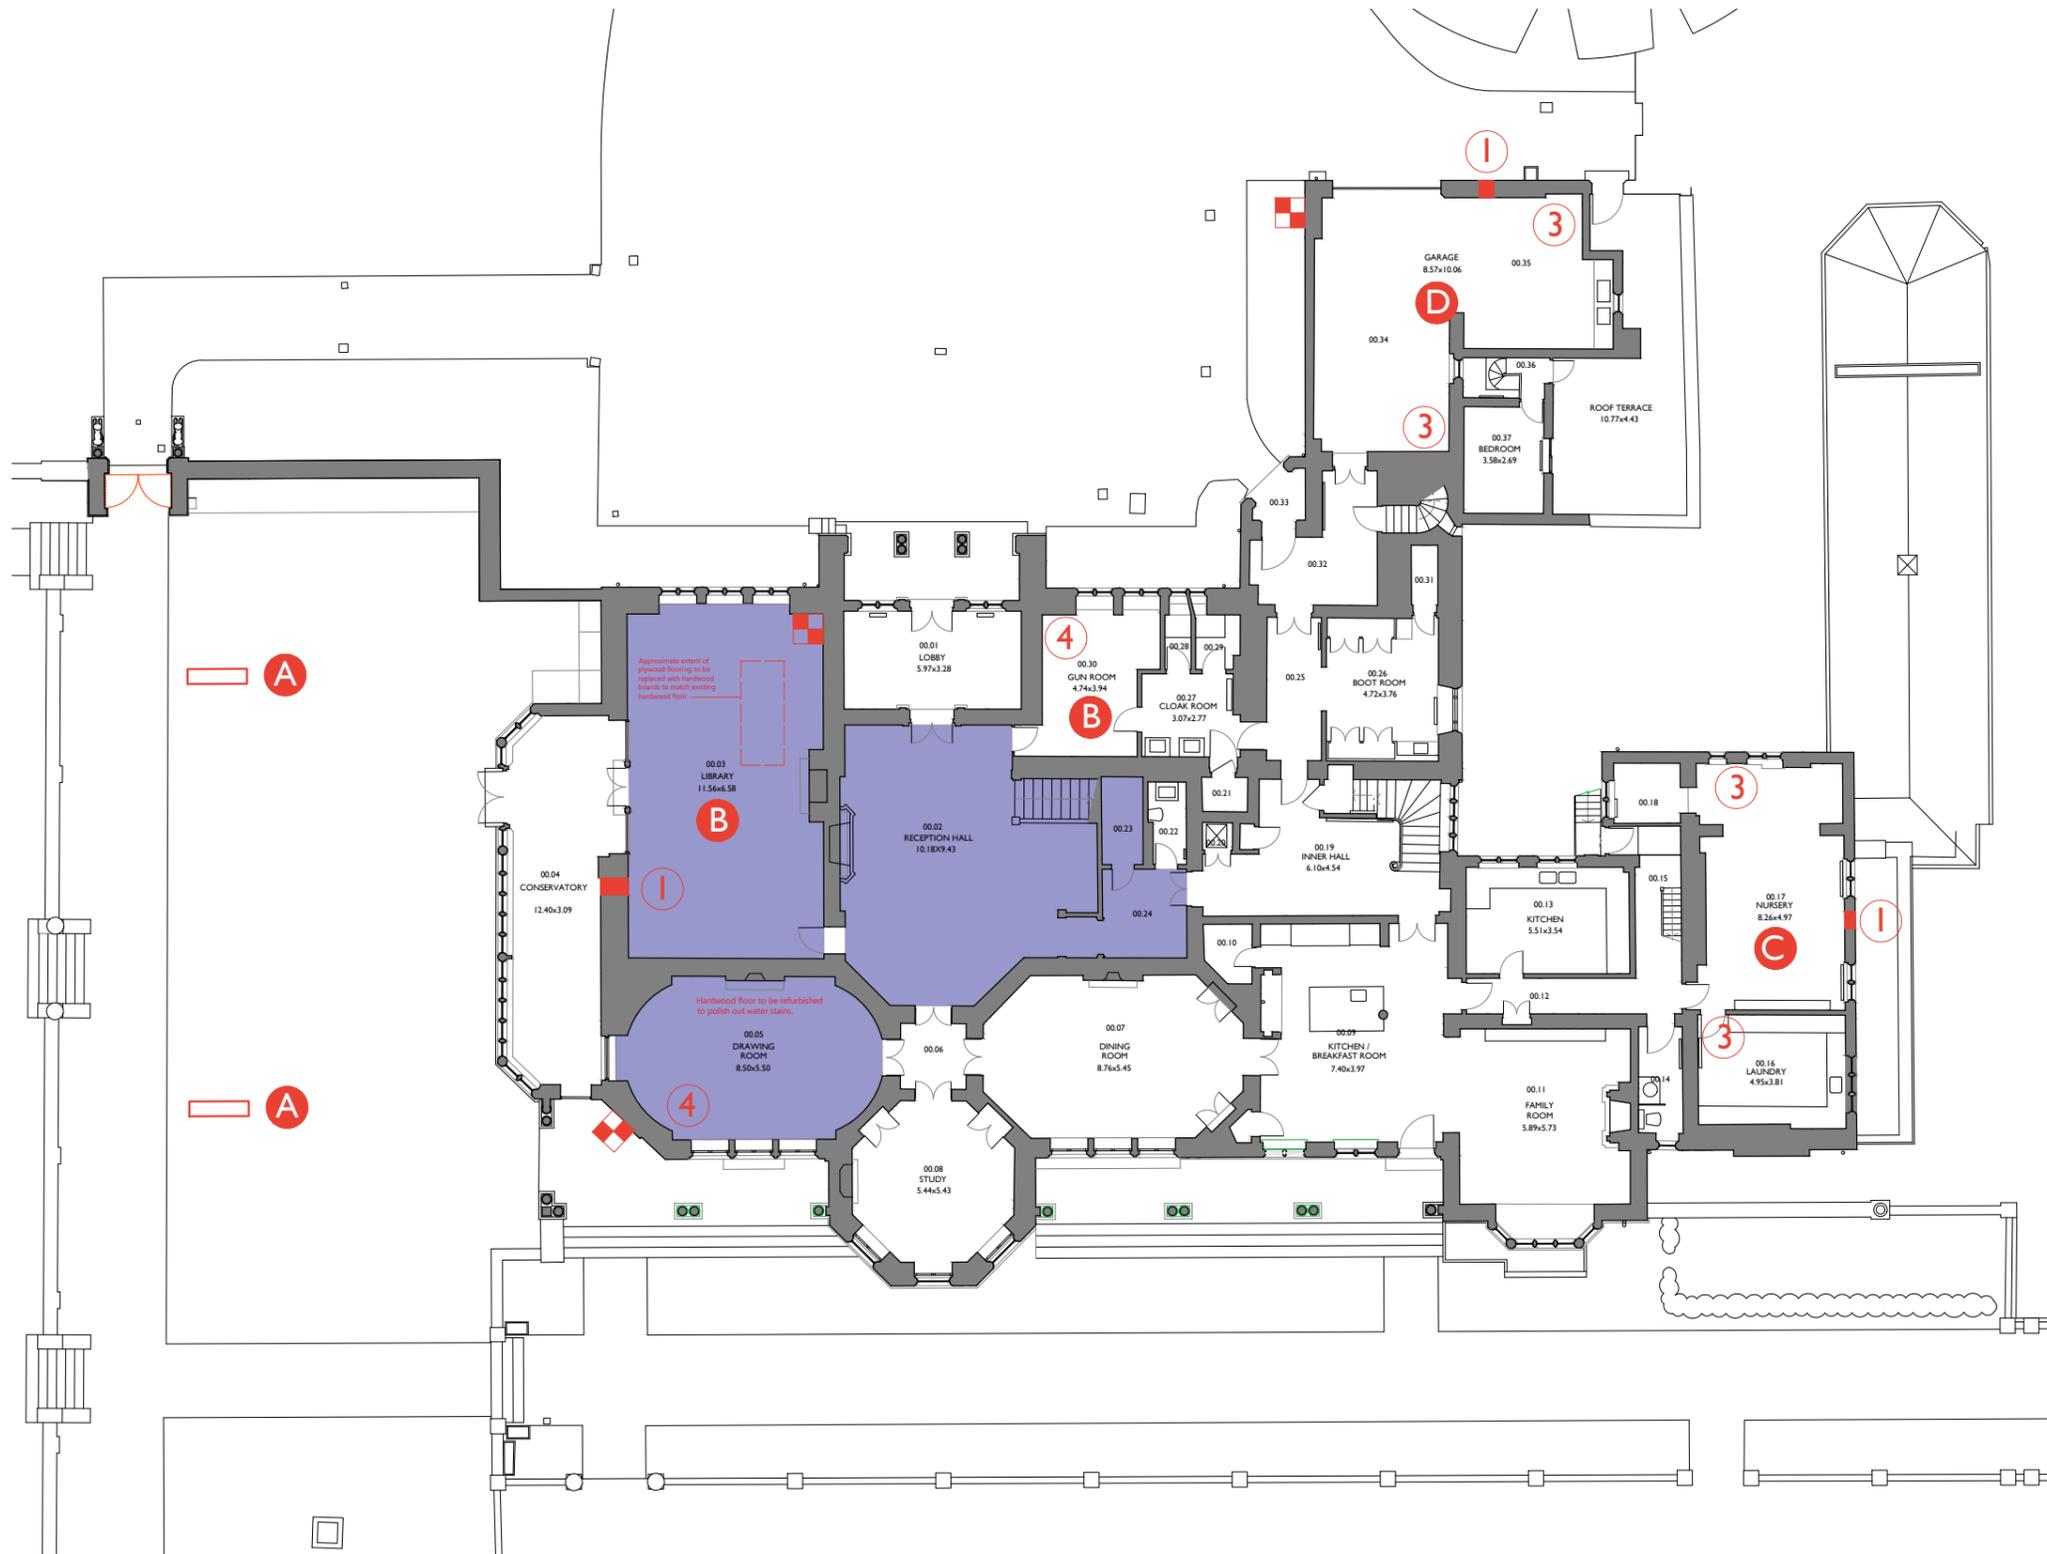
**Note:**  
 The following summarises the purpose of the investigations in each area. These are to be read with the scope and methodology key below:

- A** - To determine extension of west wing from early to mid 19th century, demolished in the 1930's.
- B** - To determine extent of early to mid 19th century construction fabric vs 1890's stone over-clad addition.
- C** - To determine remaining fabric from original Nash Service wing following upward extension and subsequent demolition in the 1930's.
- D** - To determine roof structure above corrugated sheets.
- E** - To determine structural foundation and/or wall build up within existing footprint (non original Nash footprint).

- 1.0x1.0m (plan size) trial pit to establish depth and profile of the existing foundation. Depth of foundation unknown. Trial pit to be dug to a depth 100mm lower than the existing foundation. Where digging pits next to existing brick footings care is to be taken to ensure that the brick corbels are not damaged during excavation. External finishes to be carefully set aside for reinstatement on completion of the investigation.
- 0.5x2.0m (plan size) trial pit to establish depth and profile of historic foundation to previously demolished west wing. Depth of foundation unknown. Trial pit to be dug to a depth 100mm lower than the existing foundation. Where digging pits next to existing brick footings care is to be taken to ensure that the brick corbels are not damaged during excavation. Allow for reinstating the turf on completion of the investigation.

- 2** - Carefully remove floor finish and set aside. Lift floor boards to expose a minimum of 3No. timber floor joists. There must be sufficient access to measure the width, depth and spacing of the joists. Replace boards and finishes on completion of the investigation.

- 3** - Carefully remove 0.5x0.5m of the ceiling to determine construction of floor over; allow for drilling through slab to confirm thickness - removing floor finishes as required to prevent any damage. Ceiling and floor finishes to be reinstated on completion of investigation.

- 4** - Carefully remove floor finish and set aside. If timber floor - Lift floor boards to expose a minimum of 3No. timber floor joists. If concrete floor - allow for drilling through slab to confirm thickness and if there is a void below. Replace boards and finishes on completion of the investigation.

- Existing hardwood flooring to be re-polished and/or stained to a darker tone. Refer to proposals set out in the Schedule of Interior Finishes and photographs of the sample in the DASHIA report.

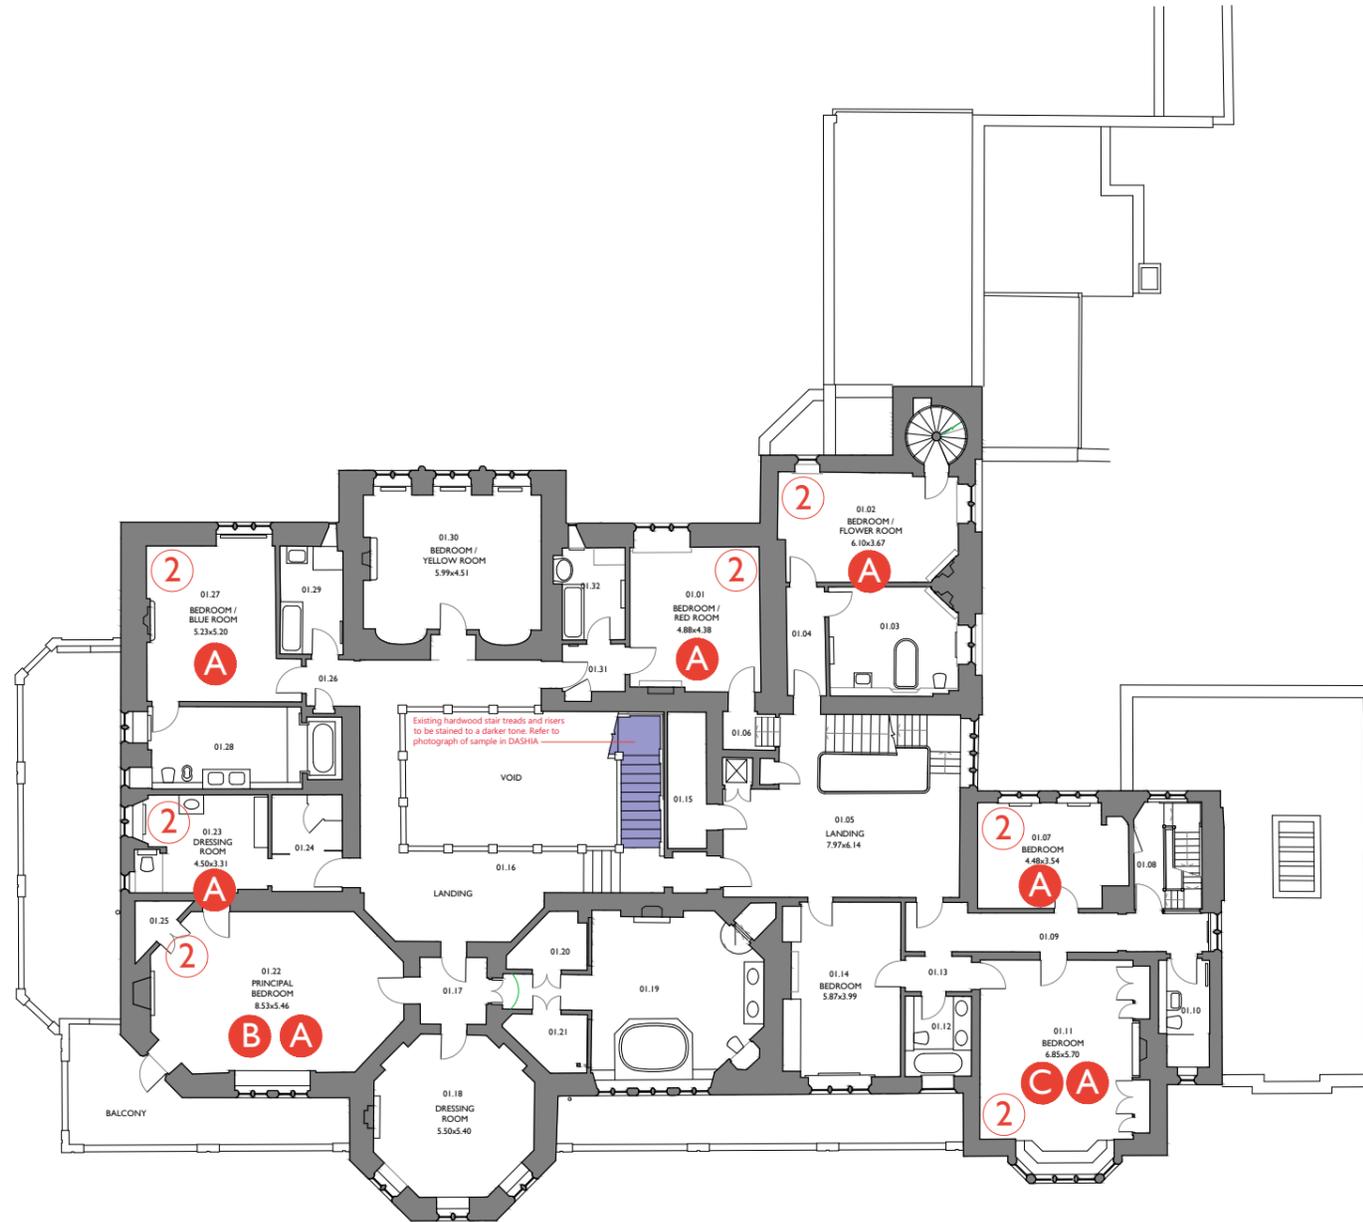
**Note:**  
 The following summarises the purpose of the investigations in each area. These are to be read with the scope and methodology key below.

- A** - To determine extension of west wing from early to mid 19th century, demolished in the 1930's.
- B** - To determine extent of early to mid 19th century construction fabric vs 1890's stone over-clad addition.
- C** - To determine remaining fabric from original Nash Service wing following upward extension and subsequent demolition in the 1930's.
- D** - To determine roof structure above corrugated sheets.
- E** - To determine structural foundation and/or wall build up within existing footprint (non original Nash footprint).

- 1.0x1.0m (plan size) trial pit to establish depth and profile of the existing foundation. Depth of foundation unknown. Trial pit to be dug to a depth 100mm lower than the existing foundation. Where digging pits next to existing brick footings care is to be taken to ensure that the brick corbels are not damaged during excavation. External finishes to be carefully set aside for reinstatement on completion of the investigation.

- 0.5x2.0m (plan size) trial pit to establish depth and profile of historic foundation to previously demolished west wing. Depth of foundation unknown. Trial pit to be dug to a depth 100mm lower than the existing foundation. Where digging pits next to existing brick footings care is to be taken to ensure that the brick corbels are not damaged during excavation. Allow for reinstating the turf on completion of the investigation.

- 2** - Carefully remove floor finish and set aside. Lift floor boards to expose a minimum of 3No. timber floor joists. There must be sufficient access to measure the width, depth and spacing of the joists. Replace boards and finishes on completion of the investigation.

- 3** - Carefully remove 0.5x0.5m of the ceiling to determine construction of floor over; allow for drilling through slab to confirm thickness - removing floor finishes as required to prevent any damage. Ceiling and floor finishes to be reinstated on completion of investigation.

- 4** - Carefully remove floor finish and set aside. If timber floor - Lift floor boards to expose a minimum of 3No. timber floor joists. If concrete floor - allow for drilling through slab to confirm thickness and if there is a void below. Replace boards and finishes on completion of the investigation.

- Existing hardwood flooring to be re-polished and/or stained to a darker tone. Refer to proposals set out in the Schedule of Interior Finishes and photographs of the sample in the DASHIA report.

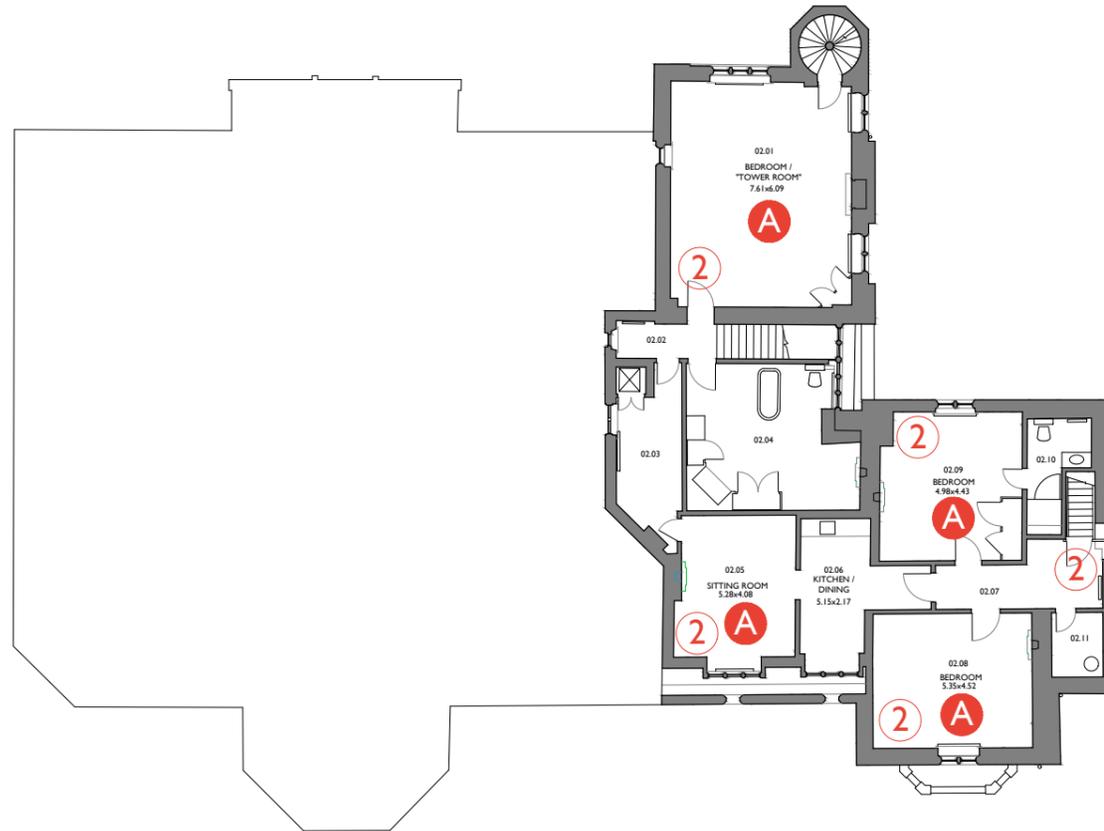
- Note:**  
 The following summarises the purpose of the investigations in each area. These are to be read with the scope and methodology key below:
- A** - To determine extension of west wing from early to mid 19th century, demolished in the 1930's.
  - B** - To determine extent of early to mid 19th century construction fabric vs 1890's stone over-clad addition.
  - C** - To determine remaining fabric from original Nash Service wing following upward extension and subsequent demolition in the 1930's.
  - D** - To determine roof structure above corrugated sheets.
  - E** - To determine structural foundation and/or wall build up within existing footprint (non original Nash footprint).

1.0x1.0m (plan size) trial pit to establish depth and profile of the existing foundation. Depth of foundation unknown. Trial pit to be dug to a depth 100mm lower than the existing foundation. Where digging pits next to existing brick footings care is to be taken to ensure that the brick corbels are not damaged during excavation. External finishes to be carefully set aside for reinstatement on completion of the investigation.

0.5x2.0m (plan size) trial pit to establish depth and profile of historic foundation to previously demolished west wing. Depth of foundation unknown. Trial pit to be dug to a depth 100mm lower than the existing foundation. Where digging pits next to existing brick footings care is to be taken to ensure that the brick corbels are not damaged during excavation. Allow for reinstating the turf on completion of the investigation.

Carefully remove floor finish and set aside. Lift floor boards to expose a minimum of 3No. timber floor joists. There must be sufficient access to measure the width, depth and spacing of the joists. Replace boards and finishes on completion of the investigation.

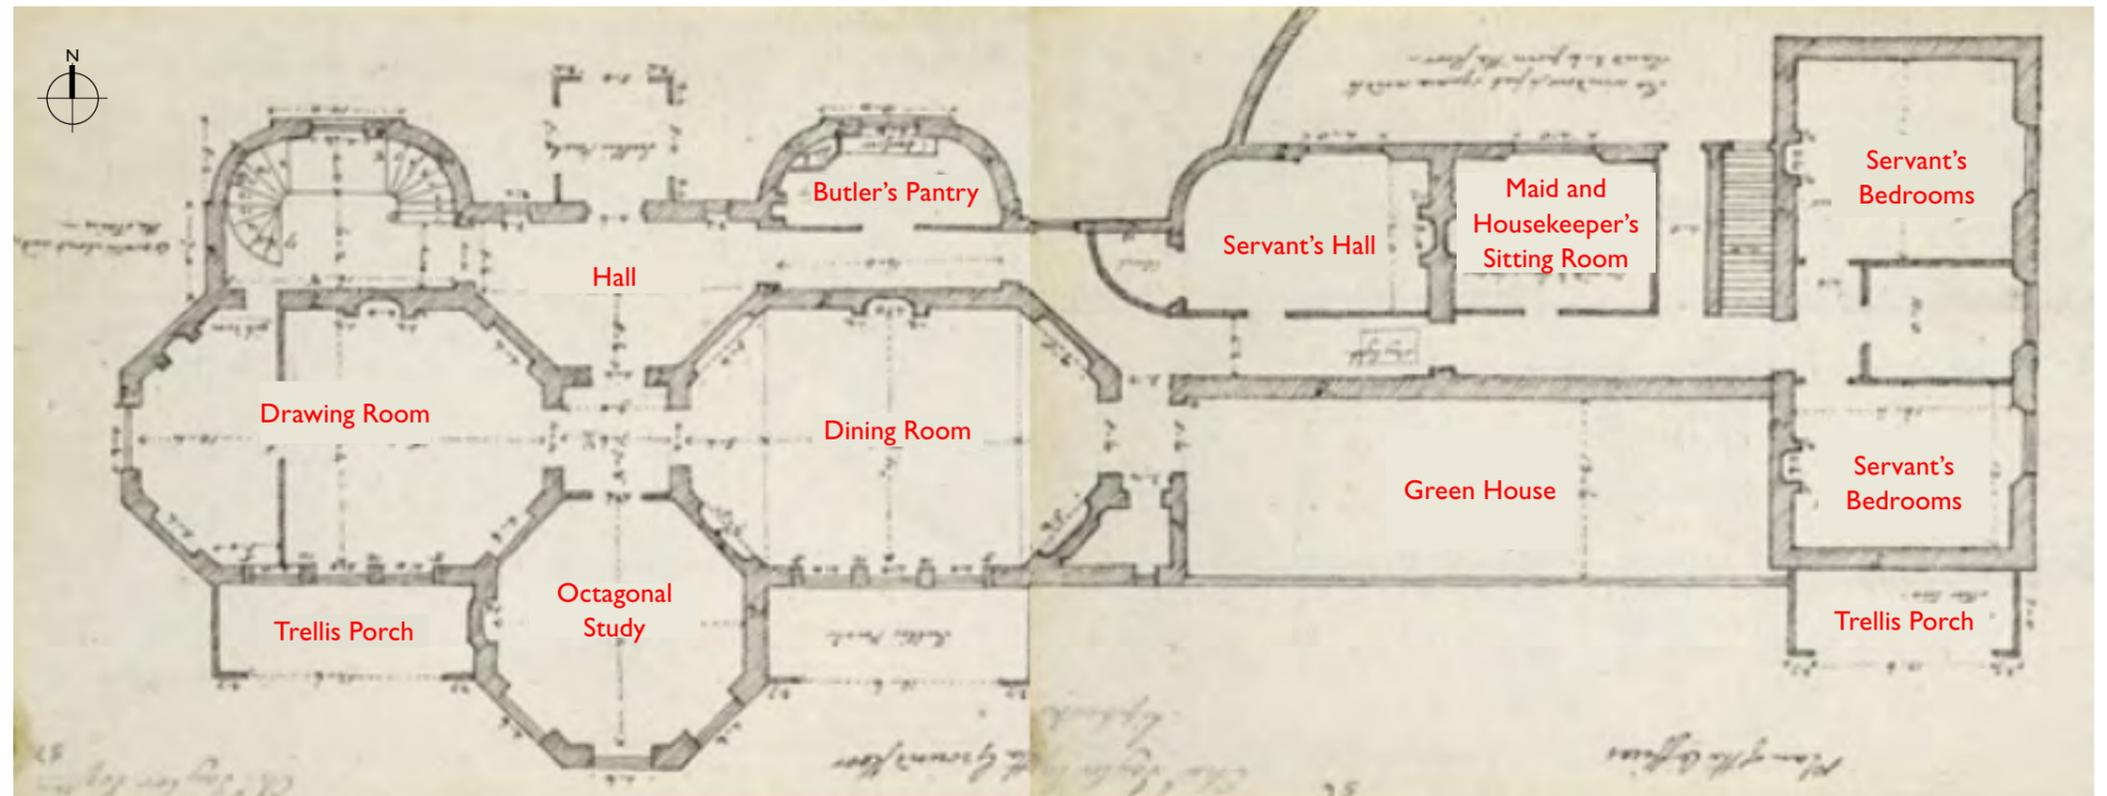
Ground floor plan dated c.1800

Nash arranged the lozenge-shaped Drawing Room and Dining Room along a shared axis separated by a small, vaulted link vestibule, which gave access to the Octagonal Study aligned on the axis of the main north entrance to the house. This was sheltered by a small trellis porch flanked by two single storey projecting bays - the east containing a butler's pantry and the west containing a small staircase leading up to the first floor chamber storey. The principal entrance hall was the starting point at the west end of the spine corridor which connected through to a narrow 'office wing' to the east containing the servants' hall, housekeeper's sitting room and servants' bedrooms. The kitchens are not shown on the original plans, but were almost certainly located in the basement, accessed by the stairs adjacent to the servants' bedrooms. A greenhouse extended along the south side of the office wing, accessed through the private entrance in the Dining Room, with doors leading out onto the gardens. The first floor contained the bed chambers arranged around a principal central hallway and adopted the same lozenge and octagon plan as the ground floor below.

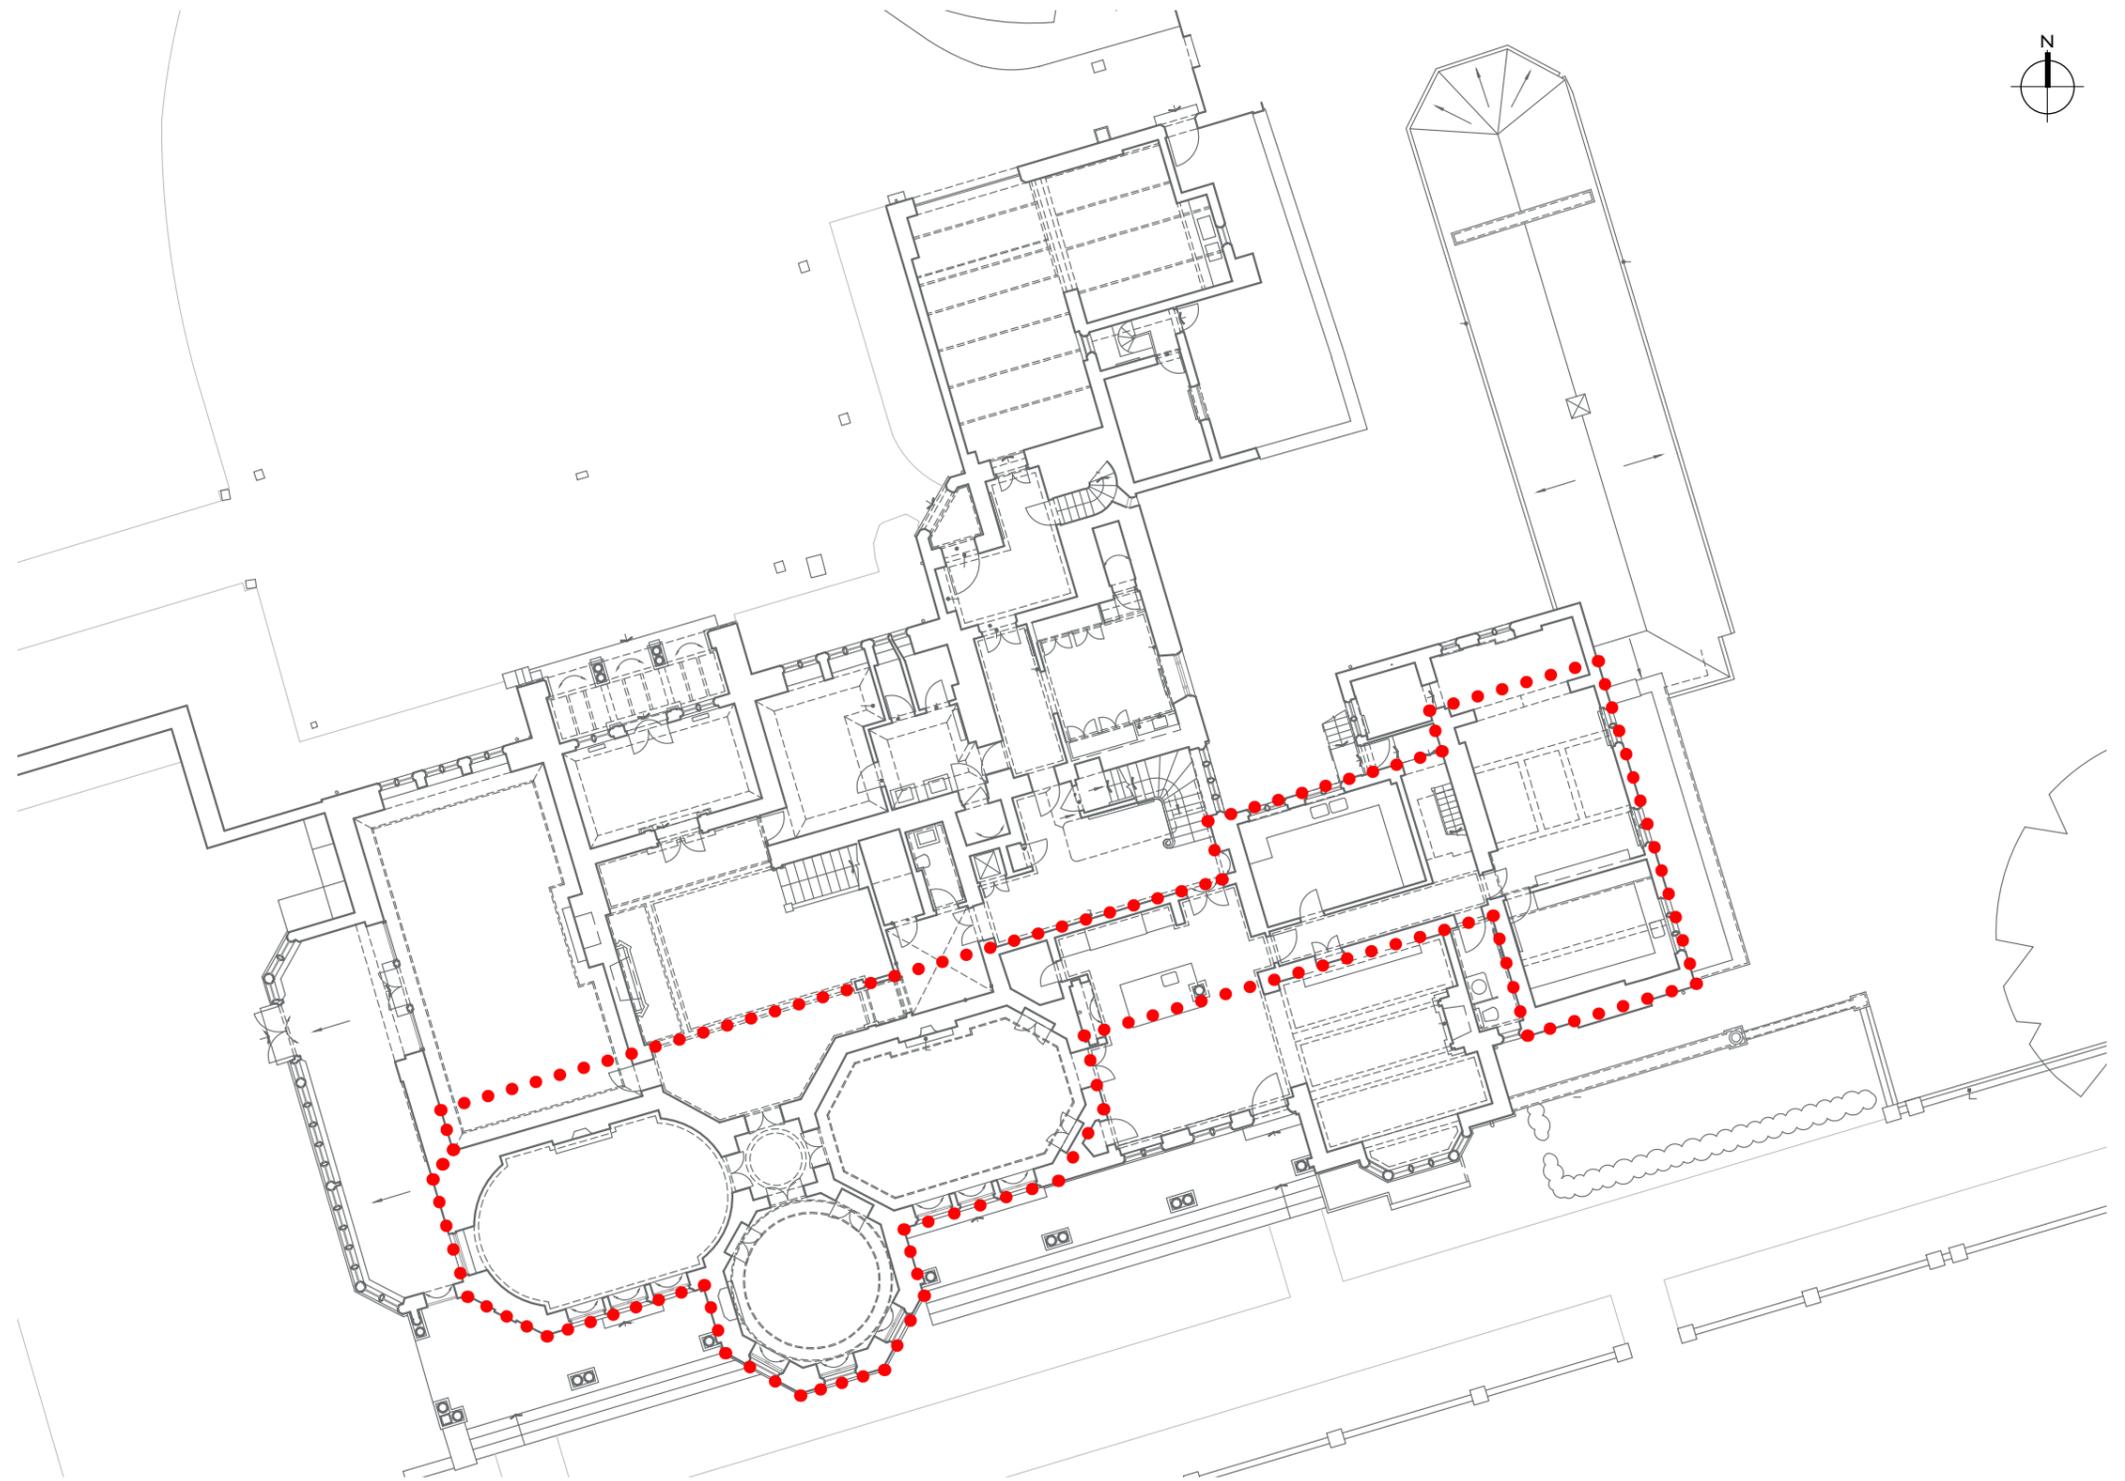
*Nash's original ground floor plan superimposed onto an existing floor plan.*

Nash's original house has since been entombed by a series of 19th and 20th century alterations and refacings, but much of it is still legible in the current floor plan. The lozenge-shaped and octagon rooms still remain in their original form and parts of the office wing survive in a much-altered state. The present corridor is on the original alignment as is the back kitchen (former housekeeper's sitting room) and the children's playroom (former servant's bedrooms).

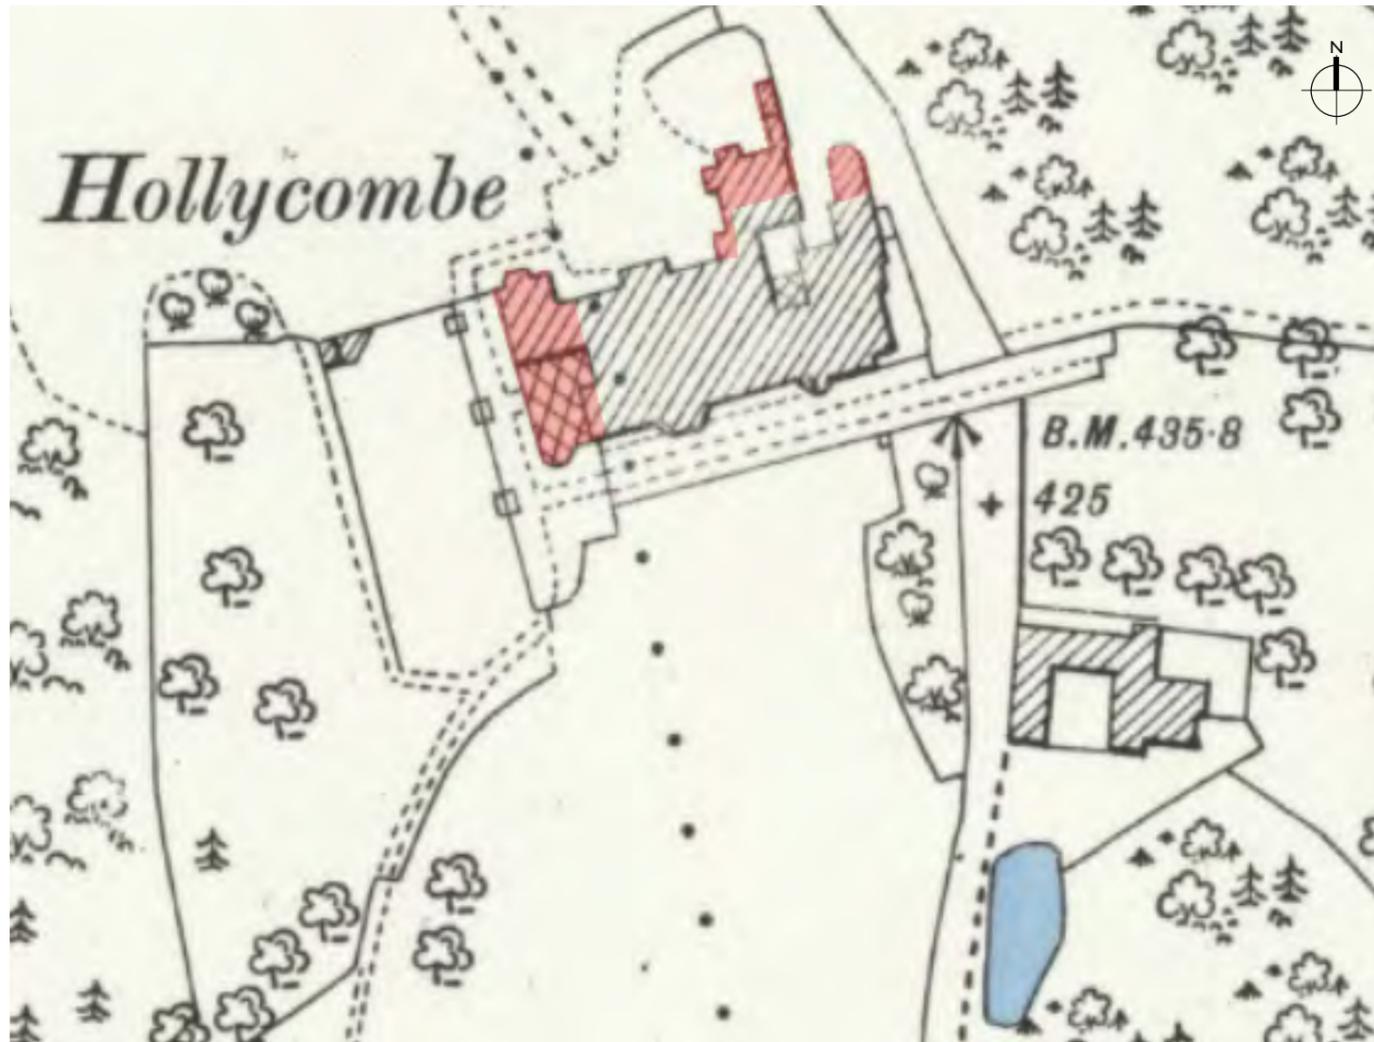
The second edition 25 inch to the mile scale Ordnance Survey map of 1895 marked up in red by the author to show the new west wing added by John Clarke Hawkshaw following the 1892 fire (since demolished) and the extensions to the east and north ends of the house.

Hawkshaw's alterations went beyond the cosmetic and included some quite substantial structural changes and extensions. The Octagonal Drawing Room shown on the 1874 OS map was demolished and replaced by a new three storey west wing with a glass roof conservatory overlooking the valley to the south, a new two storey north wing was erected over what is now the single storey garage, a four storey tower was built to overlook the front forecourt and the service yard buildings were extended northwards.

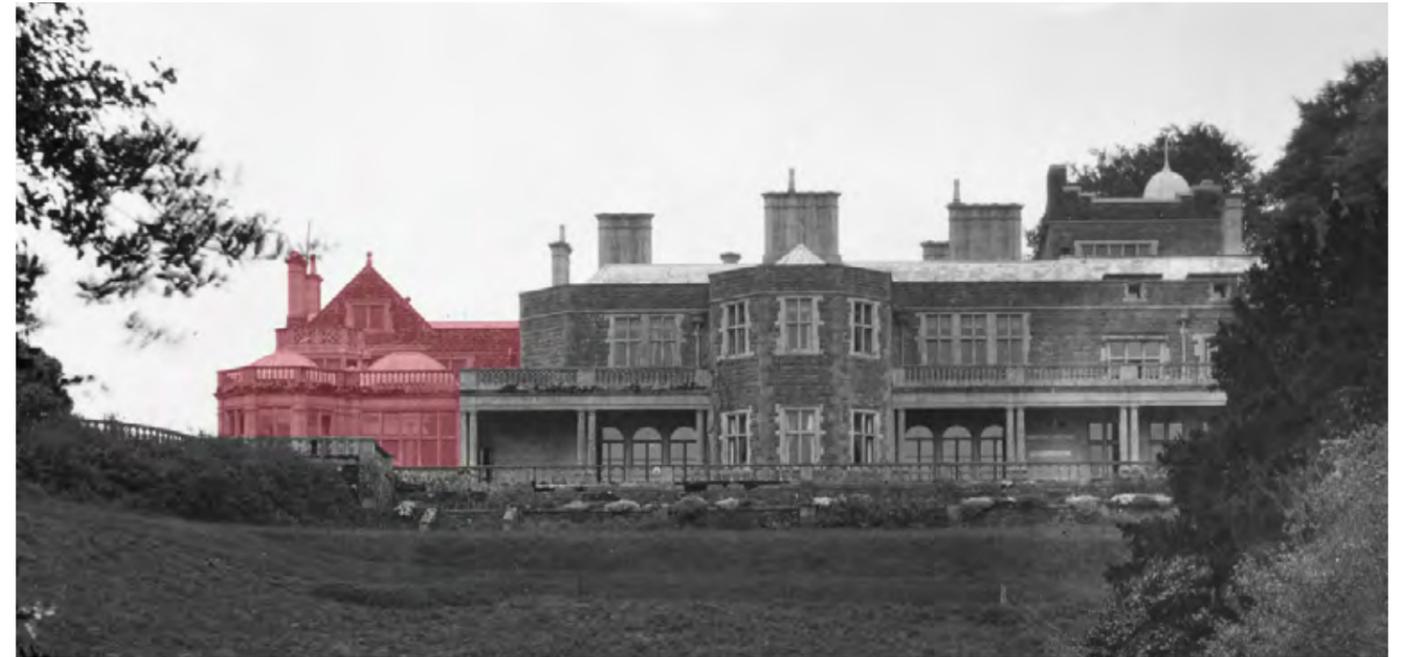
Photograph dated 1932 of the south elevation of the house showing the west wing extension marked up in red. The structure was three storeys to the north with a single storey conservatory to the south lit by a series of glass domes.

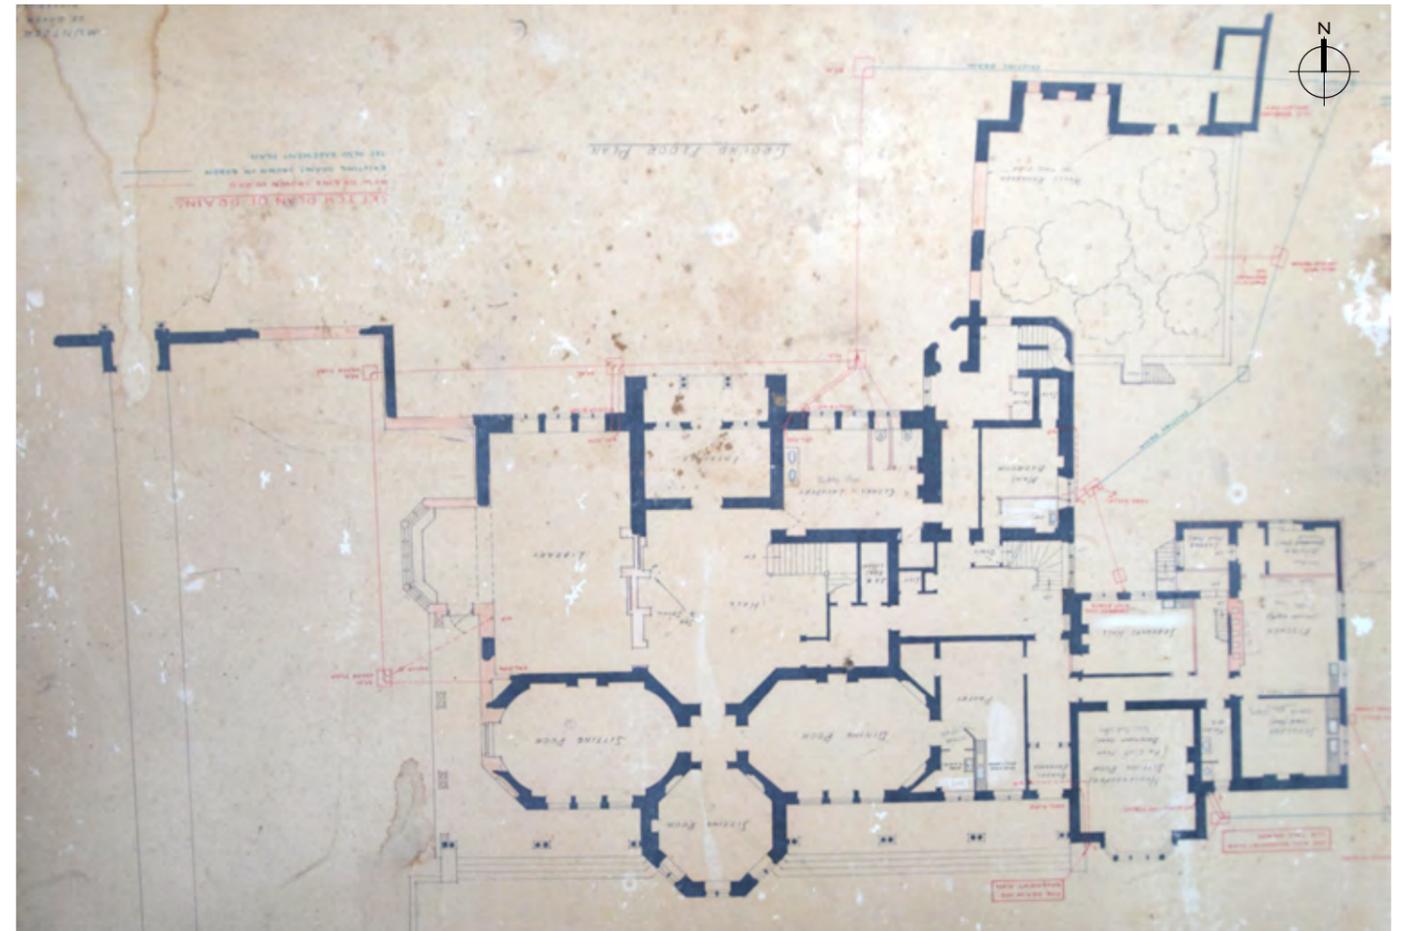
Ground floor plan dated 1936 showing the west wing demolished and a new canted bay window in its place and the north wing replaced by a new walled garden enclosure.

The west wing erected by Hawkshaw in 1892 was pulled down and in its place the present garden was laid out and the east and north wings were demolished down to ground floor level.

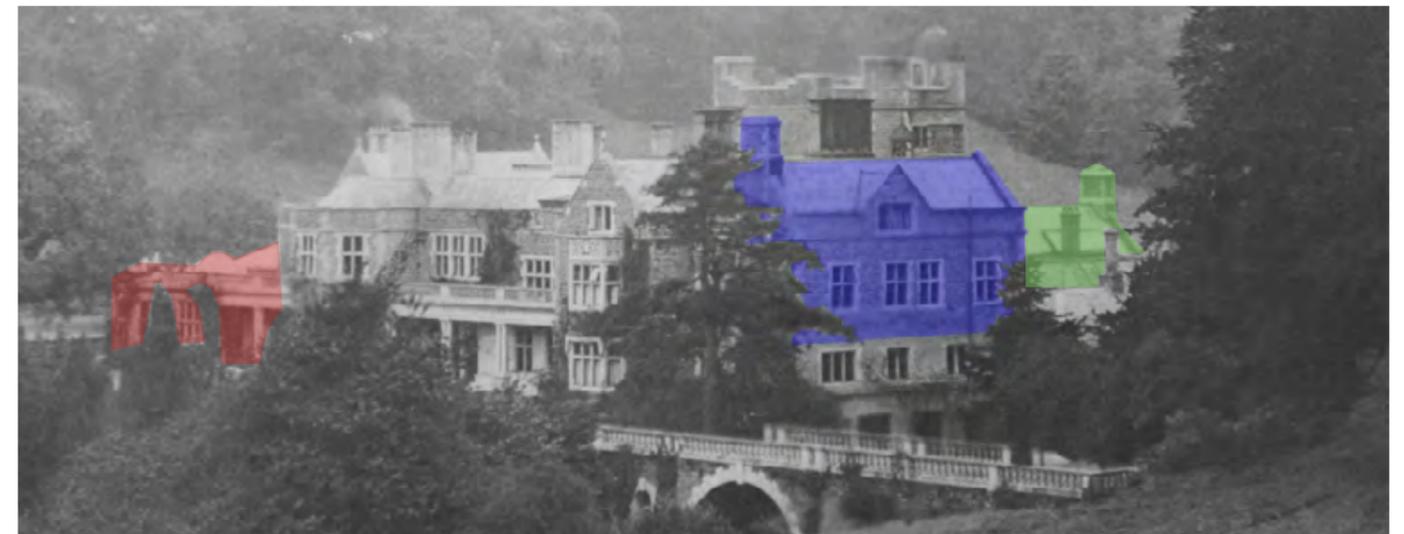
Undated early 20th century photograph from the east showing the west wing (red), east wing (blue) and north wing (green) all demolished by Lord Rea in the mid-1930s.
