HOLLYCOMBE HOUSE AND ESTATE  
DESIGN, ACCESS AND HERITAGE IMPACT ASSESSMENT:  
PROPOSED INTERNAL REDECORATION AND INVESTIGATIVE WORKS  
ISSUE 01 : DECEMBER 2021

# HOLLYCOMBE HOUSE AND ESTATE: DESIGN, ACCESS AND HERITAGE STATEMENT

This Design, Access and Heritage Impact Assessment supports the Listed Building Consent application for building fabric investigation works, a scheme of interior redecoration which includes the re-finishing of existing hardwood flooring.

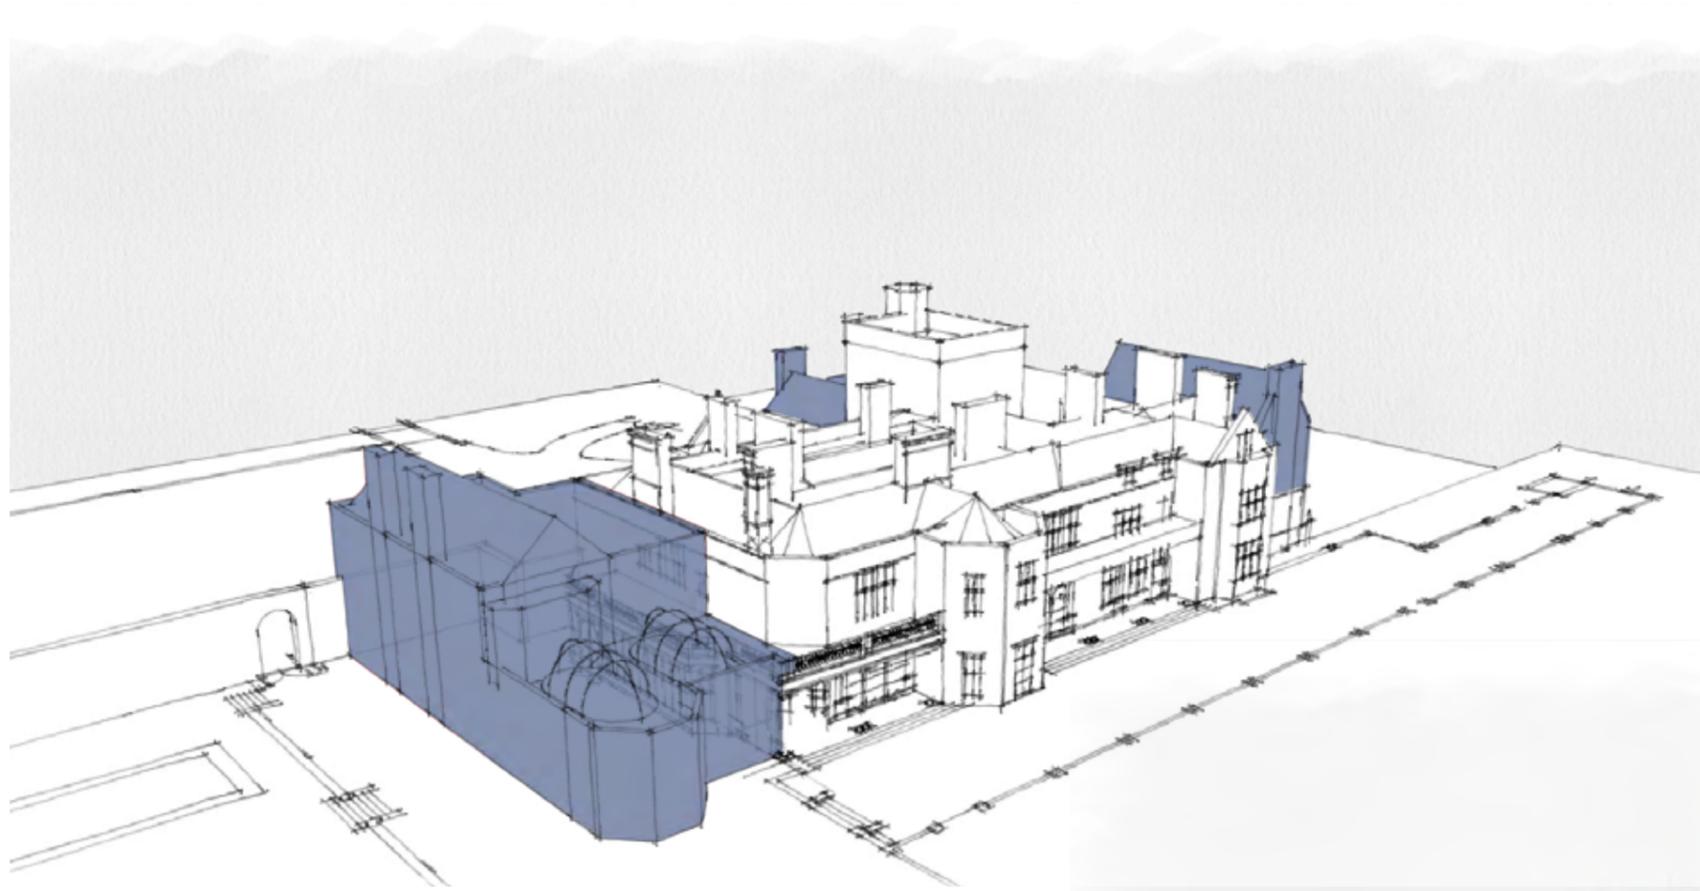
*Model of Hollycombe House from the south west showing the former west wing in blue, demolished by Sir Walter Rea in c.1936.*

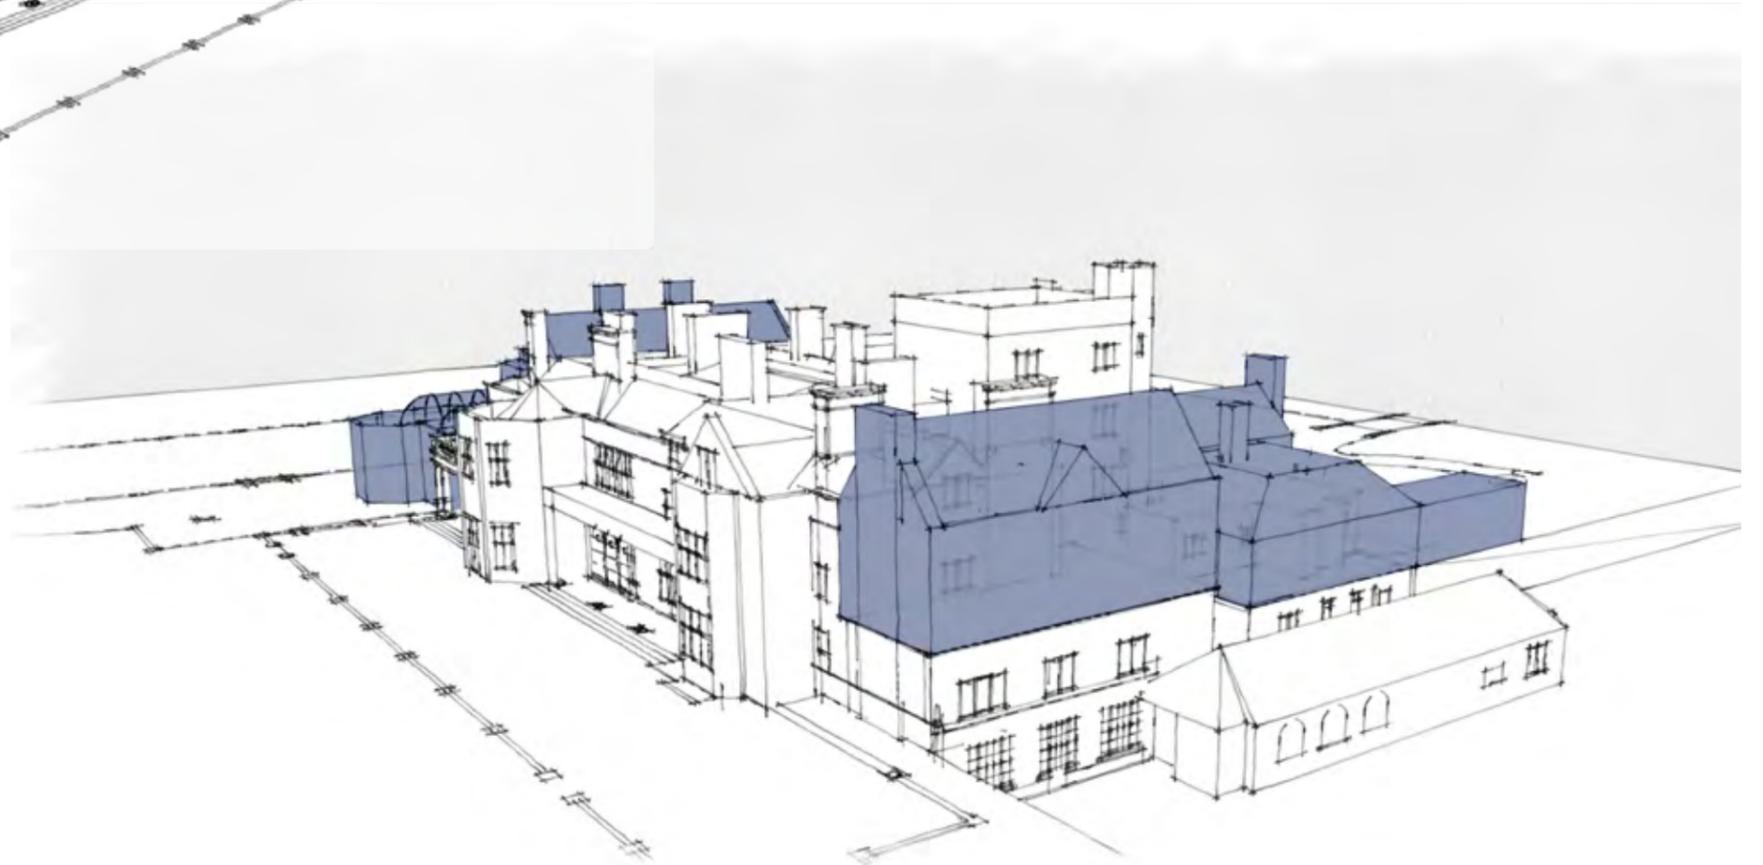
*Model of Hollycombe House from the south east showing the former east and north wings in blue, demolished by Sir Walter Rea in c.1936.*

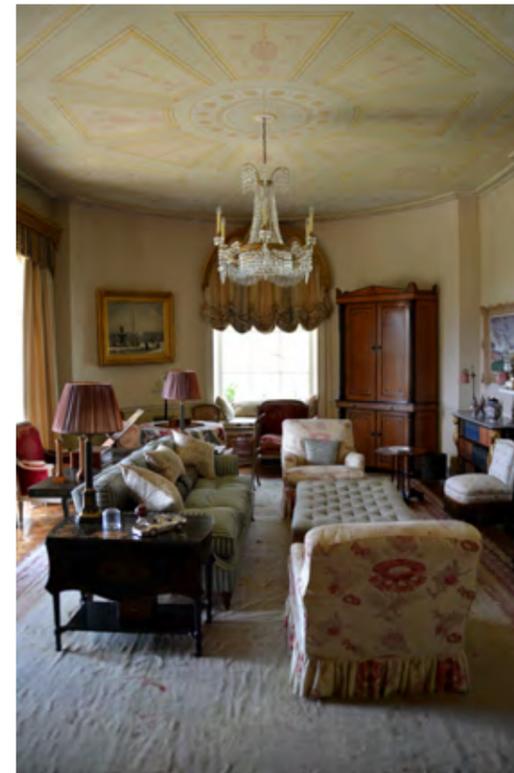
*The ground floor Drawing Room ceiling dated to the late 19th century. Only the lower section of wall (currently painted in modern paintwork) is to be redecorated.*

This application seeks consent to undertake a full redecoration of all areas excluding the decorative ceilings and part of the wall found in the Ground Floor Drawing Room and Study which have been found to date from the late 19th Century.

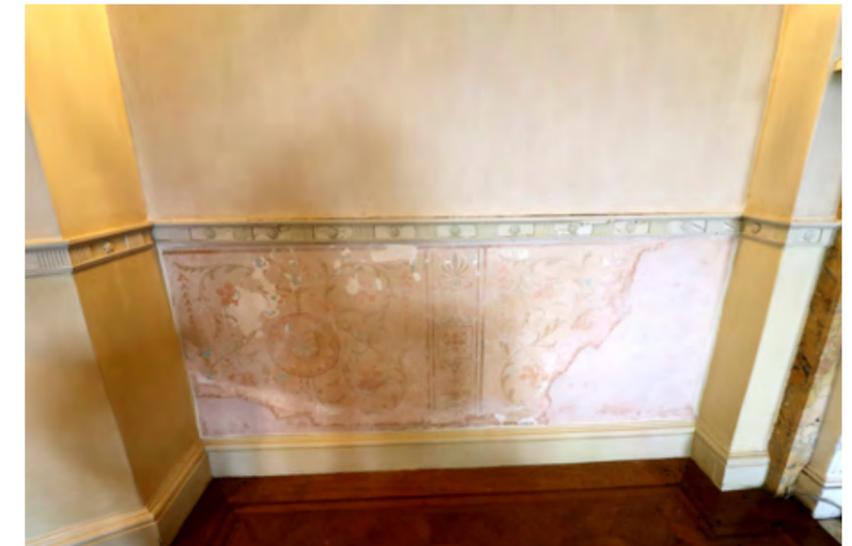
*The section of decorated dado adjacent to the Drawing Room fireplace dated to the late 19th/ early 20th century - not being painted over.*

The Drawing Room (5) features a section of decorative painted dado adjacent to the fireplace dating to the late 19th or very early 20th century, which appears to match the decorative ceiling seen today; this more historic section will be retained and not painted over.

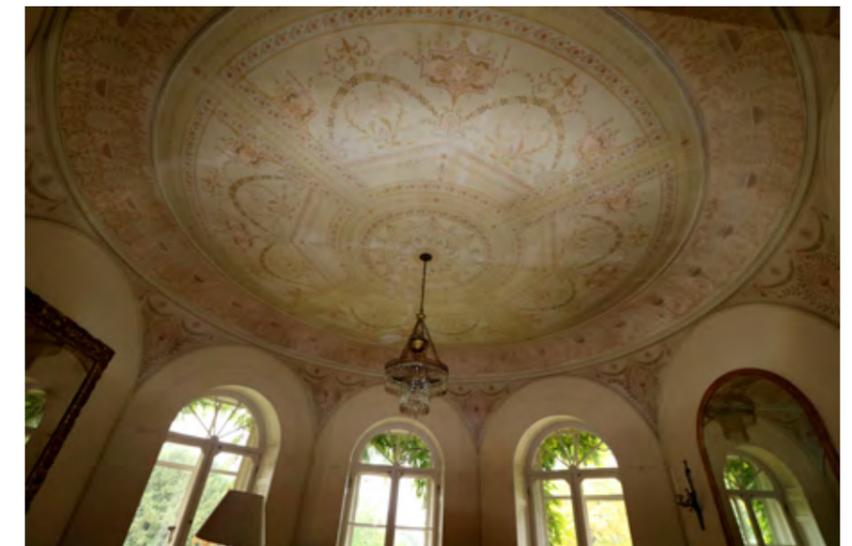
*The ground floor Study ceiling dated to the late 19th century. Only the lower section of wall (currently painted in modern paintwork) is to be redecorated.*
