PROJECT
Hollycombe Estate

TITLE
**Opening Up_Decor Ground Floor Plan
As Proposed
Hollycombe House**

SIZE	SCALE	LAST REVISED	DRAWN	CHECKED
A1L	1:100	17/12/2021	FF	DZ
REV	SUITABILITY/REASON FOR ISSUE			
P01	S4 - Planning			
DRAWING NAME				
241179-PUR-01-GF-DR-A-2100

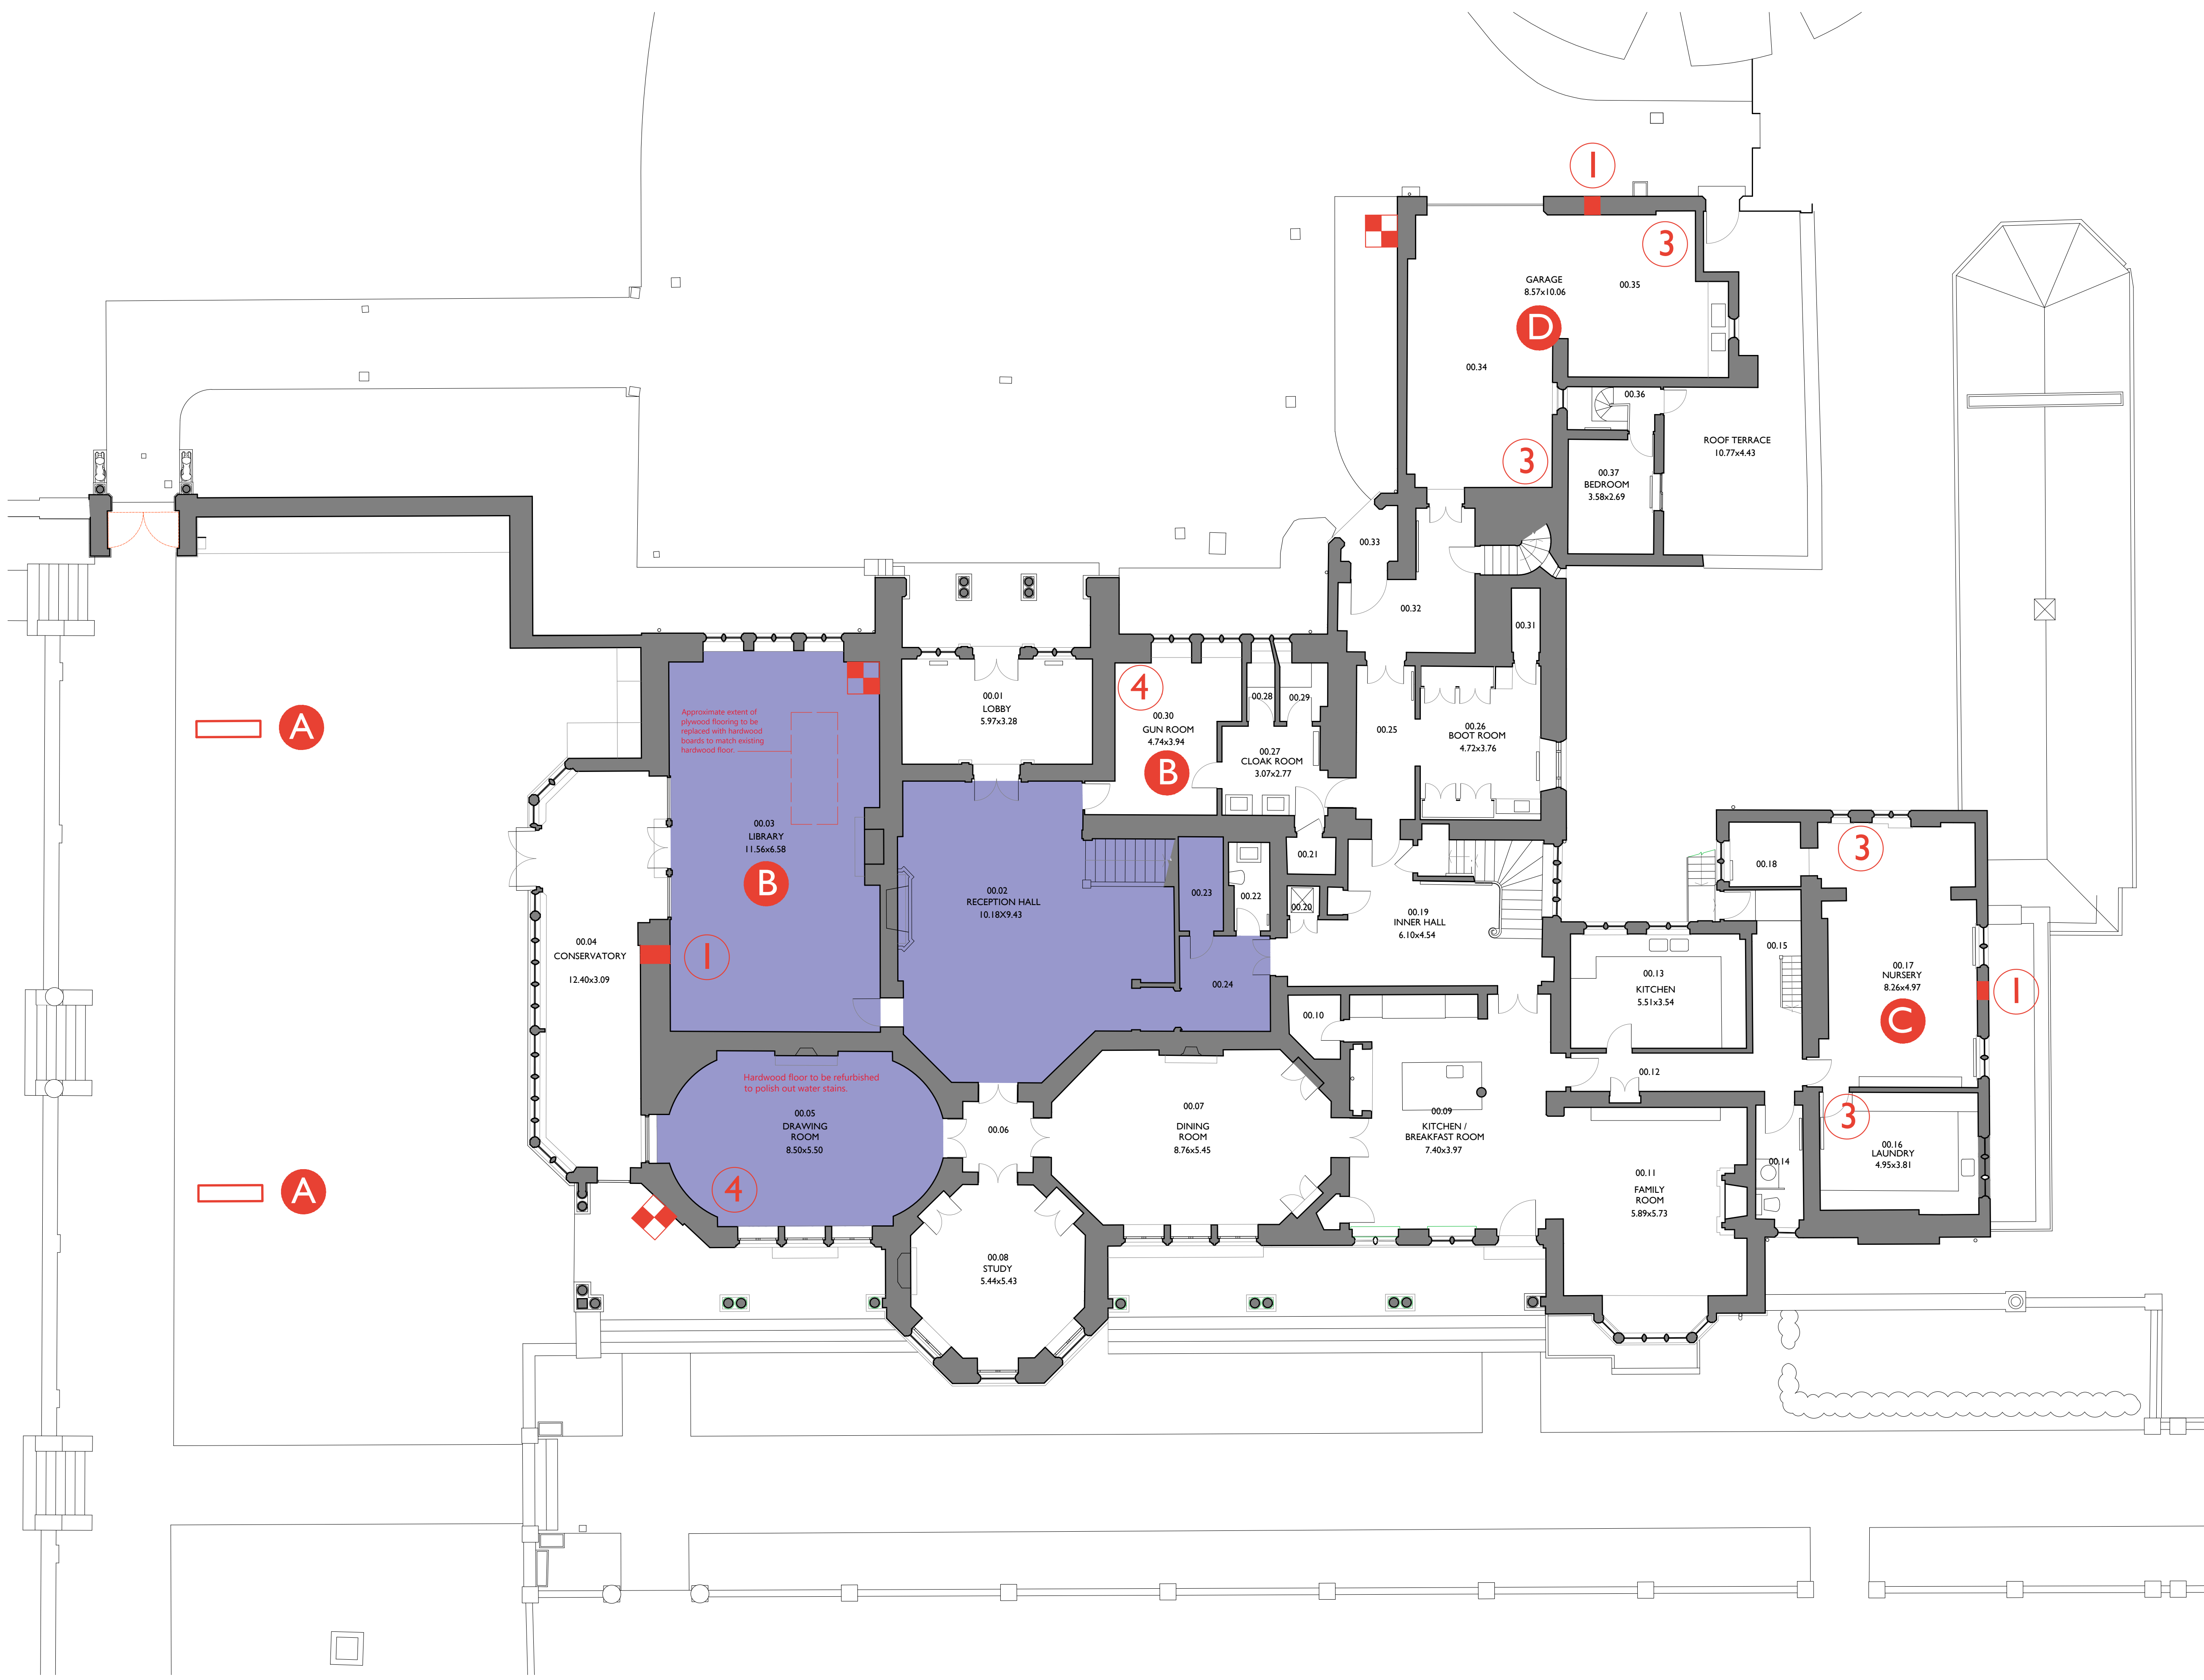
I Ground Floor Plan_Proposed Opening Up Works / Decoration
2100 1:100 @ A1

Note:
The following summarises the purpose of the investigations in each area. These are to be read with the scope and methodology key below:

- A** - To determine extension of west wing from early to mid 19th century, demolished in the 1930's.
- B** - To determine extent of early to mid 19th century construction fabric vs 1890's stone over-clad addition.
- C** - To determine remaining fabric from original Nash Service wing following upward extension and subsequent demolition in the 1930's.
- D** - To determine roof structure above corrugated sheets.
- E** - To determine structural foundation and/or wall build up within existing footprint (non original Nash footprint).

- 1.0x1.0m (plan size) trial pit to establish depth and profile of the existing foundation. Depth of foundation unknown. Trial pit to be dug to a depth 100mm lower than the existing foundation. Where digging pits next to existing brick footings care is to be taken to ensure that the brick corbels are not damaged during excavation. External finishes to be carefully set aside for reinstatement on completion of the investigation.

- 0.5x2.0m (plan size) trial pit to establish depth and profile of historic foundation to previously demolished 'west wing'. Depth of foundation unknown. Trial pit to be dug to a depth 100mm lower than the existing foundation. Where digging pits next to existing brick footings care is to be taken to ensure that the brick corbels are not damaged during excavation. Allow for reinstating the turf on completion of the investigation.

- 1** - Wall finishes to be carefully removed each side of the wall to determine wall construction. 50mm diameter core to be made through the full depth of the wall to confirm thickness and build-up. (Where investigation is proposed to external wall no finishes are to be removed). Finishes to be reinstated and made good on completion of the investigation. External holes are to be filled using the core and sealed in mortar.

- 2** - Carefully remove floor finish and set aside. Lift floor boards to expose a minimum of 3No. timber floor joists. There must be sufficient access to measure the width, depth and spacing of the joists. Replace boards and finishes on completion of the investigation.

- 3** - Carefully remove 0.5x0.5m of the ceiling to determine construction of floor over. allow for drilling through slab to confirm thickness - removing floor finishes as required to prevent any damage. Ceiling and floor finishes to be reinstated on completion of investigation.

- 4** - Carefully remove floor finish and set aside. If timber floor - Lift floor boards to expose a minimum of 3No. timber floor joists. If concrete floor - allow for drilling through slab to confirm thickness and if there is a void below. Replace boards and finishes on completion of the investigation.

- Existing hardwood flooring to be re-polished and/or stained to a darker tone. Refer to proposals set out in the Schedule of Interior Finishes and photographs of the sample in the DASHIA report.
