**Preliminary Ecological Appraisal at 12 Main Street, Bulwick,
Northamptonshire**

Prepared for Harris McCormack

October 2021

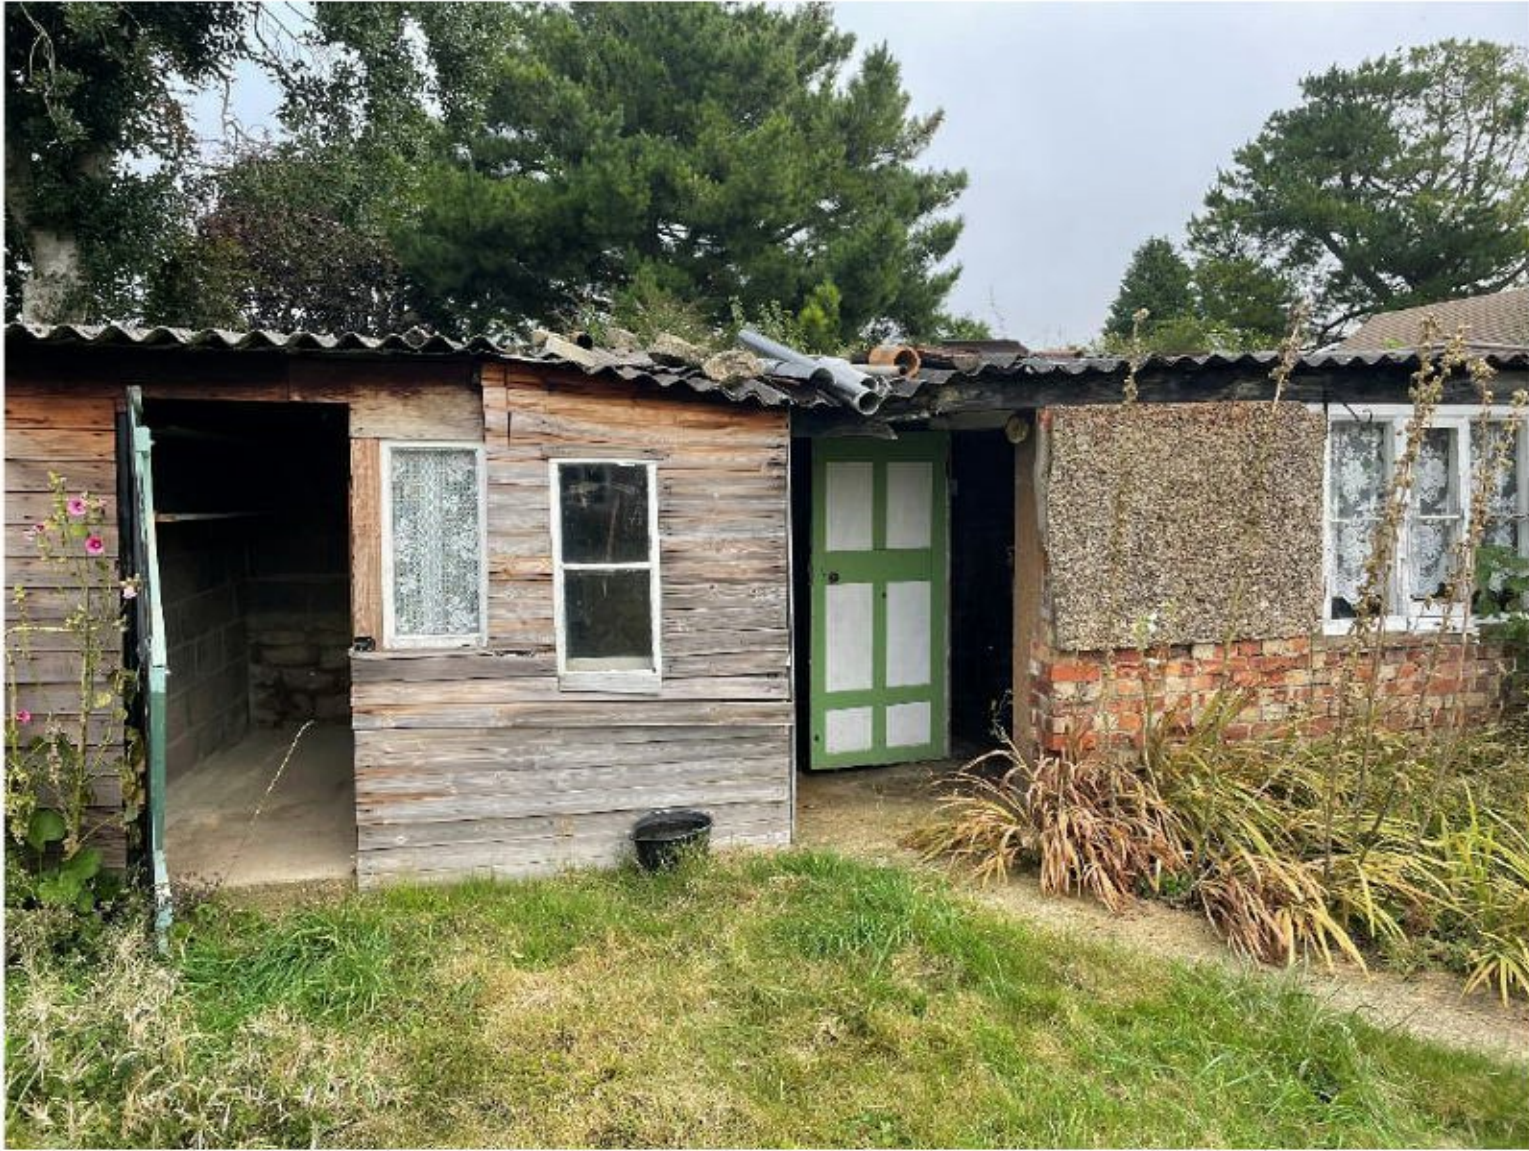
Plate 1 Garden Room-Front View

Building Name/Number	1			
Building Grid Reference	SP9635294207			
Type of Building	Garden Room			
Age of Building	20 th century			
Condition of Building	Semi-Derelict			
Wall Construction	Brick/Timber/Concrete			
Roof Construction	Corrugated asbestos			
Roof Type	Sloping			
Potential Access Points for Bats	Open access			
Roof Void	Yes		No	X
Insulation	Yes		No	X
Structure of Roof	Not applicable			
Roof Lining	None			
Dimensions of Roof Void	Not applicable			
Suitable Roosting Features	None			
Evidence of Bats	None			
Evidence of Birds	None			
Potential to Support Roosting Bats	Negligible			
Suitable for Hibernating Bats	No

5.3 The building on the site is in a semi-derelict condition and unsuitable to support roosting bats, it was graded as having negligible potential.

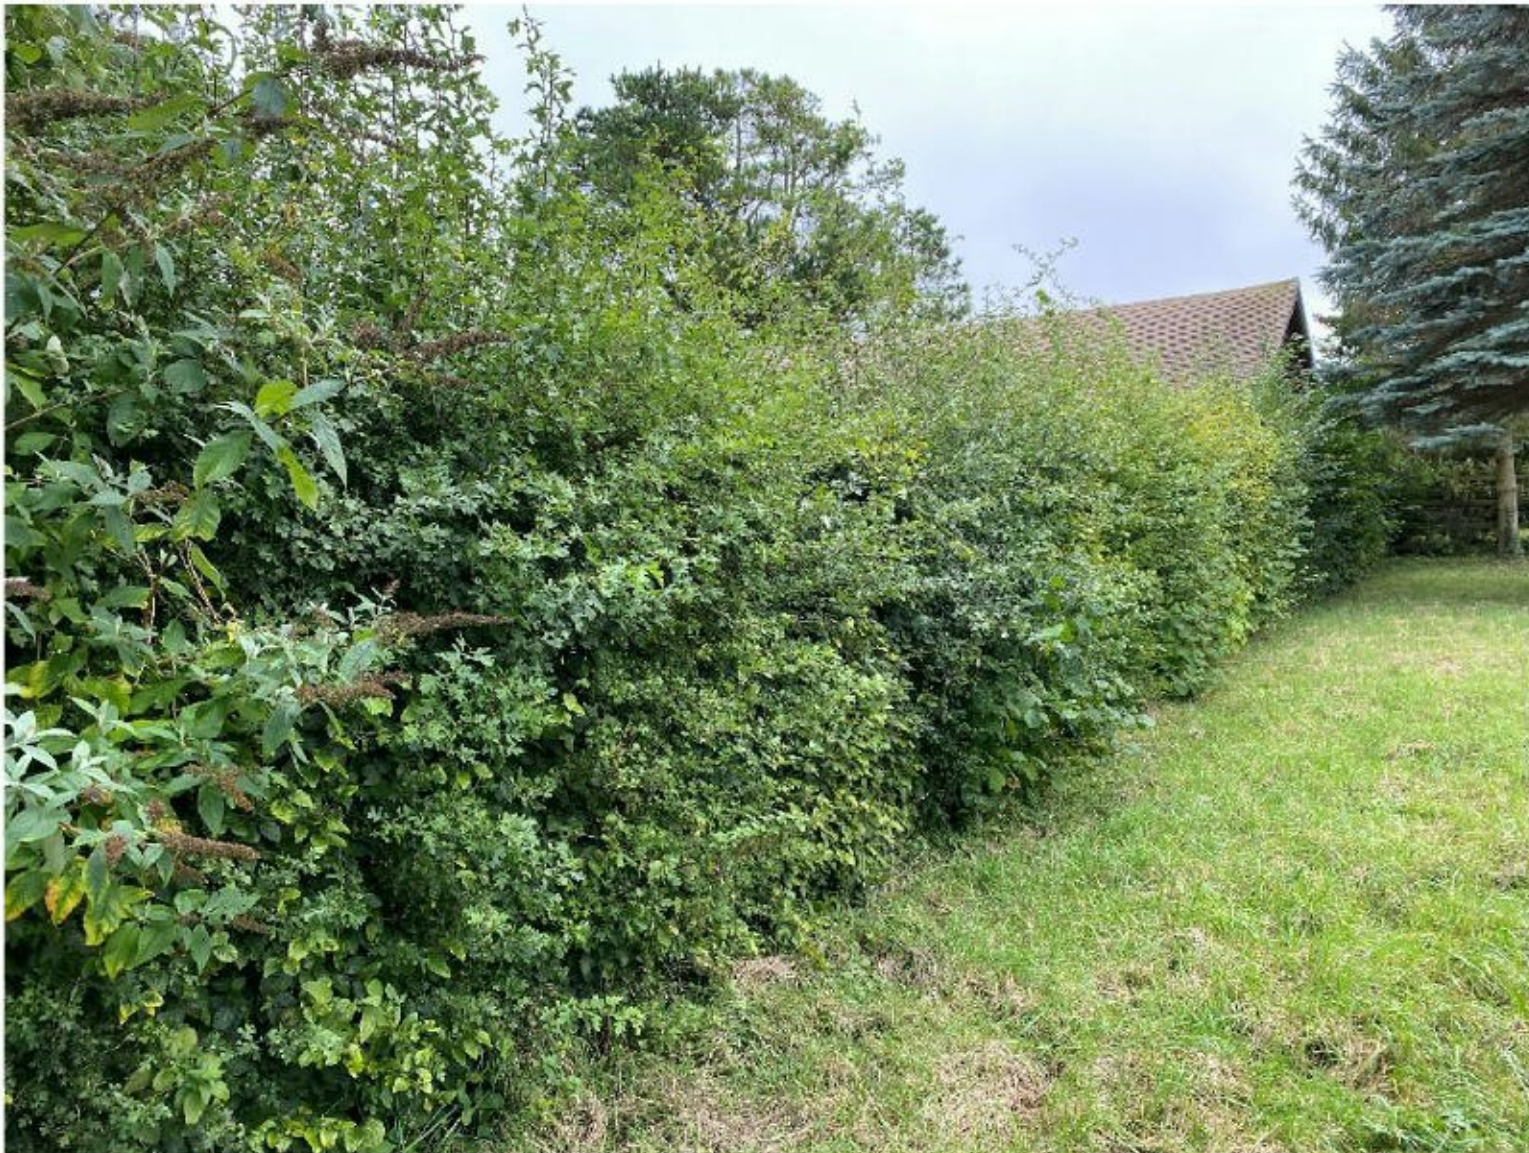
Plate 10 Hedgerow

5.10 The hedgerow survey recorded five woody species and did not meet the Hedgerow Regulations criteria as an important hedgerow

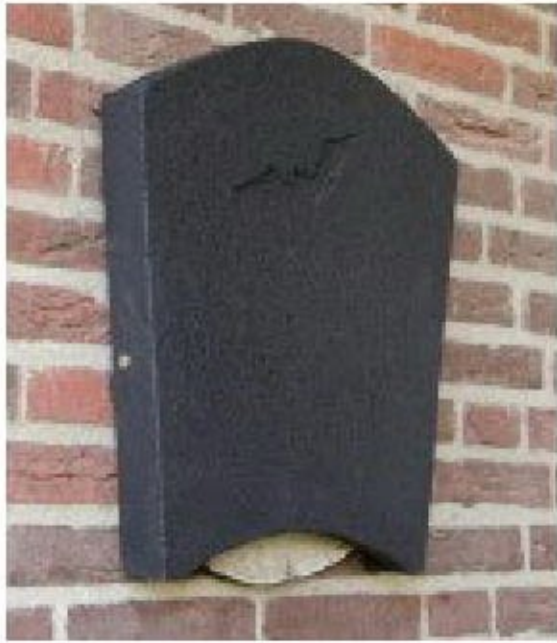
Beaumaris Woodstone Bat Box (3)

Suitable for crevice dwelling bats, the Beaumaris Bat Box is made from 100% woodstone and is available in two sizes.

These boxes have a rough interior to provide lots of grip. They have good thermal insulation, reducing temperature fluctuations within the box. They are painted black to best absorb the sun's heat, which is important as bats need to increase their body temperature before they emerge in the evening.

Suitable for wall mounting.

7.1 To provide enhancements bat boxes should be installed in a south facing position at a height of not less than three metres.

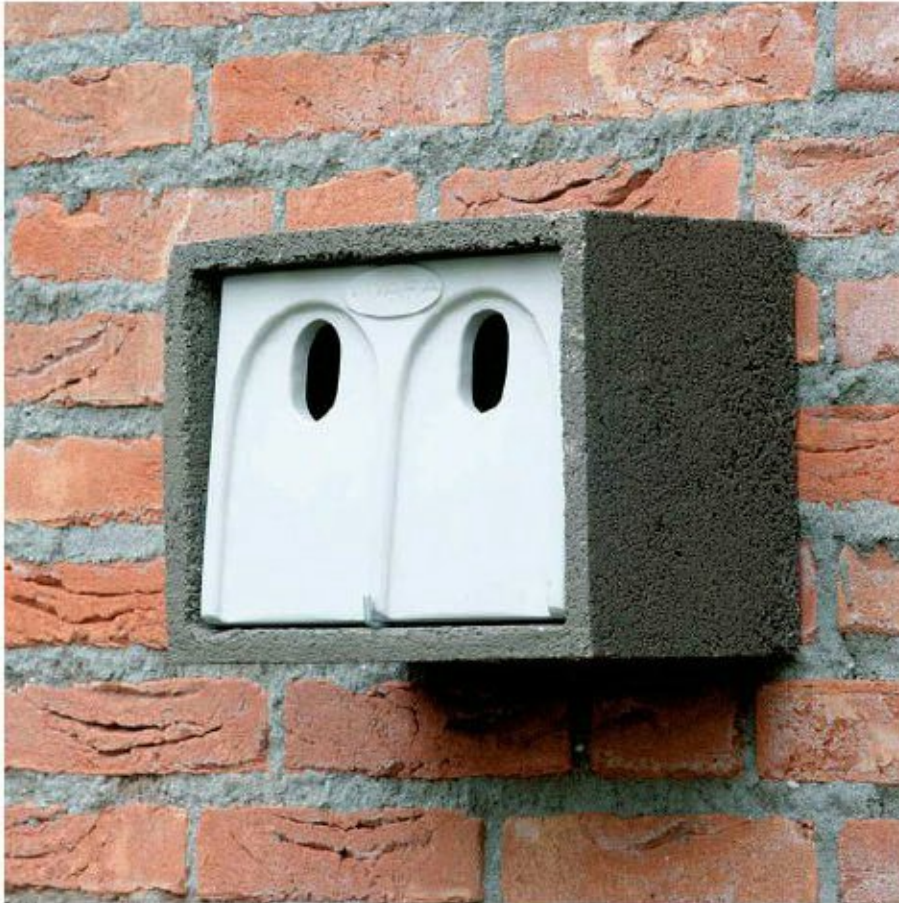
WoodStone Sparrow Nest Box

The House Sparrow Nest Box is from the Vivara Pro range and is manufactured from WoodStone - a mix of concrete and FSC wood fibres. This material is strong and highly insulating which helps to provide a thermally stable environment within the box. It also protects against damage from predators such as woodpeckers, squirrels and cats. It has two breeding chambers making it particularly suitable for house sparrows as they prefer to nest in colonies.

The House Sparrow Nest Box can be integrated into the masonry of a new house or fixed onto an external wall using strong screws and wall plugs (not included). If possible, it should be positioned near to vegetation and at a minimum of 2 m above ground.

7.4 The installation of bird boxes will enhance biodiversity; this should comprise of Sparrow Terraces and Swift boxes (in groups of 3) installed between north and east at heights of two to five metres.

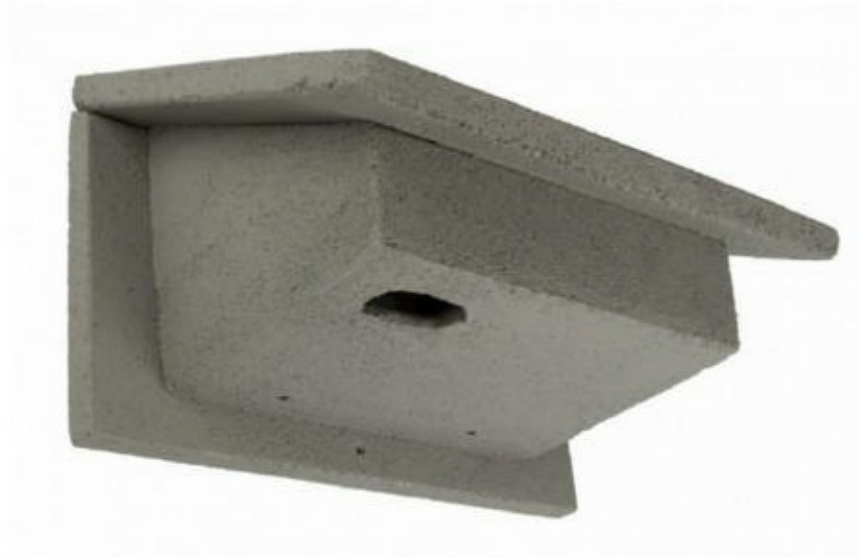
WoodStone Swift Box

The FSC certified WoodStone Swift Nest Box is constructed entirely out of WoodStone meaning it is long lasting and won't rot away like a traditional wooden nest box. Swift numbers are declining, in part because of the loss of nesting sites. Installing a swift box is a great way to help these birds and to ensure their continued presence in our surroundings. There is an opening at the back of the box for easy cleaning with the nest entrance on the underside of the box. This type of entrance is preferred by swifts but discourages house sparrows and starlings from occupying the box. This box should be installed at least five metres above the ground, ensuring that there is unobstructed access for birds entering and leaving. If possible, boxes should be sited under the shelter of eaves or overhanging roofs.

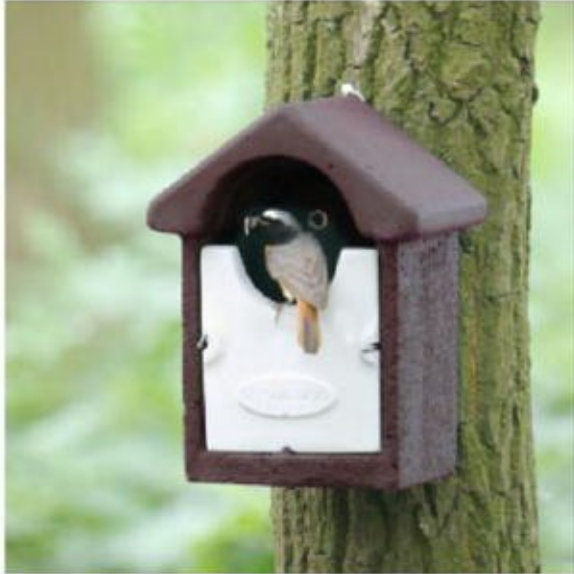
Woodstone Open Nest Box

These attractive nest boxes are manufactured from WoodStone which is a mix of concrete and FSC certified wood fibres. Unlike a traditional wooden nest box, these boxes will not rot away or deteriorate and are guaranteed for 10 years.

These open nest boxes are suitable for wrens, robins, song thrushes and blackbirds, and they are available in brown, green or grey to complement both natural woodland and garden settings.

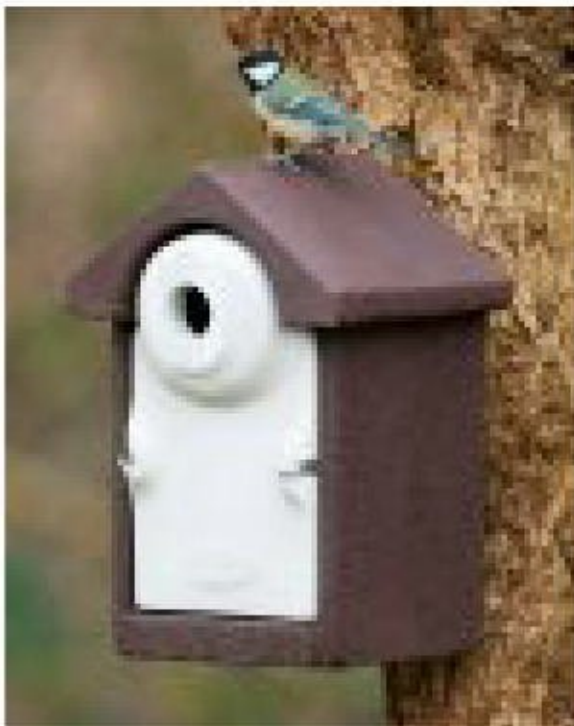
Woodstone 28mm Hole

These attractive nest boxes are manufactured from WoodStone which is a mix of concrete and FSC certified wood fibres.

These 28mm hole nest boxes are suitable for blue tits, tree sparrows, great tits, crested tits and coal tits and they are available in brown, green or grey to complement both natural woodland and garden settings.

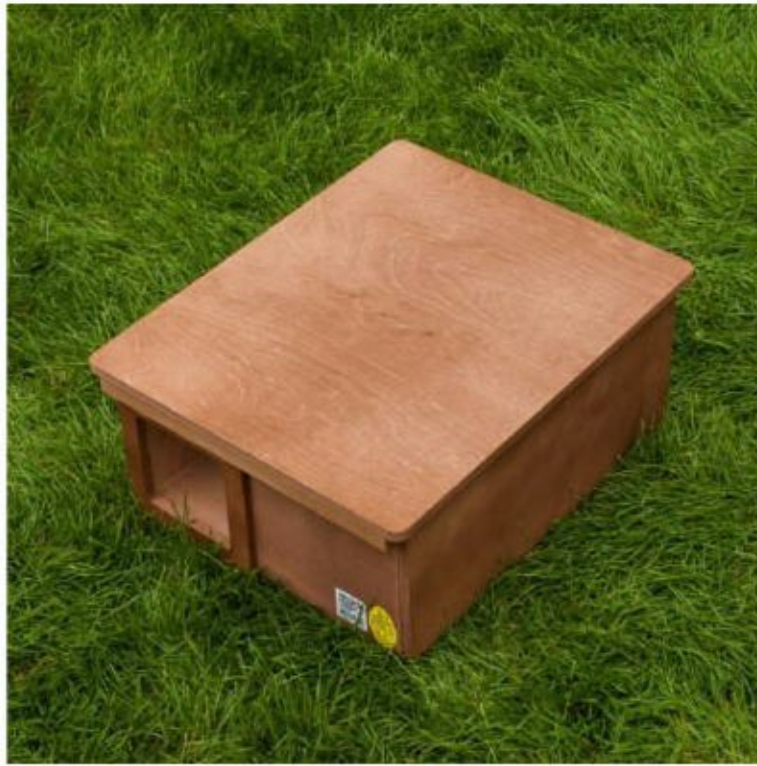
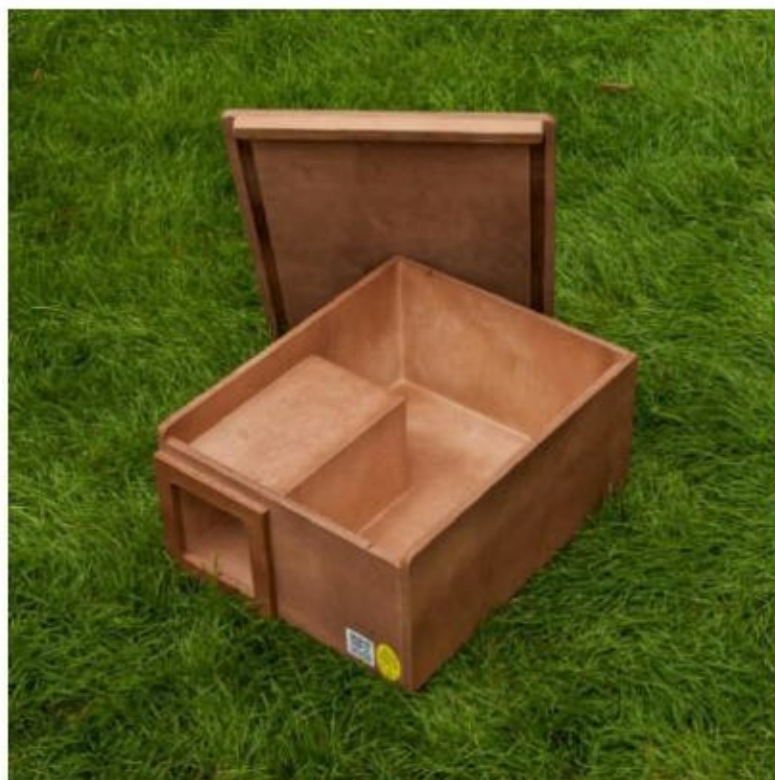
Hedgehog Nest Box

A completely redesigned hedgehog nest that incorporates all the best features of previous nests, is far safer for the hedgehog, and eliminates loose entrance tunnels and plastic pipes by building all these features into one robust design.

- * Fully built-in tunnel with 5" square access for even the largest hedgehog to avoid unwanted visitors.
- * Raised 'step' at entrance to enable the box to be partly buried.
- * Totally safe nesting area well away from the tunnel entrance.
- * Lower roof to enable the hedgehog to build a snug nest.
- * Specially designed inbuilt "unlockable" ventilation to provide just the right temperature and humidity without draughts.
- * Totally removable roof for easy inspection and cleaning.
- * Underfloor runners letting air to the underside of the box but allowing the box to be pushed easily into place in undergrowth, etc.
- * Reinforced and strengthened corners making a sturdy nest box.
- * One compact unit easy to position.

Exterior quality 12mm resin bonded ply. The box remains untreated on the inside. Best situated in a quiet corner of the garden and covered with leaves and other garden debris. Removable lid for cleaning purposes and reinforced corners, manufactured with surface sunk nails to resist rusting.

Nest box size: Height 22cm x Width 38cms x Length 47cm

7.5 To provide enhancements Hedgehog homes should be provided across the site.
