BLAGDON MANOR FARM NORTH TAMERTON CORNWALL

Bat & Nesting Bird Survey

JUNE 2021

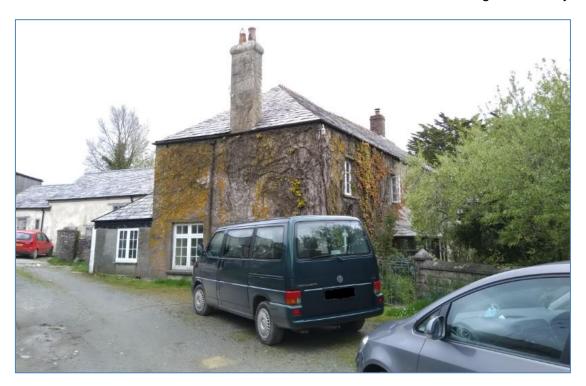
Fig 3 - Blagdon Manor Farmhouse.

Blagdon Manor Farmhouse is of traditional stone construction (Fig 3)

Blagdon Manor Farmhouse is a Listed, 17c, two-storey detached building of traditional stone construction with a natural slate roof, and terracotta ridge tiles. The roof has two rendered brick-built chimney stacks with lead flashing at the base. There are wooden fascias carrying plastic guttering throughout. There are some gaps underneath ridge tiles, wooden fascias, and at raised flashing around the base of chimney stacks.

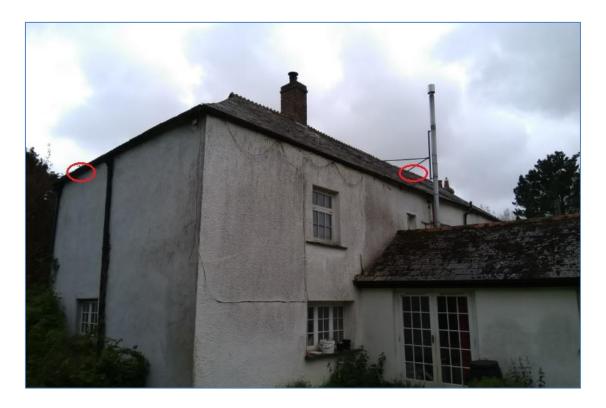
Fig 4 – Bat emergence points.

2152	1 x Common Pipistrelle	Yes	Emerged from underneath ridge tile (Fig 4).
2152	1 x Soprano Pipistrelle	Yes	Emerged from underneath external fascia boarding at eastern elevation (Fig 4).
2200	2 x Common Pipistrelle	Yes	Emerged from underneath ridge tile (Fig 5).
2200- 2209	Common Pipistrelle and Soprano Pipistrelle	No	Foraging over farmhouse and garden/surrounding habitats.
2209	1 x Brown Long- eared	Yes	Emerged from underneath ridge tile (Fig 5).
2210	1 x Brown Long- eared	Yes	Emerged from underneath ridge tile (Fig 5).
2212	1 x Brown Long- eared	Yes	Emerged from underneath ridge tile (Fig 5).
2212- 2220	Brown Long-eared and Noctule	No	Foraging over farmhouse and garden/surrounding habitats.

Scattered bat droppings were identified inside the loft. Four Common Pipistrelle, one Soprano Pipistrelle, and three Brown Long-eared bats emerged from the roof at the ridge tiles, and beneath wooden fascias (Figs 4 & 5). These species were observed foraging around the house, and gardens.

- Access points and suitable habitat for roosting crevice-dwelling bats shall be retained. These shall include the provision of small gaps and spaces measuring 2.5cms in width x 7cms in length underneath at least four ridge tiles along both sides of the main ridge. At least one 2.5cm x 7cm gaps shall also be made available underneath wooden fascias carrying guttering at the eastern elevation.

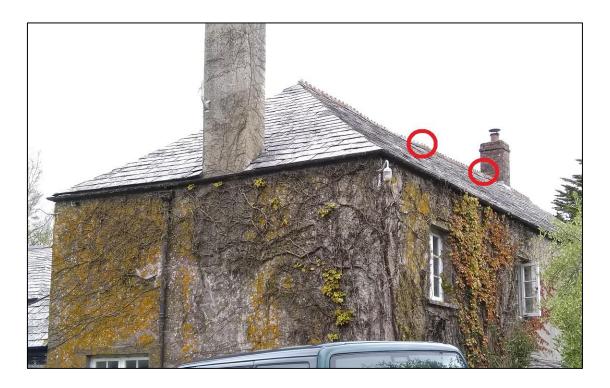
Fig 5 - Bat emergence points.

Date of Survey: 09/06/21					
Type of Survey: Sunset/Emergence					
Sunse	t Time: 2128				
Weather Conditions: 100% cloud cover. Still & dry.					
Start T	ime: 2113		Finish Time: 2243		
Start T	emp: 16°C		Finish Temp: 15°C		
Time	Species Recorded	Emerging?	Behaviour/Notes		
2128-	Common Pipistrelle	No	Foraging over farmhouse and		
2151	2151		garden/surrounding habitats.		
2151	1 x Common	Yes	Emerged from underneath ridge tile		
	Pipistrelle		(Fig 5).
