Dovecote Cottage Walpole St Peter

Preliminary Roost Appraisal

Reference: 43-2102-GE-ES

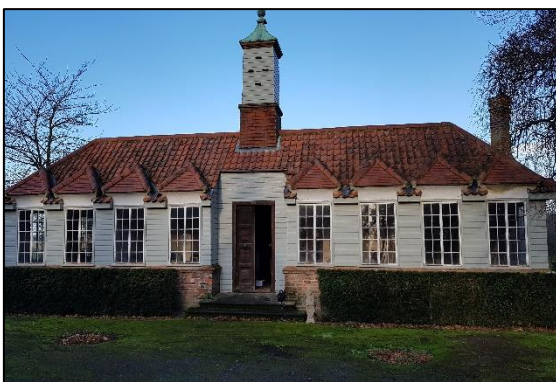
5.3.2 The building had a brick base with weatherboarding on the walls and a part pantile, part bitumen roof (Figure 1).

- 5.3.3 The ridge tiles appeared well sealed with some raised tiles on the front aspect, particularly at the western end. The west and eastern hipped roof was also to pantiles, but these were in relatively good condition.

Figure 1: Dovecote Cottage – southern aspect (front).

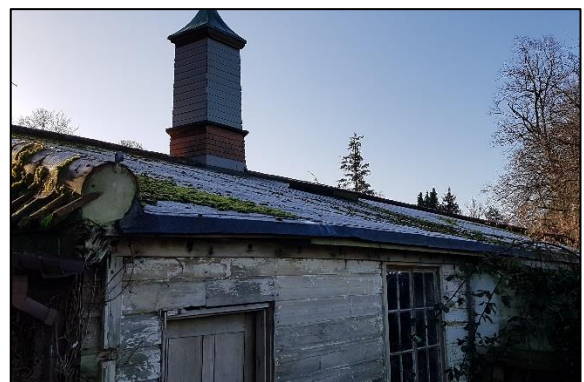
- 5.3.4 The rear of the property (north aspect) had no tiles and was covered in a bitumen felt lining (Figure 2). The lining was intact with no splits or tears present.

Figure 2: Rear view of lined roof.

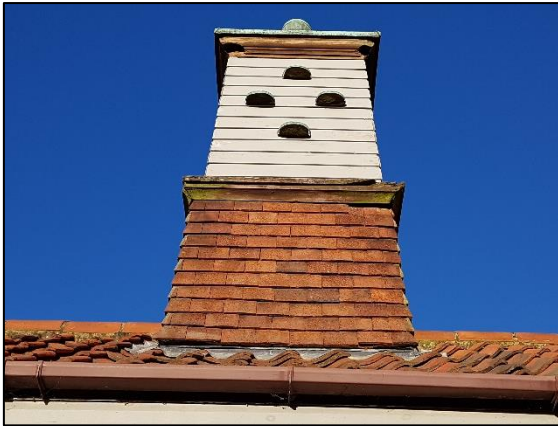
- 5.3.5 There were hanging tiles on the turret (Figure 3) and around the windows. The tiles above the windows were generally well sealed (Figure 4) although there was some gapping to the front of the turret, but there were no signs of bat use such as staining and the majority appeared well cobwebbed.

Figure 3: Hanging tiles on turret.

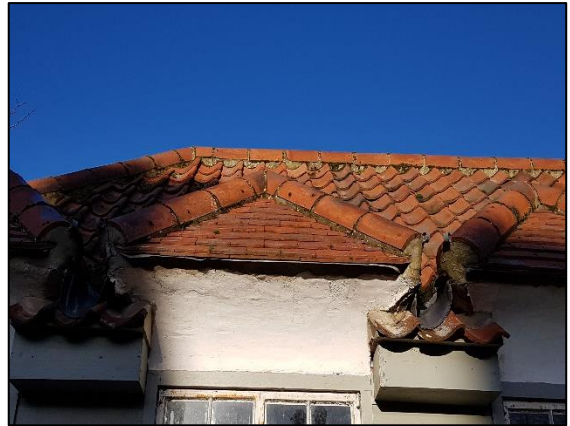
Figure 4: Tiles above windows

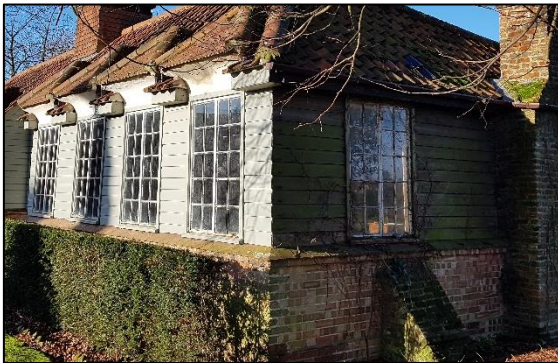
- 5.3.8 The metal window frames were weatherworn but they were tightly sealed, with no gaps between the frames and the walls.
- 5.3.9 The weatherboarding to the front aspect was painted whereas the sides and rear were untreated. Whilst weather worn the boarding was tightly sealed (Figure 5).

Figure 3: Painted and untreated weatherboarding – tightly sealed.

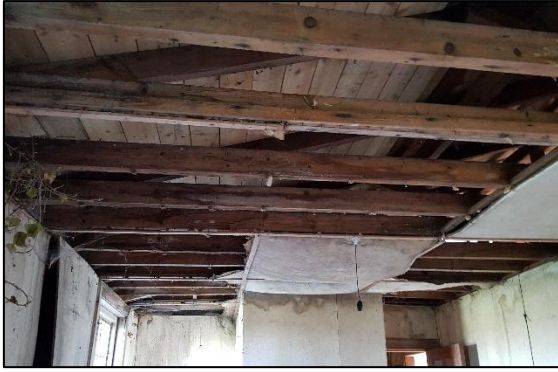
- 5.3.11 Internally the building was in a bad state of repair, with very little ceiling left, making the space essentially open to the roof structure (Figure 6).
- 5.3.12 The roof was wood panel lined to the rear (under the bitumen lining - Figure 7) and felt lined at the front (under the pantiles – Figure 8). The lining in both cases was in sound condition.
- 5.3.13 The beams were narrow with no cracks or splits noted and the roof structure was cluttered (Figure 9).
- 5.3.14 Both the walls and roof were very damp in places and there was heavy cobwebbing, especially at gable ends and around the corners of the roof.
- 5.3.15 The windows to each aspect and the lack of ceiling meant that the roof area was bright and well lit.

Figure 6: Internal view – rooms open to roof structure.

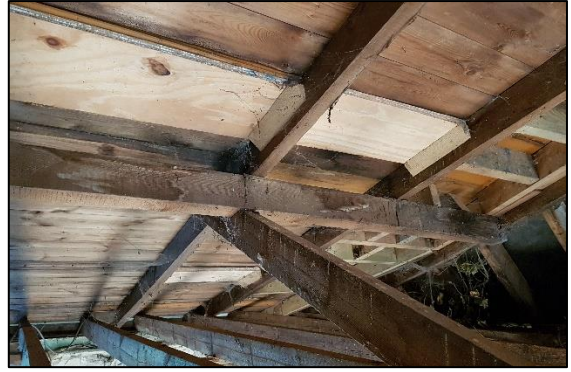
Figure 7: View of roof structure – wooden lining.

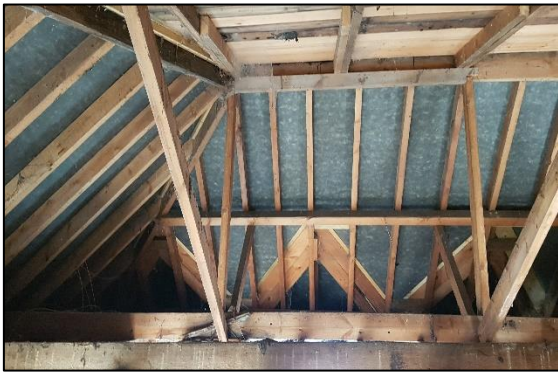
Figure 8: View of roof structure – felt lining.

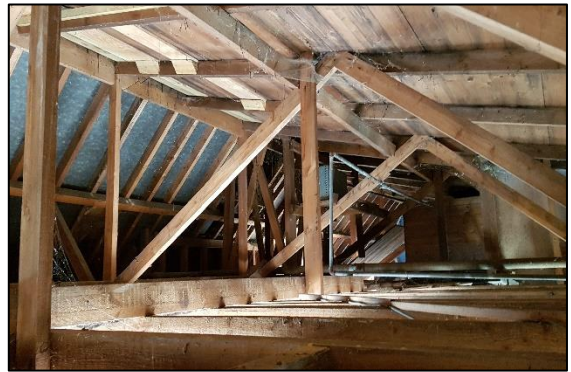
Figure 9: Cluttered roof structure.

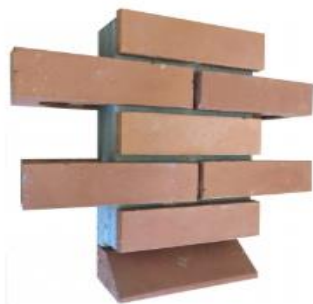
Figure 4: Habibat integrated bat box with brick finish.

- One bat box to be installed on the eastern aspect where there is a clear flight path for bats entering and leaving. There are two options available:
 - *Integrated bat box.* These are built into the fabric of the building and come in a variety of designs depending on the materials being used. For example, the Habibat bat box comes in a selection of designs to suit brick built buildings (Figure 3), whilst the Schwegler bat tube (Figure 4) is designed to be installed beneath a rendered surface. This makes it ideal for situations where you wish the box to be discrete as only the entrance hole will be visible. It can also be painted to match your building with an air permeable paint if desired.

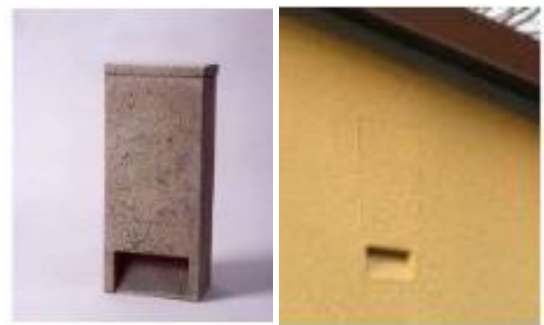
Figure 5: Schwegler 1FR bat tube and rendered finish with only the hole visible.

- *Wall mounted bat box.* Fixed to the external wall of a building, the [Beaumaris bat box](#) is a popular choice as is the [Schwegler 1FQ Bat Roost](#).
