Dusk Survey Results

6-8 Carlin Gate

6-8 Carlin Gate, Blackpool, Lancashire, FY2 9QX
Dusk Survey Results in Relation to Bats

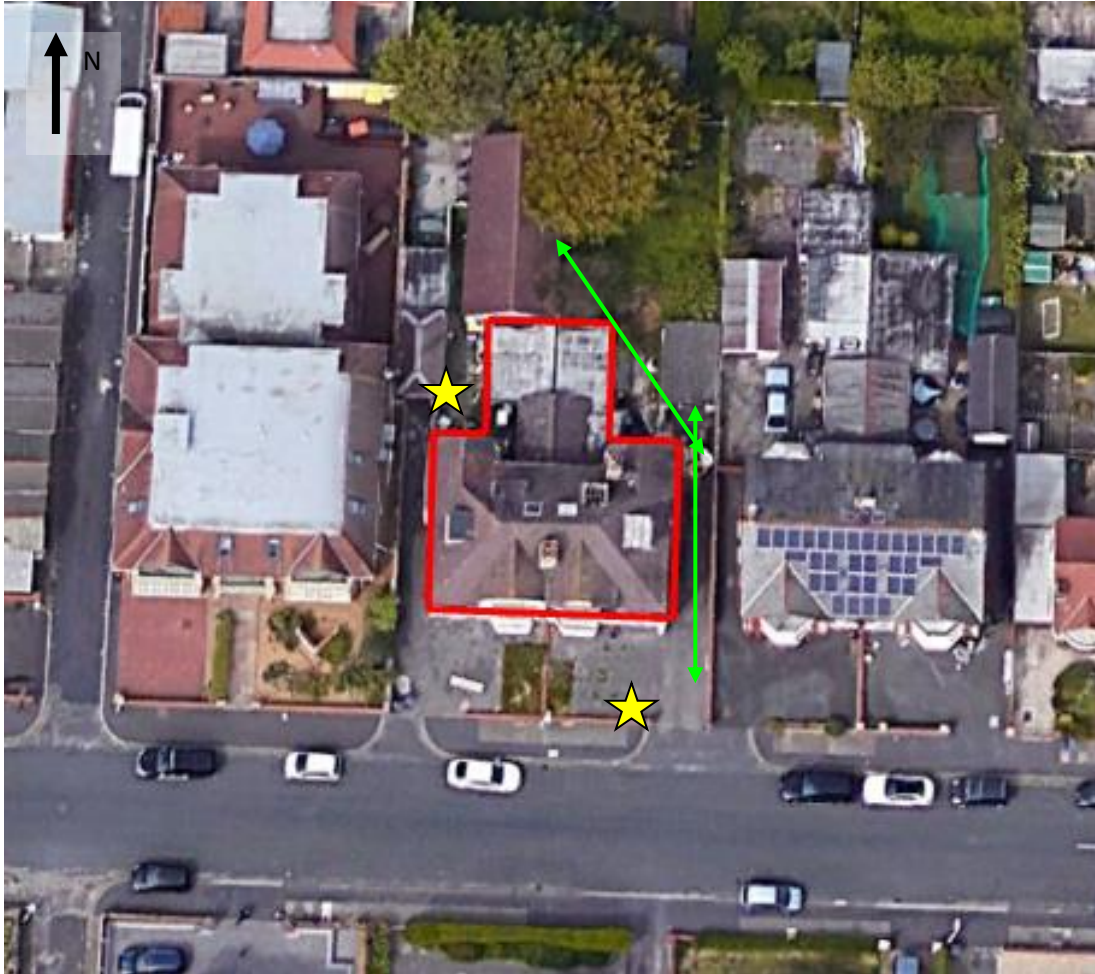
Figure 5.2 - Visual Aid - Dusk Survey 2 Results with Key

Dusk Survey 2 - 08/06/2021

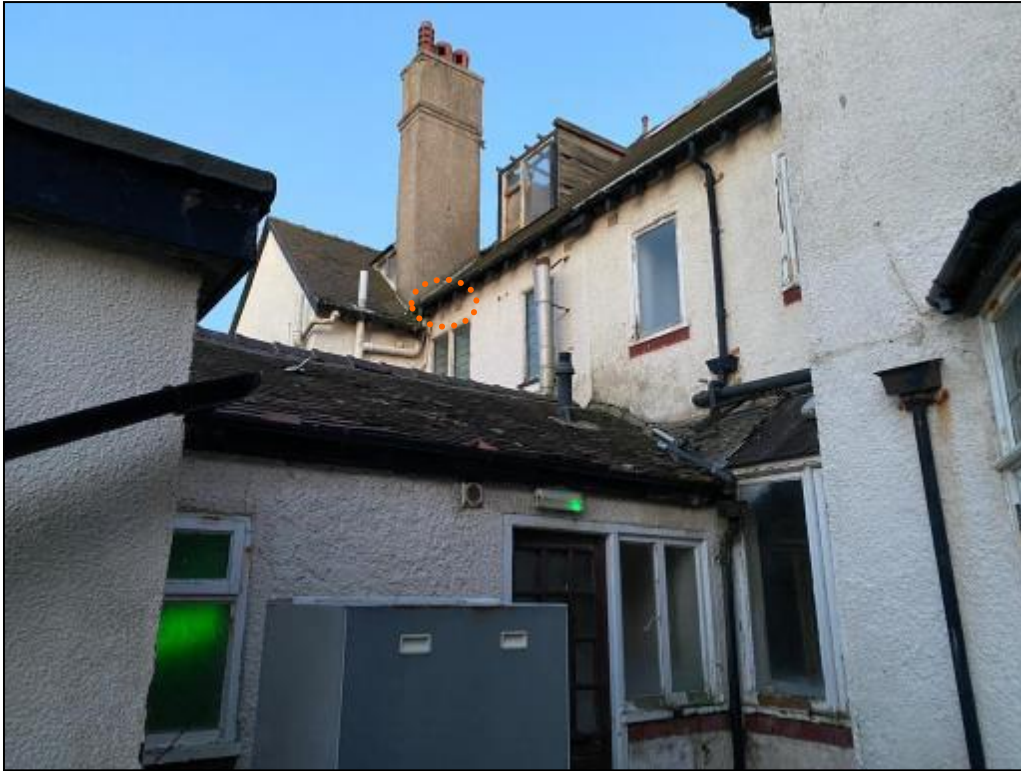
Figure 5.3 - *Visual Aid* - Emergence location at the open eaves of the northern elevation, where 3 Common Pipistrelle emerged during the first dusk survey from wall-plate level.

- 6.1 The survey results gathered by Tyrer Ecological Consultants Ltd conclude that number 8 Carlin Gate is being used by up to 3 Common Pipistrelle (*Pipistrellus pipistrellus*) bats for roosting purposes. Based upon the evidence, the building is host to a 'Day roost' for the named species in low numbers, with 3 bats emerging from the open eaves on the northern gable elevation ridge.

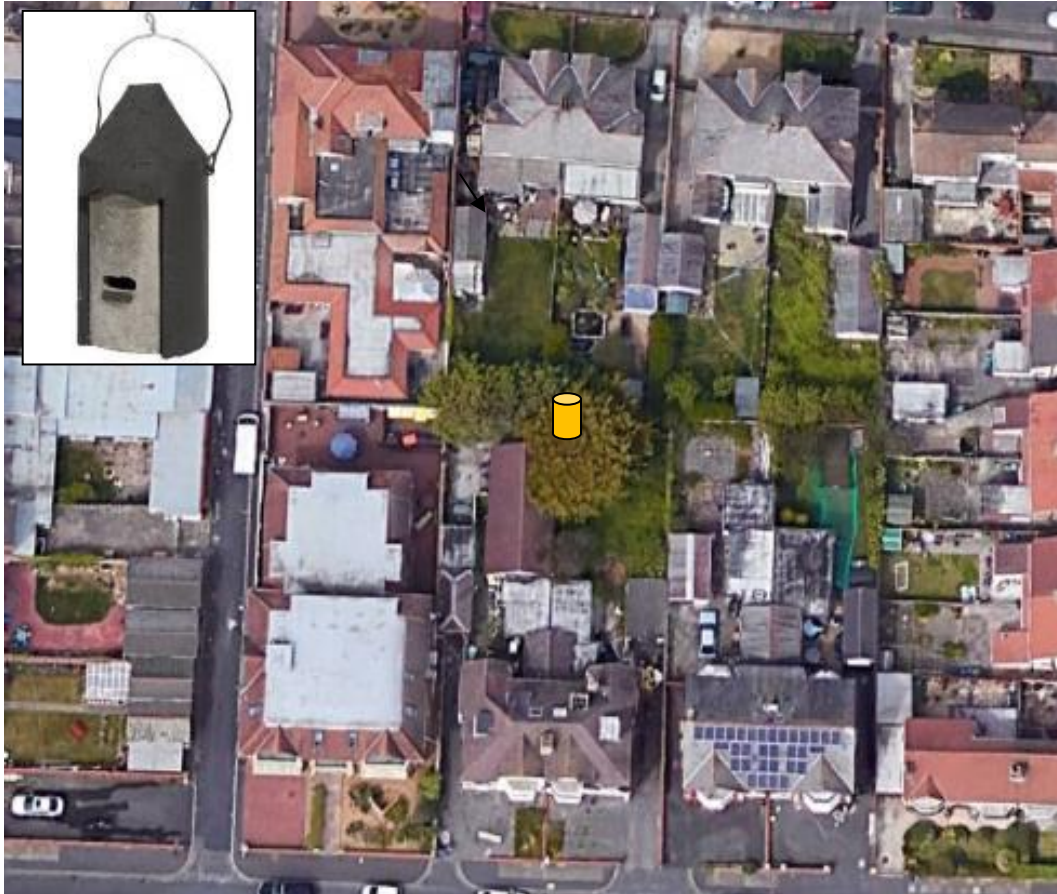
Figure 7 - Proposed location of receptor roost [

] (Google Earth, 2020), and 2F Schwegler Bat box (overlaid)

- 7.8 To ensure that bats are not left without a roost while the work takes place one Schwegler 2F bat box (or suitable equivalent) will be mounted on a tree in proximity to the survey area. The box will act as a receptor should bats have to be captured and relocated during the work schedule (See Figure 7.1). Should this tree not be retained under the development proposals, alternatives including pole-mounted boxes may be considered.

The receptor bat box will act as a receiver box for if bats have to be captured by hand and relocated to it by the ecologist during the work schedule; it will be retained permanently post-development to provide a permanent roost opportunity for bats.

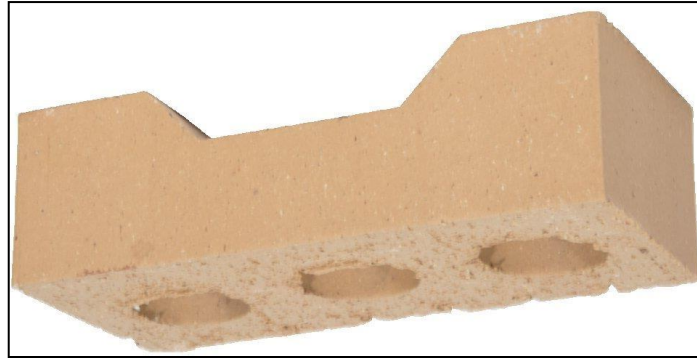
The bat brick should be placed with the entrance hole at the top, at wall plate level on the southern elevation of the north-east wing.

- New roosting provision will be re-created in the form a bat brick on the northern elevation of a new building: the bat brick will be installed under the eaves with the entry hole at the top to make an inconspicuous access point.
- As part of this roost creation process it is imperative that traditional bitumen 1F roofing felt will be used as the chosen **local** underfelt/roof lining as opposed to any breathable roofing membrane (BRM). Modern breathable roofing membranes (BRM) entrap bats through wear and tear in the synthetic polymers used to protect the breathable membrane causing bats harm, injury and death. Where bitumen 1F felt is not the chosen roof lining for the building, an area of the felt may be instated in a 1m² area around the access points; however, this must be separated from the rest of the roof space using timber roofing batons to prevent bats moving out of this area.

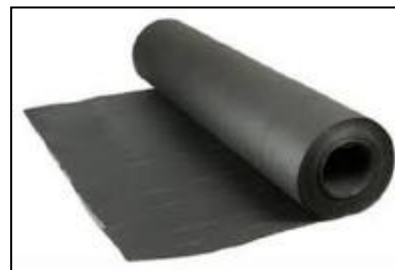
This area of Bitumen 1F underfelt should be incorporated during the roofing of the new development, with the bat brick installed at the northern elevation.
