EXTENDED PHASE 1 HABITAT SURVEY & DAYTIME BAT SURVEY

LAND OFF FLEETWOOD ROAD,
THORNTON CLEVLEYS,
LANCASHIRE

DECEMBER 2021

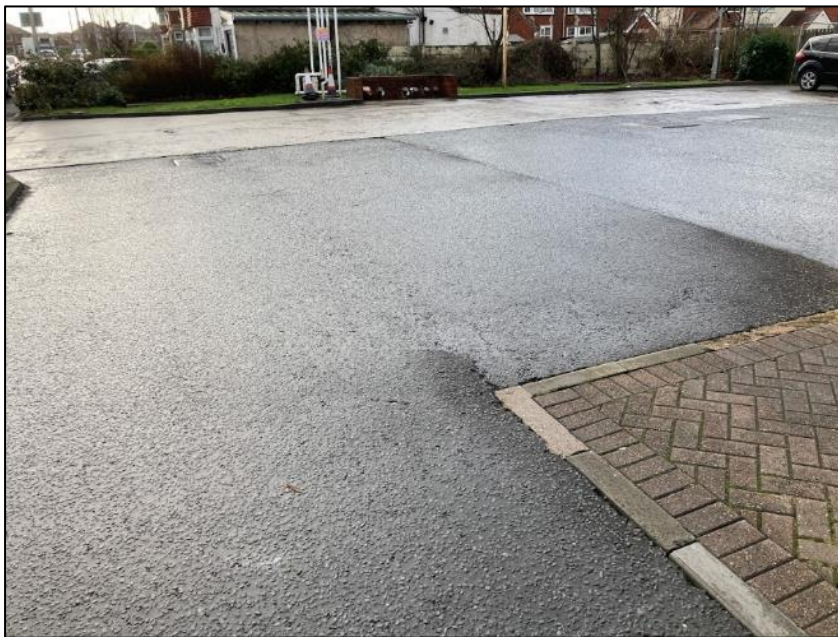
- 3.2 Bare ground is located across the site consisting of the access points, petrol filling station (PFS) forecourt and some other areas of currently unused bare ground in the western part of the site which have ephemeral/short perennial species establishing around the peripheries and within cracks (see Photograph 1).

Photograph 1 showing an area of bare ground on site

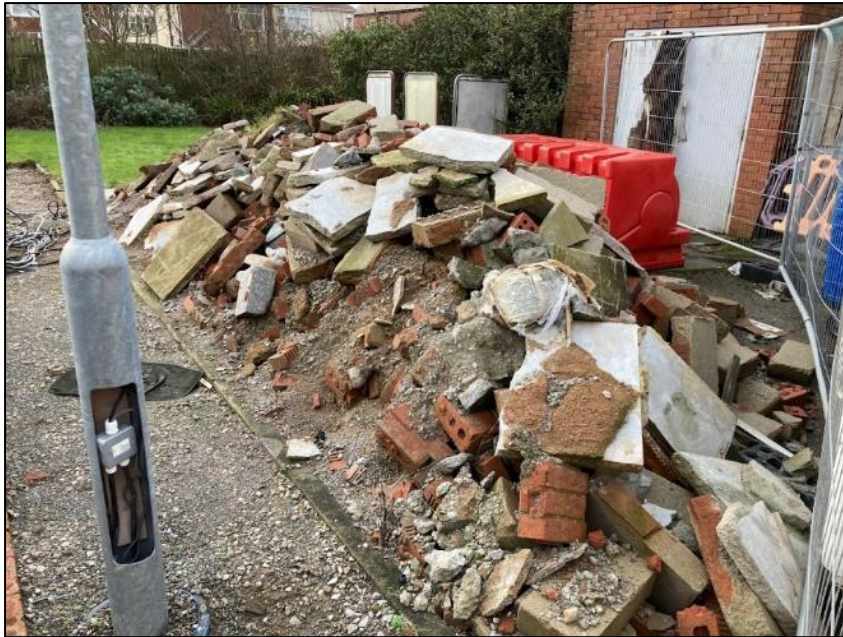
- 3.3 A spoil pile consisting of building materials is located on site (see Photograph 2).

Photograph 2 showing the spoil pile on site

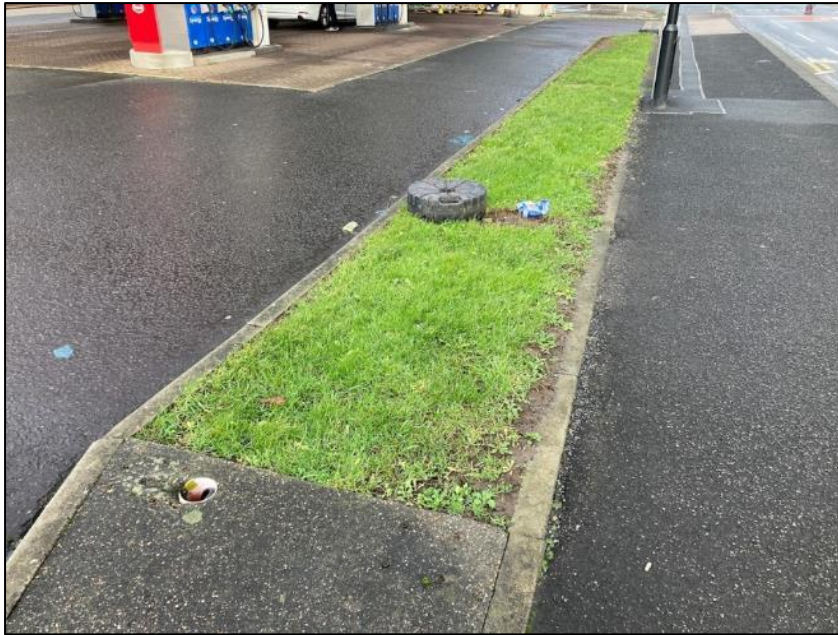
- 3.5 Pockets of amenity grassland occur around the PFS forecourt area (see Photographs 3 and 4). The areas of grassland are mown and species-poor. Dominant species include Perennial Rye-grass *Lolium perenne*, Creeping Buttercup *Ranunculus repens*, Dandelion *Taraxacum officinale* agg., Ribwort Plantain *Plantago lanceolata*, Daisy *Bellis perennis* and White Clover *Trifolium repens*.

Photograph 3 showing the amenity grassland

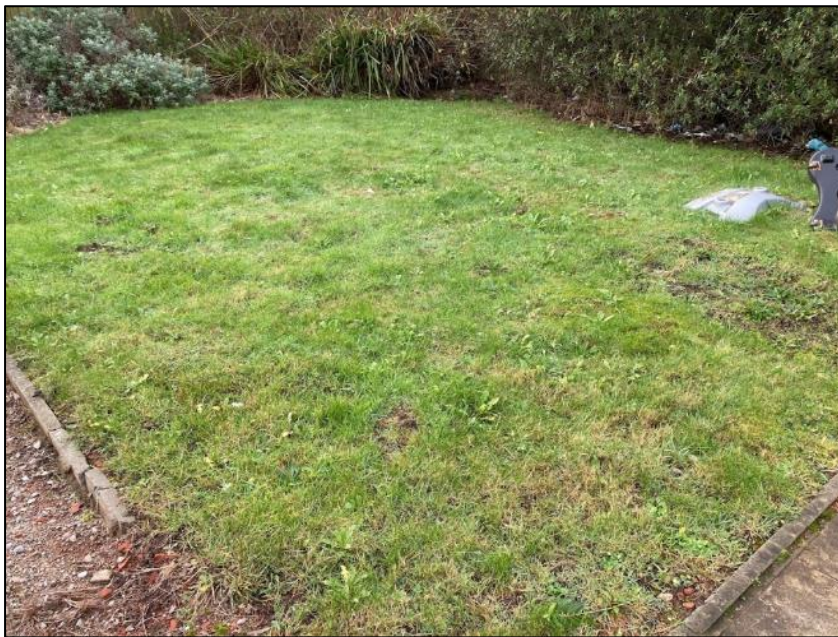
Photograph 4 showing the amenity grassland

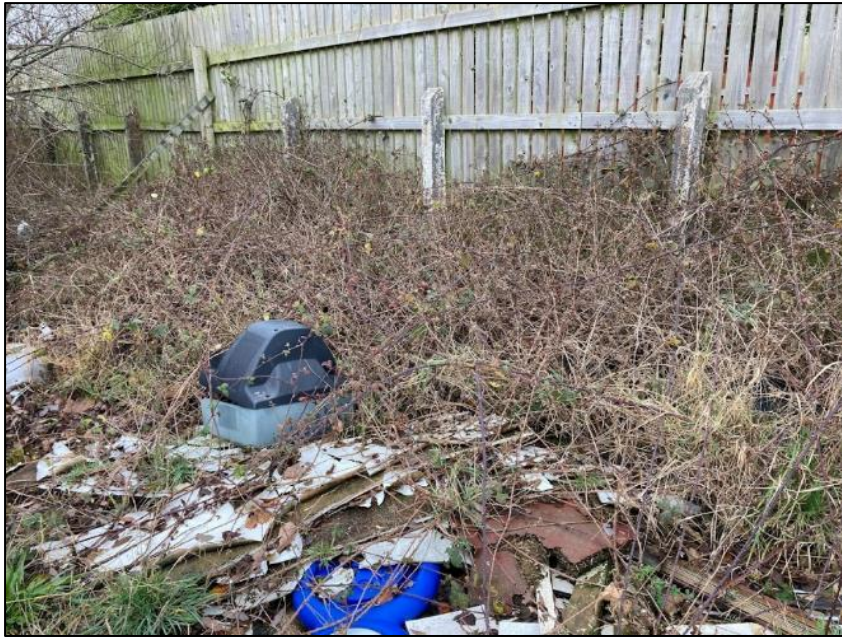
- 3.6 Tall, ruderal vegetation is across the western part of the site, particularly along the boundaries (see Photograph 5). This habitat is dominated by Bramble *Rubus fruticosus* agg. Other abundant species include Common Nettle *Urtica dioica*, Cleavers *Galium aparine*, Cock's-foot *Dactylis glomerata*, Yorkshire Fog *Holcus lanatus*, Pendulous Sedge *Carex pendula*, Creeping Buttercup *Ranunculus repens* and Japanese Knotweed *Reynoutria japonica*.

Photograph 5 showing the tall, ruderal herb

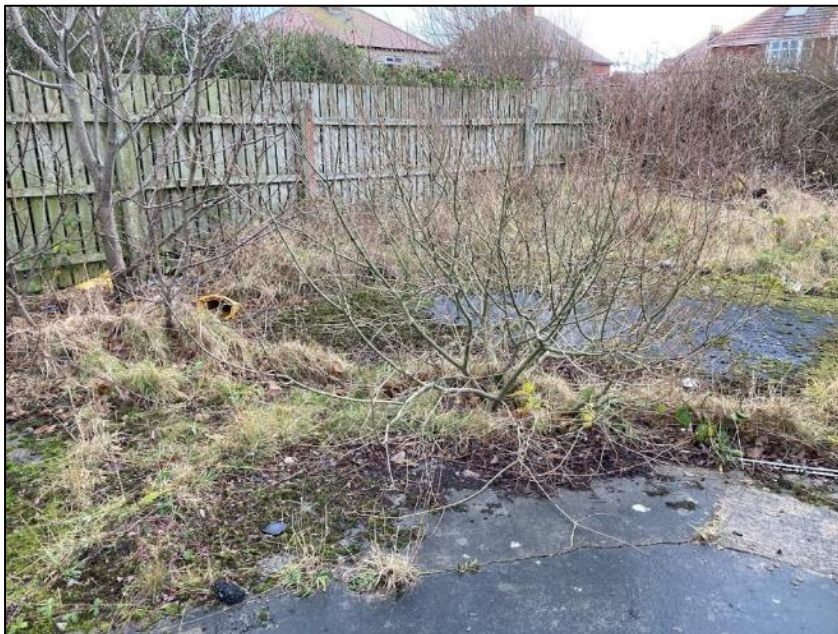
- 3.7 Scrub is present within the western part of the site as both scattered and continuous/dense features (see Photographs 6 and 7). Abundant species are Goat Willow *Salix caprea*, Sycamore *Acer pseudoplatanus*, Hawthorn *Crataegus monogyna*, Cotoneaster species, Ash *Fraxinus excelsior*, Bramble *Rubus fruticosus* agg., Butterfly Bush *Buddleja davidii* and Rosebay Willowherb *Chamaenerion angustifolium*.

Photograph 6 showing some of the scattered scrub on site

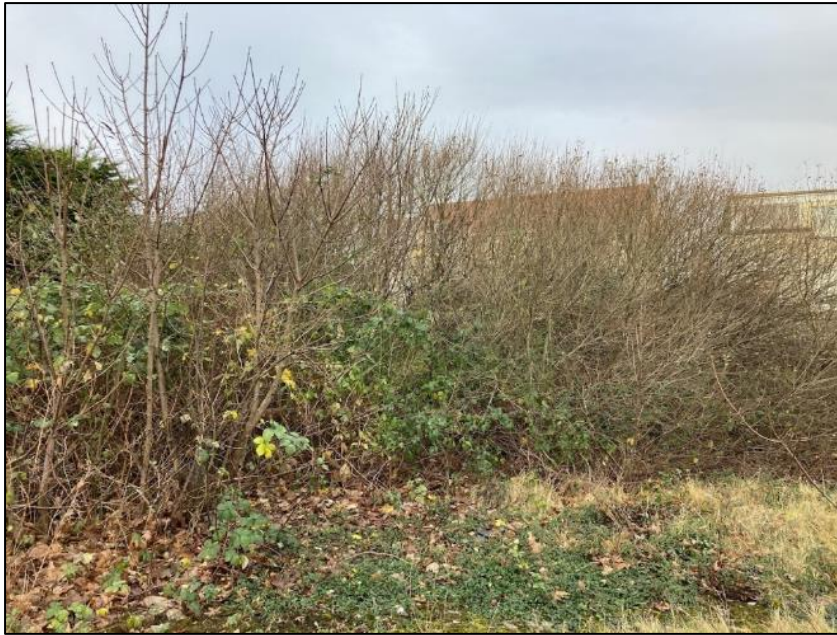
Photograph 7 showing the area of continuous scrub on site

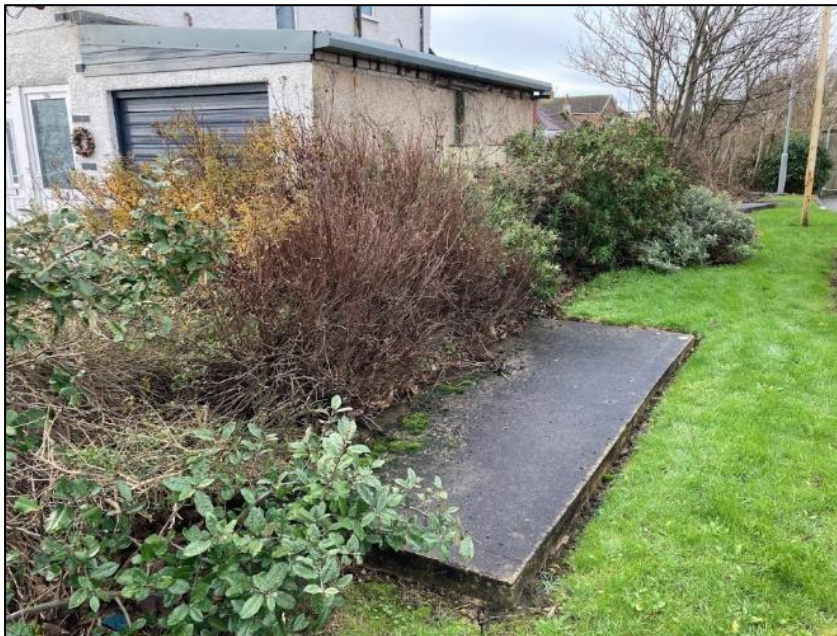
- 3.8 Shrub beds occur along the southern boundaries of the site, bordering areas of amenity grassland (see Photograph 8). These are mature and support garden varieties such as Cotoneaster *Cotoneaster* var., Hebe species, Viburnum species, Pendulous Sedge *Carex pendula* and Bramble *Rubus fruticosus* agg.

Photograph 8 showing a shrub bed

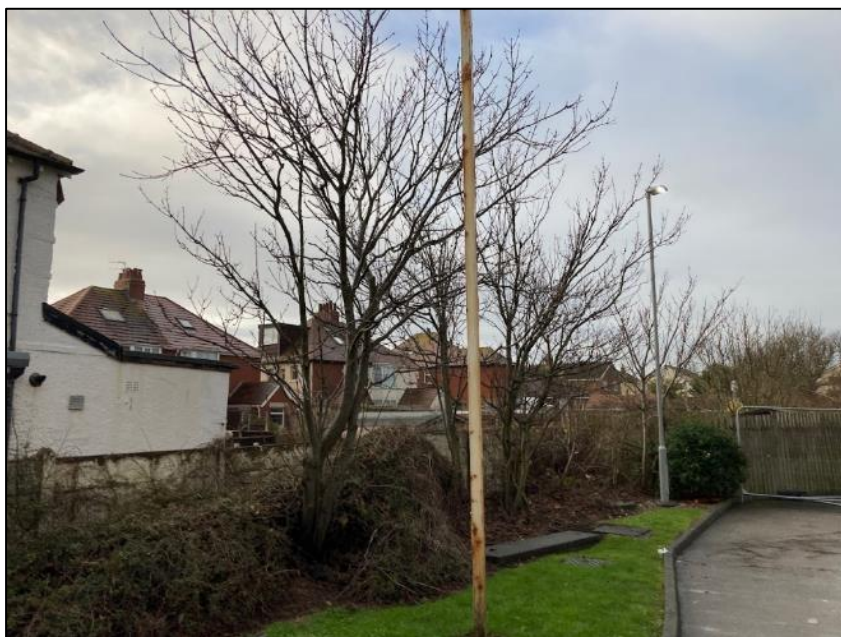
- 3.10 Scattered trees are located across the western part of the site and along the southern boundary, within an introduced shrub bed (see Photographs 9). Species include Sycamore *Acer pseudoplatanus*, Goat Willow *Salix caprea* and Prunus species.

Photograph 9 showing some of the scattered trees

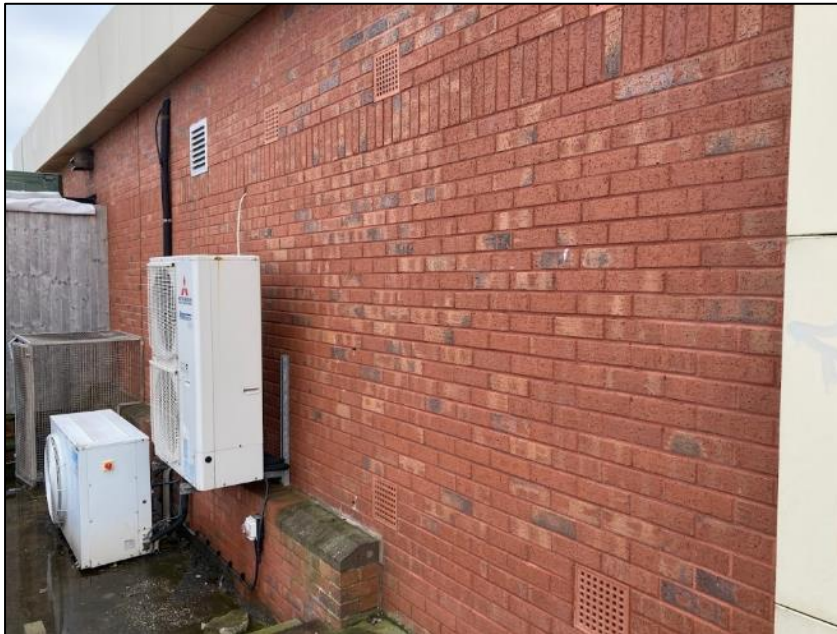
Photograph 10 showing the exterior of the building

- 3.15 The building is constructed from brick. The brickwork is complete and in good condition, as is the associated mortar (see Photograph 10). External vents and points at which cables enter through the walls are sealed, creating no gaps or holes.

- 4.5 The buildings on site have been the subject of a daytime bat survey. The PFS was thoroughly surveyed internally and externally. The building is in good condition and well-sealed. Negligible opportunities were found for bats to enter or exit the building. The external roof and brickwork are intact, with no evidence of bat activity found nor any suitable cavities found. No inaccessible roof voids exist in building. The small storage building is also in good condition with no potential entry points or suitable bat roosting habitat found. It is considered the PFS building, and the small storage building offer negligible bat roost suitability and no further survey work or mitigation is required.

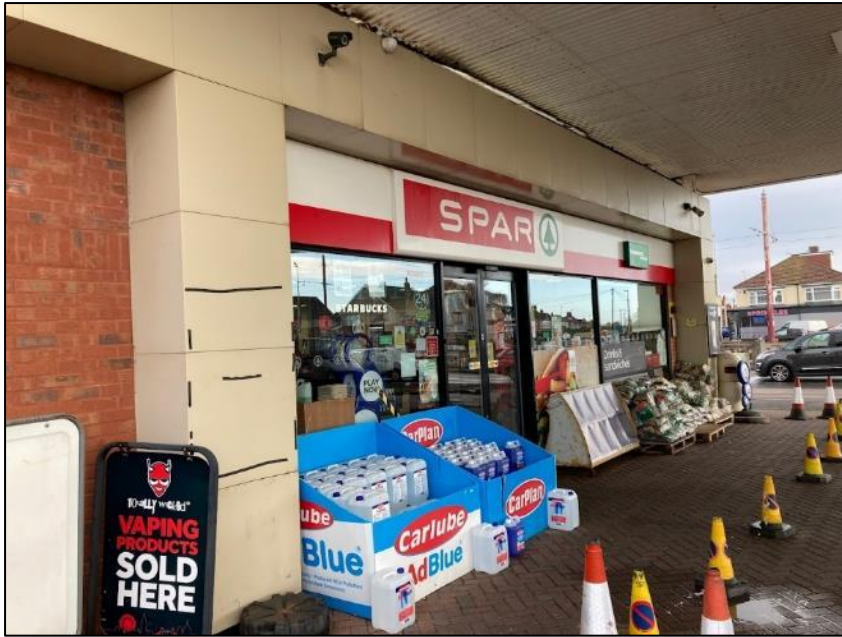
Photograph 11 showing the exterior of the building

- 3.16 Sections of the exterior are clad with metal and plastic signage (see Photograph 11). The signs are in good condition and free from cracks and gaps.

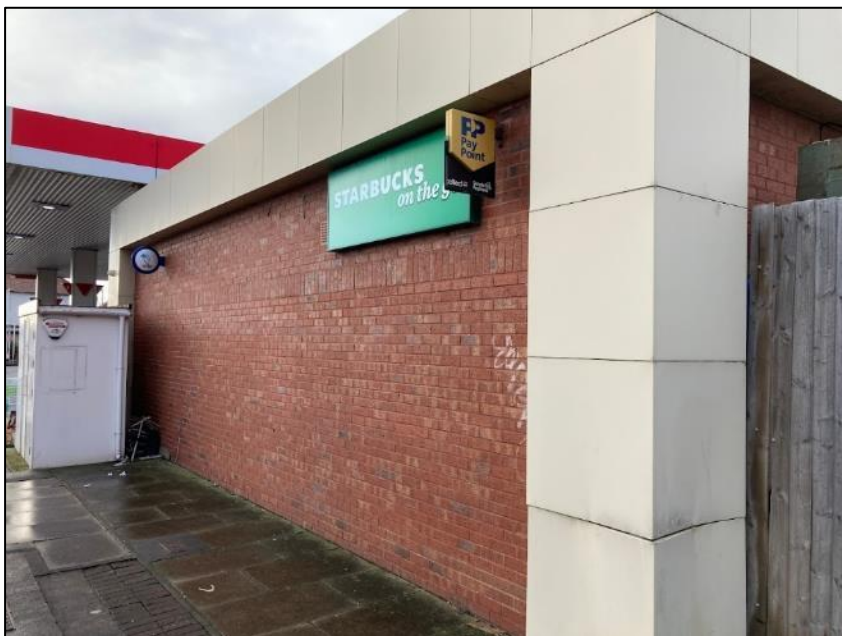
Photograph 12 showing the metal box cladding

- 3.17 The metal window and door frames are in reasonable condition and are well-sealed to the surrounding masonry. The flat roof is covered with corrugated metal panels. The panels could not be seen externally but the underside of the roof could be seen from the internal space. No access points or water ingress was found, suggesting the roof is well-sealed and in good condition. The metal box cladding that covers the roof edges are in good condition and well-sealed to the top of the walls (see Photograph 12).

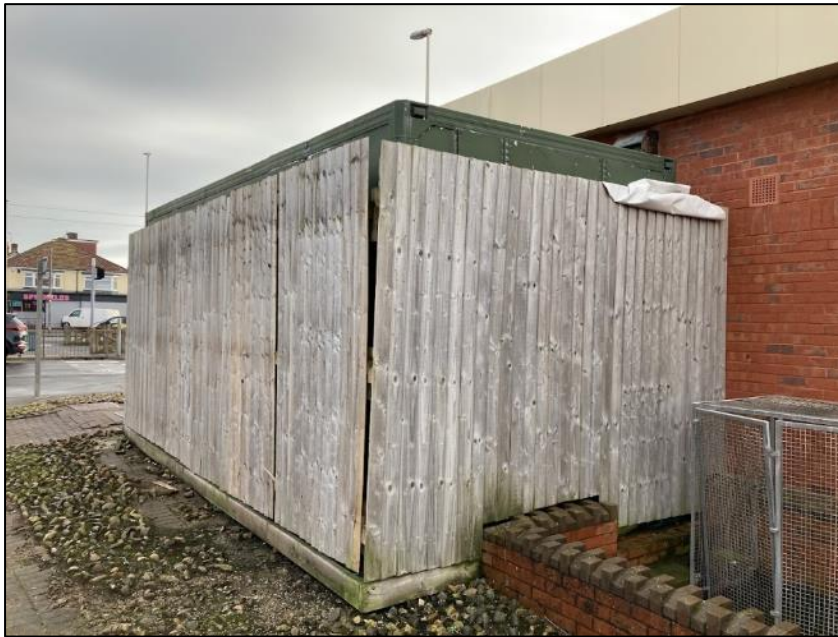
Photograph 13 showing the exterior of the building

- 3.18 A small extension is located to the rear of the building (see Photograph 13). This consists of a sealed metal container with no potential entry points found.

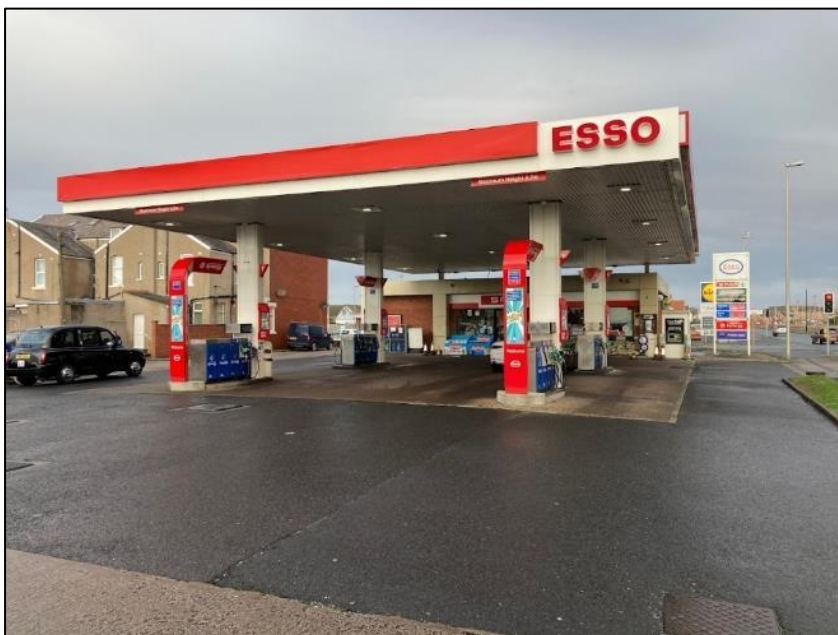
Photograph 14 showing the canopy over the forecourt

- 3.19 A canopy covers the forecourt, which is attached to the filling station building. This is constructed from a metal frame and cladding. The frame and cladding panels are in good condition, with no gaps or cracks located (see Photograph 14).

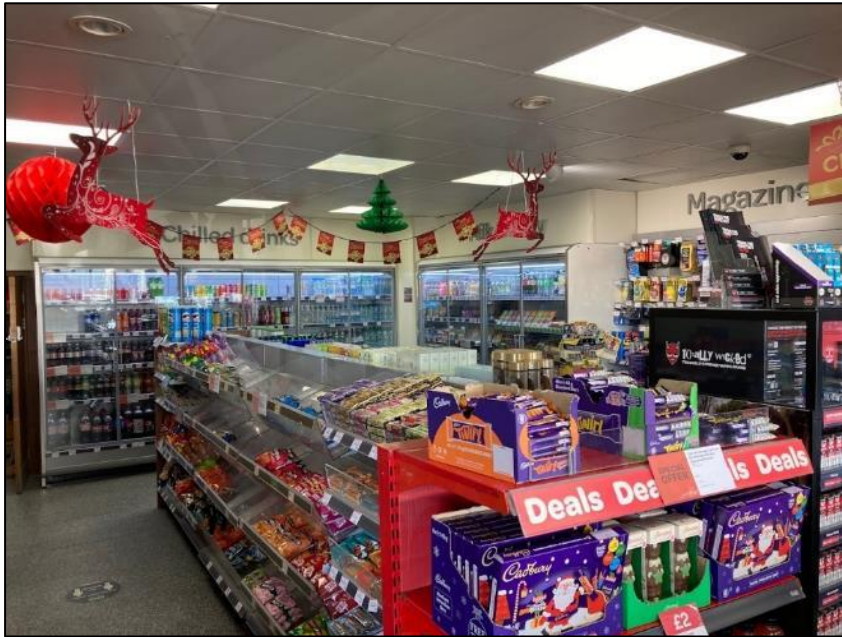
Photograph 15 showing the internal space of the petrol filling station

- 3.20 The internal spaces of the filling station offer a typical PFS sales building, with shelving, refrigerated units and a payment counter. A small office and storage spaces make up

the rest of the internal space (see Photographs 15 and 16). These spaces are well-finished, with no habitats associated with roosting bats.

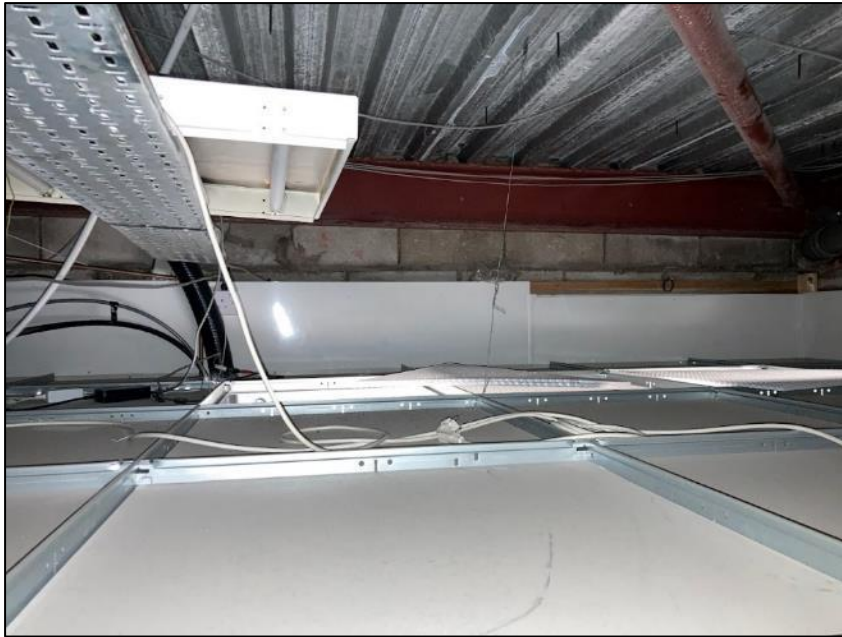
Photograph 17 showing the void space

- 3.21 A space is located between the false ceiling and the underside of the roof (see Photograph 17). This was accessed at multiple points by pushing the ceiling tiles upwards. The space consists of many services including lighting and ventilation ducting. The space is very cobwebbed and dusty (see Photograph 18).

- 3.22 The interior concrete block walls are in good condition and well-sealed with mortar. The void appears well-sealed as no daylight could be seen around the roof edges. The vents and ducts are well-sealed to the internal walls with expanding foam. No evidence of bat activity was found within the filling station building.

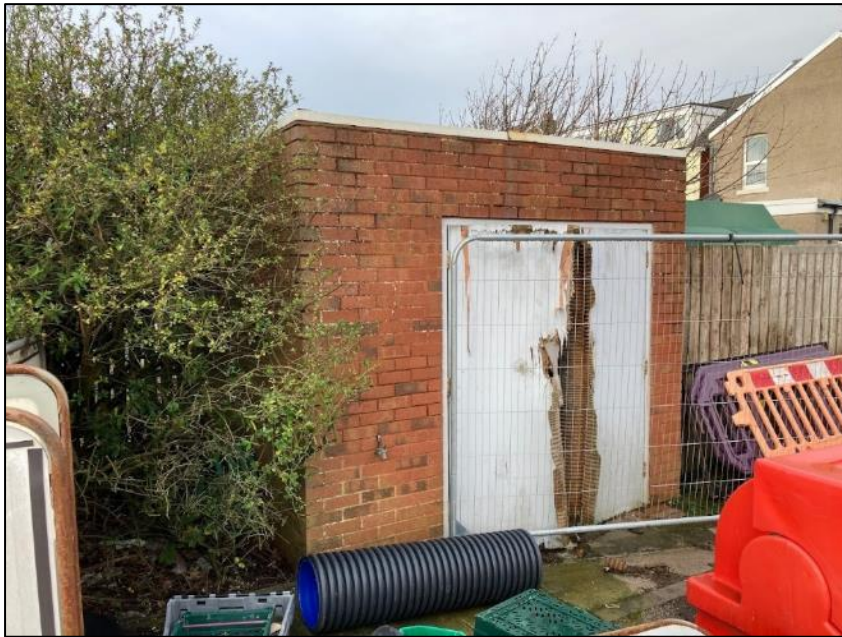
Photograph 19 showing the storage building

- 3.23 A small, detached, single storey storage building is located on site (see Photograph 19). The masonry is in good condition and well-sealed with mortar with no potential entry points or roosting habitat found (see Photograph 20).

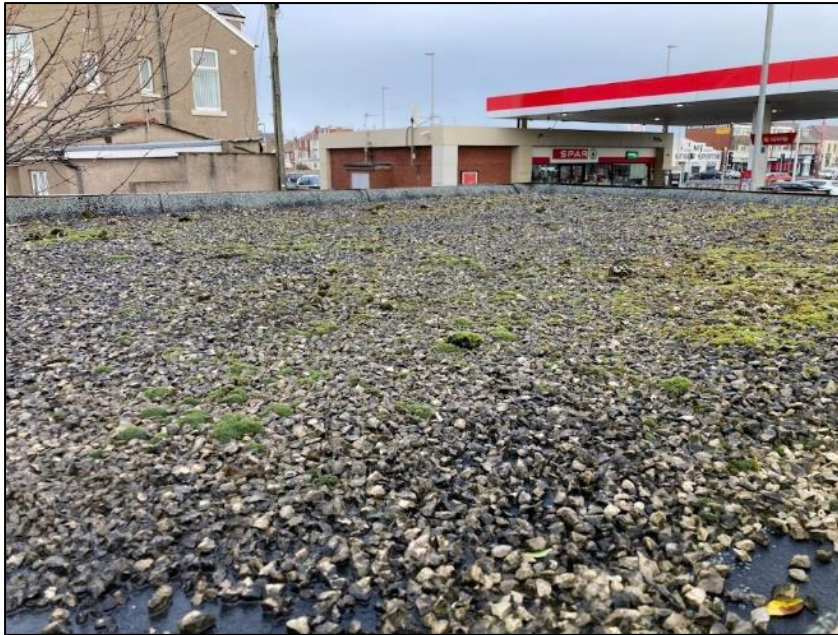
Photograph 21 showing the flat roof

- 3.24 The flat roof is covered with roofing felt and stone chipping (see Photograph 21). The felt is in good condition and fitted flush to the roof edges. The roof edges are finished with timber bargeboards. These are showing signs of age, however, are fitted flush to the exterior masonry.

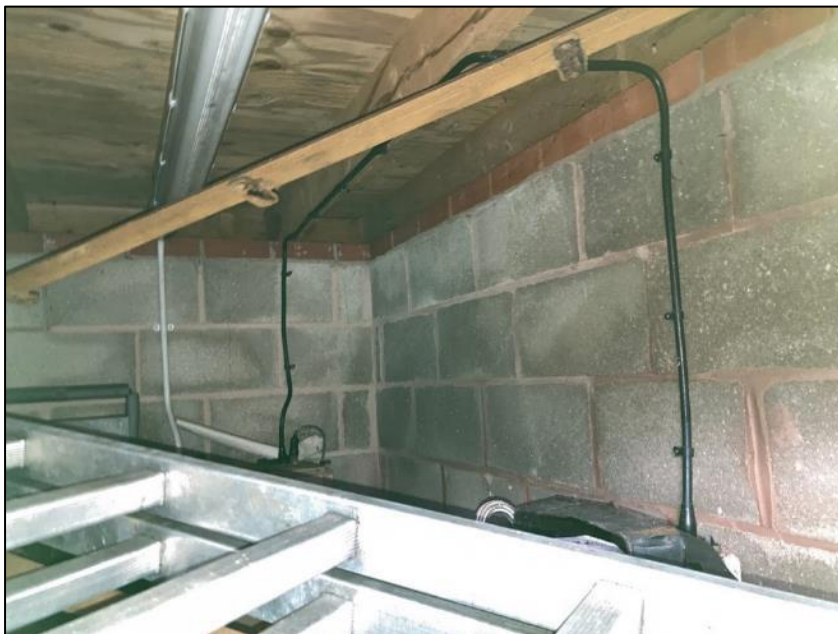
Photograph 22 showing the interior of the storage building

- 3.25 The internal space is heavily used for storage with equipment stacked up to the underside of the roof with no roof void space present (see Photograph 22). The internal masonry is in good condition, as is the associated mortar. No suitable bat roost habitat is present, nor any evidence of bat activity or occupancy found.

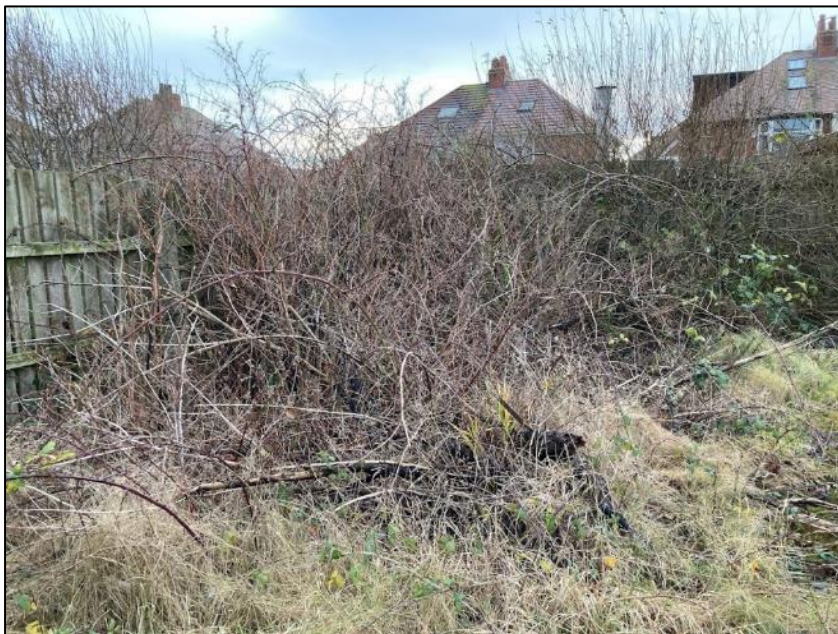
Photograph 23 showing the stand of Japanese Knotweed

- 3.31 Japanese Knotweed *Reynoutria japonica* occurs on site, within an area of tall, ruderal herb on the southern boundary (see Photograph 23). This is an invasive, non-native species and is listed on Schedule 9 Part II (plants) of the Wildlife and Countryside Act 1981 (as amended), making it illegal to allow their spread in the wild. The staff on site informed that the Japanese Knotweed has been treated recently.

- 4.9 Japanese Knotweed is located on site. This species must be removed from the site using a recognised methodology prior to or during site clearance work.

5.4 The Japanese Knotweed must be carefully removed from site, using a recognised methodology. This should be digging out and removal off-site to a licensed landfill or digging out and deep burial with a suitable barrier membrane on site.
